International Boundary and Water Commission United States Section

Lower Rio Grande Flood Control Project
Arroyo Colorado Post Flood Cleanup
June 22, 2011

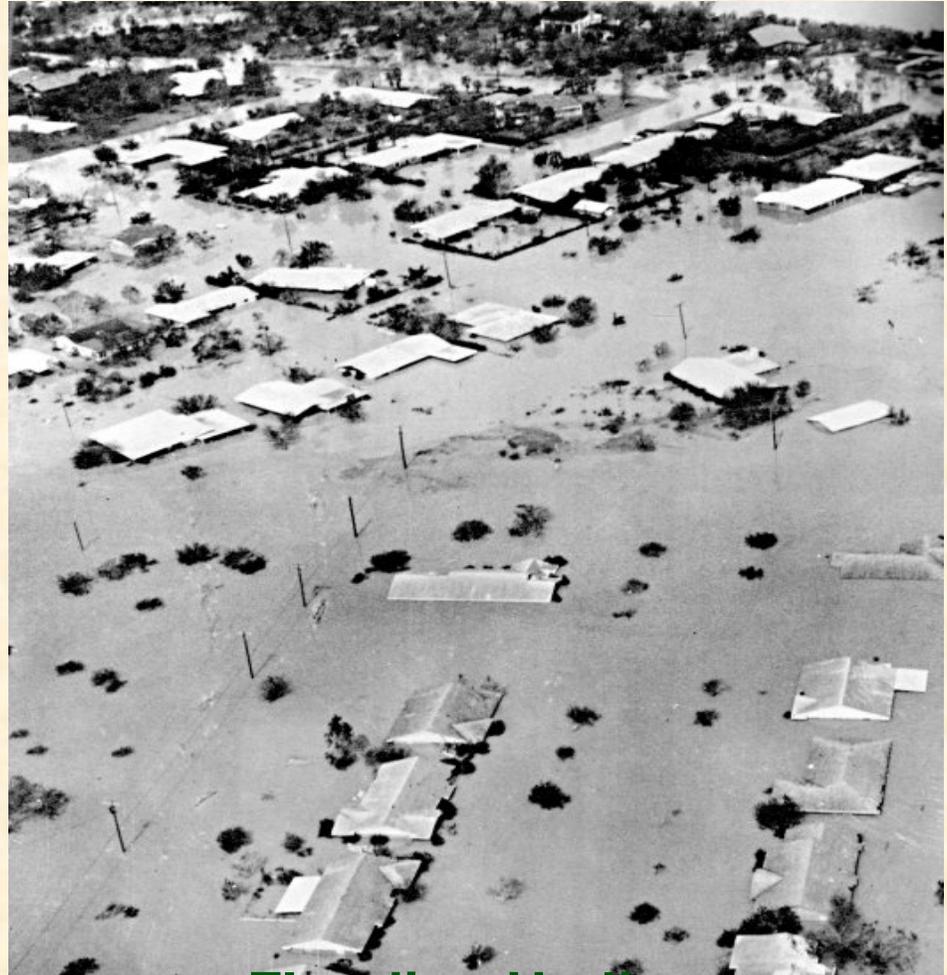
Flooding Harlingen,
Texas, 1967

- A weir failed causing 60,000 cfs to flow into the Arroyo Colorado

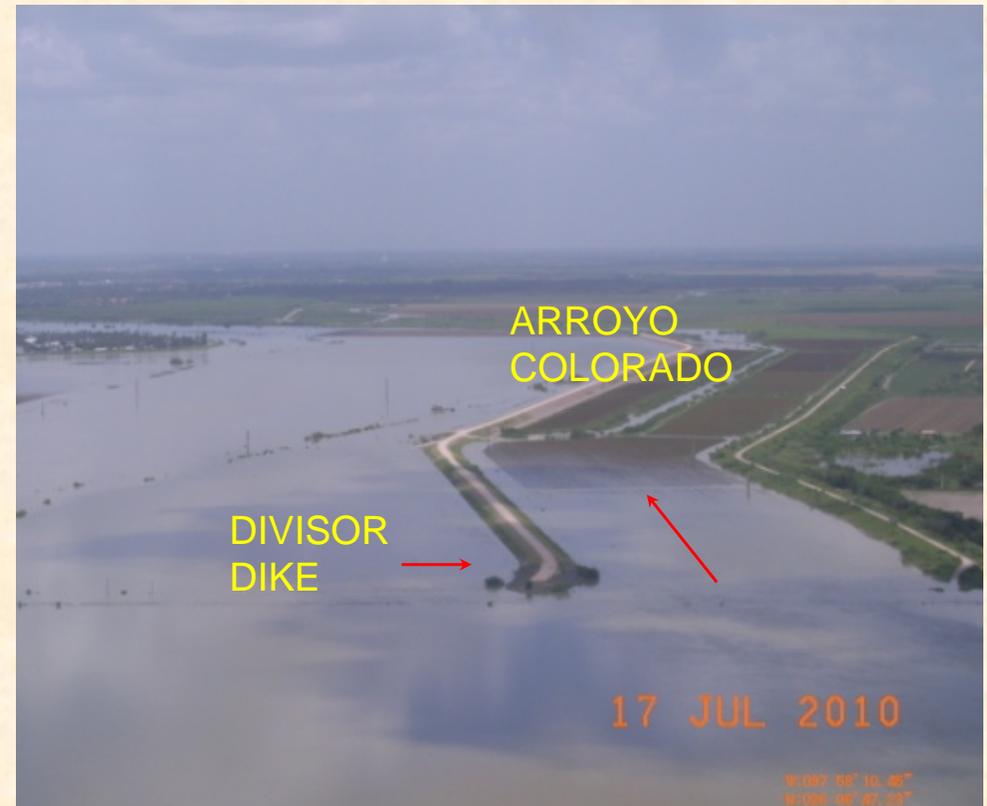
Divisor Dike, Hurricane Alex, Arroyo Colorado, Mercedes, Texas

- A Divisor Dike was constructed in 1968 to ensure the arroyo will receive its design flow of 21,000 cfs during a major event

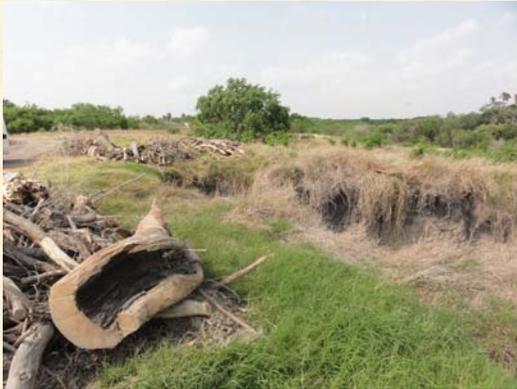
Dead Trees
April 21, 2011

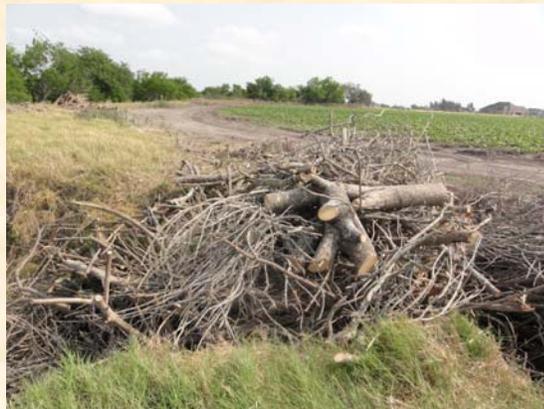
Debris
Stockpiled
April 21, 2011

Remove Dead Trees

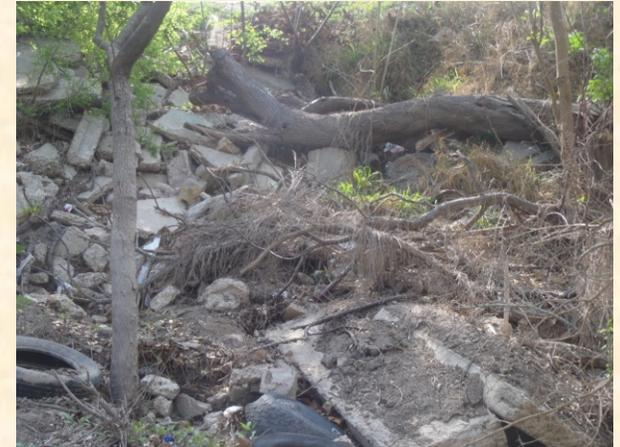
Arroyo
Colorado
Photo taken
3-9-11

- USIBWC removed 15 truck loads of dead trees and debris below the 21,000 cfs flow line
- USIBWC notified land owners of the cleanup
- During the cleanup USIBWC had an onsite environmental monitor

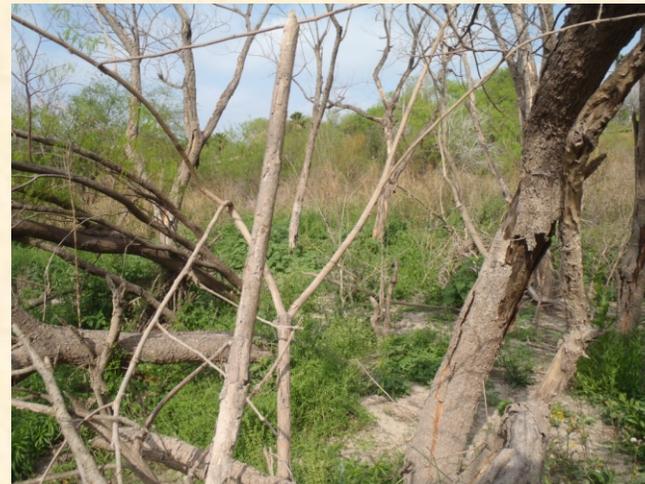
Dead Trees
to be
removed
Photo taken
3-9-11

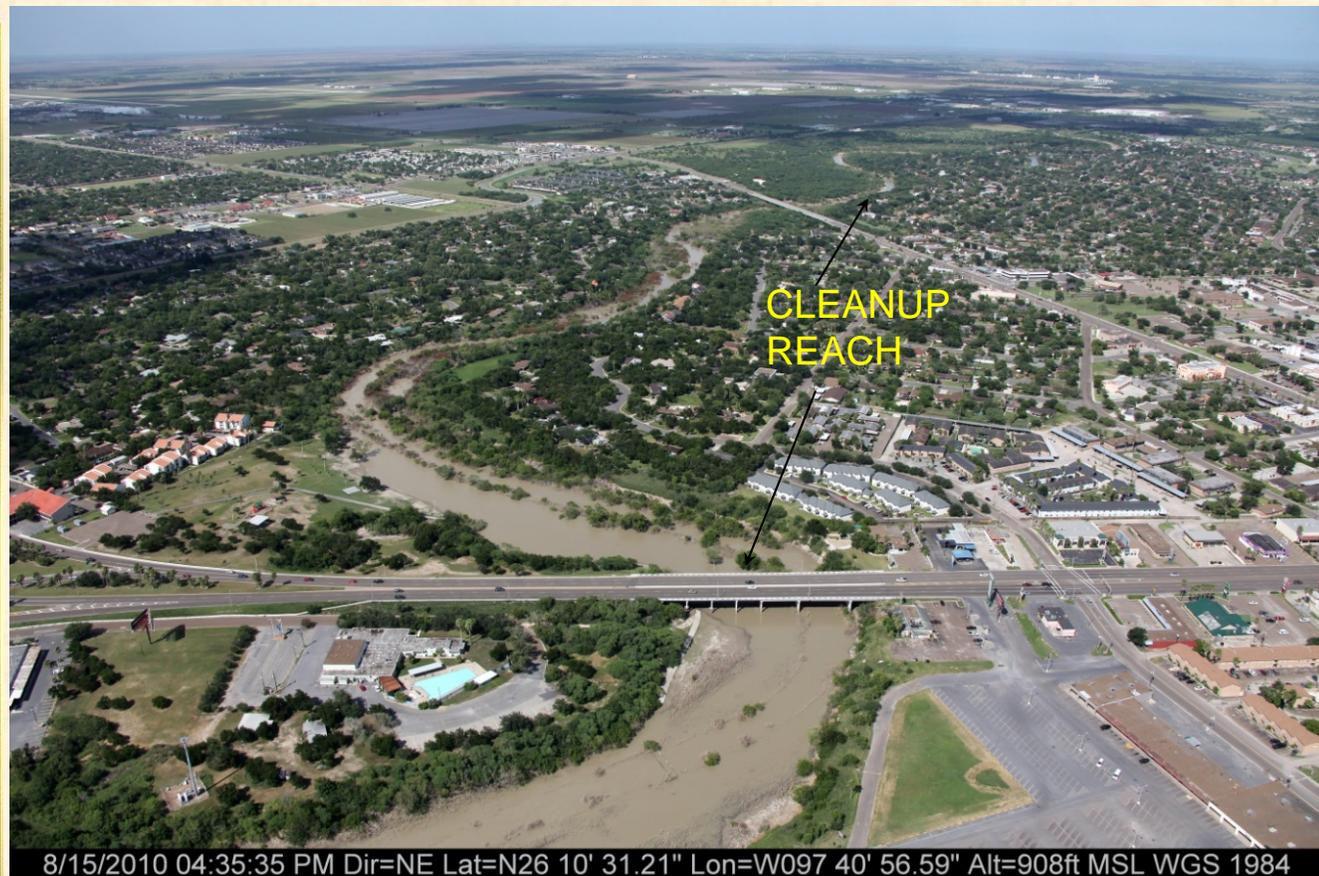
Arroyo Colorado Flow - August 15, 2010

- Flows one month after Hurricane Alex
- Note trees within the flow
- Note brown fringe of dead trees within the arroyo
