# **Upper Brownsville Geotechnical Site Investigation Update**

**International Boundary and Water Commission**  
United States Section  
Engineering Services Division

**February 11, 2015**

## UPPER BROWNSVILLE LEVEE

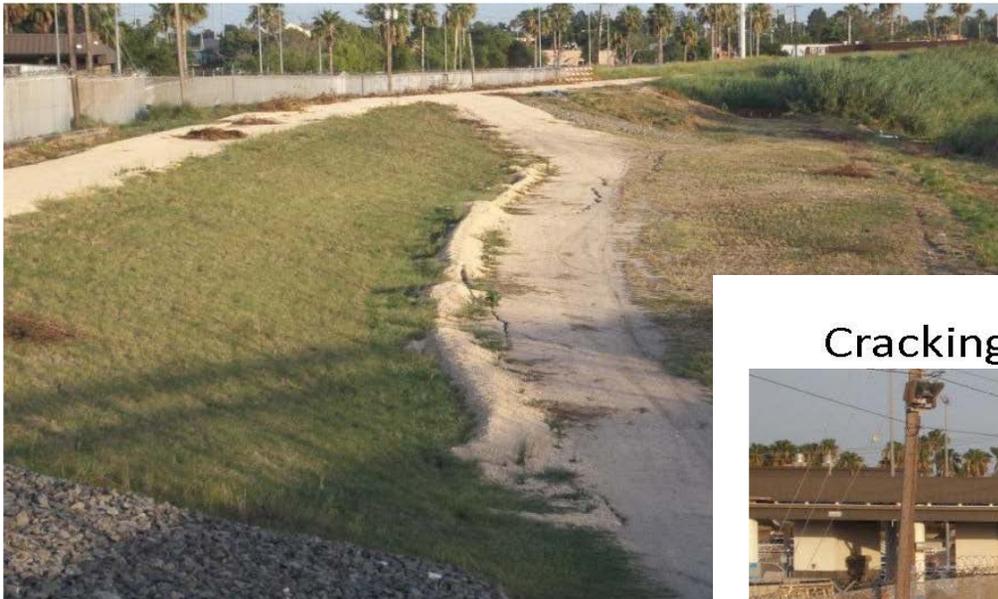
Cracks at levee toe

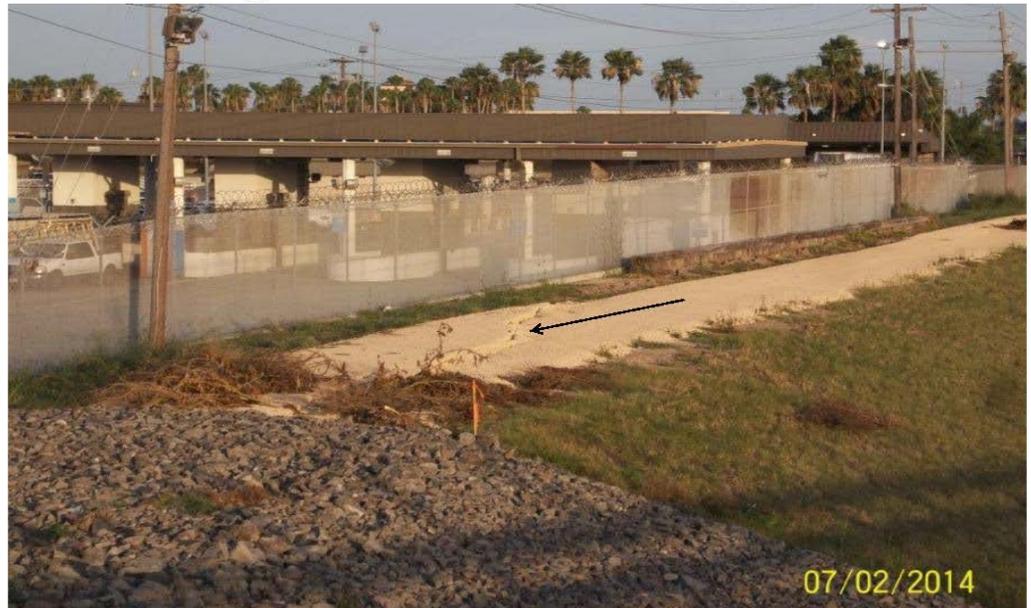
Cracking and settlement at top of levee

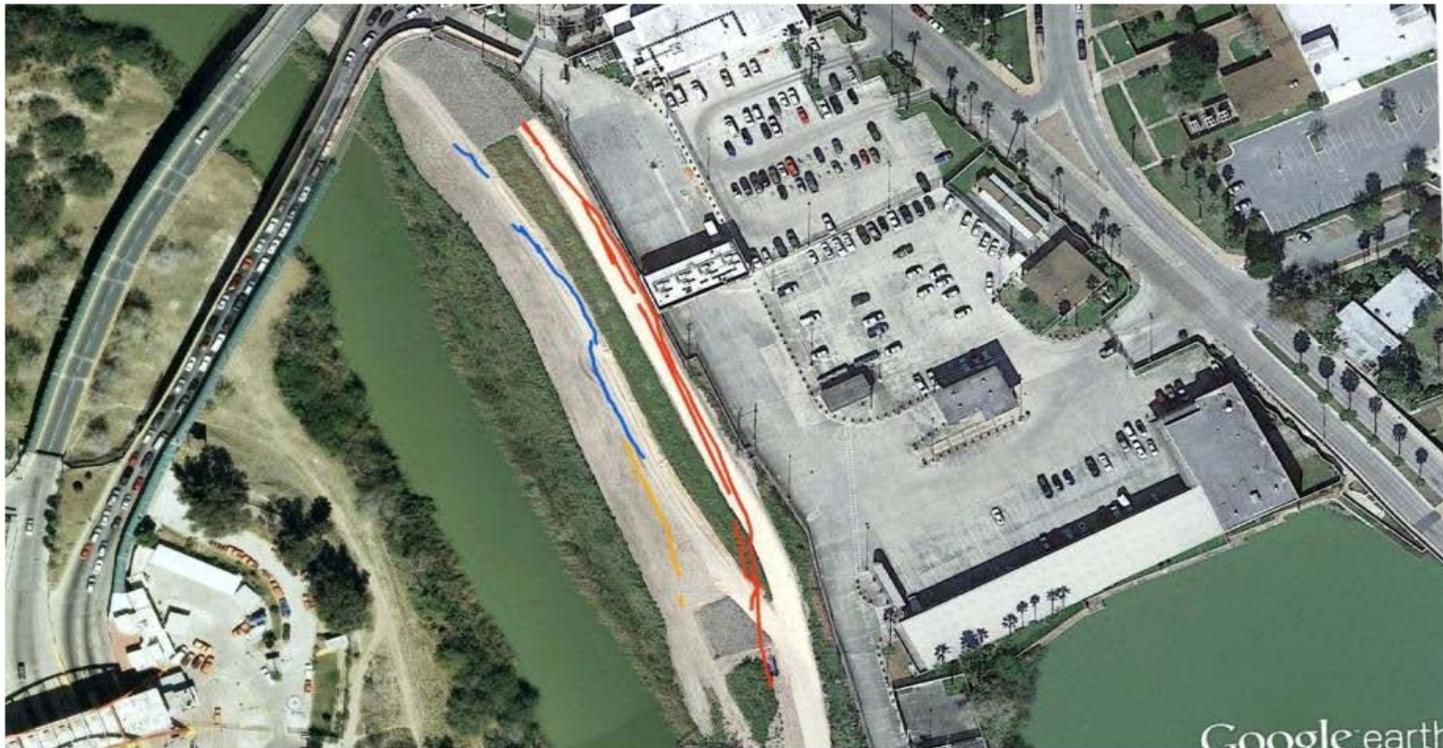
Three Major Crack Sets – 1 July 2014

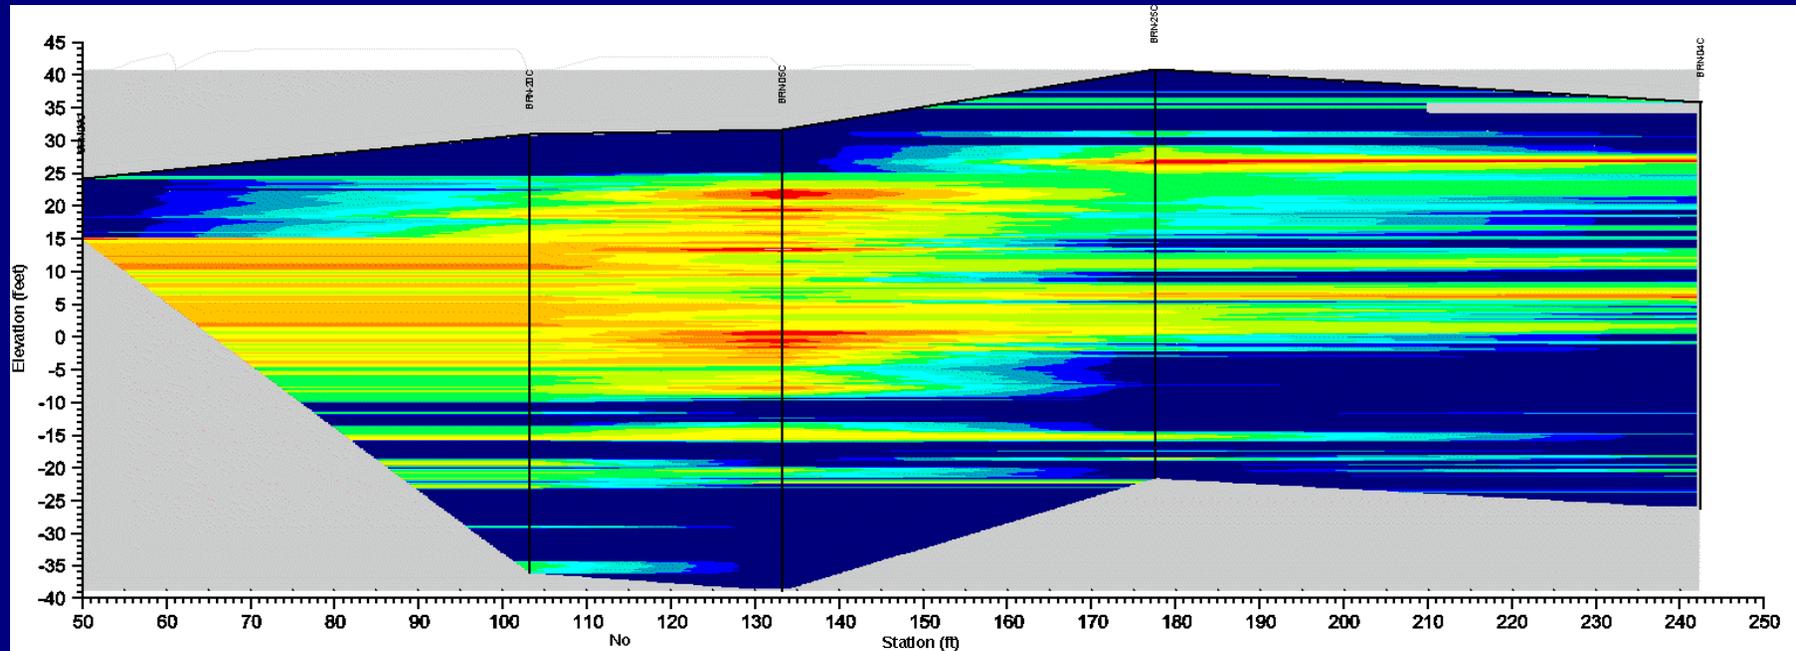
Cross Section: R2

■ In Situ anomaly causing data processing error

**Cross Section of R2  
CPT predicted Strength (ERDC version)**

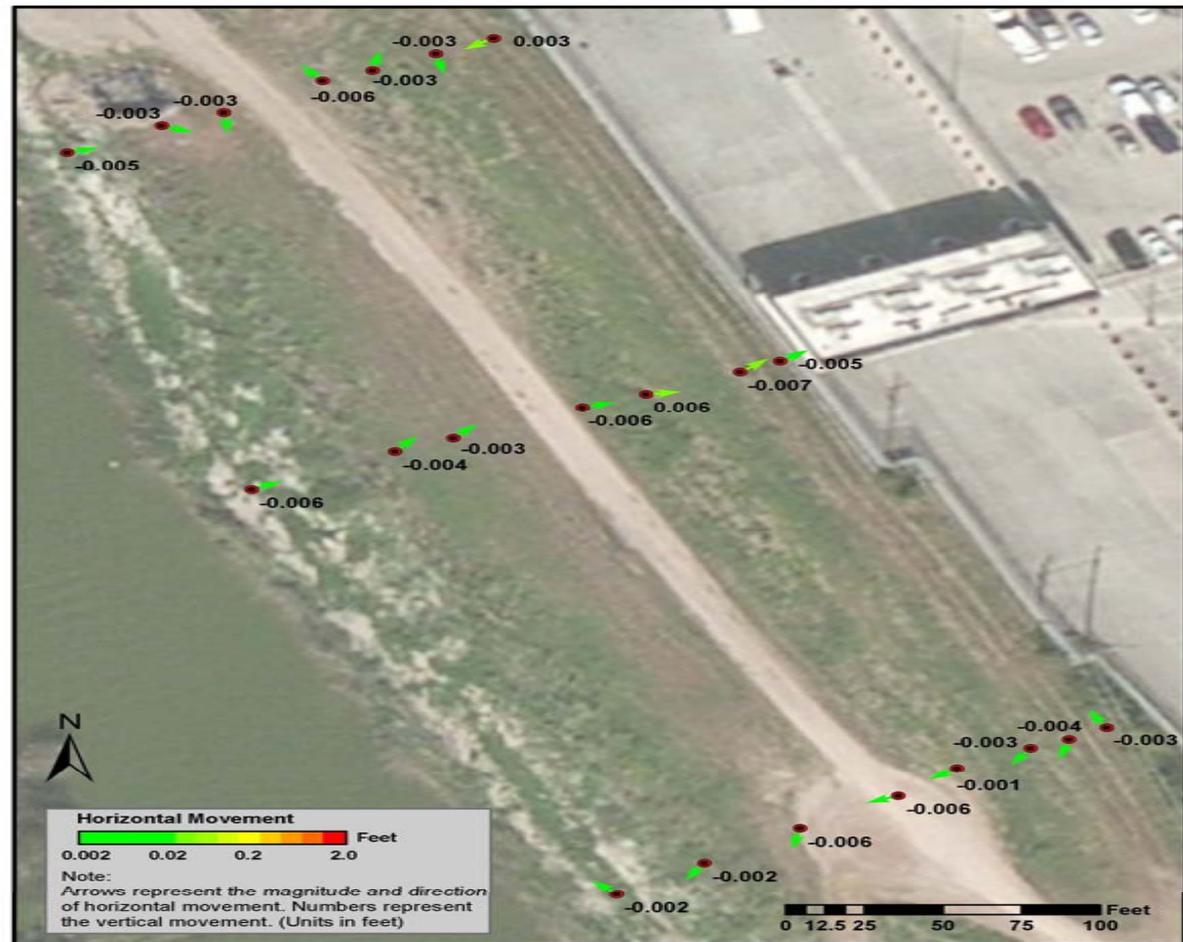
**Movement from Aug 26 to Sept 9 (Total Station)**

- Three methods of monitoring:
  - Monthly surveys
  - Inclinometers
  - Piezometers
- The results show there has been little to no movement from August 2014 to Present Day.

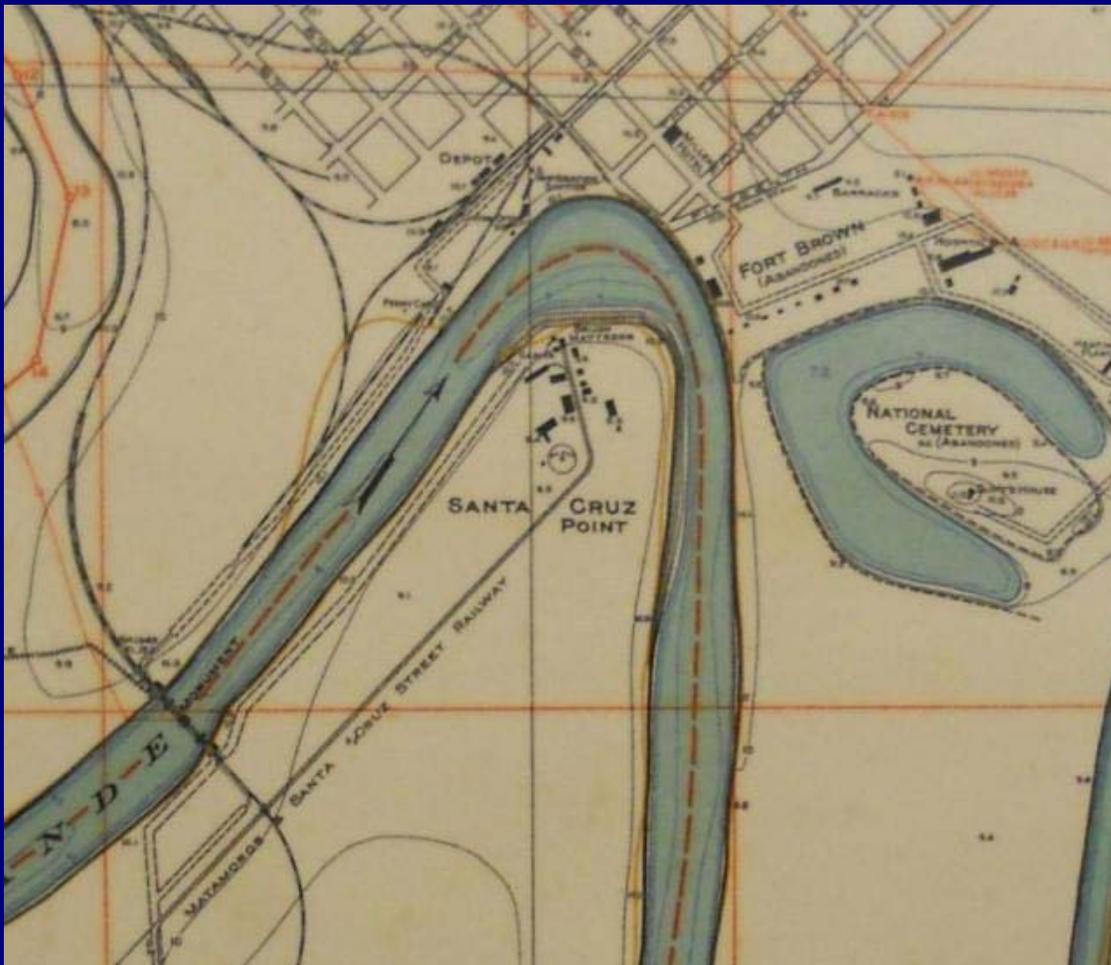
# 1911 Topographic Map by IBWC

- Scour pool in the river bend nearly 30 ft deep based on contours shown on 1911 map
- Note the Customs building adjacent to levee area of interest as landmark for historic photos that follow

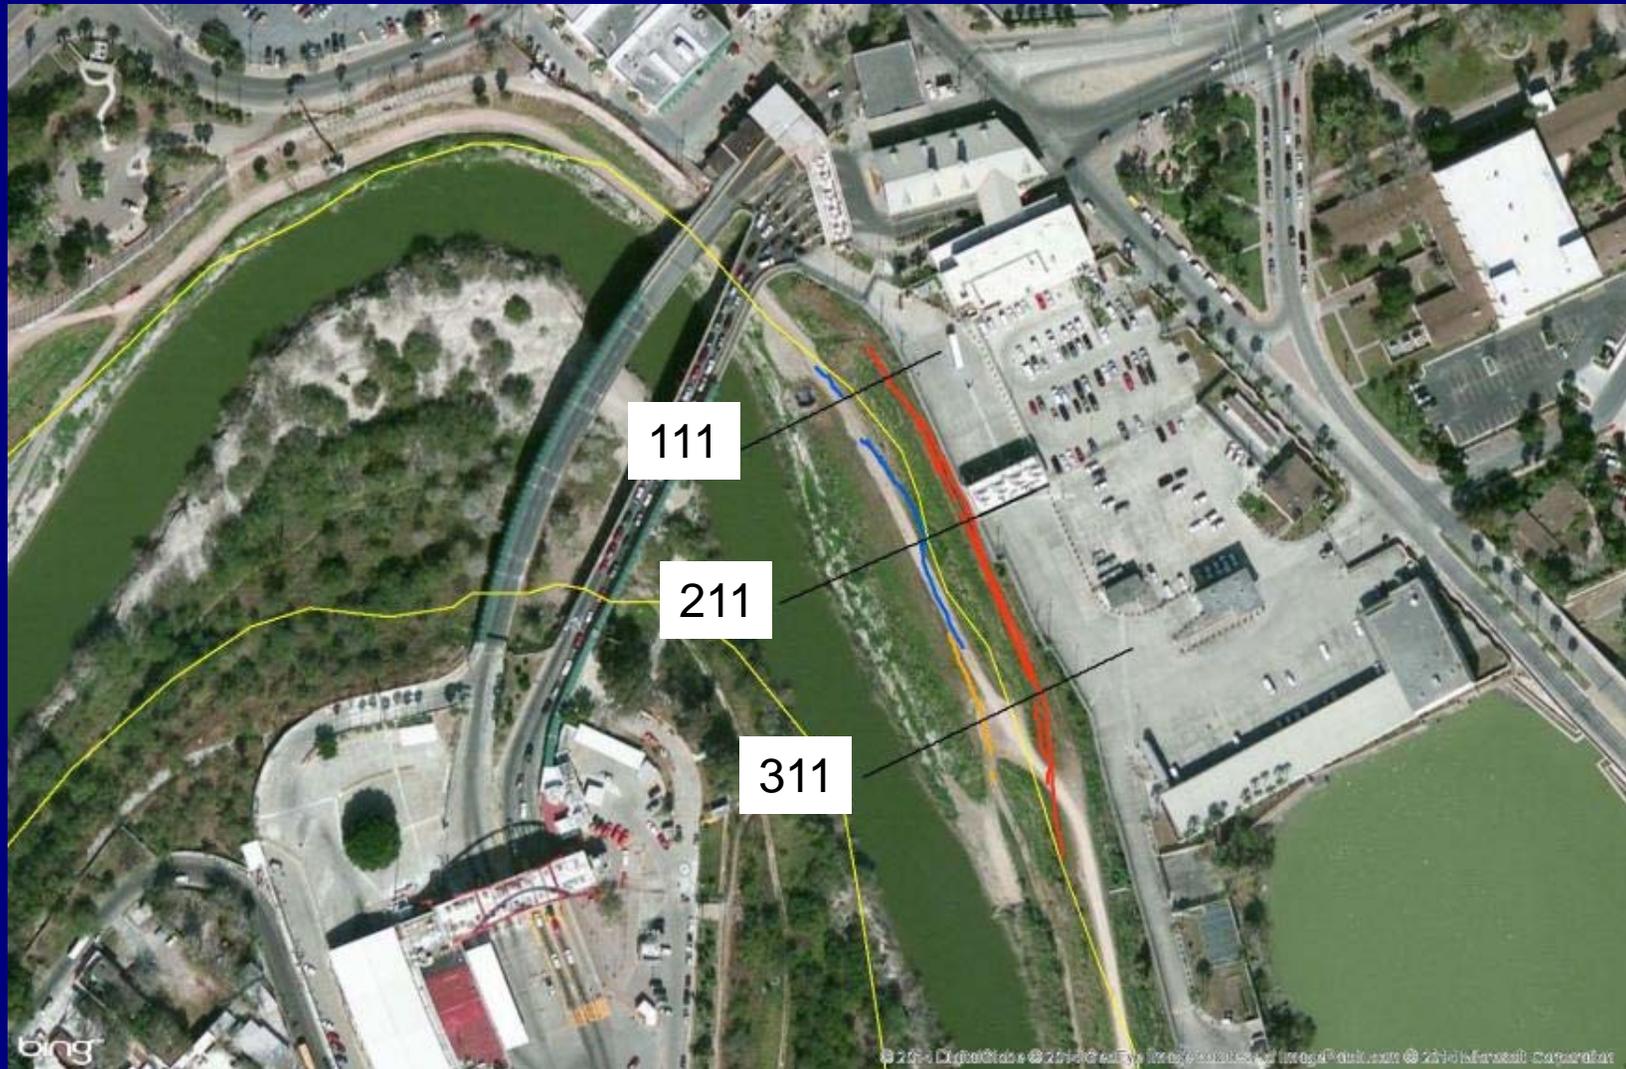
Cracks, 1930 channel, section locations, on 2013 image
