Hurricane Alex Flood Operations Lower Rio Grande Flood Control Project

Lower Rio Grande Citizens Forum

August 25, 2010

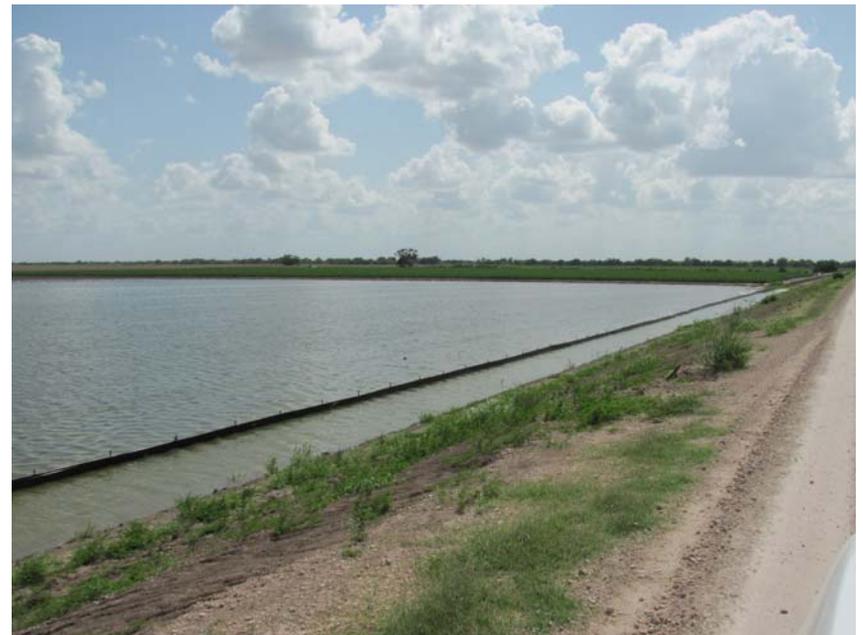
- Minor problems experienced
 - Erosion – Vegetation in recently-completed Banker Floodway levee was not well established, some erosion occurred

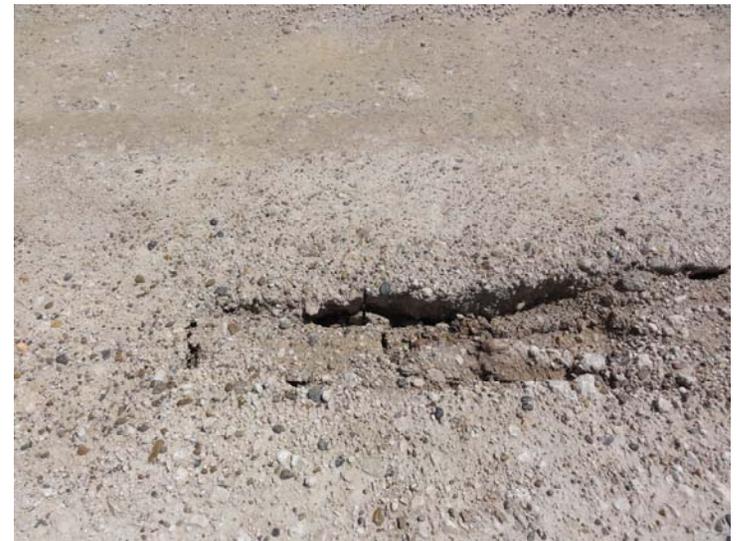
- Minor problems experienced
 - Sand boils - Near McAllen and Santa Monica.
 - Seepage - Santa Monica area
 - Cracks - near Donna, Santa Rosa, and Sebastian
- Levee-Wall
 - Cracks - downstream of the Edinburg (Peñitas) Pump House on the river levee

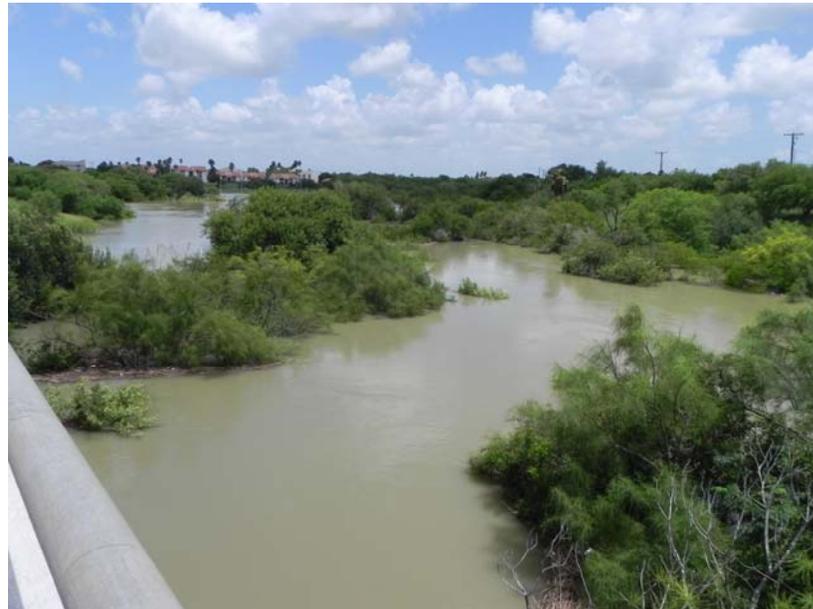
McKelvey Park, Arroyo Colorado, Harlingen

- Most levee segments conveyed flood flows with adequate freeboard
- Water surface elevations were higher than expected at:
 - Arroyo Colorado @ Harlingen – reasons under investigation.

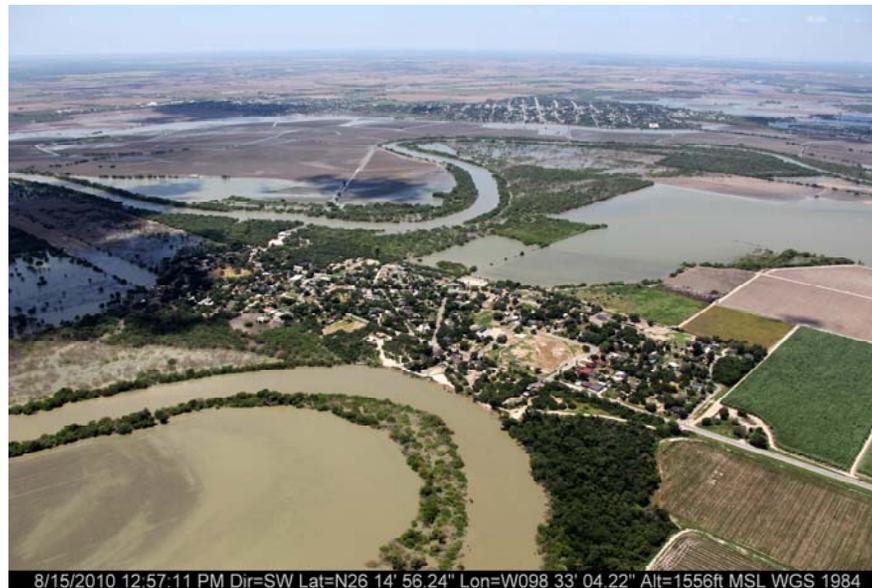
Rio Grande at Los Ebanos, upstream from levee

- Water surface elevations were higher than expected at:
 - Santa Monica
- Areas upstream of Peñitas do not have levees

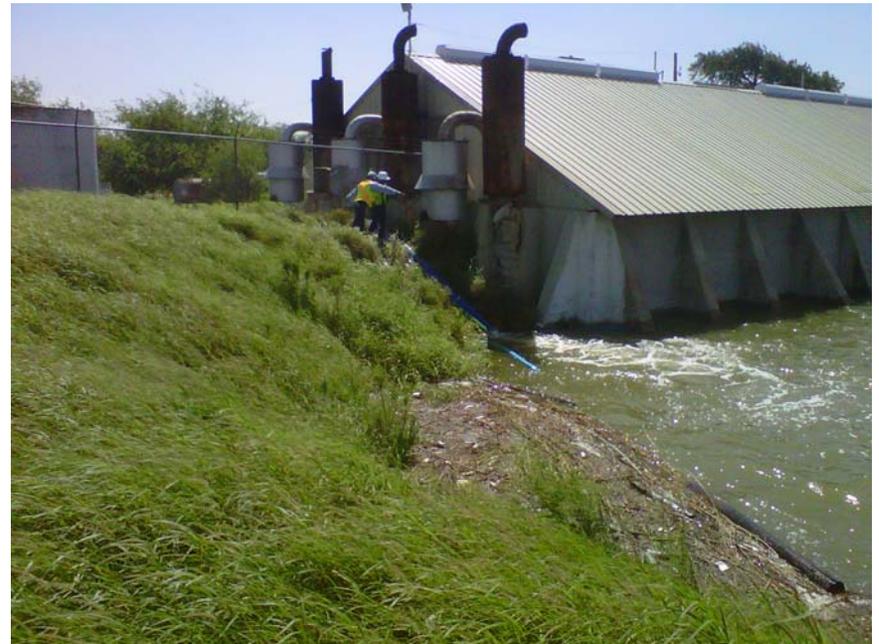
- Pumping plant located at Peñitas
 - Constructed in 1925
 - Still used by the irrigation district
 - Considered a historic structure
- Concrete floodwall attached to the pumping plant provided flood protection in the past

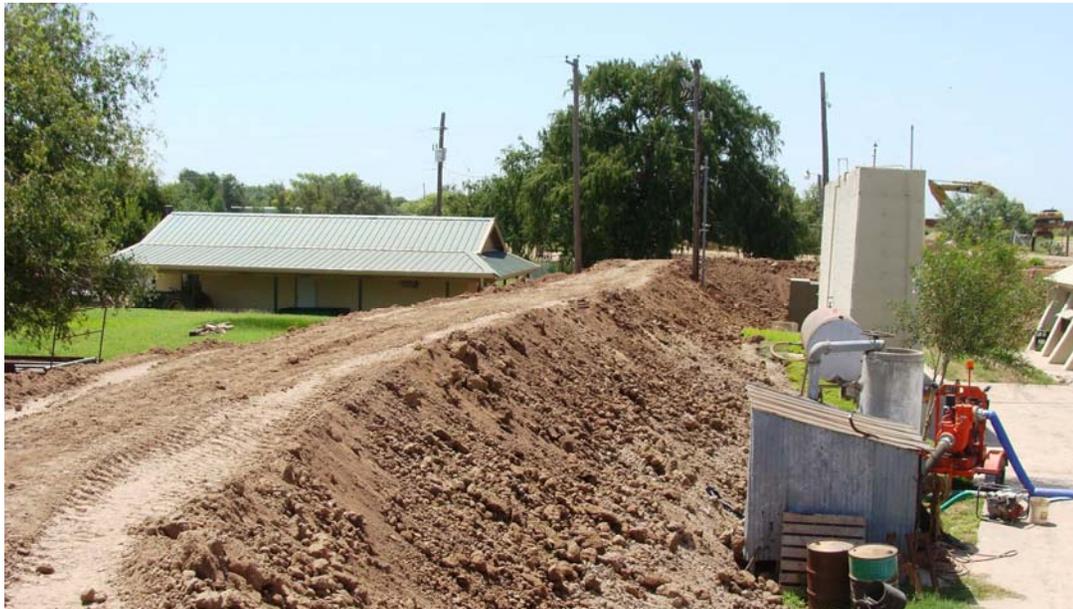
- Due to the age of the structure, concern that it could fail under flood conditions
- USIBWC and Hidalgo County coordinated to construct an earthen berm behind the pump house to provide emergency protection

- USIBWC awarded a \$5 million Recovery Act contract prior to Hurricane Alex to construct a new levee there
- New levee segment around the pump would include a gated crossing at the pump's intake channel
- Construction will begin once conditions allow

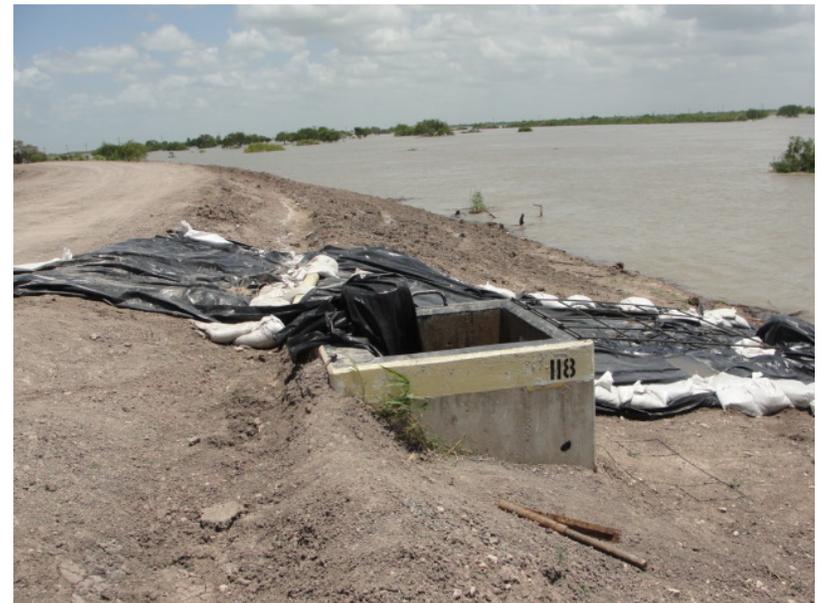
- Sometimes there is leakage even when gates are closed
- Structure problems occurred:
 - D/S of 23rd St. and Alamo Rd on north levee of the Main Floodway
 - D/S of FM 88 on the south levee of the Main Floodway
 - 9 structures in Peñitas and Mission levees
 - Some problems with structures where Recovery Act construction was underway
