# **Upper Brownsville Geotechnical Site Investigation Update**

**International Boundary and Water Commission**  
**United States Section**  
Engineering Services Division

**May 13, 2015**

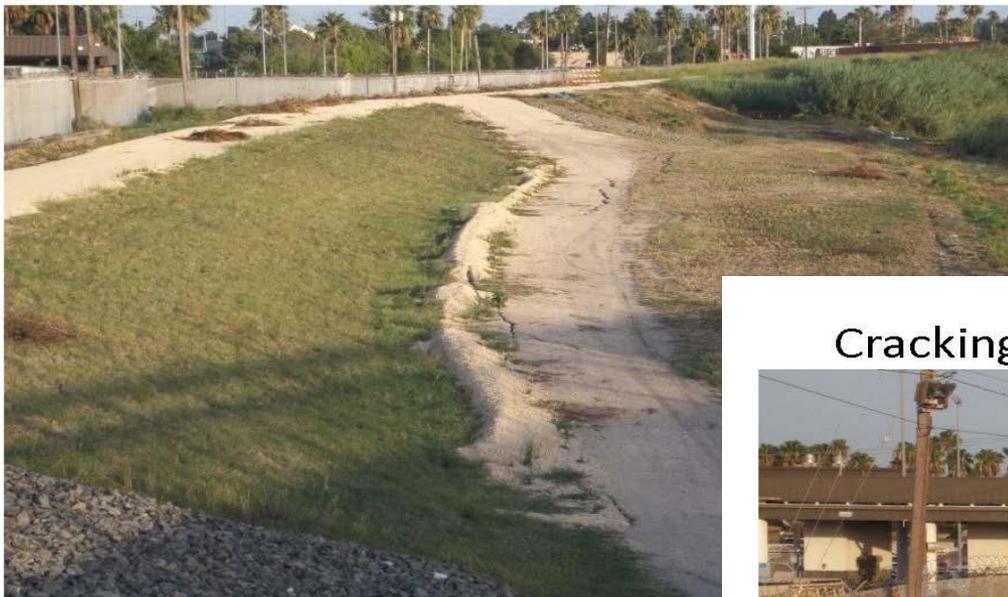
Cracks at levee toe

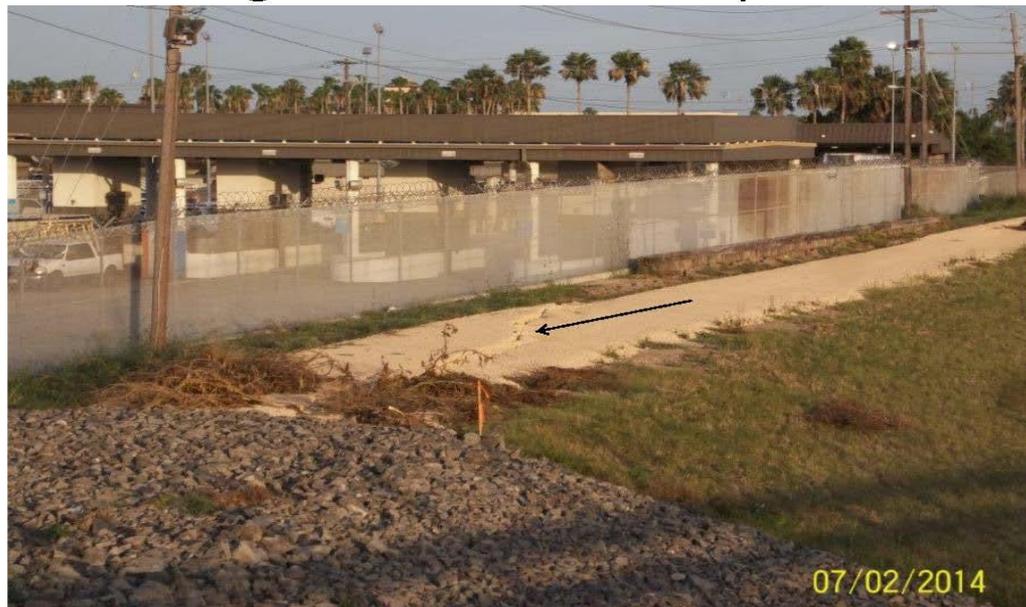
Cracking and settlement at top of levee

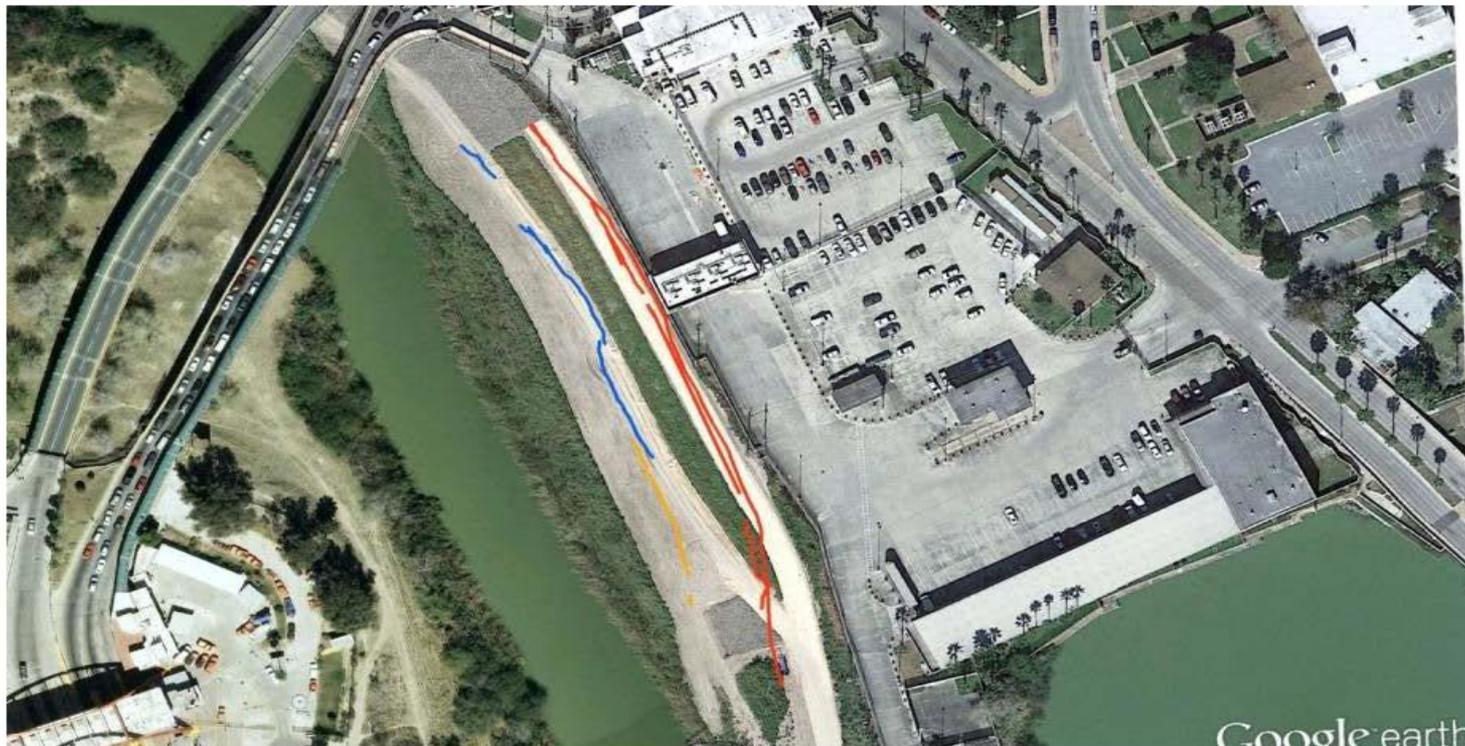
Three Major Crack Sets – 1 July 2014

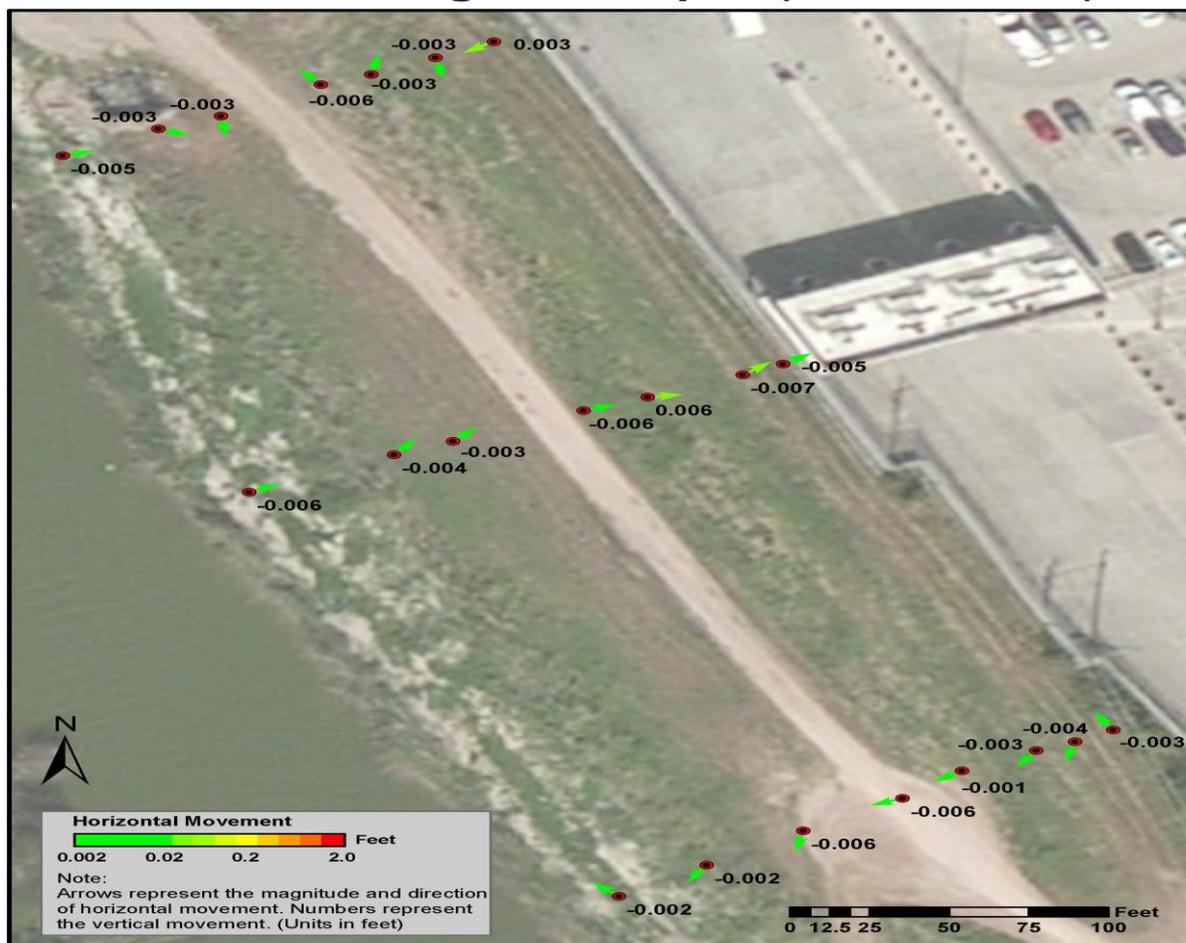
**Movement from Aug 26 to Sept 9 (Total Station)**

- Three methods of monitoring:
  - Monthly surveys
  - Inclinometers
  - Piezometers
- The results show there has been little to no movement from August 2014 to Present Day.

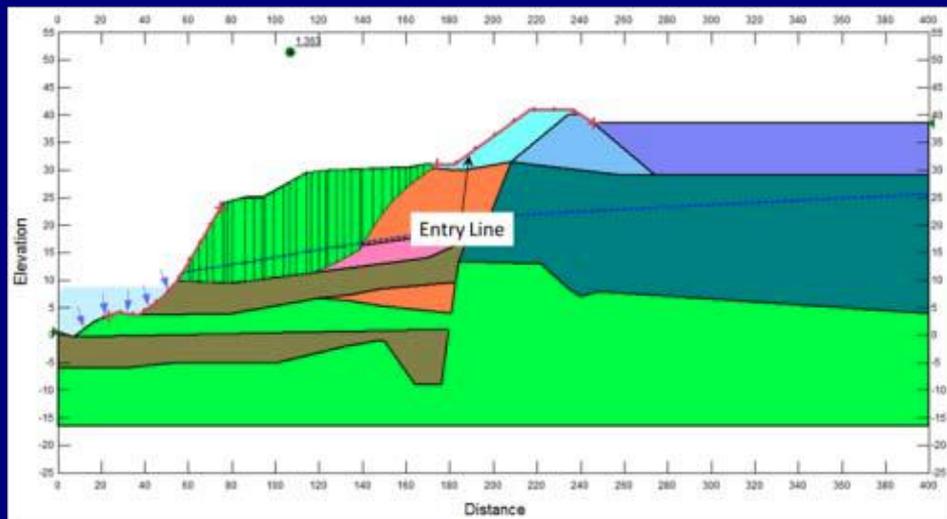
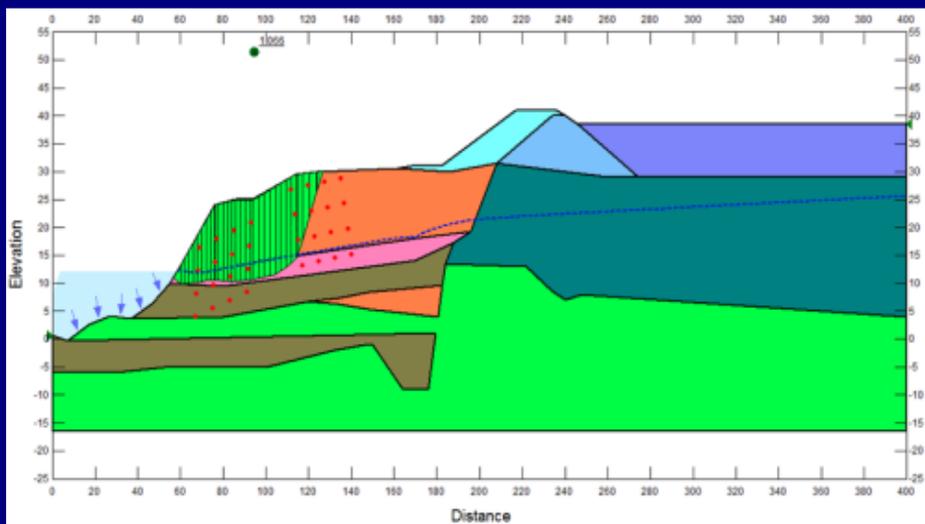
# Numerical Modeling Results (Cross Section 111)

- Infiltration surface at Station 1900+13, riverbank movement.

- Station 1900+13 with weak zone shear strength at 215 pcf.

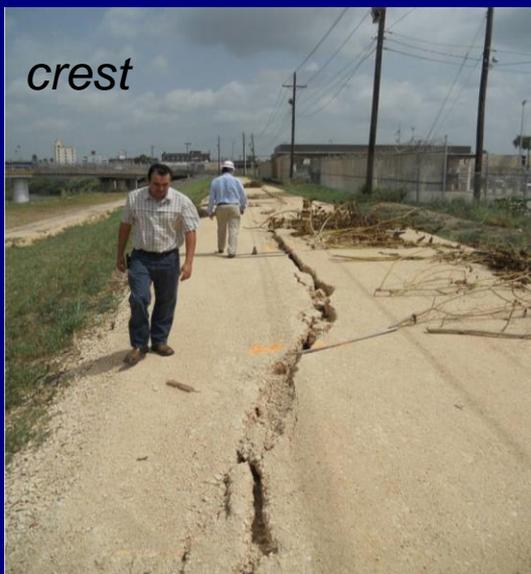
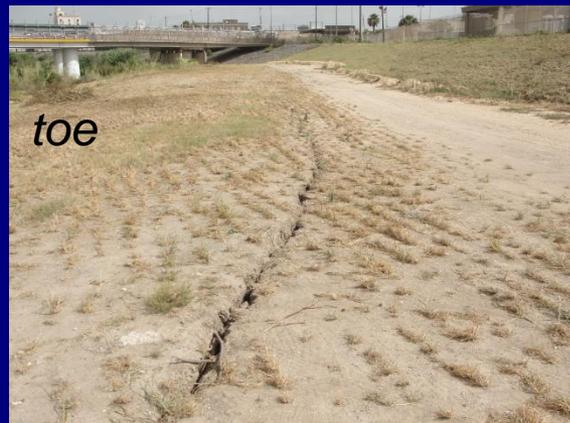
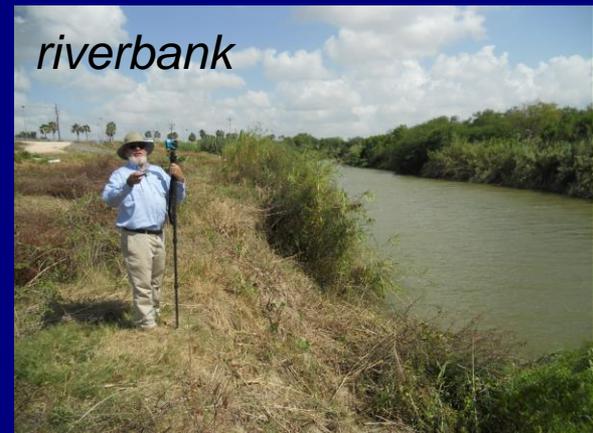
# Contributing Factors

- A series of rapid river drawdown events, combined with the local geologic conditions, led to the partial slope slide.
- Steep riverbank slopes combined with a deep scour pool in the bendway contribute to the sliding through this reach.
- Progressive/creep-type sliding is the probable mechanism that caused the cracking.
- Lake Brown's water elevation adversely impacts the stability of the levee.

- **Alternative I:** Re-grade the bank to a 1V:5H slope with appropriately sized riprap protection from the edge of the access road to below the elevation of the softer material (long term, >5yrs)
- **Alternative II:** Install a sheetpile wall behind the existing riverbank to reinforce the soft alluvial sediments (long term, >5yrs)
- **Alternative III:** Improve the soil strength at the toe of the levee using soil mixing, installing either a continuous wall or panels to improve the shear strength and rigidity of the foundation materials (long term, >5yrs)
- **Alternative IV:** Monitor existing conditions and maintain stable river elevations. Avoid rapid drawdown events (short term, 3-5 yrs)

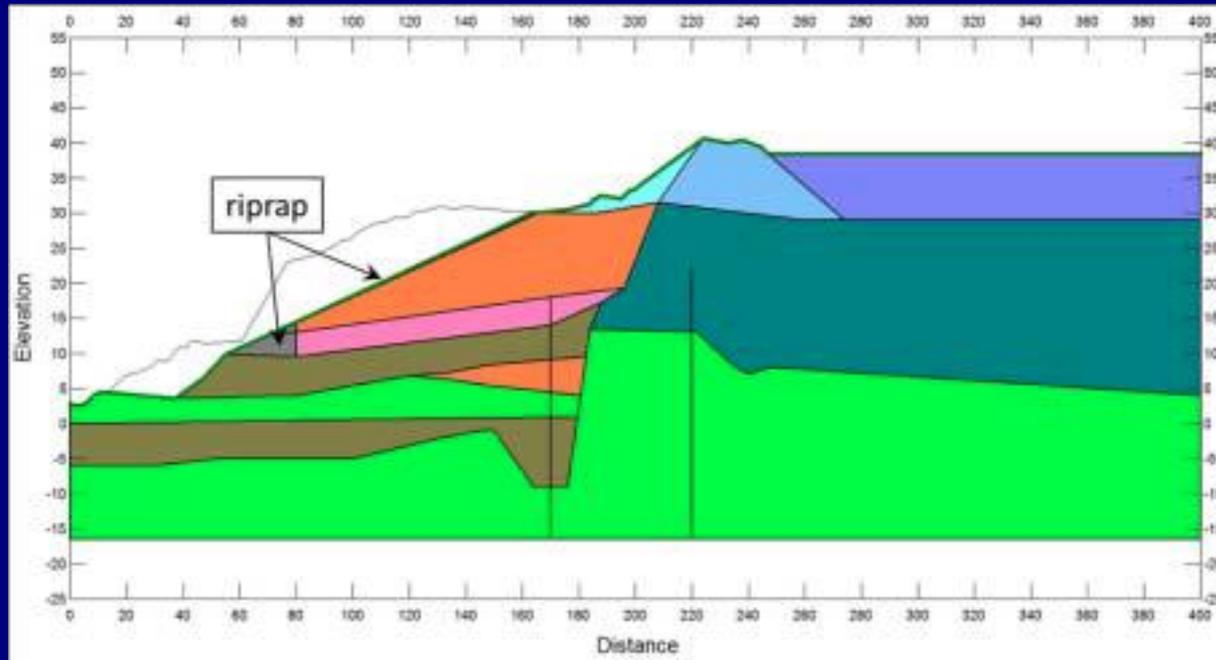
## Alternative I: Re-grade Bank & Place Rock Riprap

Analysis	Steady State Low (7.77 ft)	Steady State High (14.31 ft)	Rapid Drawdown (14.31 ft. to 7.77 ft.)	Hydrograph (transient analysis)
Pre-instability	1.26	1.10	1.00	1.02
Post-instability	1.16	1.17	1.00	1.15
Alt. I	1.24	1.22	1.20	1.56
Alt. II	1.62	1.55	1.34	1.64
Alt. III	1.56	1.67	2.19	2.32
