Status of International Outfall Interceptor Sewer Pipe in
Nogales, Arizona

International Boundary and Water Commission

October 13, 2011

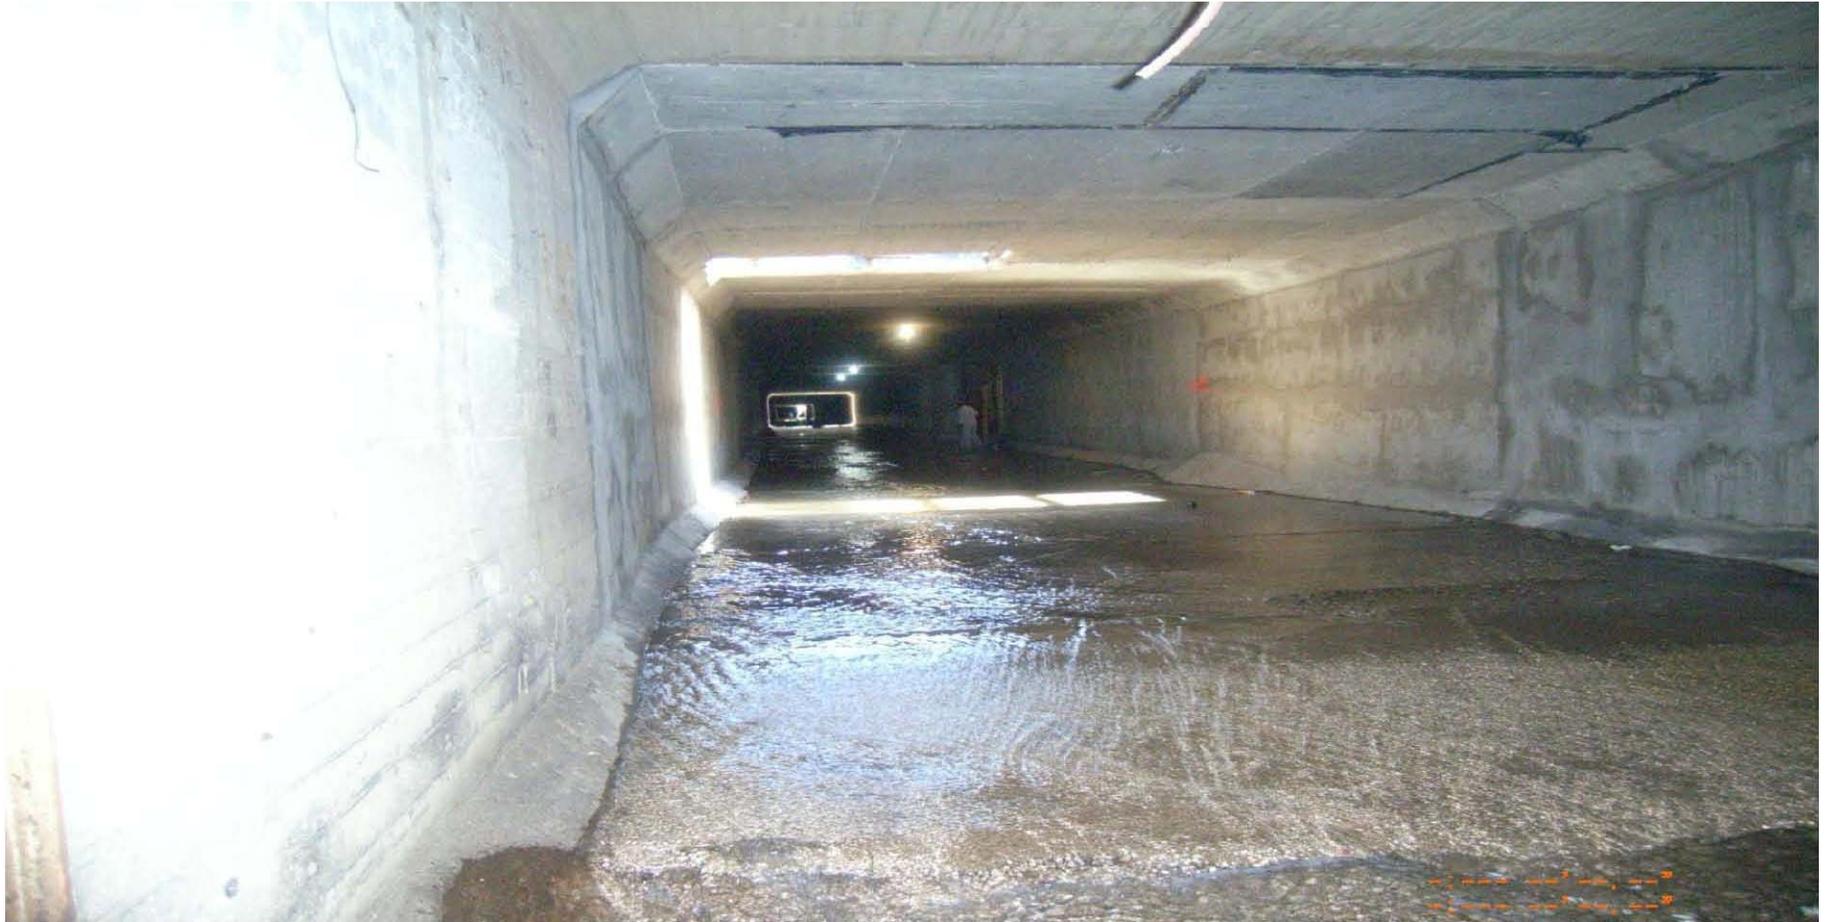
Underground Box Culvert Approx. 10' x 20' Looking South

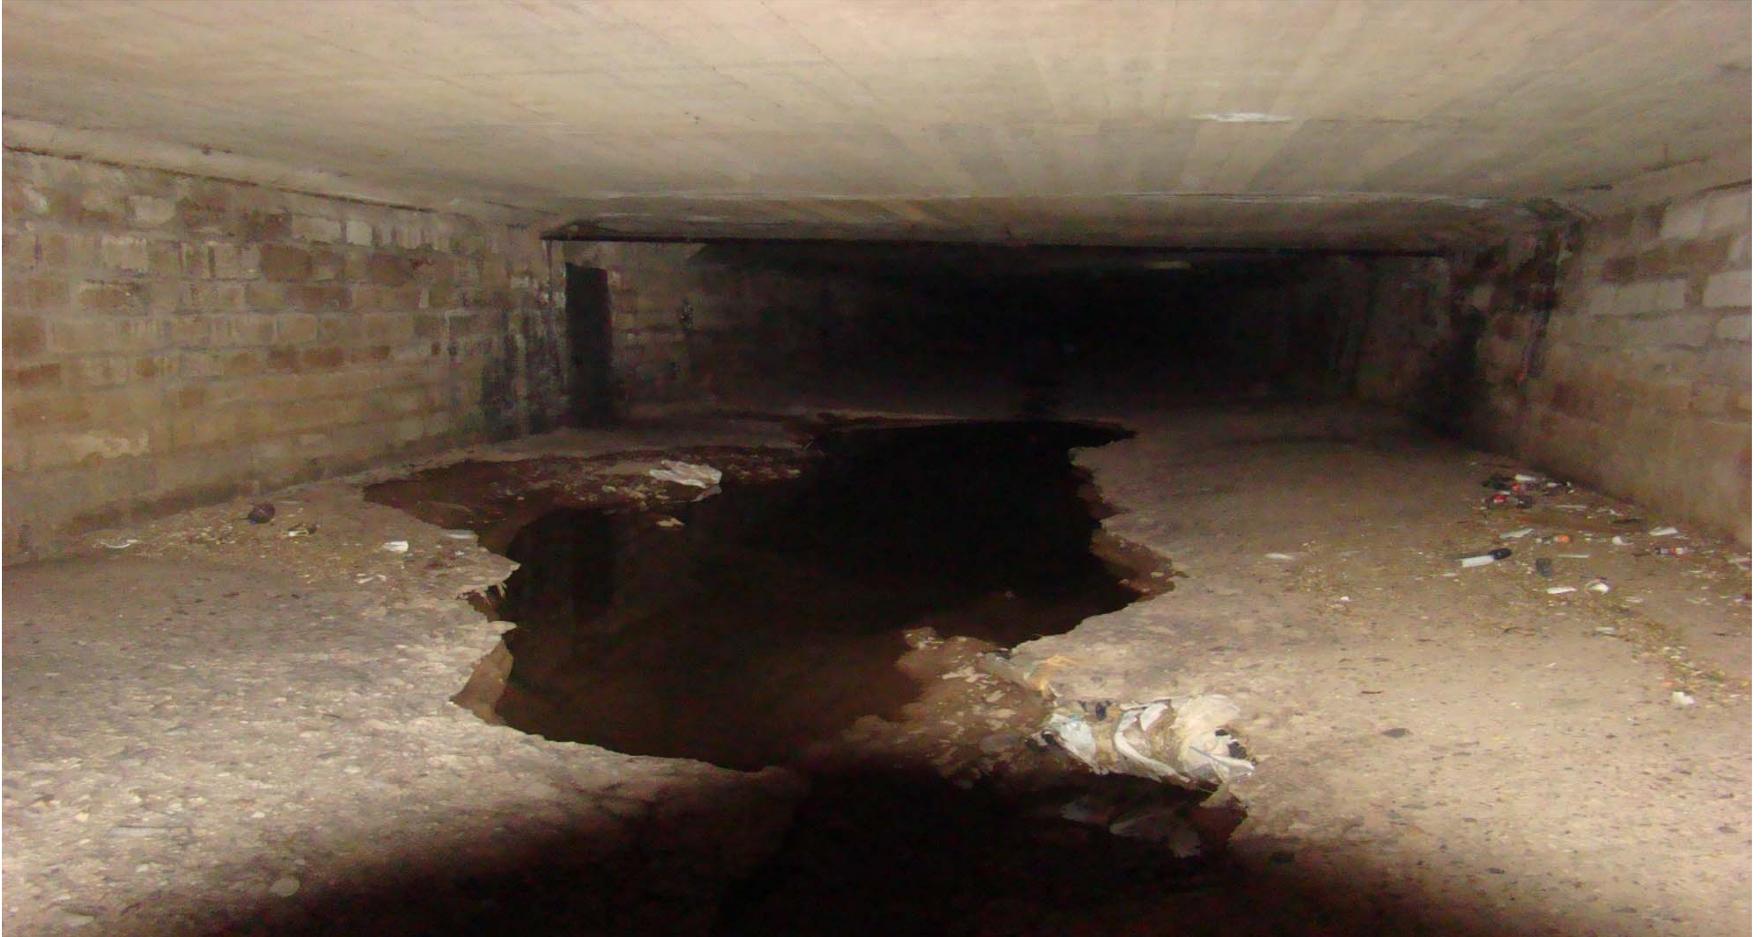
USIBWC and City of Nogales filled in voids within underground box culverts with concrete

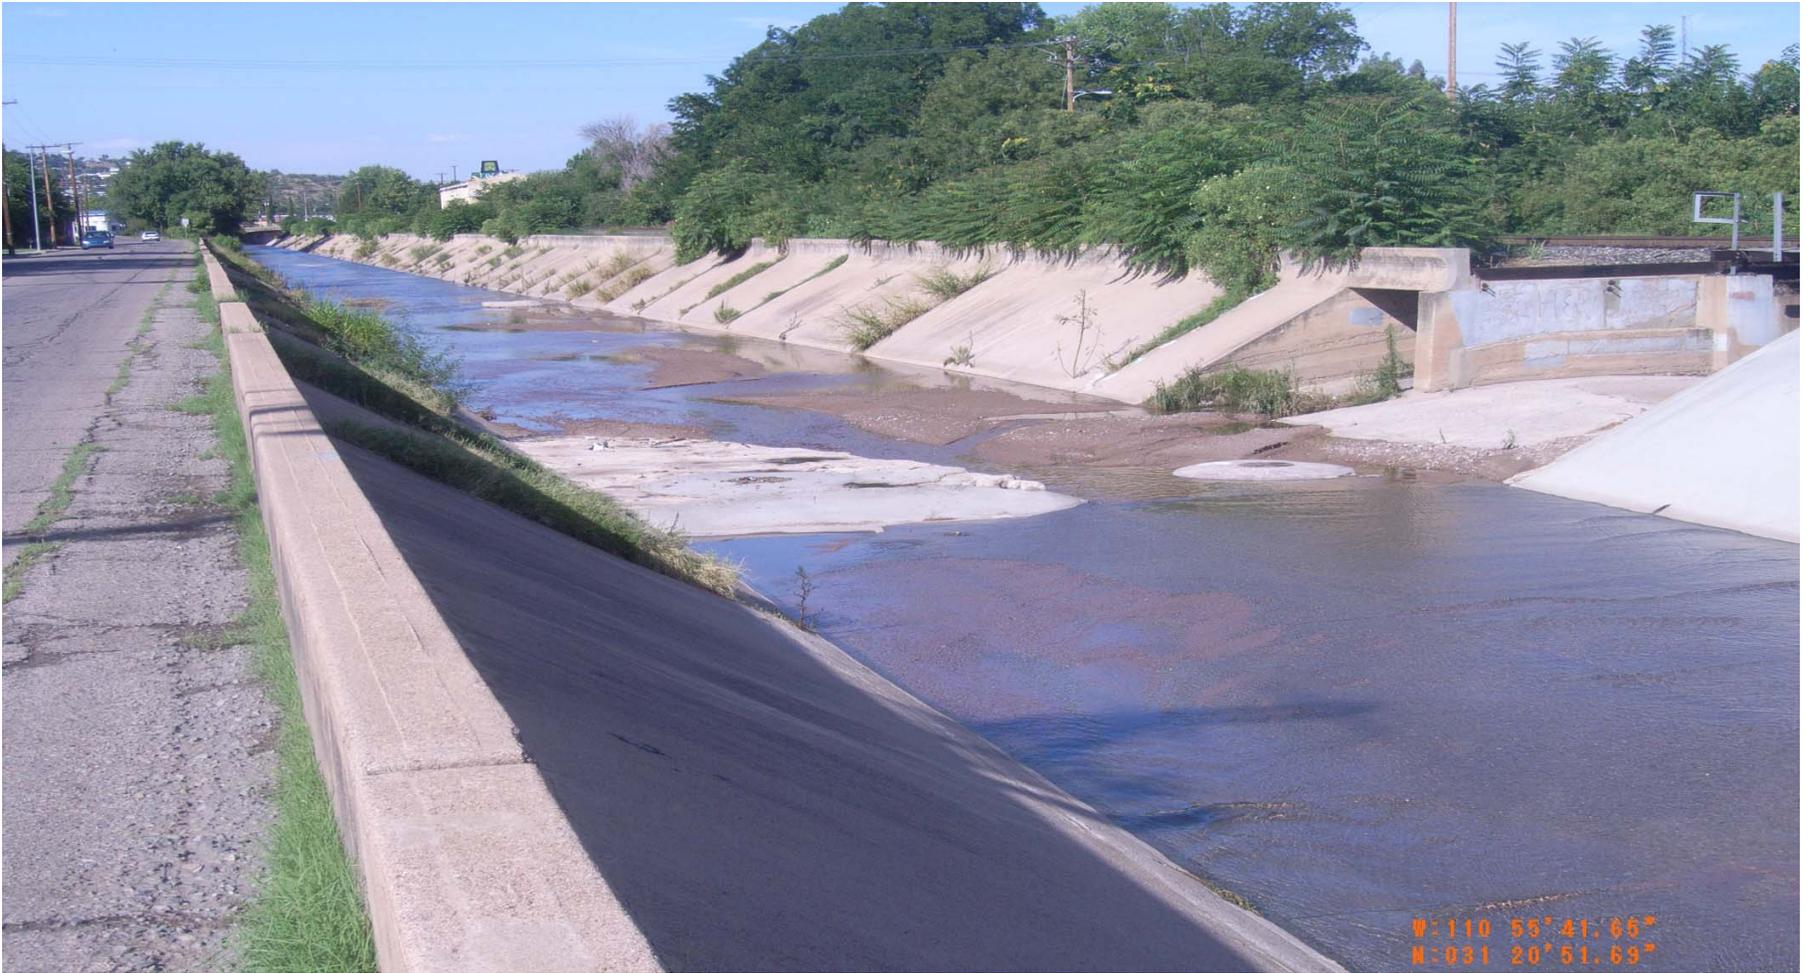
Concrete Trapezoidal Channel IOI is just beneath bottom slab

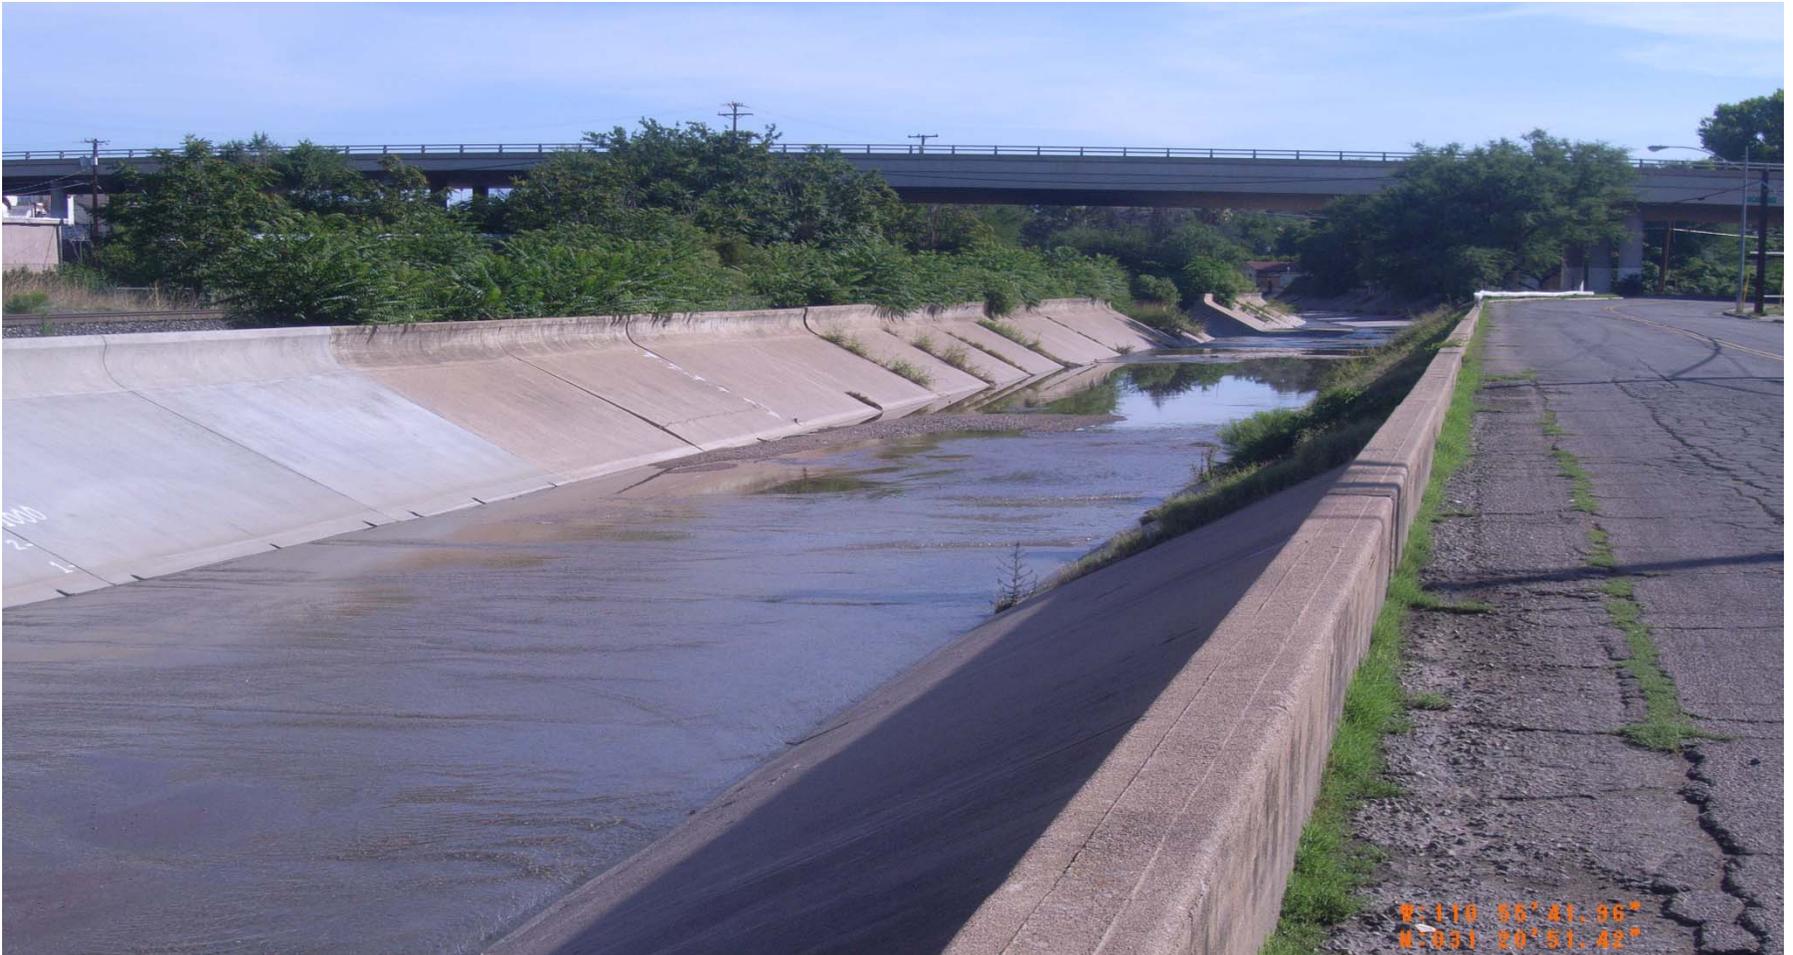
Highway Overpass: Historically damaged panels over the years

- Almost yearly repairs are needed around the Hwy 82 overpass in the trapezoidal concrete channel
- Displacement of panels have the IOI in constant jeopardy
- Last August replacement of first section of pipe from Mexico to Manhole #1
 - Cost to repair \$1.4 million
 - Provided technical expertise during design and construction

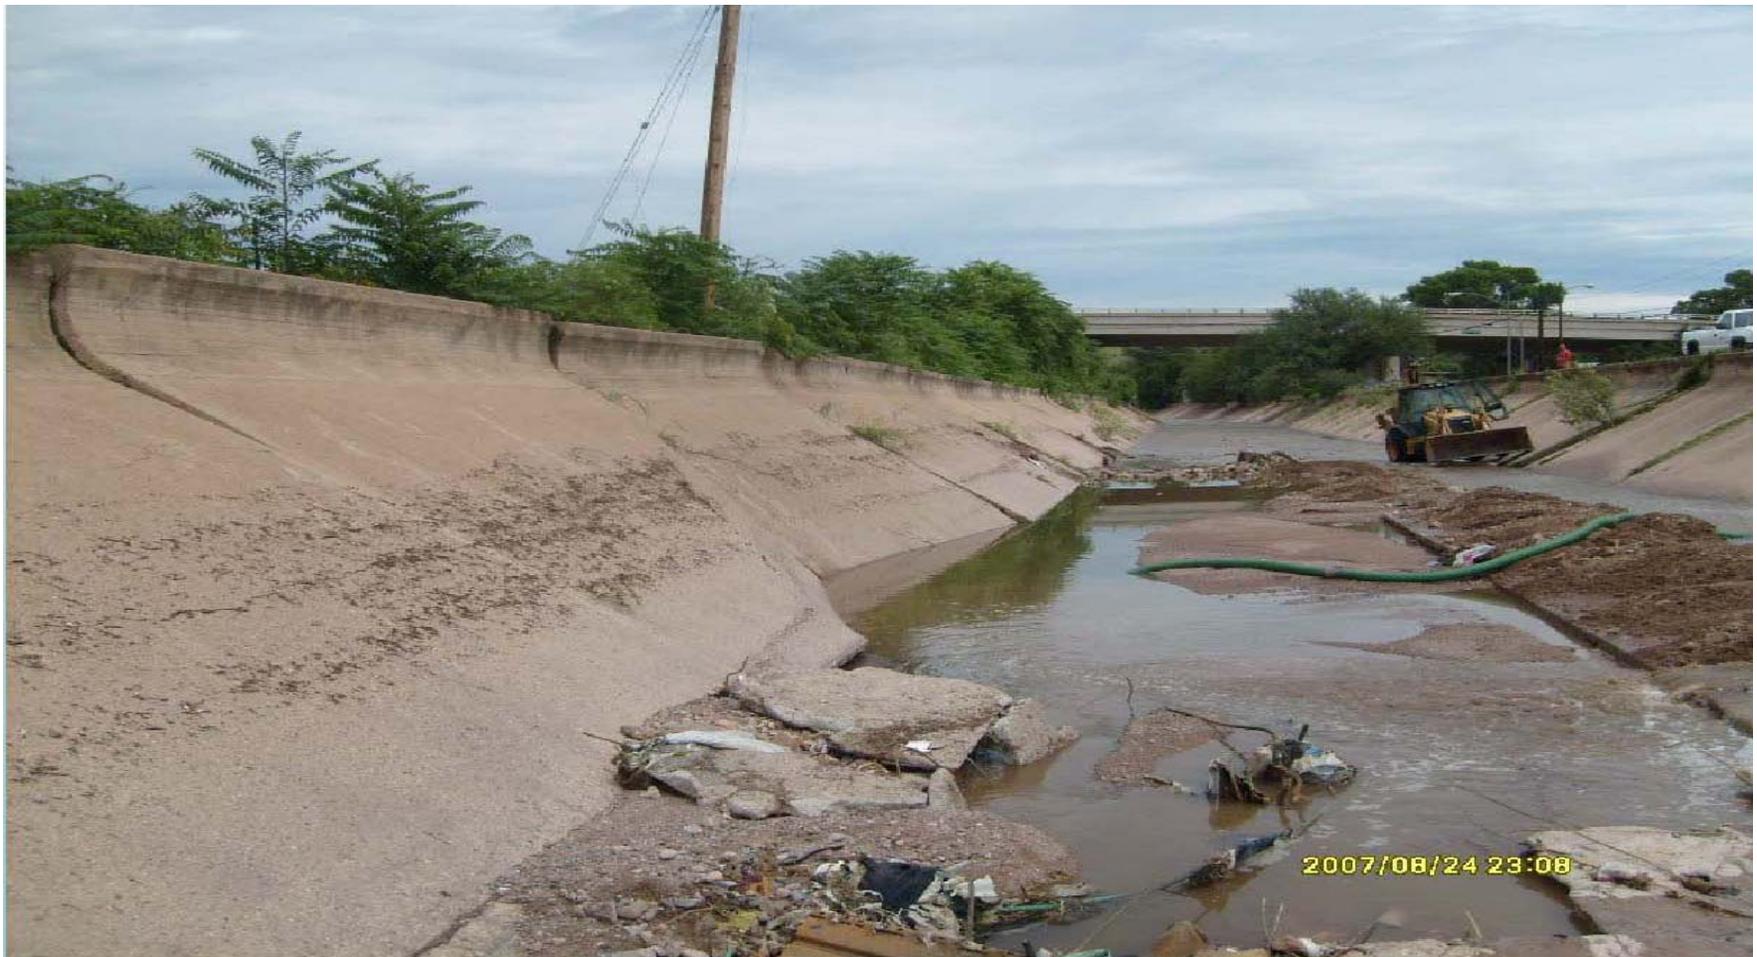
Panel and Floor displacement near Highway 82 Overpass

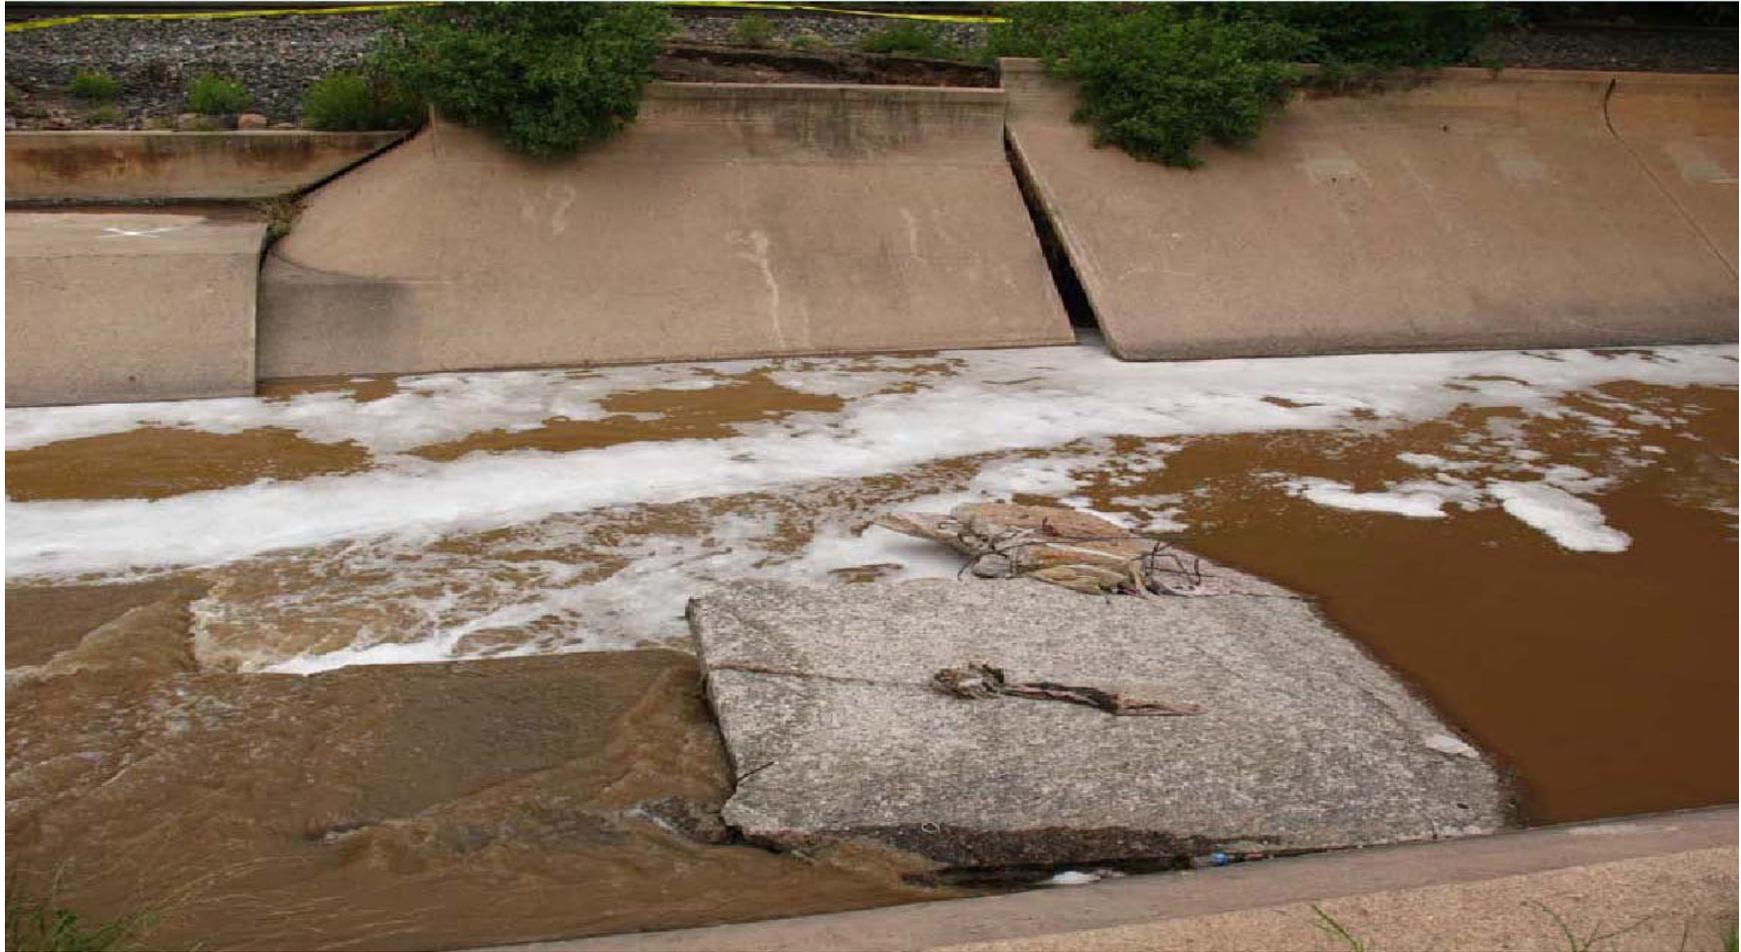
Panel Displacement; IOI on average only 2'-3' below bottom slab

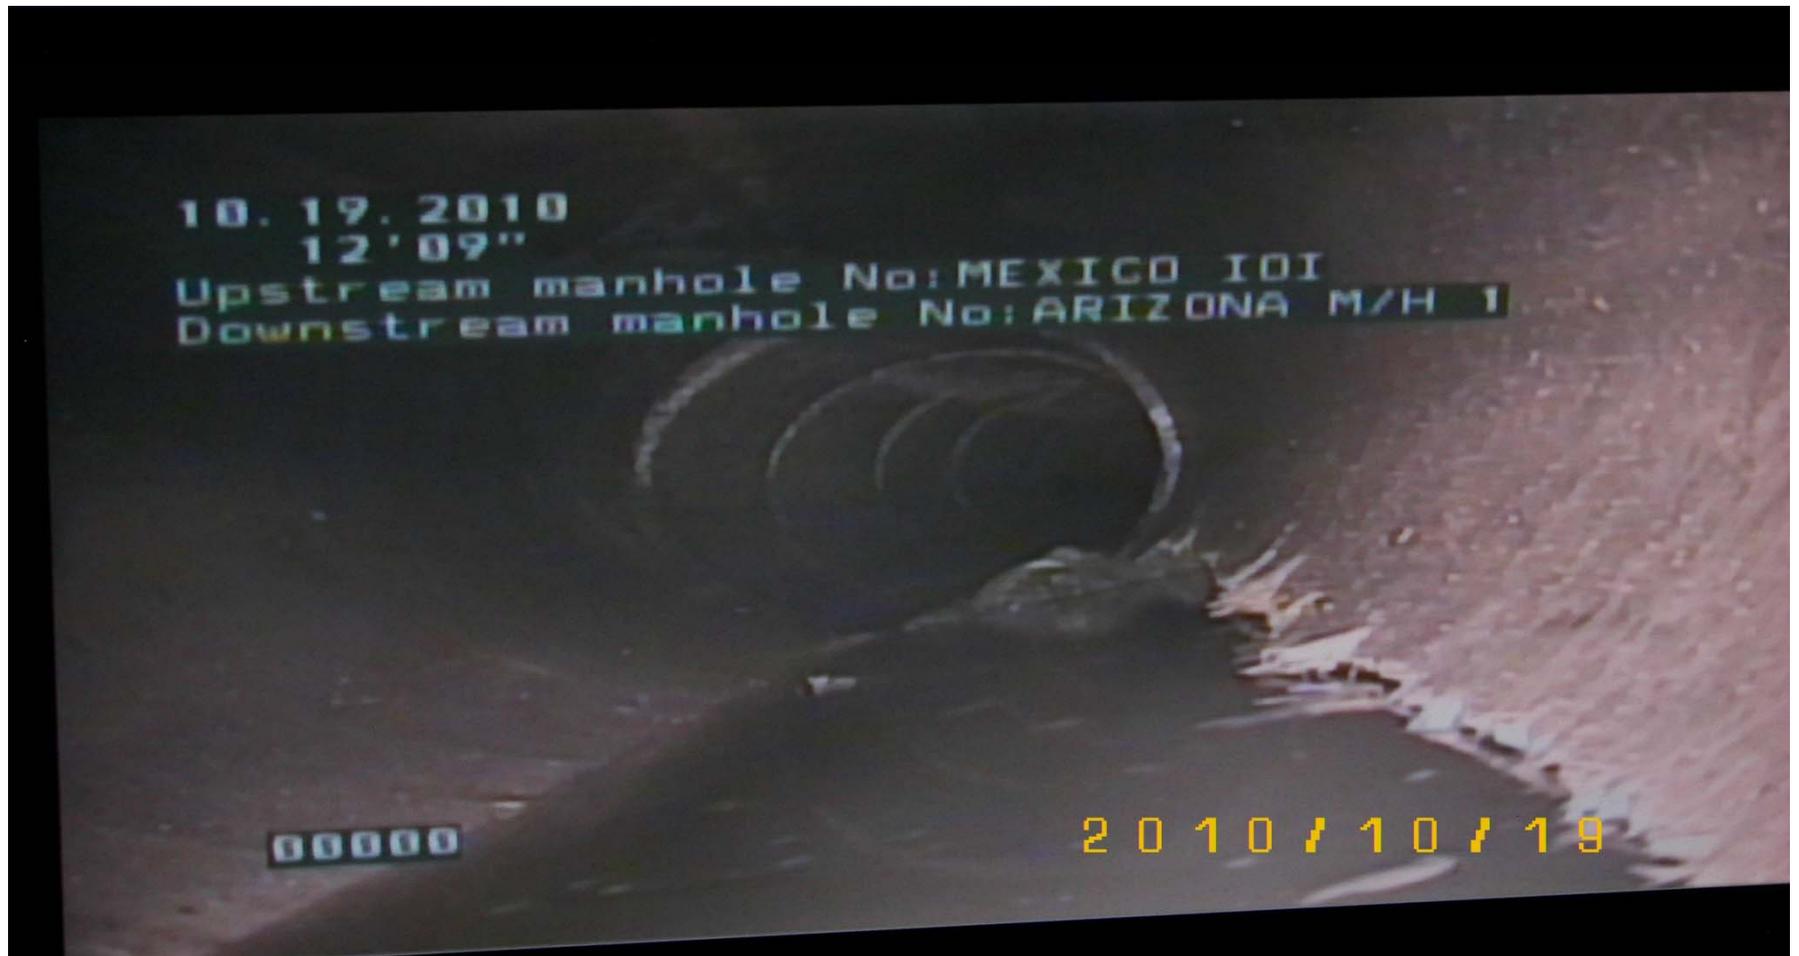
- The IOI is actively eroding and deteriorating.
 - The original structural strength of the pipeline has been compromised and the rate of deterioration is unknown.
- The remaining life of the pipeline can only be estimated.
 - Reliability of this system is only as good as its weakest link.

Eroded bottom of pipe; looking at first section of pipe into U.S.

- Assessment Program
 - Re-inspect every two or three years
- Rehabilitation (Approximately 30 million)
 - Slip Lining
 - Cured-In-Place Pipe (CIPP) – resin filled polyester tube is inserted into pipe and inflated with water or steam and cured-in-place
- Replacement (Approximately 100 million)
 - Open Cut Complete replacement of existing pipe

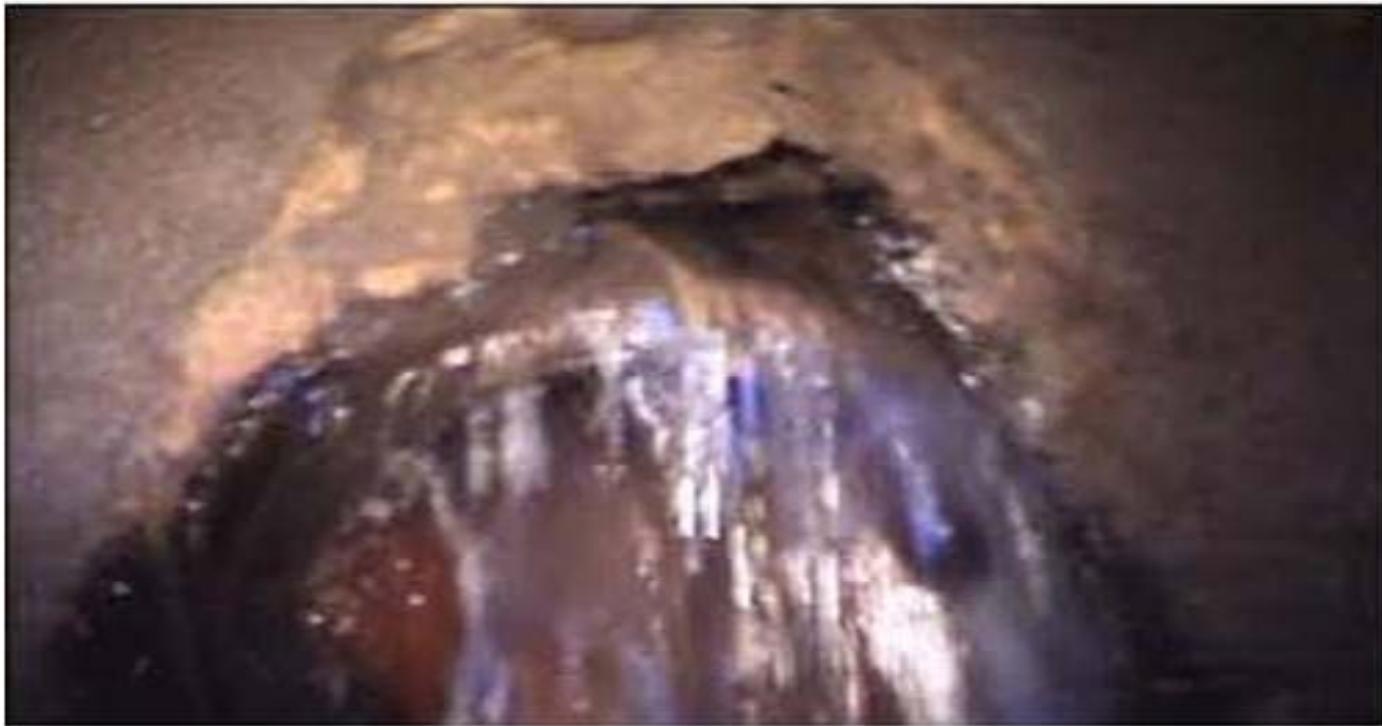
Inflow and Infiltration (I and I)

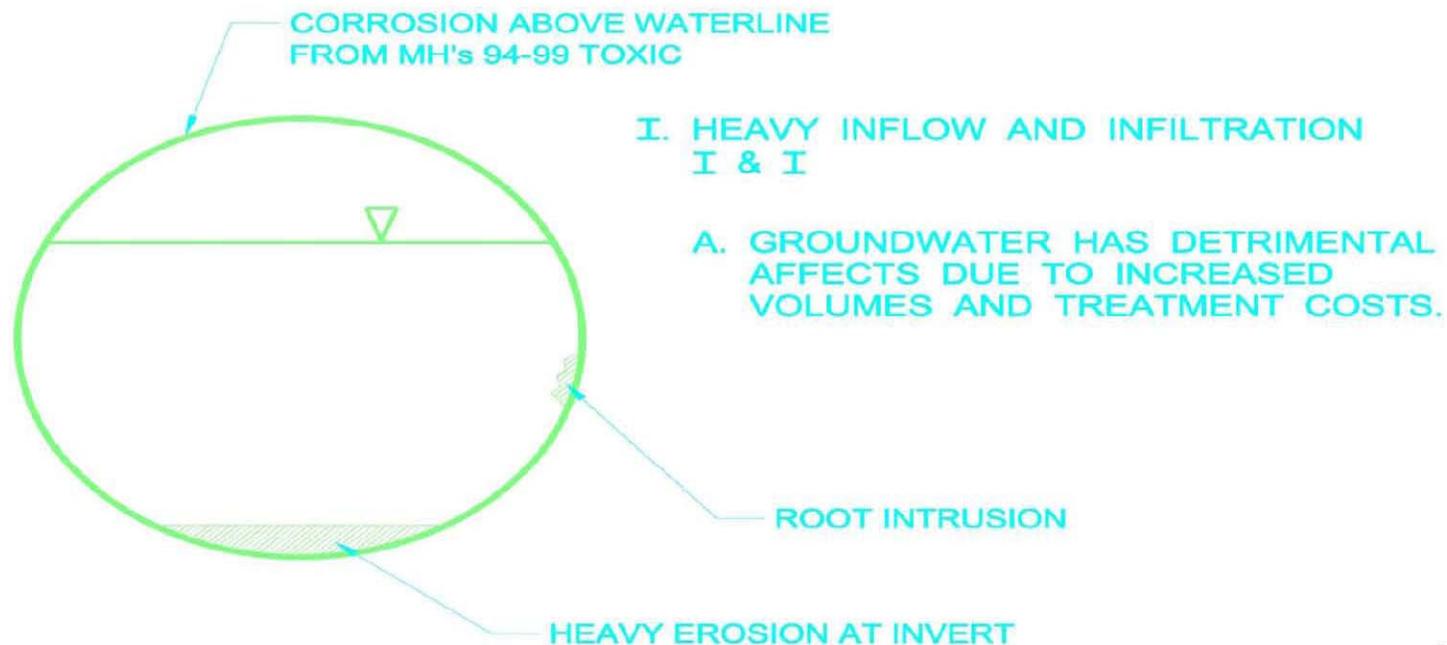
- **FINDINGS:**
- Existing condition of pipeline
- Pipeline is over 40 years old, (Typ. Lifespan of pipe is 50 years)
- Half the original pipe thickness remaining
- Erosion of invert is number one concern as seen on next slide
- Corrosion is occurring near treatment plant

Erosion of bottom of pipe due to excessive velocities of solids

EROSION VS CORROSION

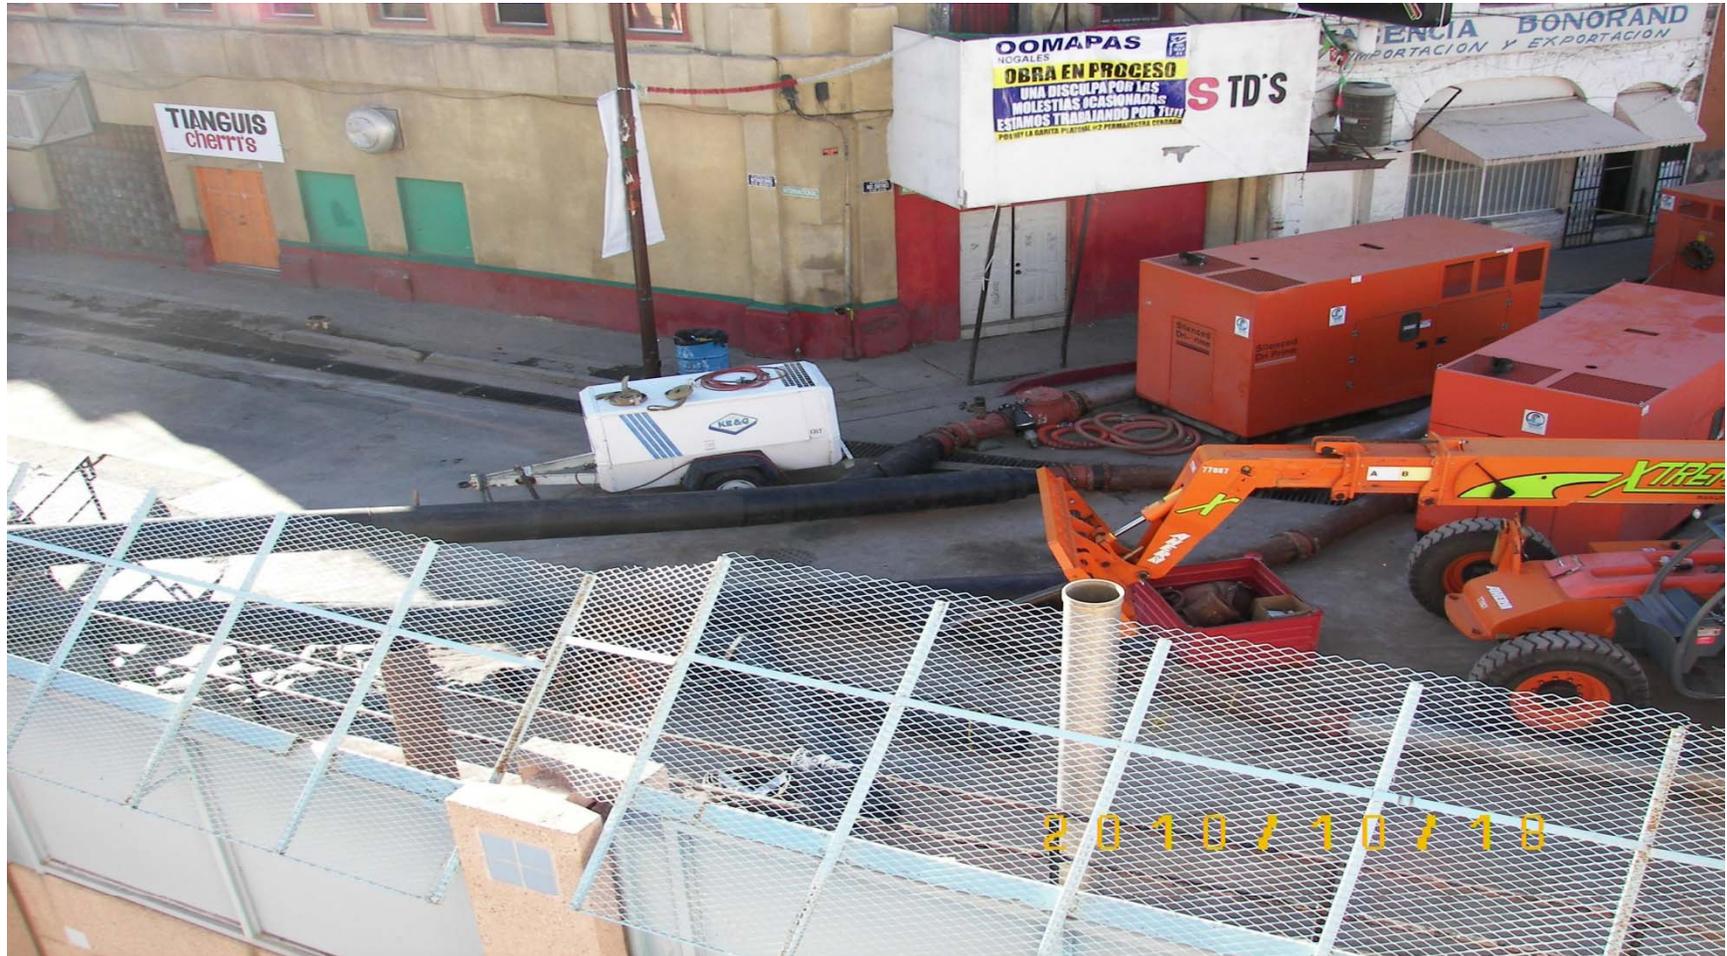
Repairs First Section of Pipe Last Year at this time; Pump Bypass

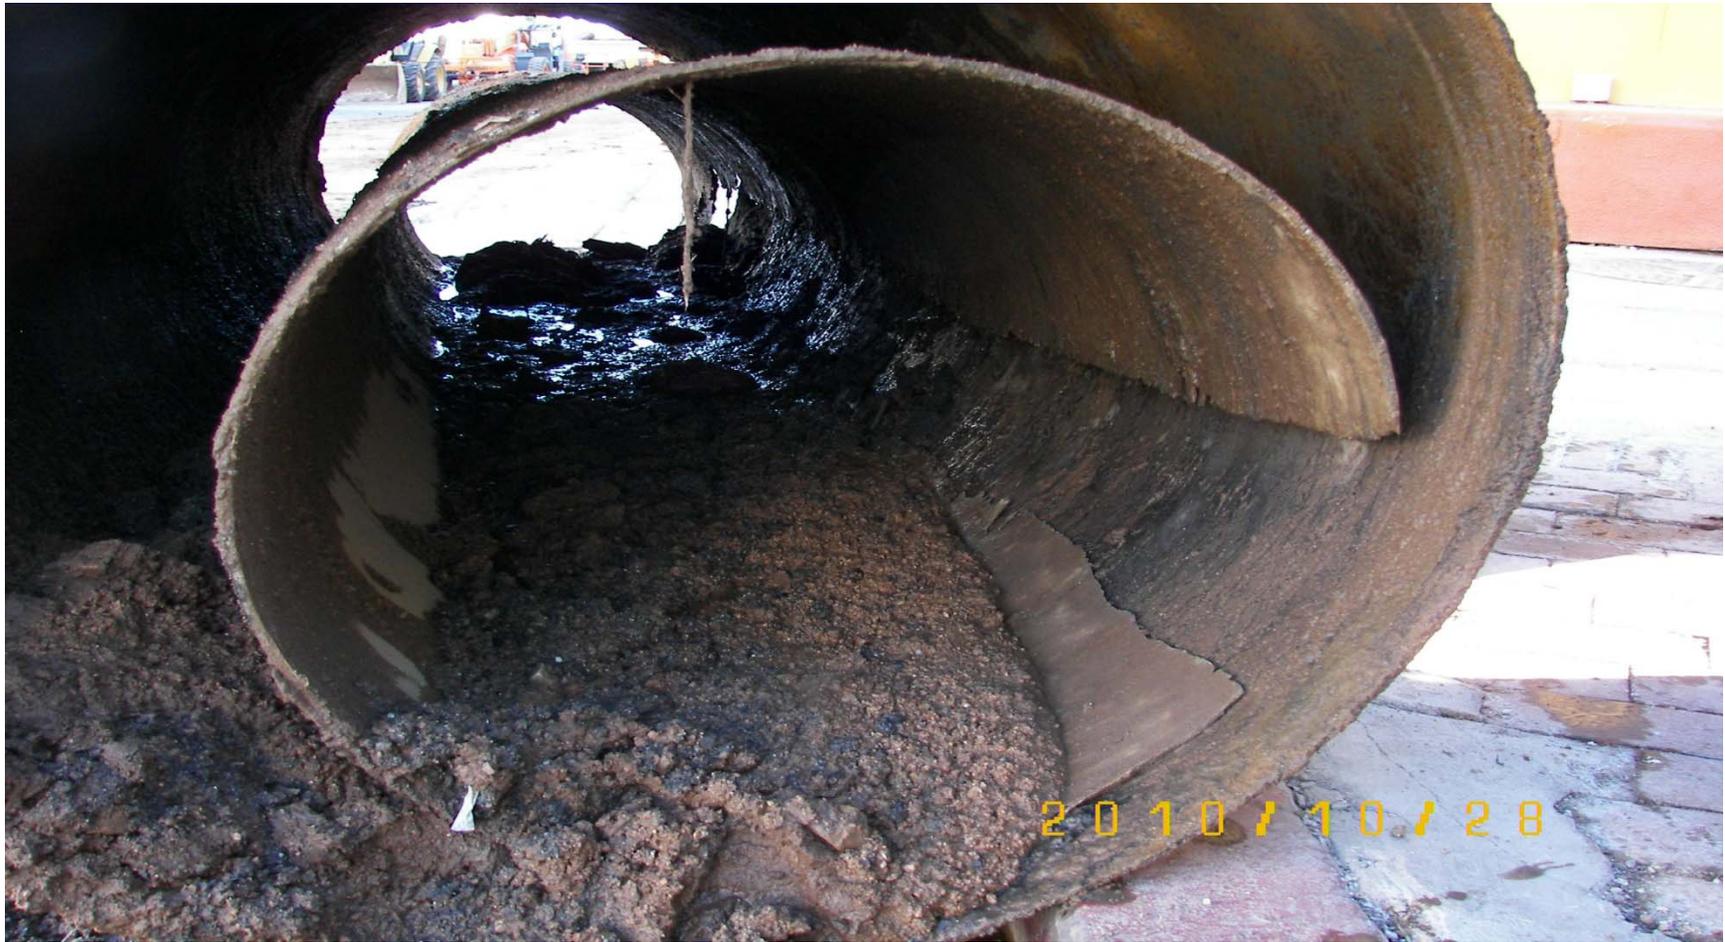
Bottom of pipe is gone due to inherent erosion
