# **State Public Utility Commission of Mexicali Water and Sanitation Division Department of Wastewater**

## **RAW WASTEWATER SPILL DUE TO FAILURES AT PUMP STATION No. 4**

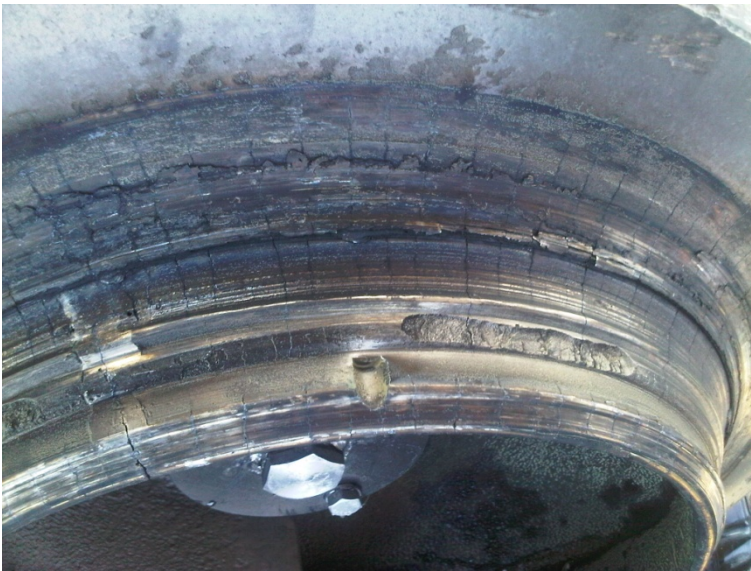
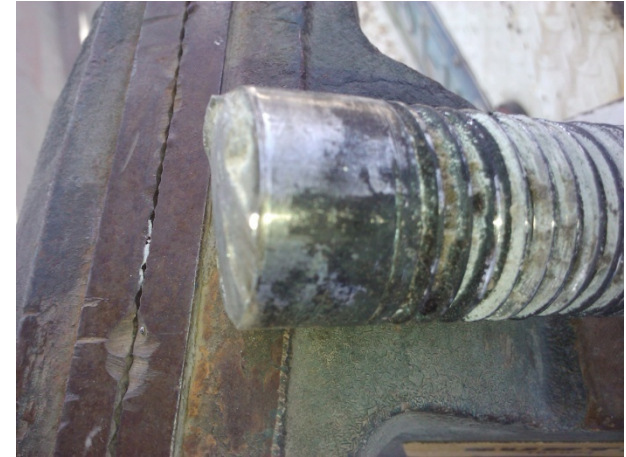
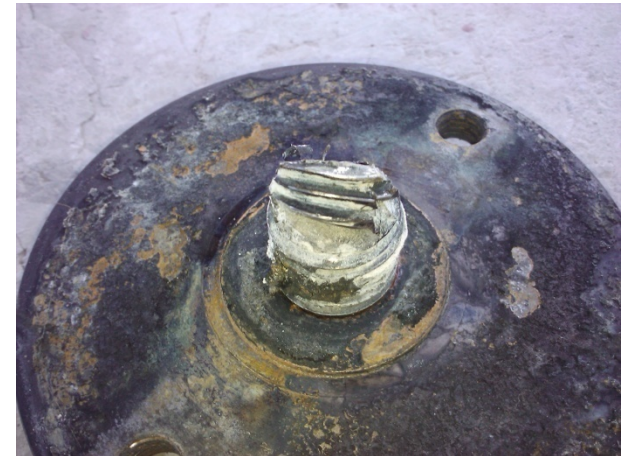
From 2009 to present, on several occasions all four of the installed pumps have experienced a similar failure due to the loss or rupture of the retaining screw between the impeller and the shaft, causing the impeller to fall and put friction and heat on the wear rings and the pump casing, severely damaging all of these parts and taking the pump out of operation.

It was concluded that the anchoring system for the impeller retaining screw was deficient and it was modified by repairing the damages caused to the pumps (impeller, suction assembly, wear rings and restraint screws) at a local shop.

- During the 2009 repairs, the retaining screw anchoring system was modified.
- During the 2010 repairs, the material and hardness of the retaining screw was changed.
- Presently, the purchase order for two new impellers is being processed to enable the fourth pump and to replace the most damaged one in the working pumps. 11 weeks delivery time
- Proposals for other brands (Flygt, ABS, Fairbank Morse) are being evaluated to either partially or totally replace the pumps.
- The problem has been communicated to the Cornell pump manufacturer for a potential redesign of the pump components. They are expected to visit next week.
- Currently, two pumps are working and tomorrow a third pump will be installed and remain on “standby.”

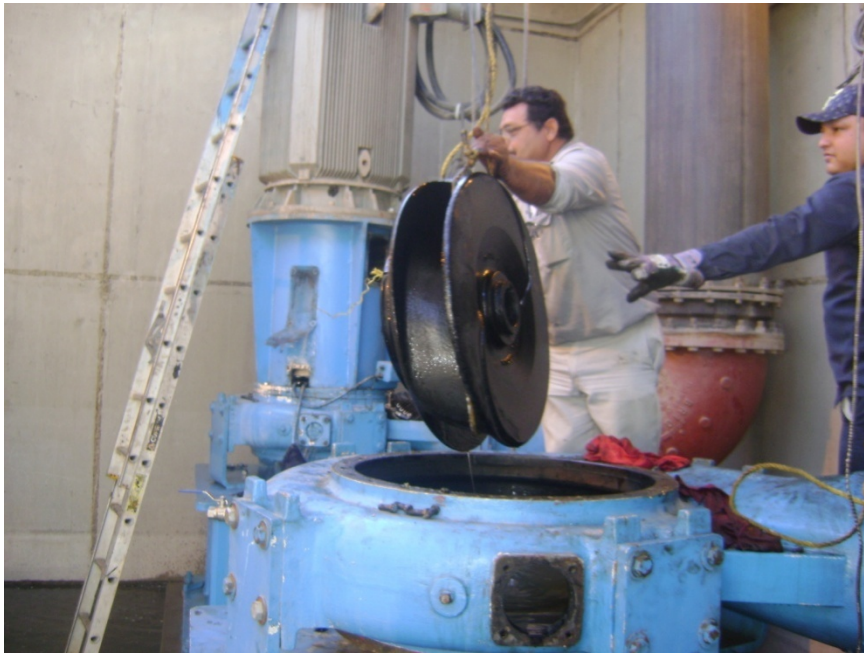
- October 2009, two new impellers and wear rings are installed in pumps #2 and #3. (There was no leakage.)
- In June 2010, pump #3 had the same failure. (There was no leakage.)
- In October 2010, pumps #3 and #4 have the same failure, leaving just one pump available. (189,000 m<sup>3</sup> (50,000 gal.) leak over 8 days.)
- In November 2010, pump #3 fails, leaving just one pump available. (44,500 m<sup>3</sup> (11,760 gal.) leak over 2 days.)

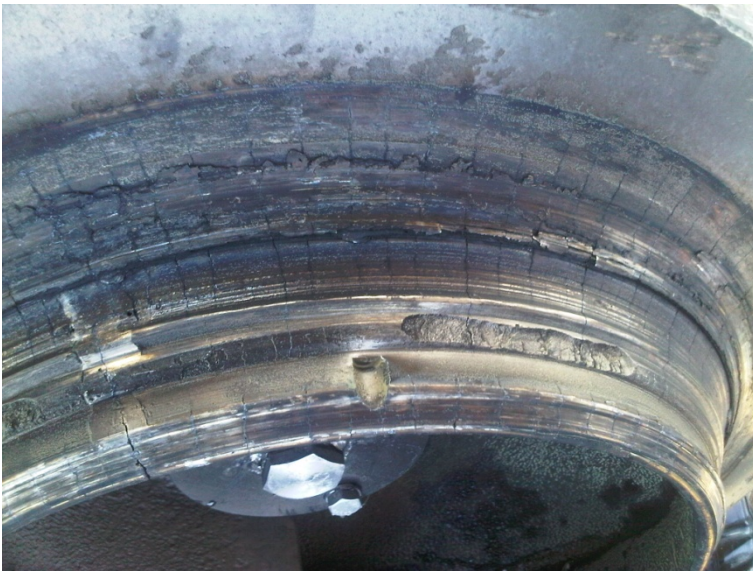
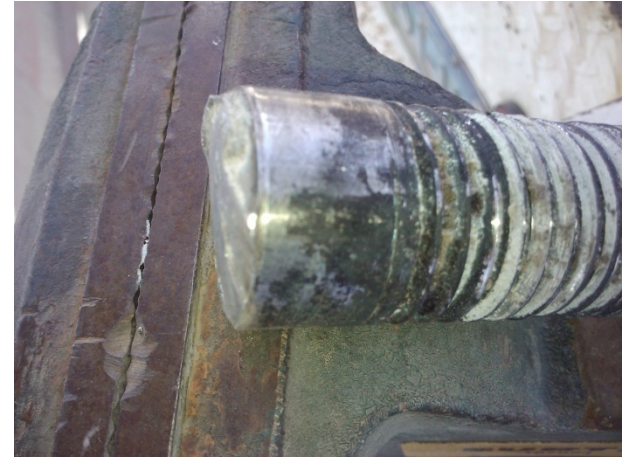
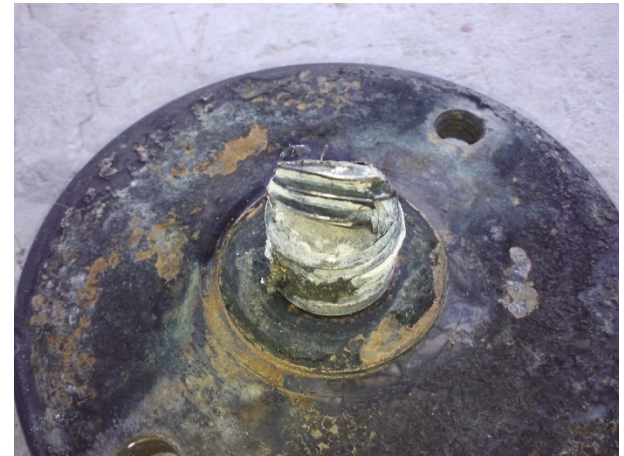
Desde el 2009 a la fecha se ha presentado en varias ocasiones una falla común en los 4 equipos de bombeo instalados, debido a la pérdida o ruptura del tornillo de sujeción entre el impulsor y la flecha, generando que el impulsor caiga ejerciendo fricción y calentamiento con los anillos de desgaste y la carcasa de la bomba dañando gravemente todas estas partes y dejando el equipo fuera de servicio.

Se concluyó que el sistema de fijación del tornillo de sujeción del impulsor era deficiente y se modificó, reparando en taller local los daños ocasionados en las bombas (impulsor zona de succión, anillos de desgaste y tornillos de sujeción).

- En las reparaciones del 2009 se modificó la fijación del tornillo de sujeción.
- En las reparaciones del 2010 se cambió el material y dureza del tornillo de sujeción.
- Actualmente se encuentran en trámite la adquisición de 2 impulsores nuevos para habilitar el 4to. equipo y reponer el más dañado de los actuales. 11 semanas de tiempo de entrega.
- Se están evaluando propuestas de otras marcas para reponer parcial o totalmente los equipos (Flygt, ABS, Fairbank Morse).
- Se expuso la problemática con el fabricante de las bombas Cornell para un posible rediseño de componentes de bombas. Se espera su visita para la próxima semana.
- Actualmente se cuentan con dos equipos de bombeo trabajando y para el día de mañana se instalará el tercer equipo quedando en “stand-by”.

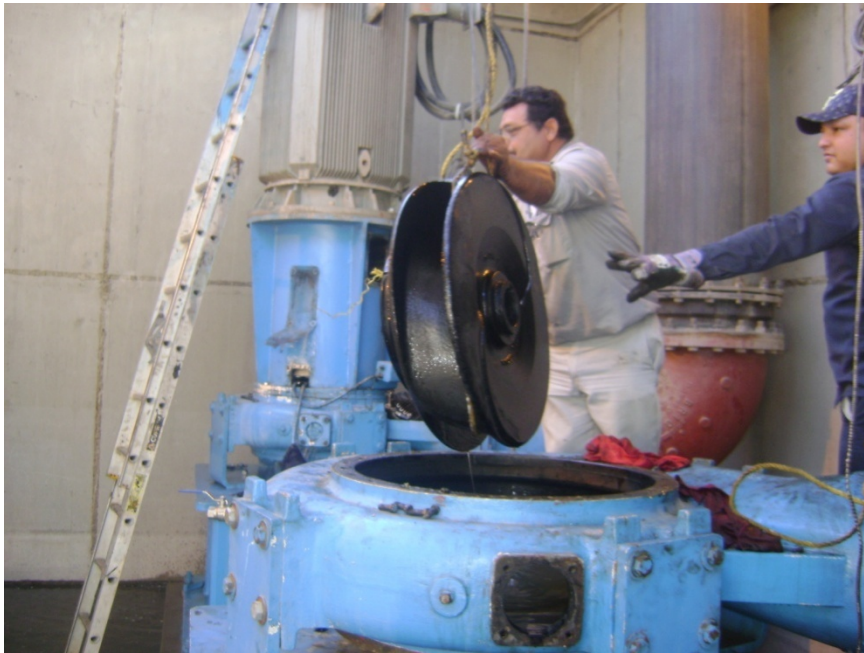
- En octubre de 2009 se instalan 2 impulsores y anillos de desgaste nuevos en las bombas No.2 y No.3 (no hubo desfogue).
- En junio de 2010 ocurrió la misma falla en la bomba No.3 (no hubo desfogue).
- En octubre de 2010 se presentó la misma falla en los equipos No.3 y No.4, quedando un solo equipo de bombeo disponible (durante 8 días se desfogan 189,000 m<sup>3</sup> – 50,000 gal).
- En Noviembre de 2010 se presenta la falla en el equipo No.3 quedando un solo equipo de bombeo disponible (durante 2 días se desfogan 44,500 m<sup>3</sup> – 11,760 gal).
