South Bay International Wastewater Treatment Plant

Update April 4, 2012 Spill

USIBWC Citizen's Forum
May 10, 2012

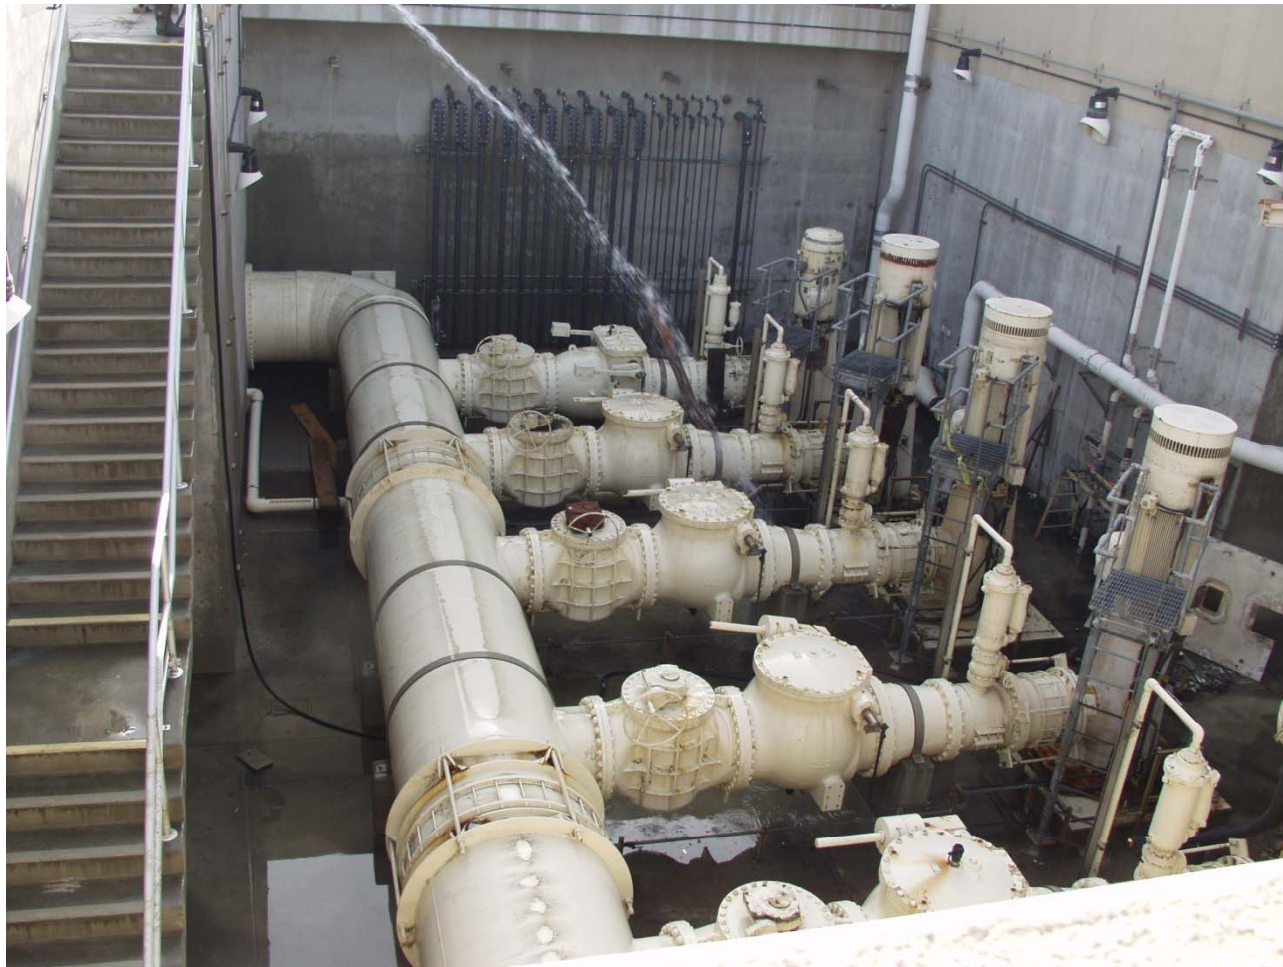
- 1) Dry well filled with sewage, pump motors were partially submerged.
- 2) Motor damage resulted, causing some pumps to be inoperative and others suspect.
- 3) Spill resulted when dry well reached capacity and sewage flowed out through the collector pipe for Stewart's Drain diversion

SBIWTP Influent Dry Well Flooding

- 1) Audible alarm was installed apart from SCADA should PLC fail
- 2) Corrections to programming error was made on following day.
- 3) PLCs networked so that should any individual PCL fail, another will report the failure.
- 4) Motors repaired (two are still out)
- 5) Appropriate disciplinary action taken for 2 operators on duty

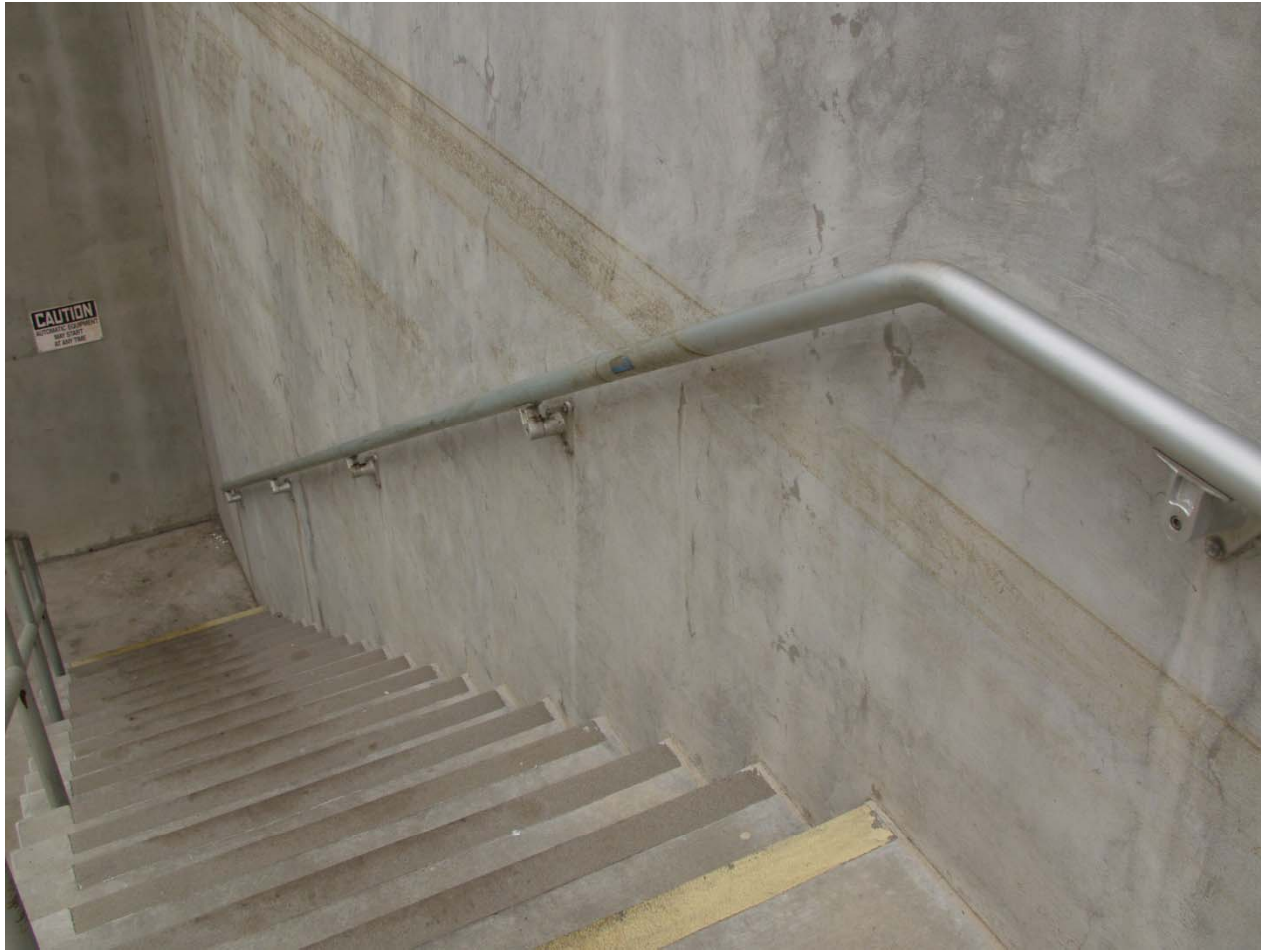
SBIWTP Influent Dry Well Flooding

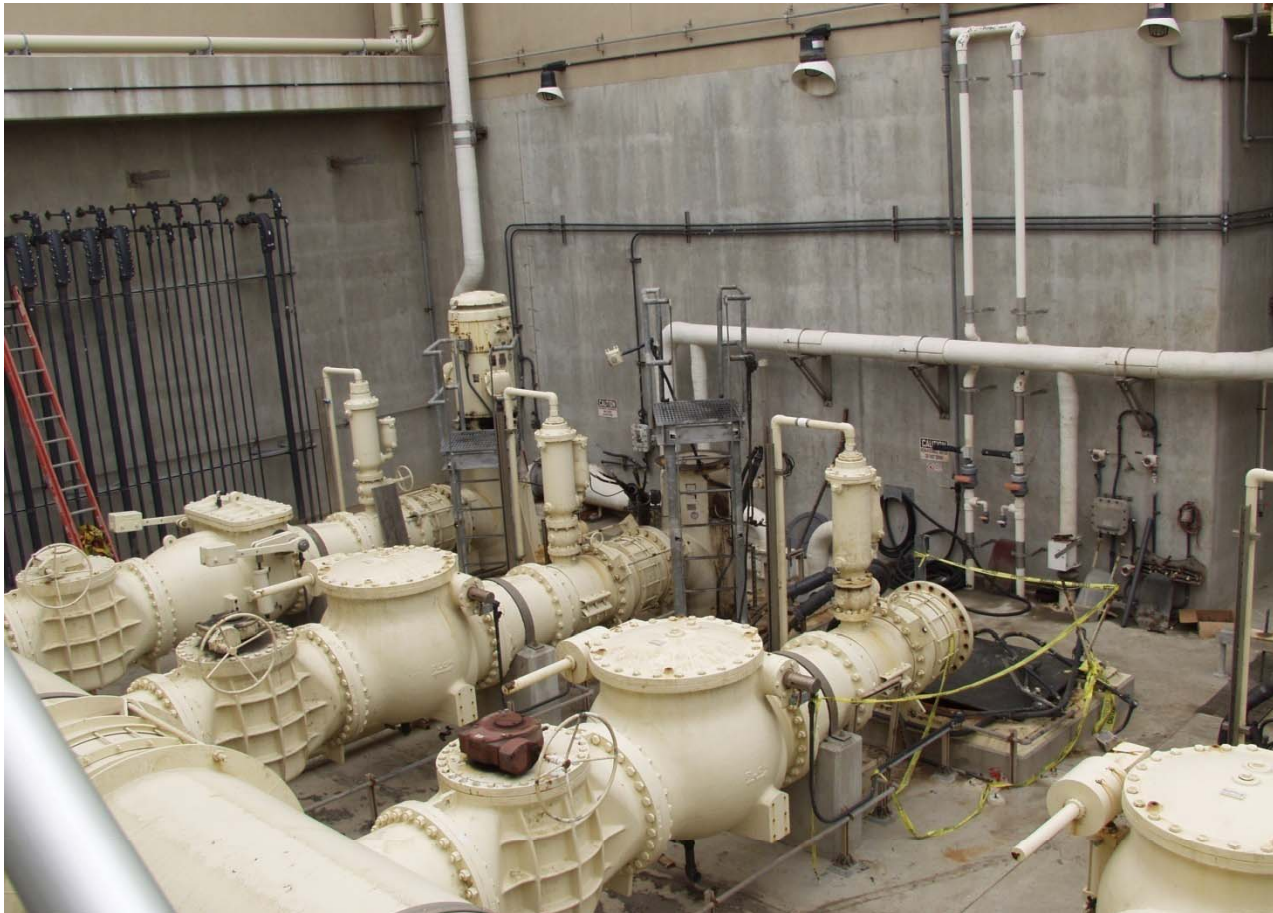
SBIWTP Influent Dry Well
