# Naco Sonora Wastewater Discharges to Naco Arizona Emergency Repairs

Southeast Arizona Citizens Forum  
VTC February 11, 2021

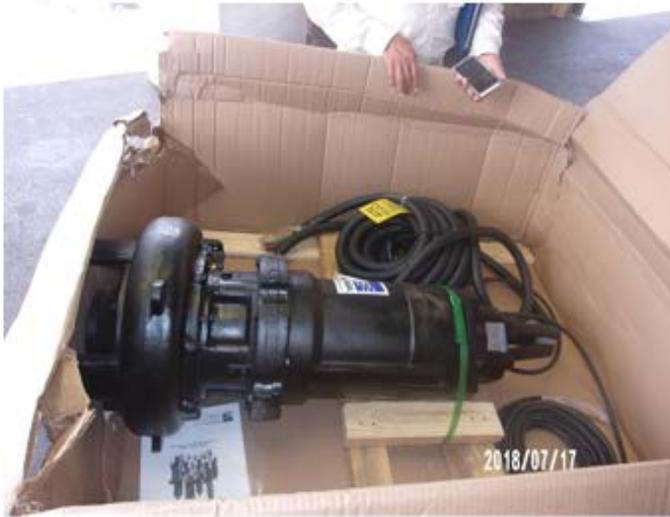
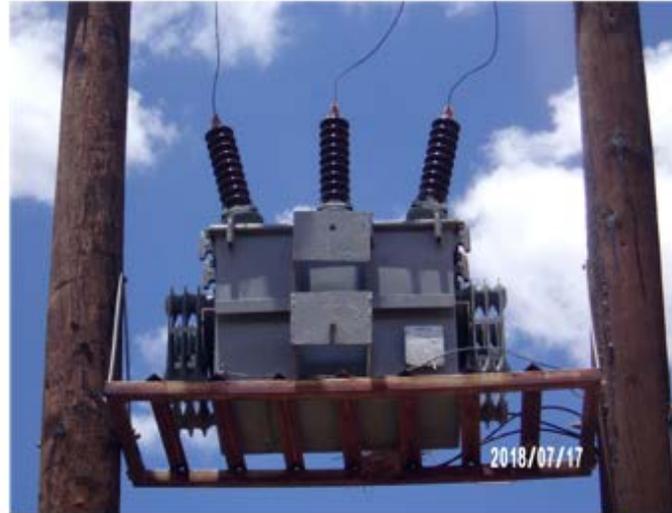
**7/18 In coordination with ADEQ, NADB installs submersible pump and transformer in International Pump Station**

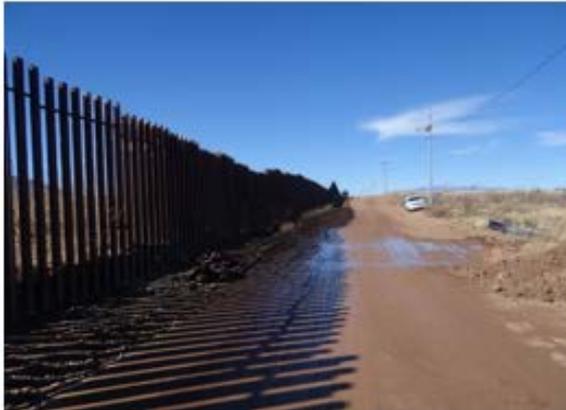
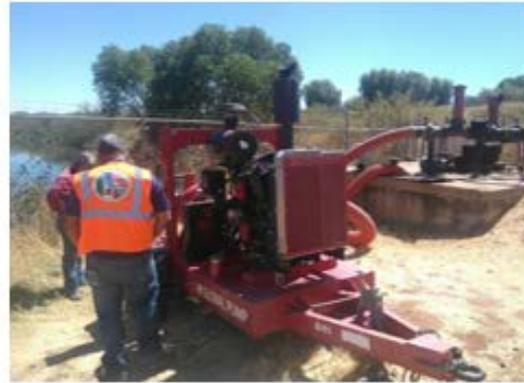
### 9/17 IBWCs pump in East Lagoon

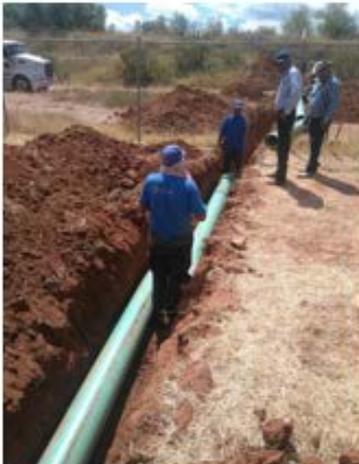
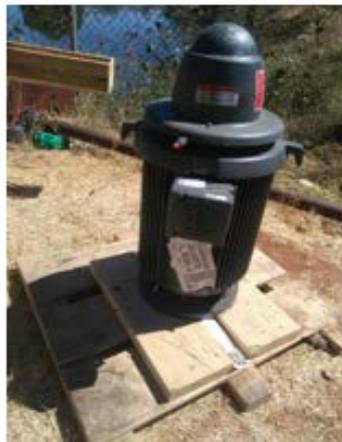
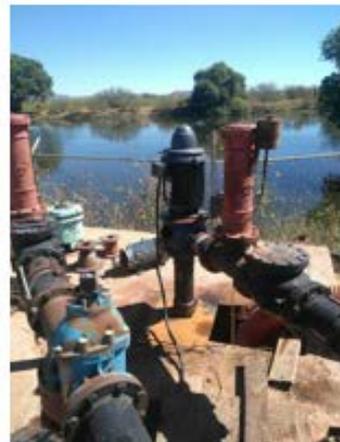
### 9/17 Materials provided by NADB, Pump by CEA

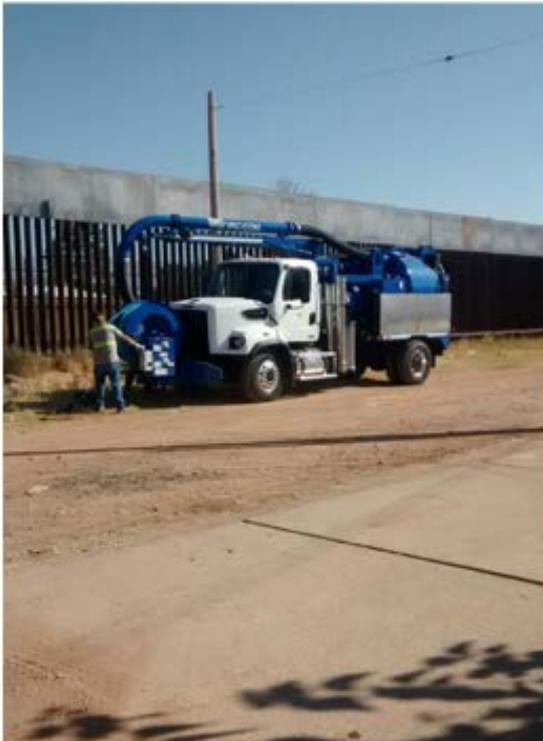
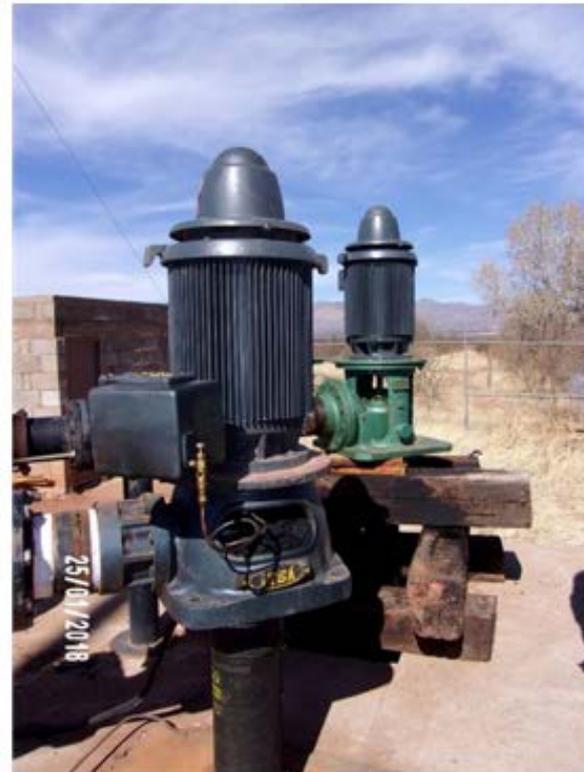
10/17 NADB hires cleaning equipment and CEA donates pump

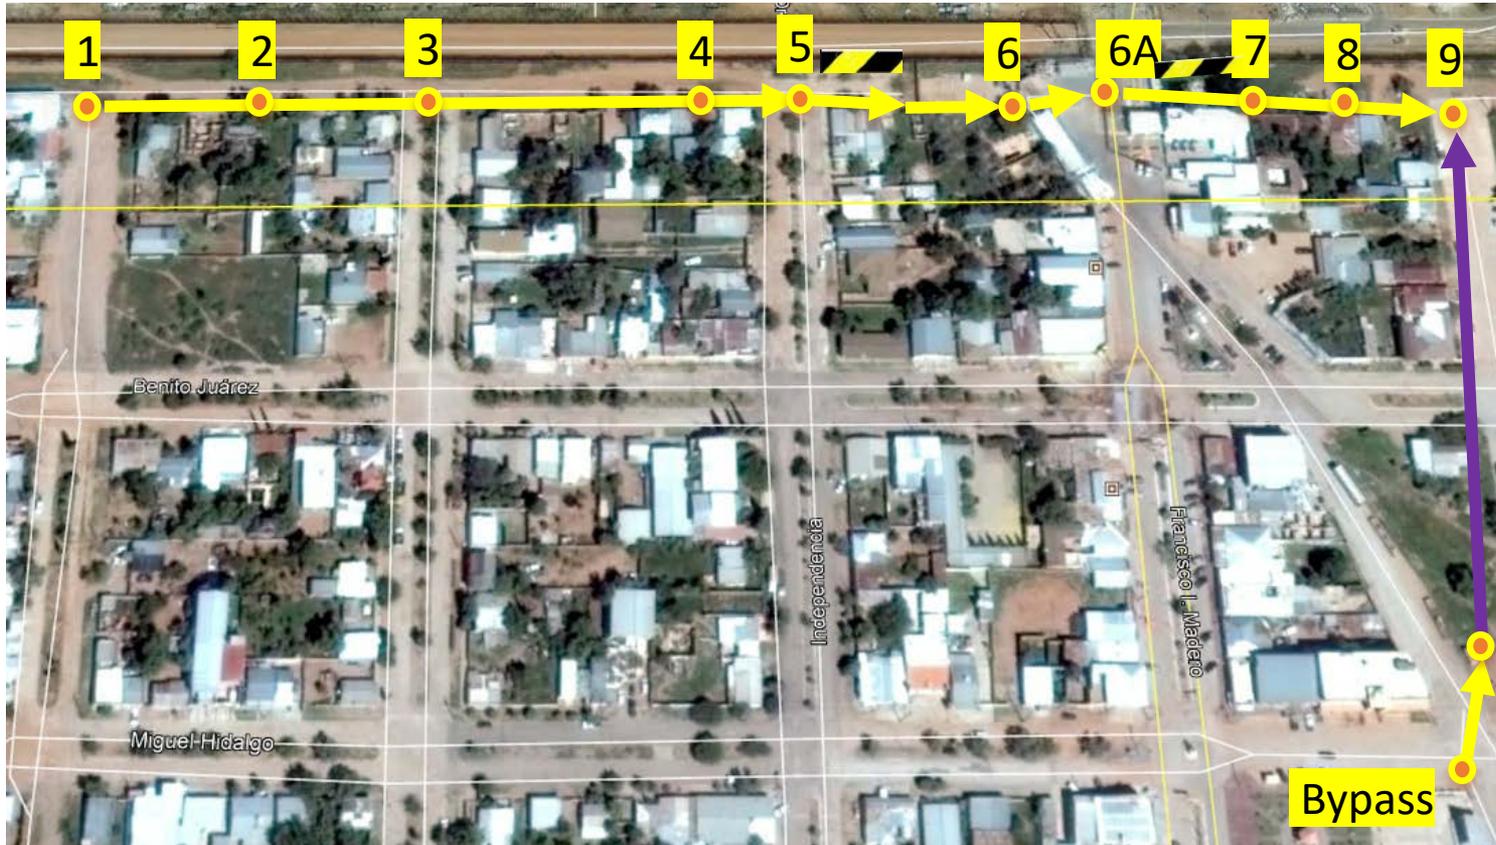
## West Portion Outfall Interceptor Replacement

530 meters of 12-inch pipe installed (100%) and in operation

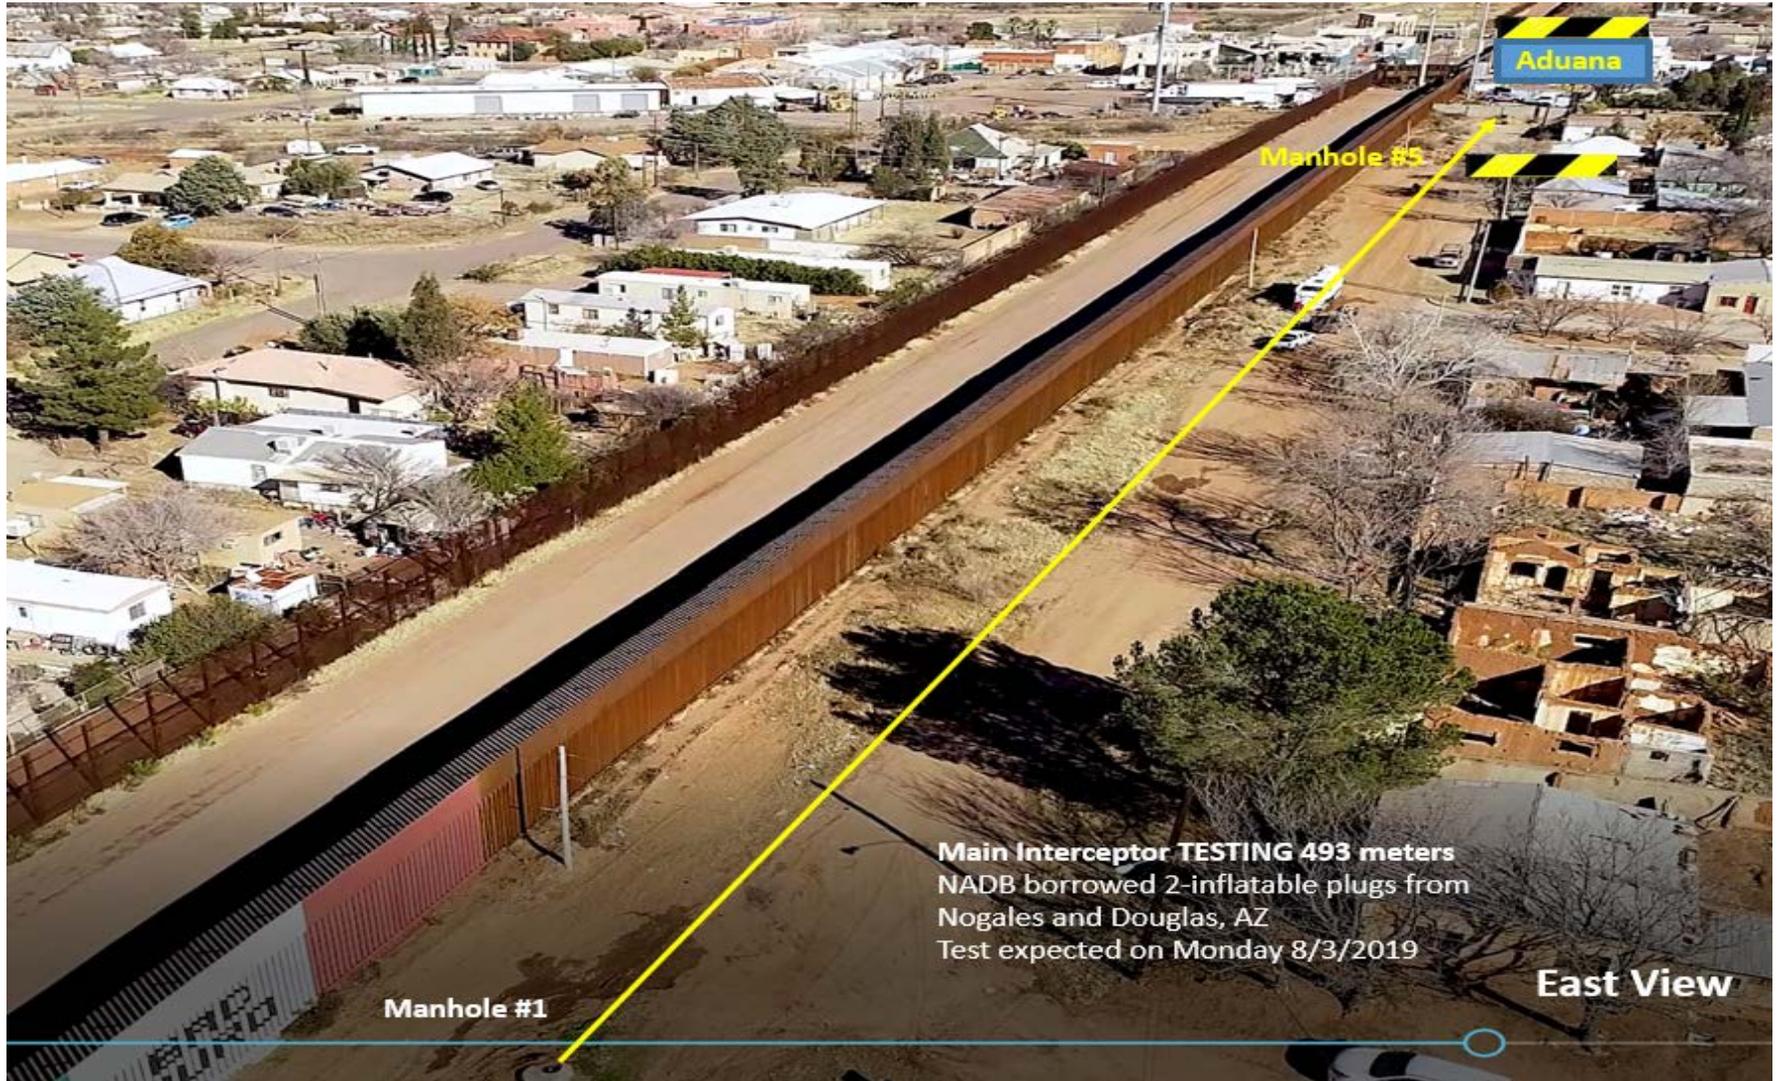
**Main Interceptor TESTING 493 meters**  
NADB borrowed 2-inflatable plugs from  
Nogales and Douglas, AZ  
Test expected on Monday 8/3/2019

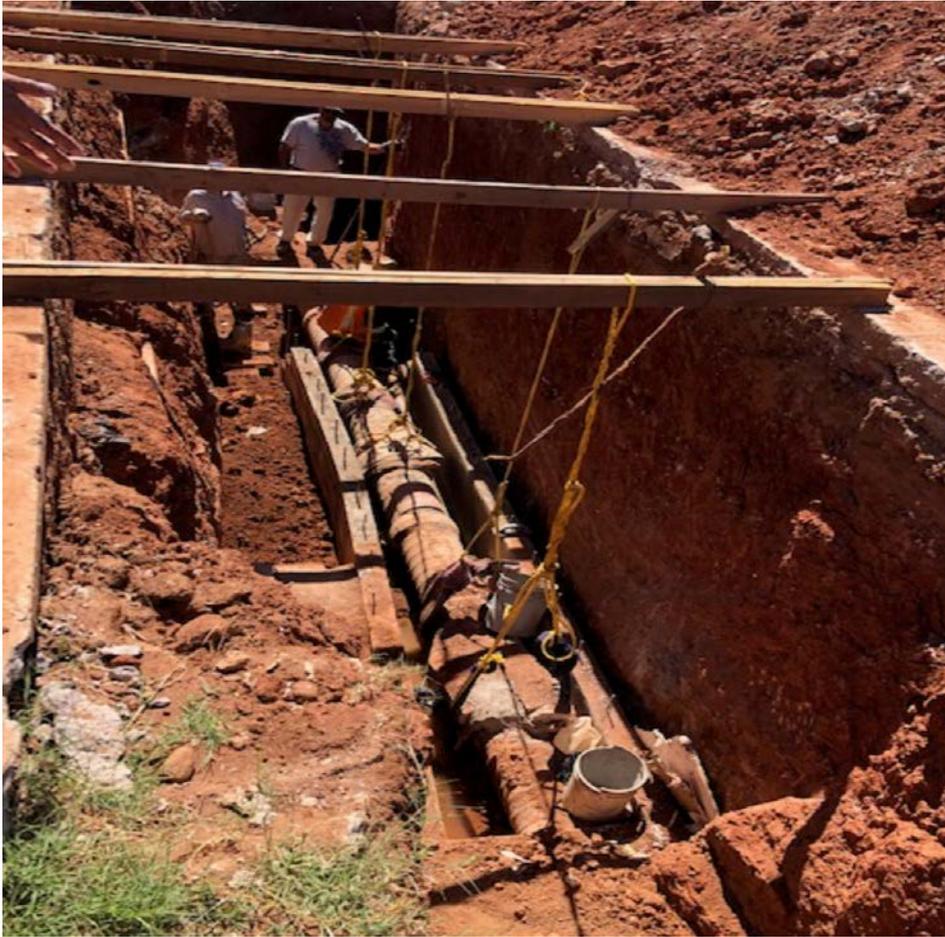
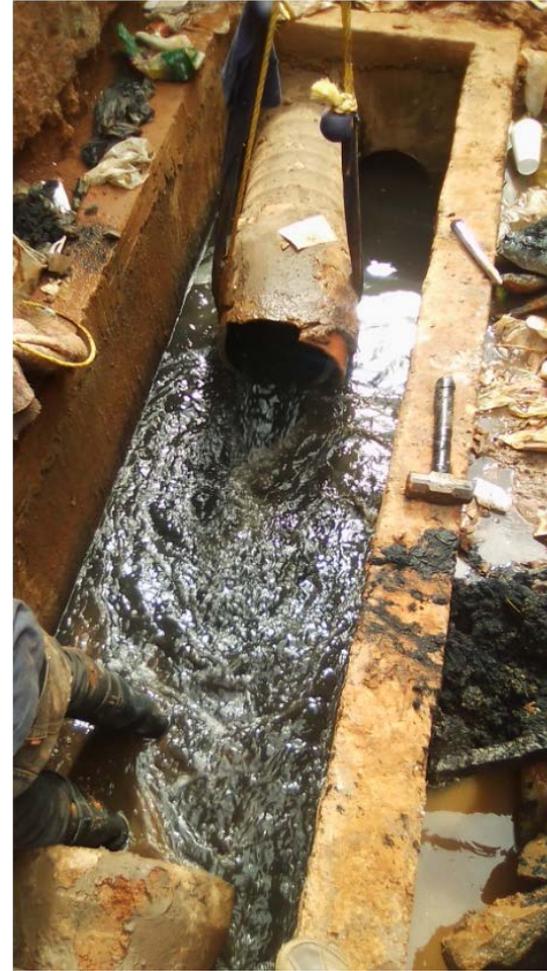
Down stream of MH#5: Construction of concrete box to solve intersection of new and old pipe
