# GRAND AND MORLEY TUNNELS IN AMBOS NOGALES DRAINAGE FEATURES AND FLOOD MAGNITUDES

International Boundary and Water Commission  
United States Section

For U.S. Department of State Meeting on April 28, 2016

## STRUCTURAL CONCERNS

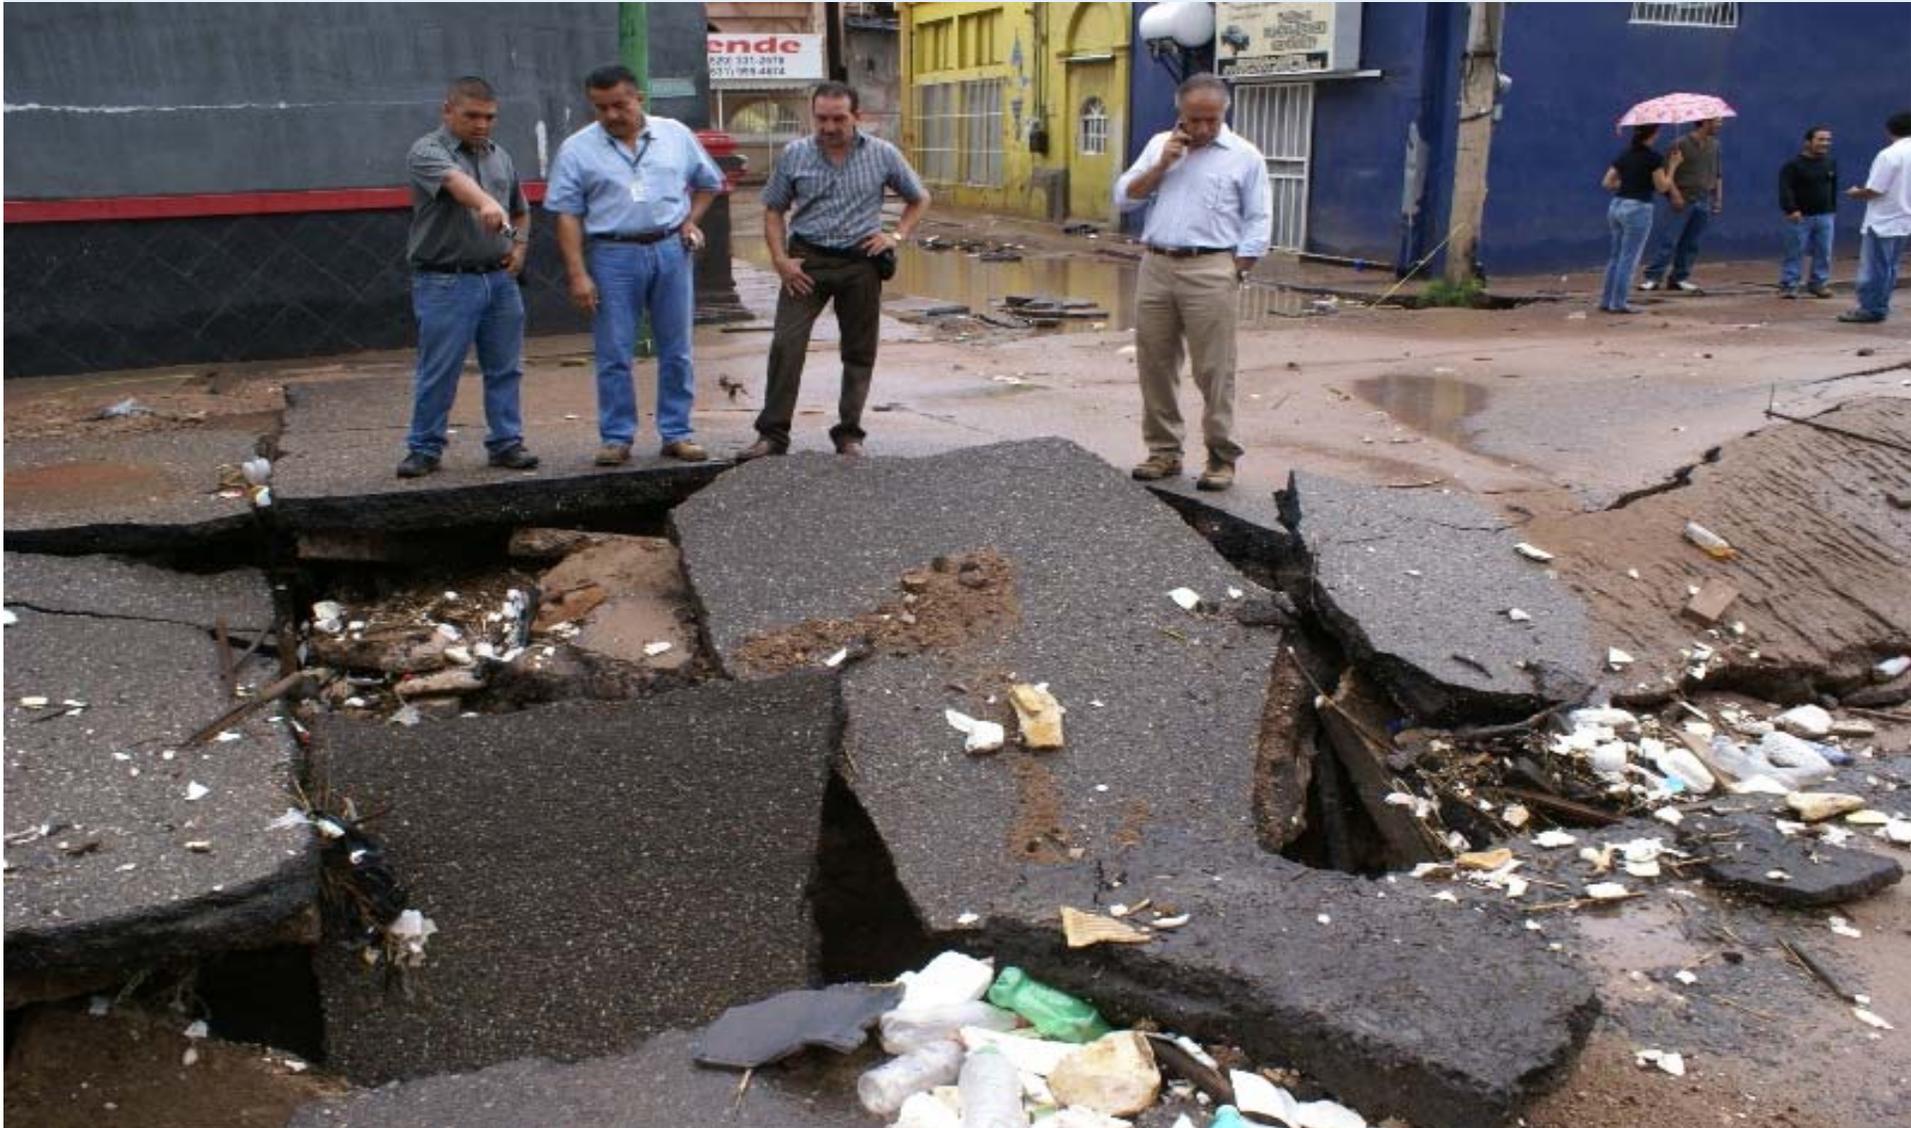
12 July 2008 Flood – Approximately 1,000 Feet of the Morley Tunnel collapsed in Nogales, Sonora adjacent to the pedestrian POE.

# MORLEY TUNNEL COLLAPSE 12 JULY 2008 NOGALES, SONORA, MEXICO

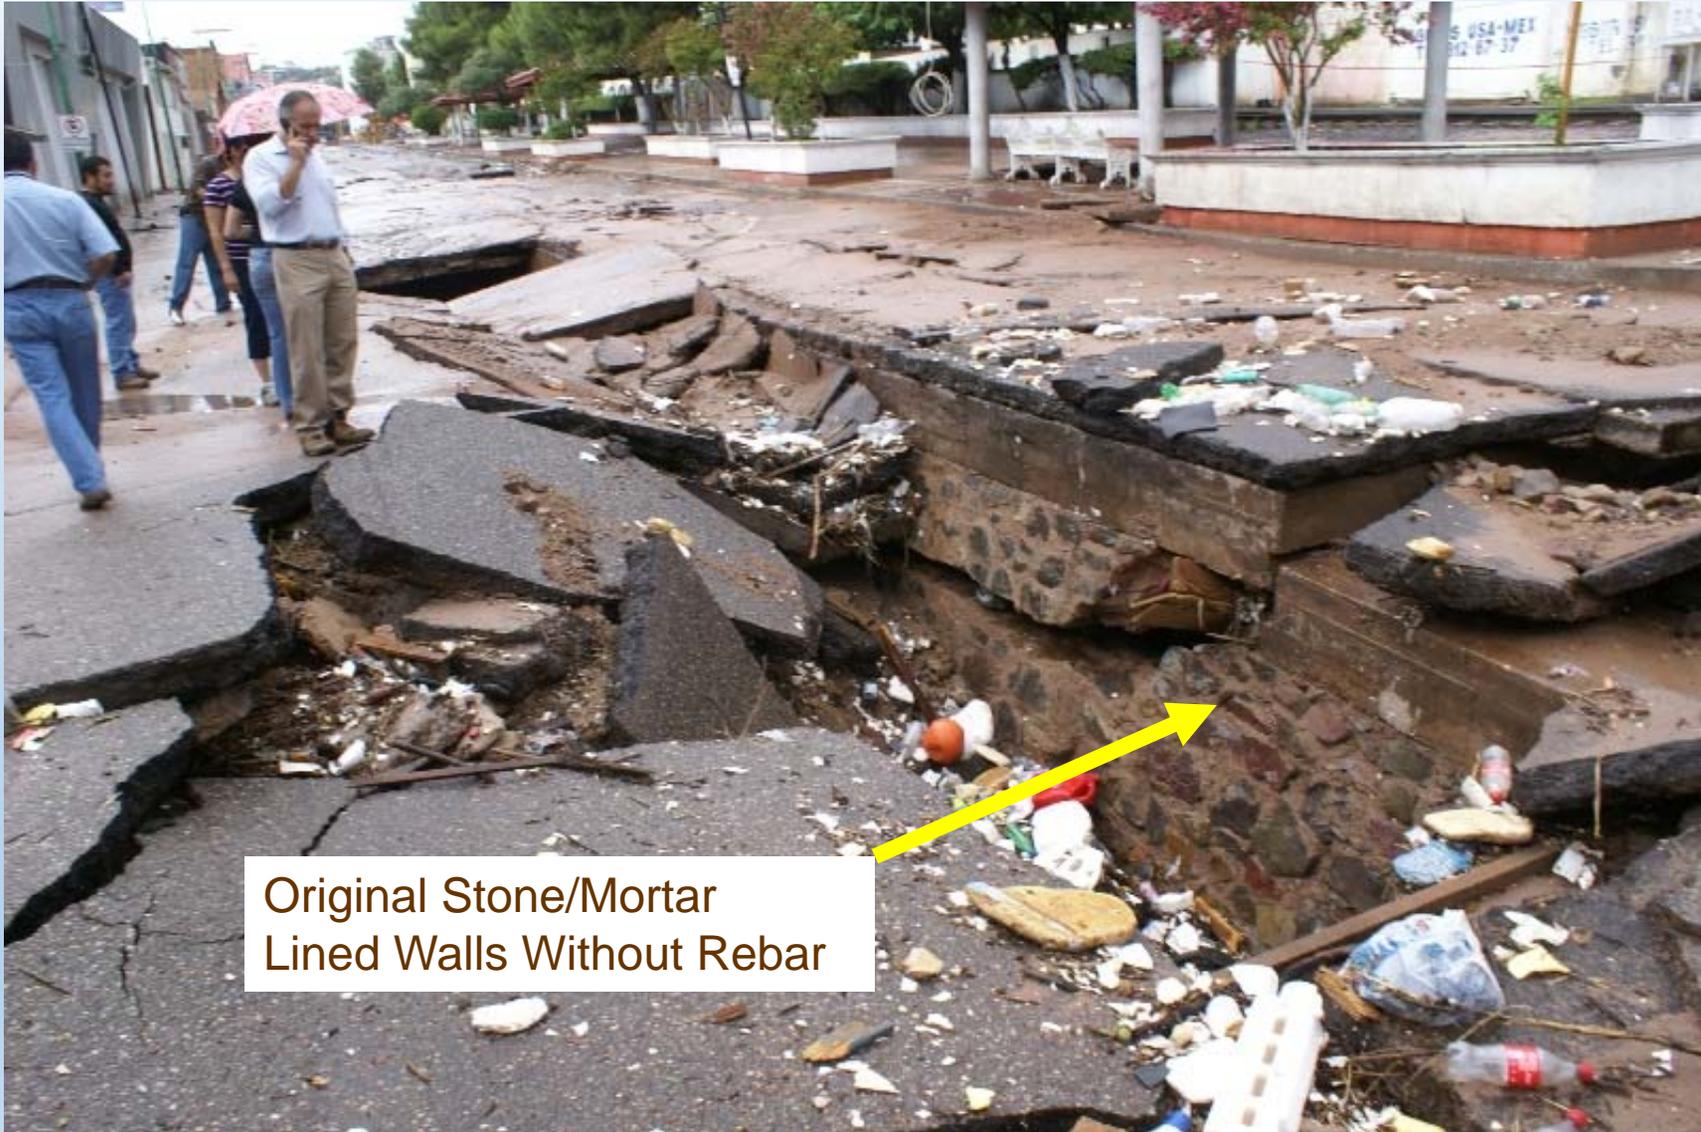
## July 12, 2008 (Day 1) Morley Tunnel Collapse in Mexico

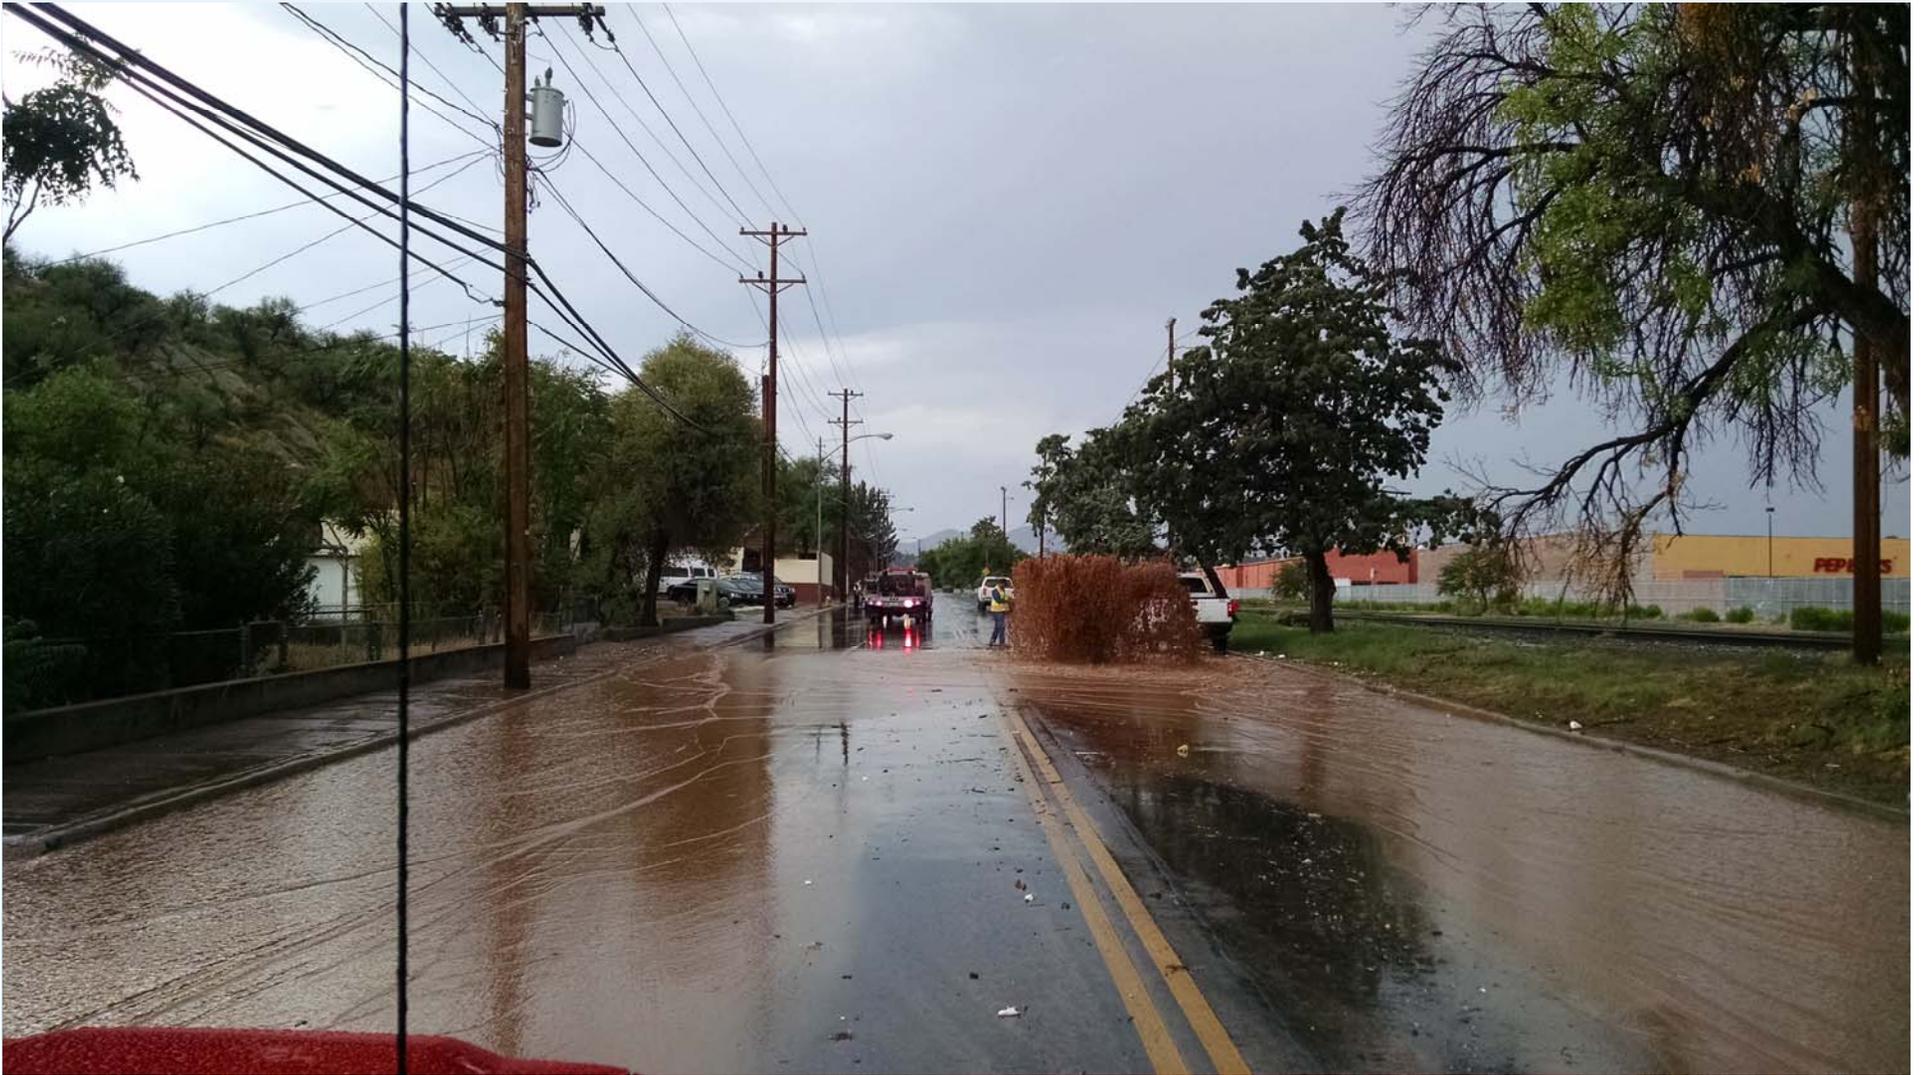
## Flooding from Manhole Pressure Flow in Nogales, AZ

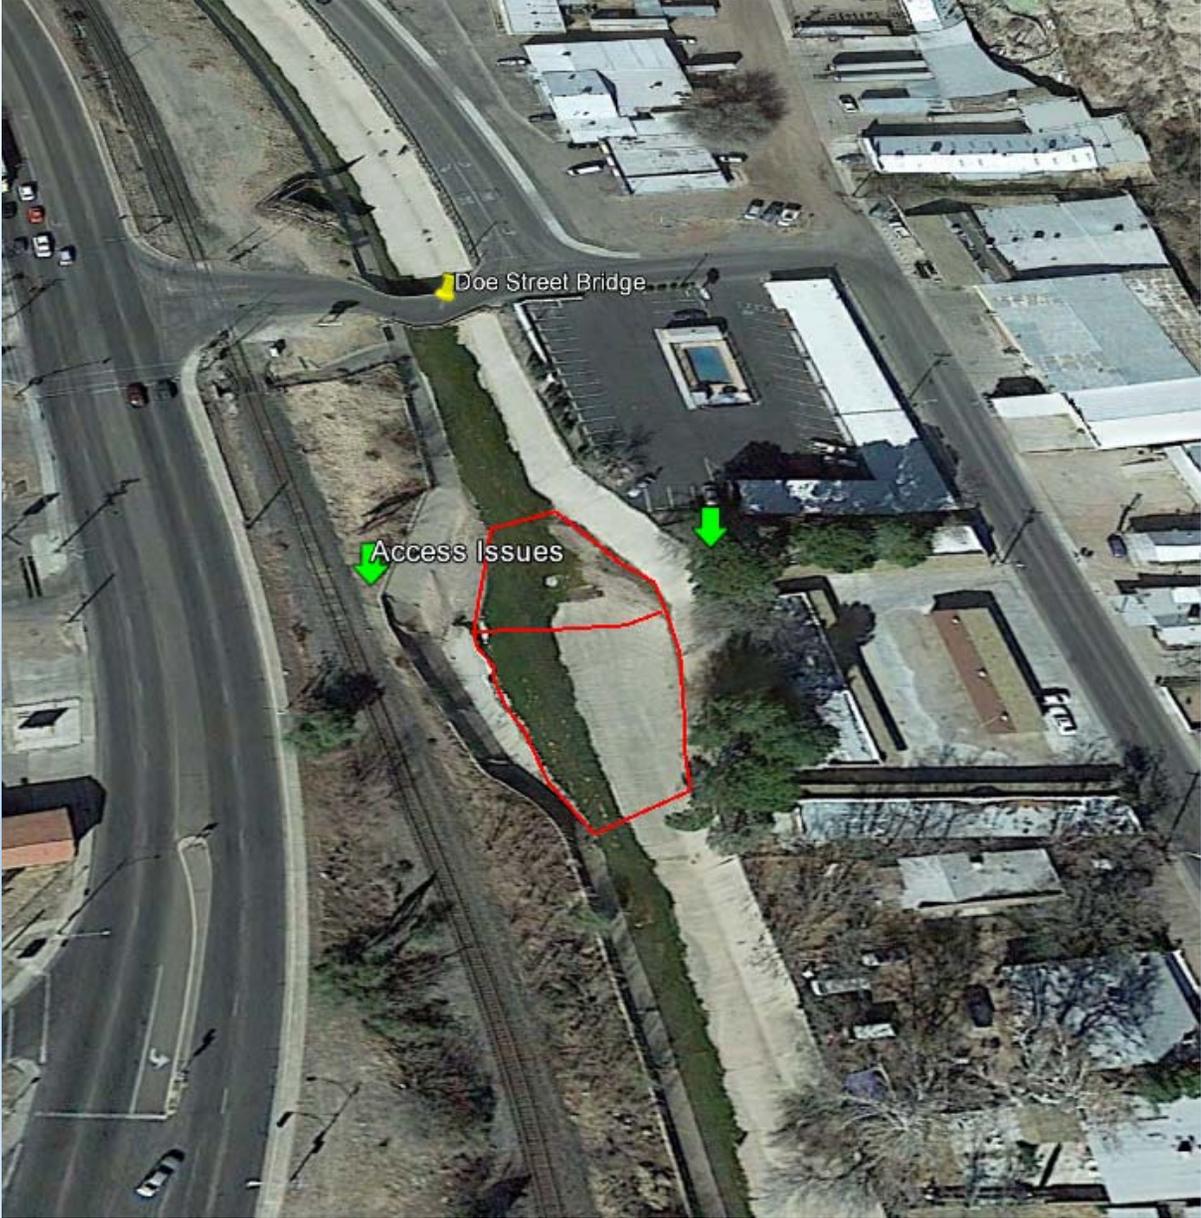
# Damage from September 18, 2014 Flooding in Nogales, AZ

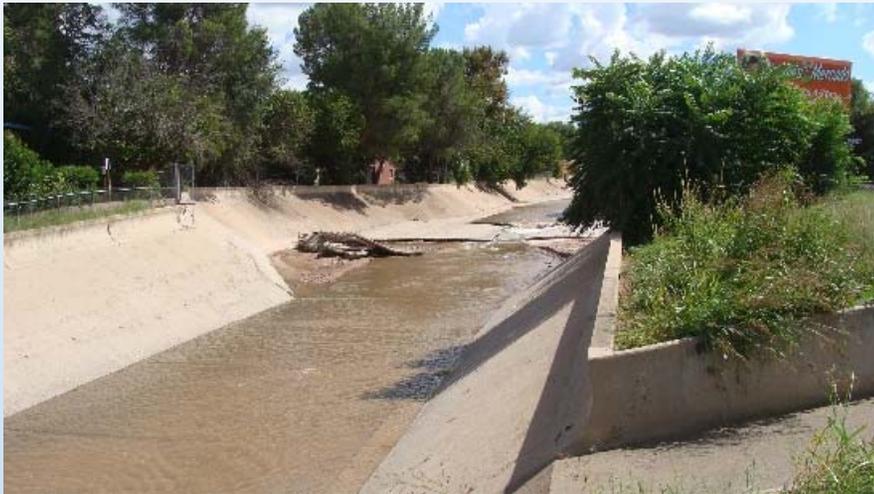
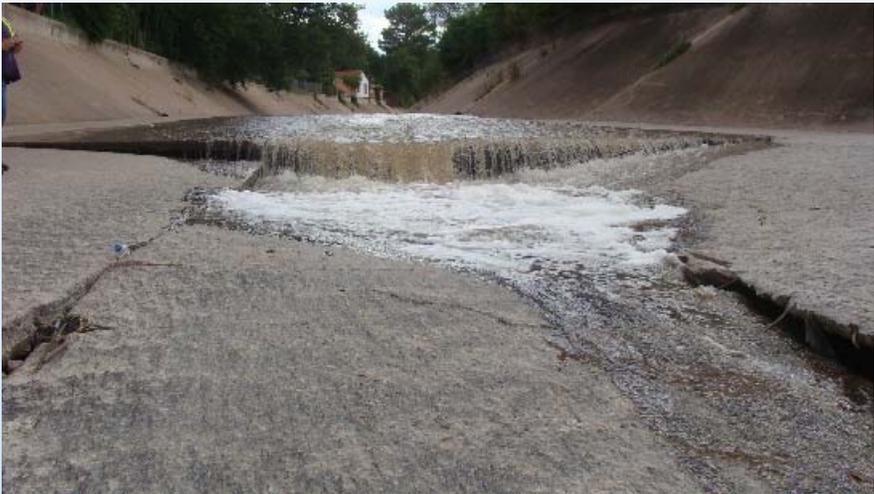
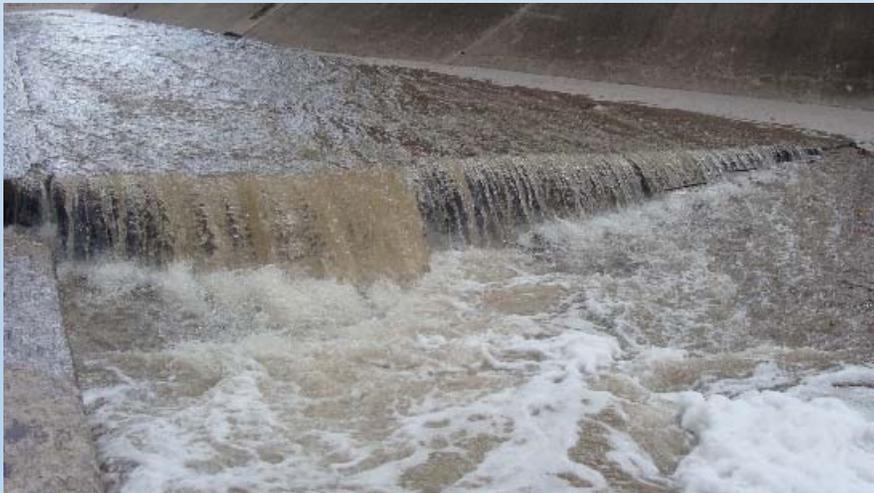
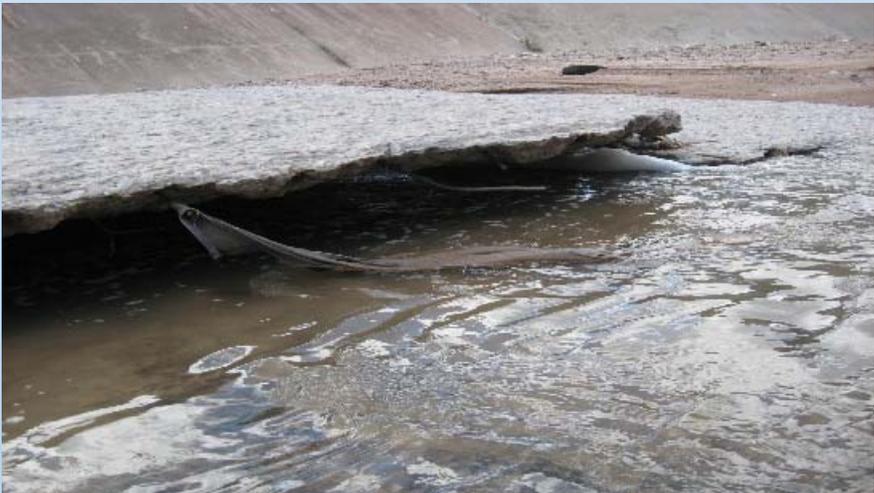
# Damage from September 18, 2014 Flooding in Nogales, AZ

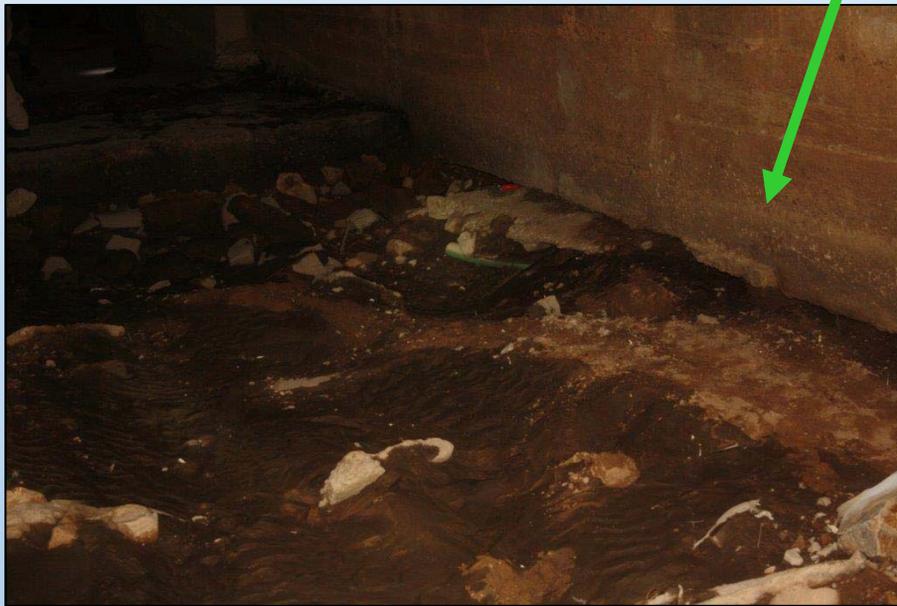
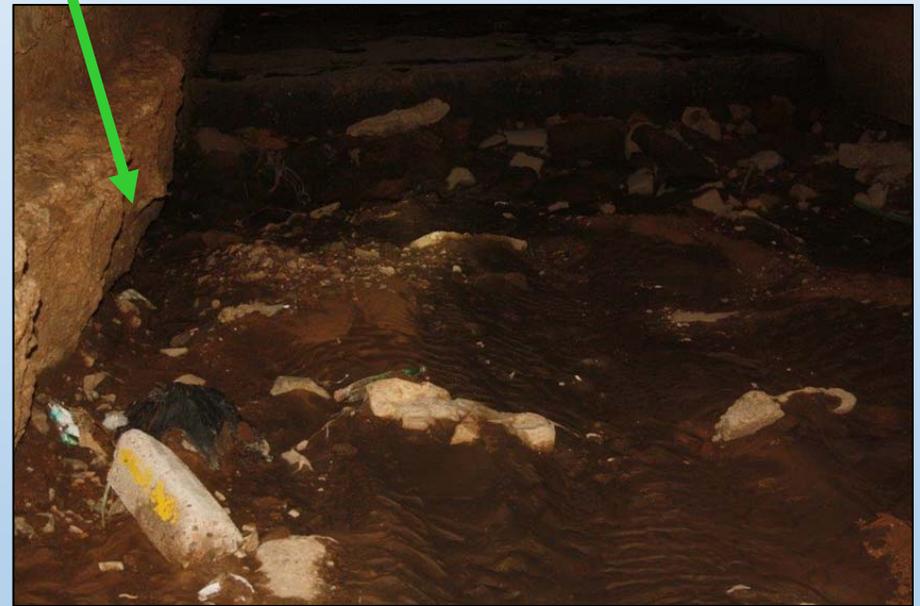
North wall of channel paralleling international boundary in Mexico

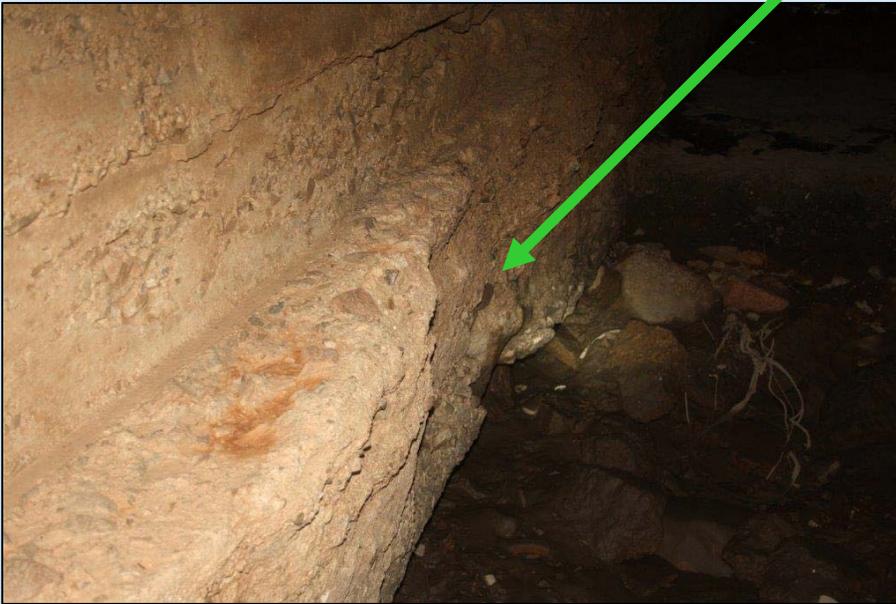
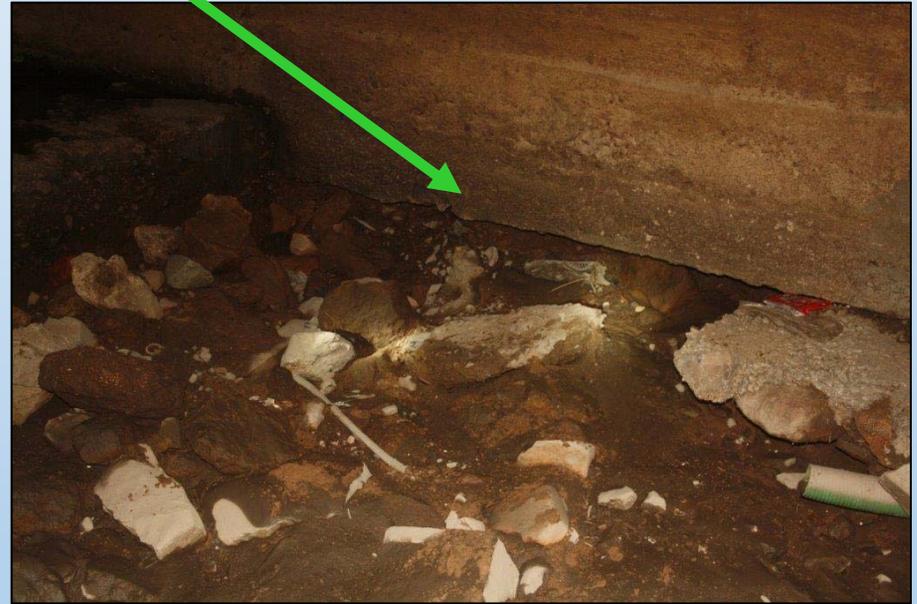
South wall of channel paralleling international boundary in Mexico

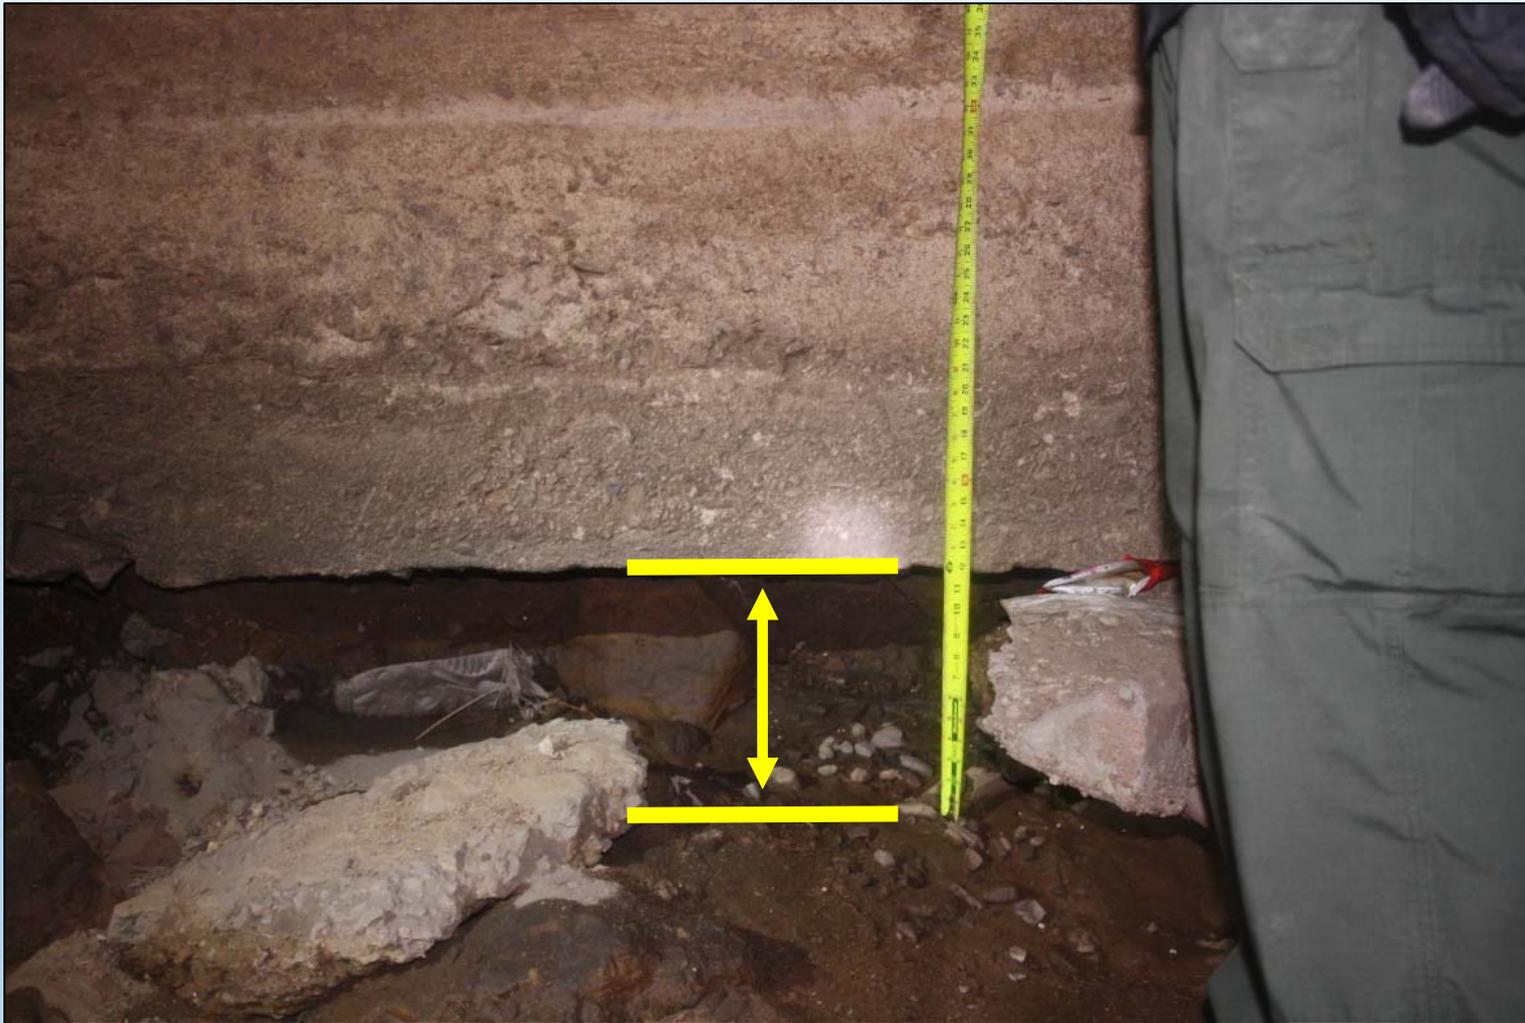
12-inch Gap Below South Wall on July 6, 2014

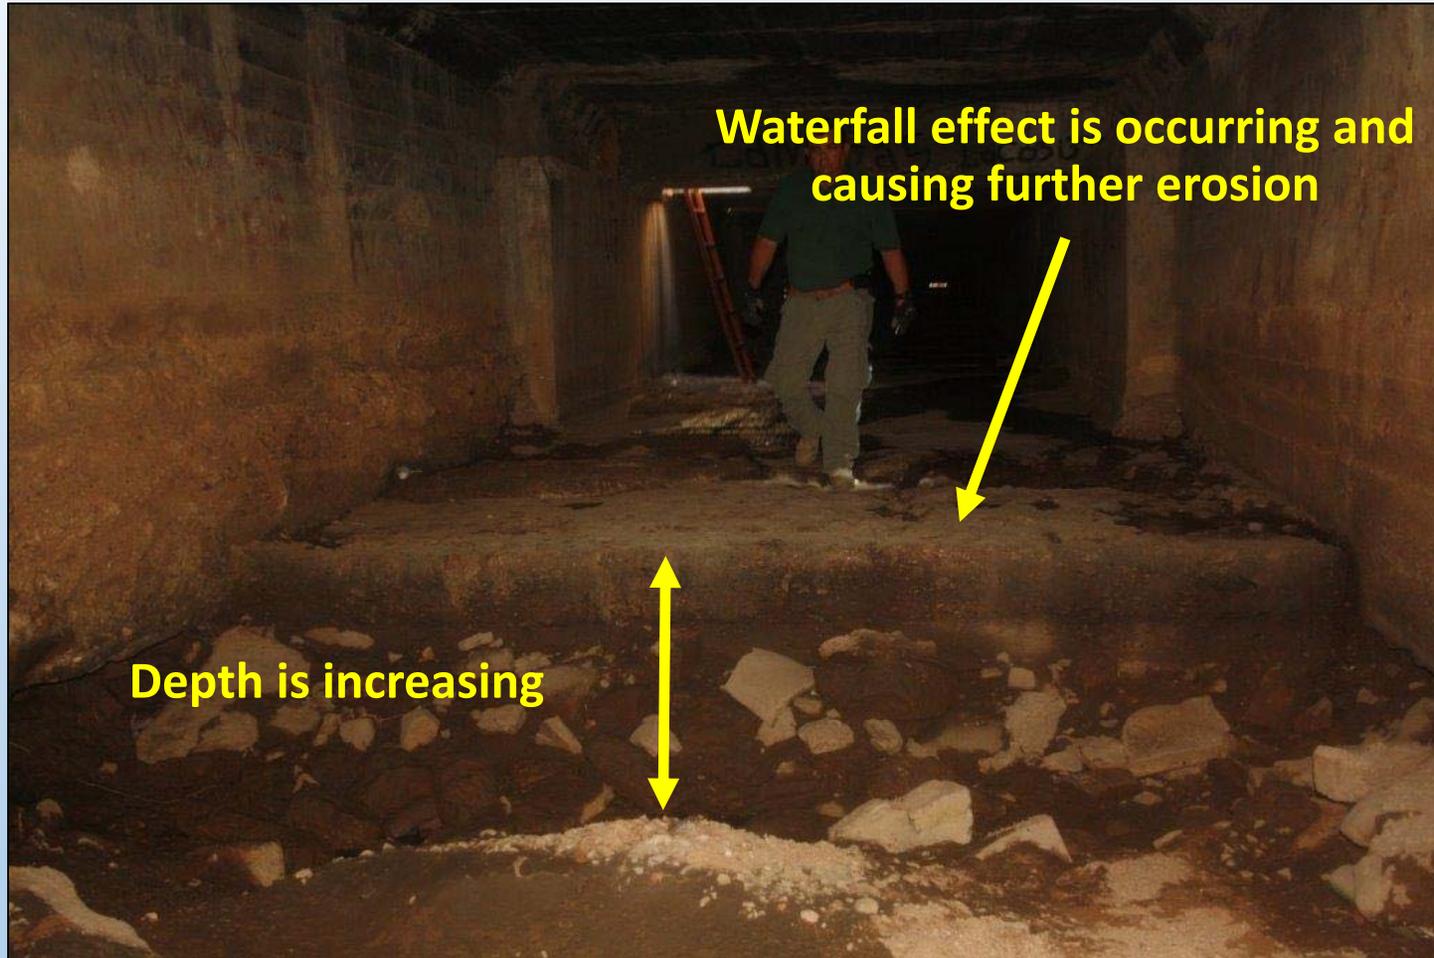
Looking west on July 6, 2014. Floor is now significantly deeper on August 7, 2014. It appears that a waterfall effect is eroding the support for the walls along the channel.

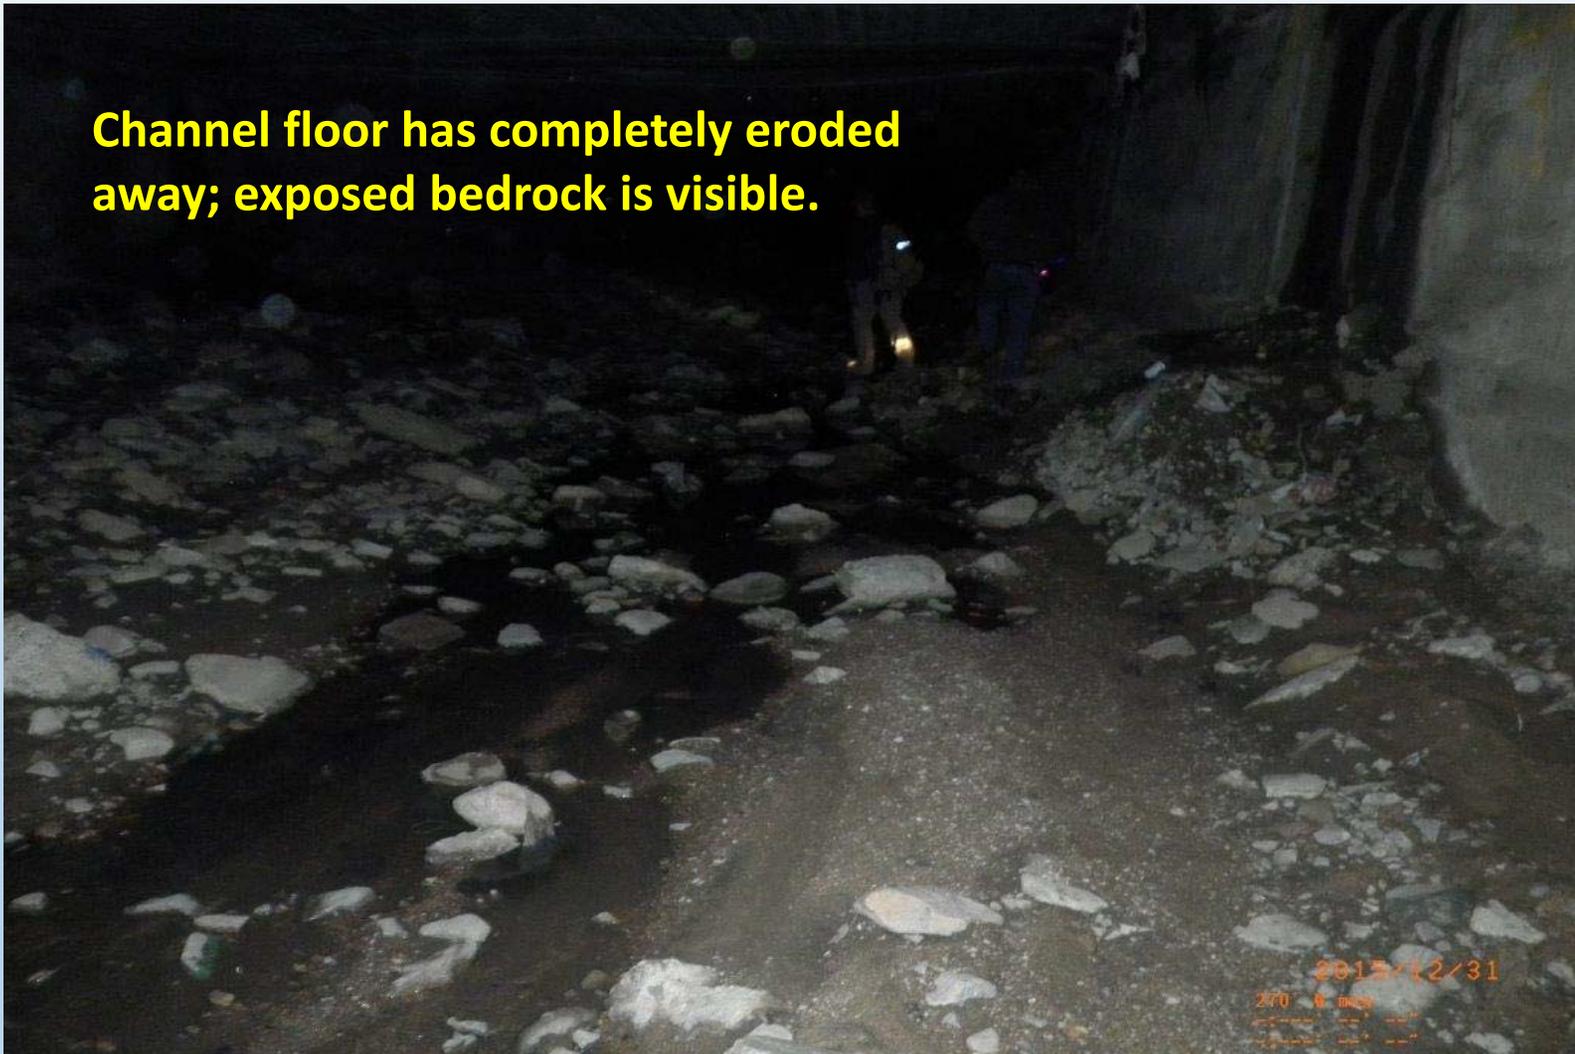
Within first 50 feet from international border.

**Channel floor has completely eroded away; exposed bedrock is visible.**

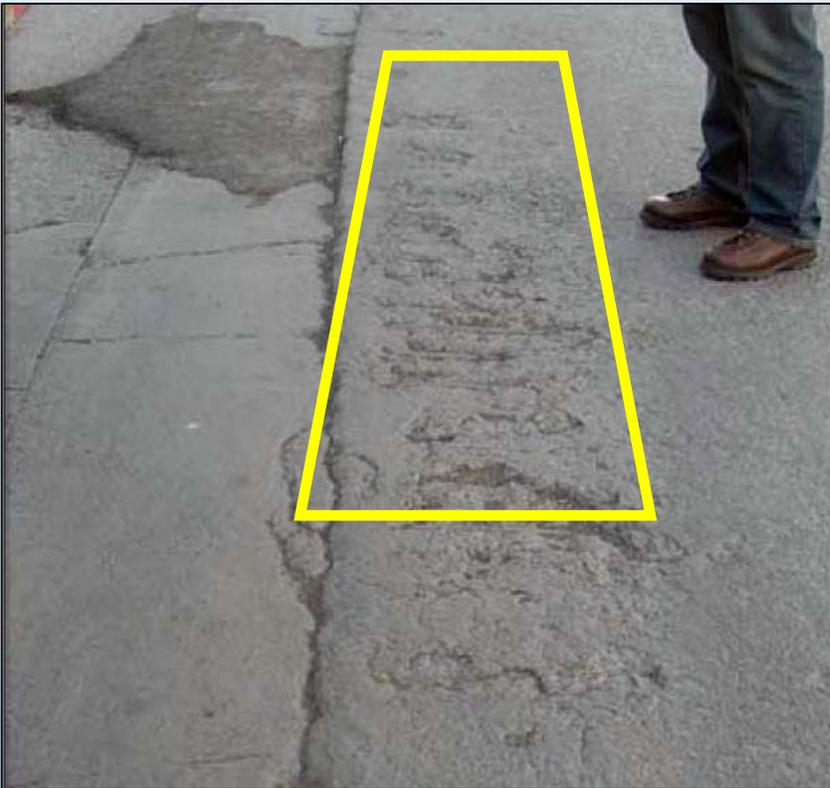
Traffic wear and tear to concrete deck, resulting in exposed rebar on the right side corner.

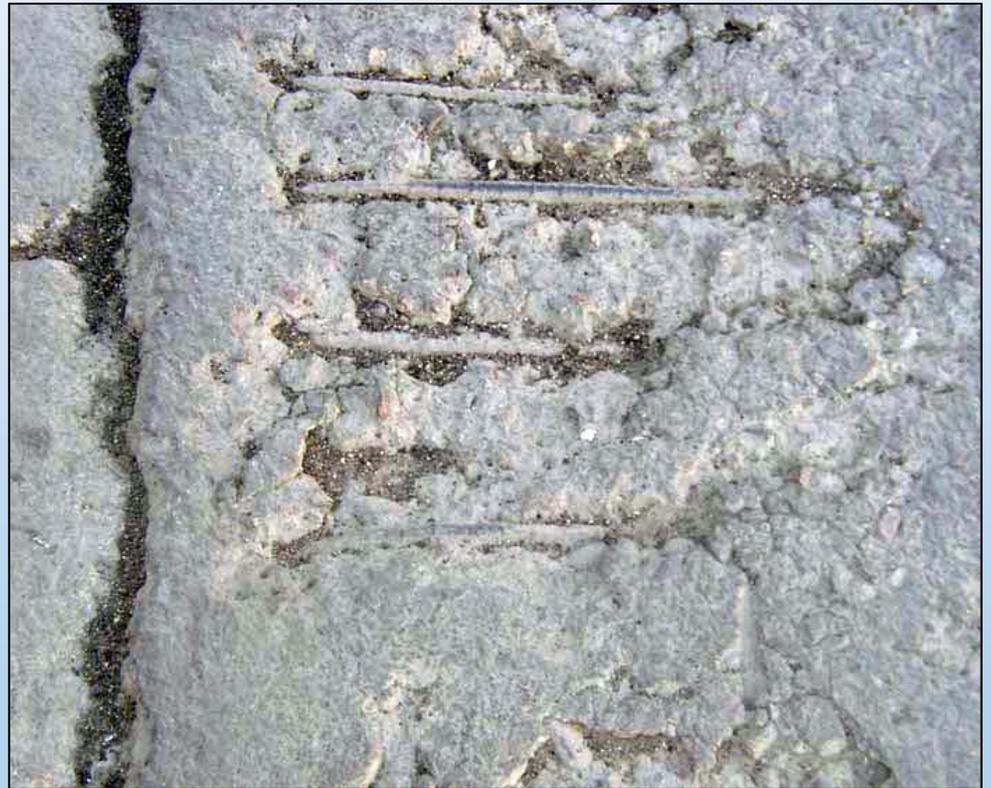
Close-up view of exposed rebar on the right side corner of the culvert deck.

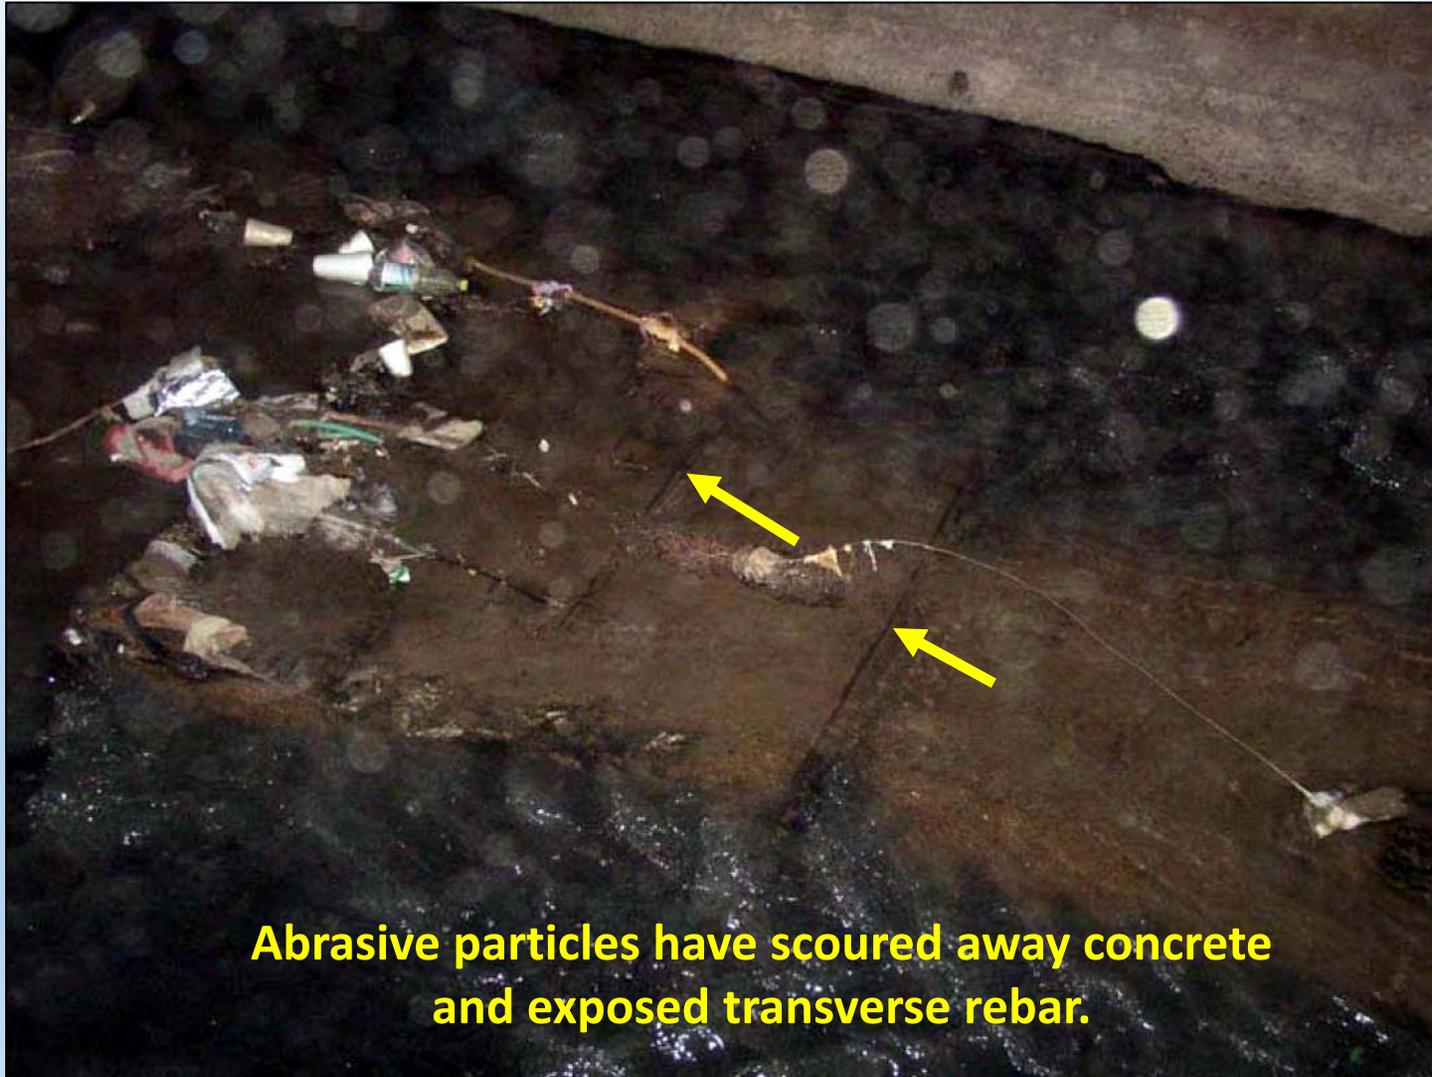
**Abrasive particles have scoured away concrete and exposed transverse rebar.**

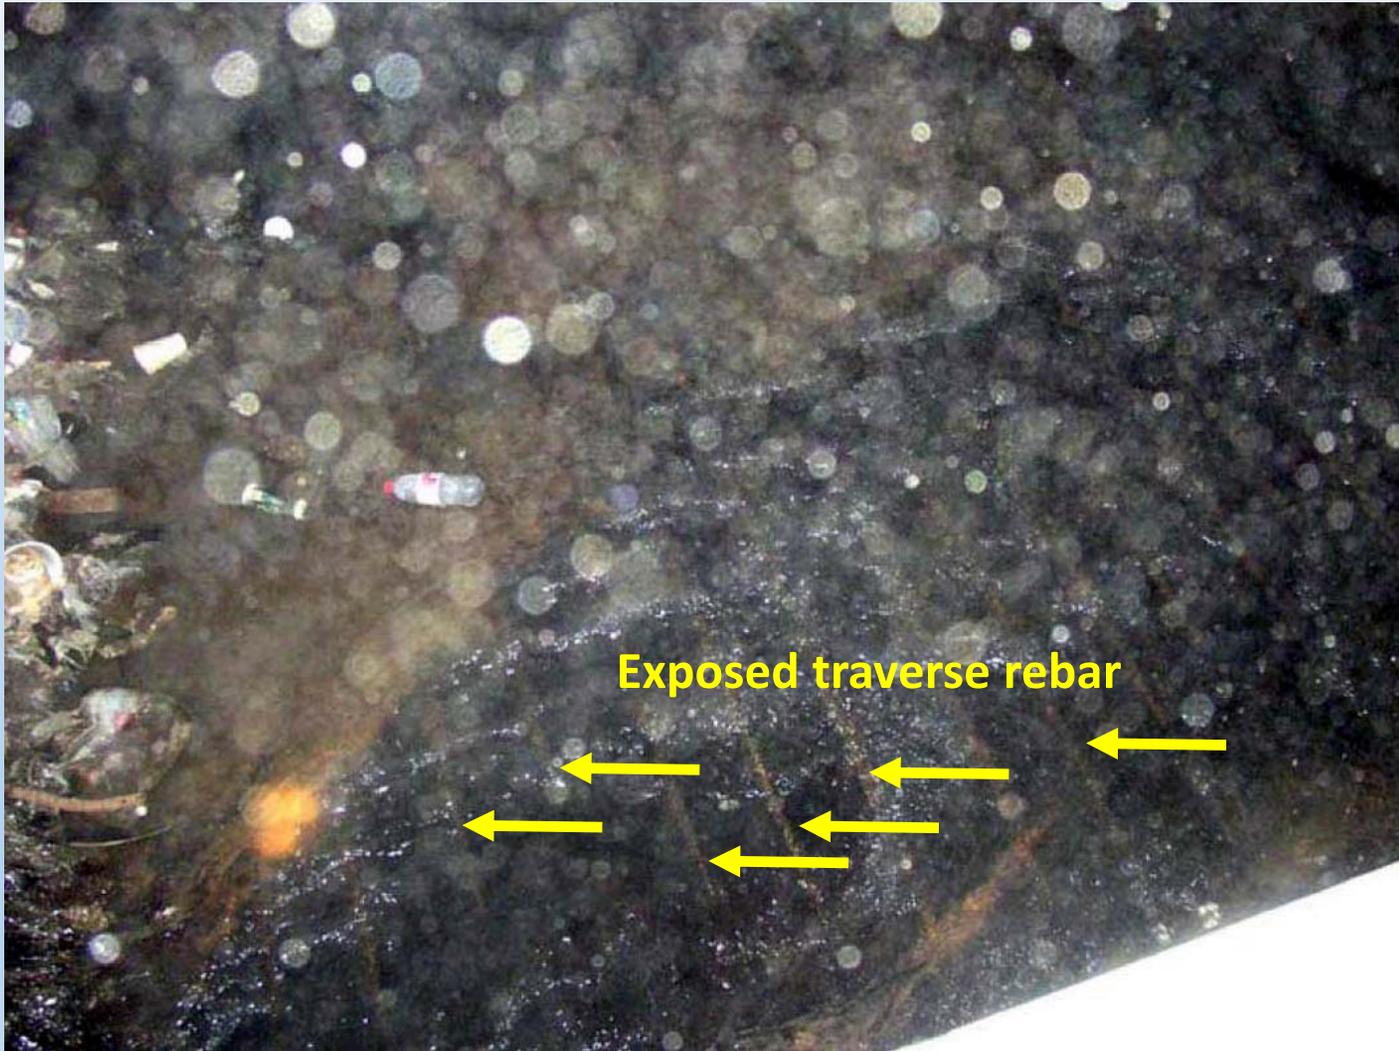
Scour has worn away concrete and exposed transverse rebar.

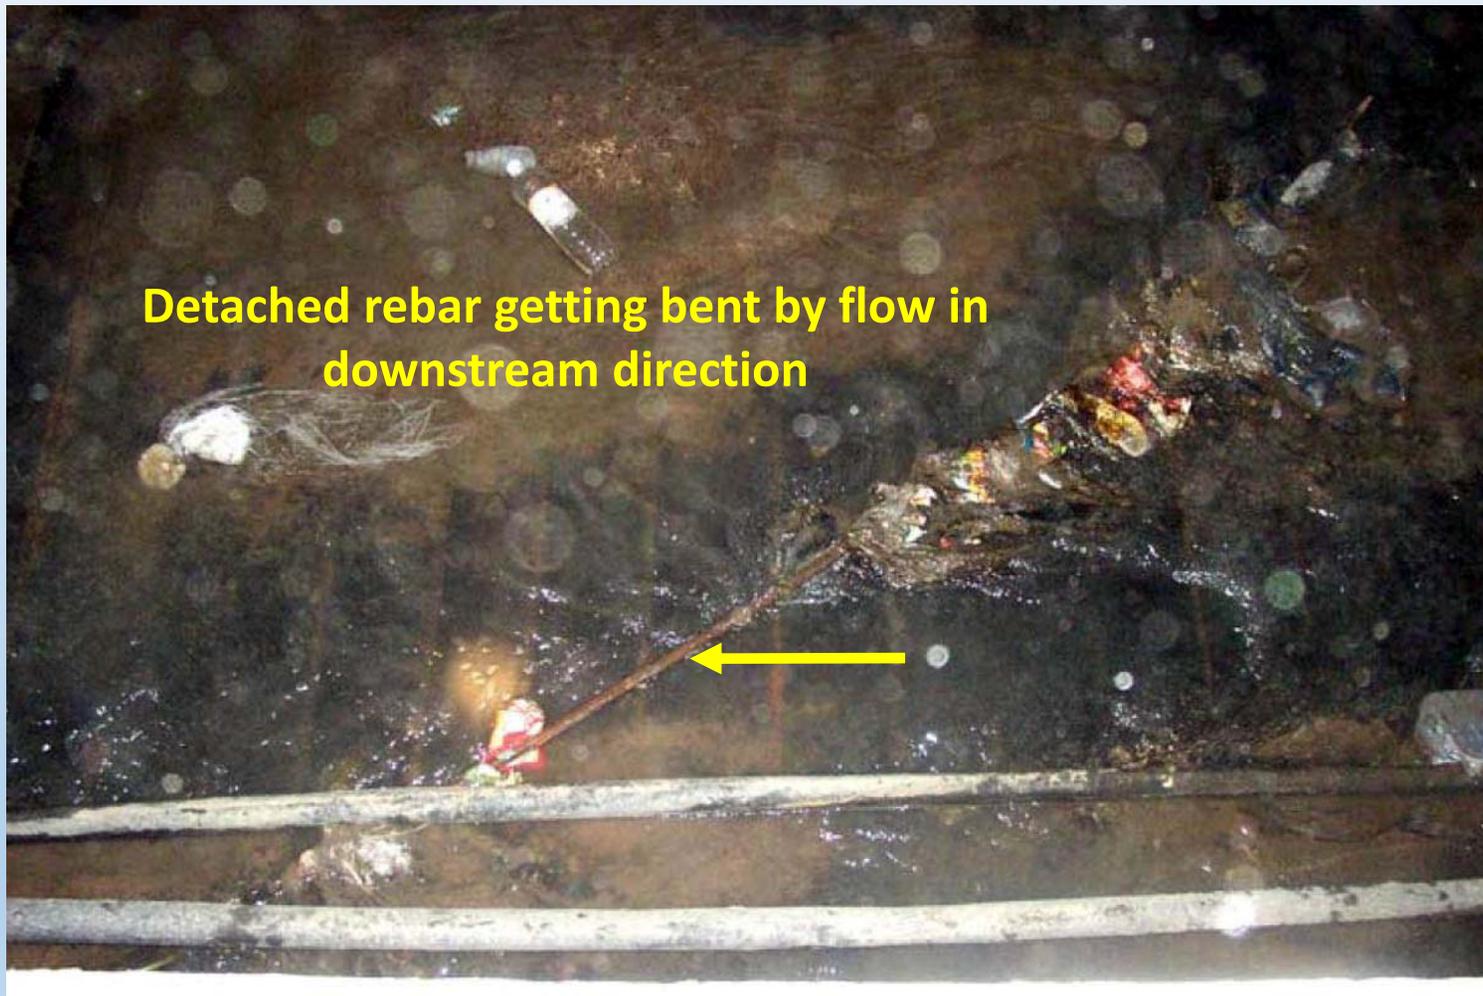
Abrasive particles eroded concrete and exposed transverse rebar.
