# GRAND AND MORLEY TUNNELS IN AMBOS NOGALES DRAINAGE FEATURES AND FLOOD MAGNITUDES

International Boundary and Water Commission  
United States Section

For U.S. Department of State Meeting on April 28, 2016

## STRUCTURAL CONCERNS

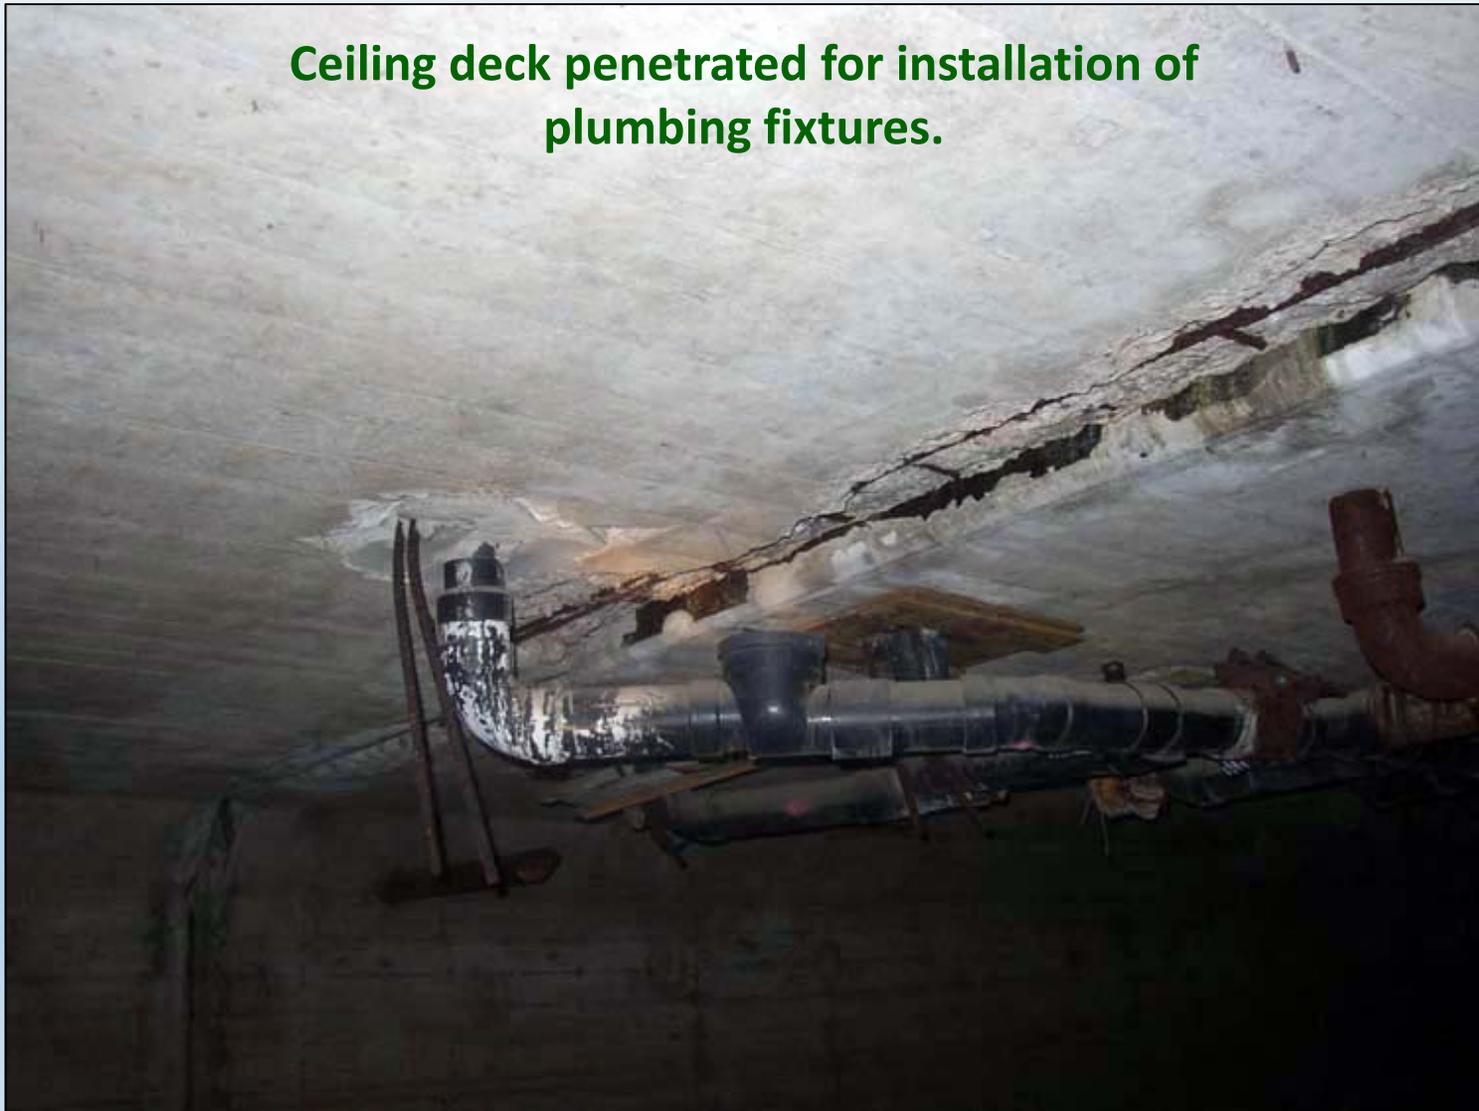
**Ceiling deck penetrated for installation of plumbing fixtures.**
