# **Bacteria Characterization in Rio Grande Segment 2304 near Laredo, Texas/ Nuevo Laredo, Tamaulipas**

**A Texas Clean Rivers Program Special Study  
FINAL REPORT**

**Field Work May and August 2011; Final Report November 2012**

**International Boundary and Water Commission, U.S. Section, Texas Clean Rivers Program**

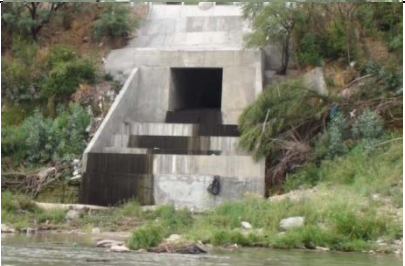
| Feature ID | Coordinates | Country | Confirmed Drain? | Description/<br>Field Notes | Photo | Bacteria Counts from August (#/100ml) |
|---|---|---|---|---|---|---|
| Feature 20 | 27.49648, -99.52573 | Mexico | Confirmed drain<br>Confirmed discharge | Large cement structure. Wet during May sampling, and discharging small trickle of clear water during August sampling. | | 14,600 (FC)<br>> 9,680 ( <i>E. coli</i> ) |

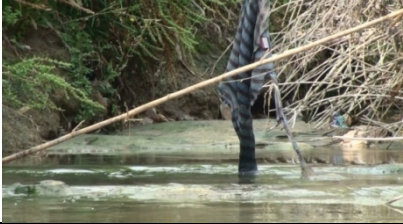
| Feature 22 | 27.49641, -99.52133 | Mexico | Confirmed discharge<br>Drain not confirmed | Small drain or tributary in Mexico. Trash and foam or biofilm. Milky, foul smelling discharge in August. | | 13,000 (FC)<br>> 9,680 ( <i>E. coli</i> ) |

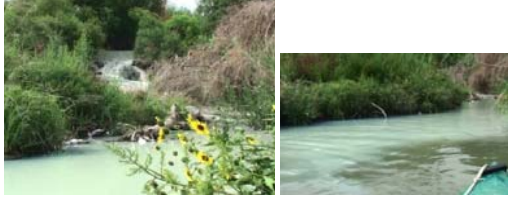
| Feature 23 | 27.49644, -99.52066 | Mexico | Confirmed drain<br>Confirmed discharge | Cement chute on bank with murky green/white discharge visible as it enters river. Large volume of discolored water discharging. Foul smell. Same as observed in April 2009 during U.S. cane removal projects. August crews noted foam. | | 336,000 (FC)<br>> 9,680 ( <i>E. coli</i> ) |

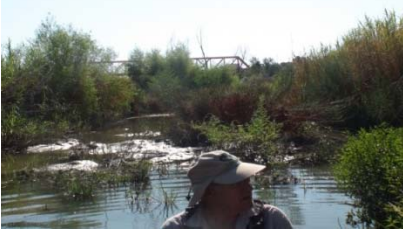
| Feature 24 near 13163 | 27.49647, -99.5197 | Mexico | No feature confirmed; However, this was one of the highest bacteria counts, but crew could not confirm a drain or feature on other side of island. | Entrance to island splitting river. Mexican side impassible. Raw sewage observed on Mexican side by May sampling crews. Crews were looking for drains on Mexican side which have been documented in the past. | | 1,300,000 (FC)<br>> 9,680 ( <i>E. coli</i> ) |

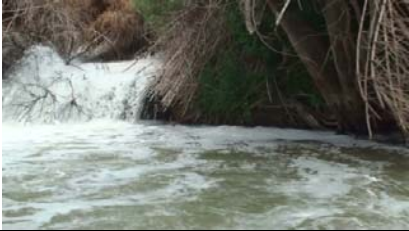
| Feature 39 | 27.49846, -99.4933 | U.S. | Confirmed drain<br>Confirmed discharge | Zacate Creek Outfall | | 256 (FC)<br>10 ( <i>E. coli</i> ) |

The bacteria values for the features of concern, listed in Table 2, show that the Feature 39, the Zacate Creek WWTP outfall, in the U.S., had low bacteria, and this drain is eliminated as a likely cause of bacteria in the river. The other drain in the U.S. (Feature 29) had bacteria levels above both U.S. and Mexican standards, but had much lower bacteria levels than other drains tested. This stormwater drain was not discharging at the time of sampling.

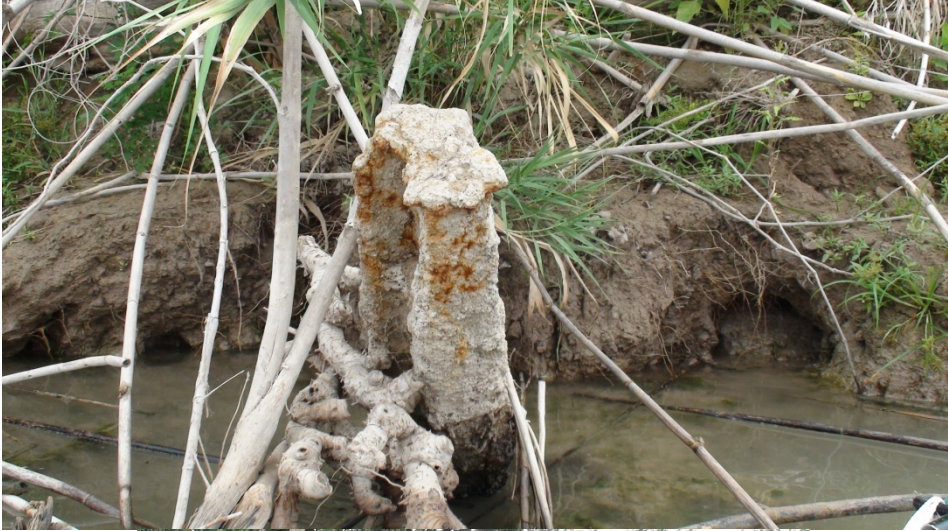
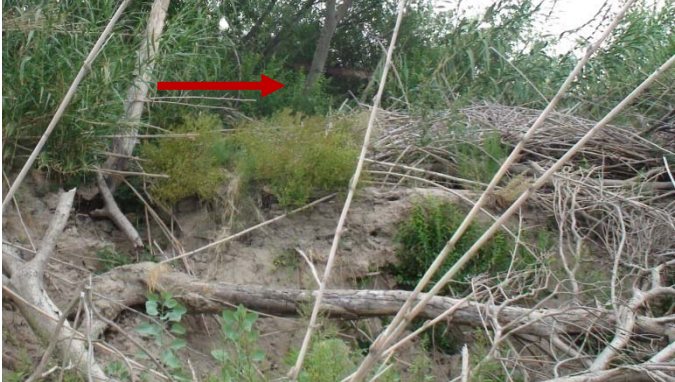
| <br> | U.S. | <b>Feature 13 –</b><br><br>Corroded metal pipe in river. Structure for possible old intake with metal building at top of bank (red arrow). | 27.50698, -99.52604 |

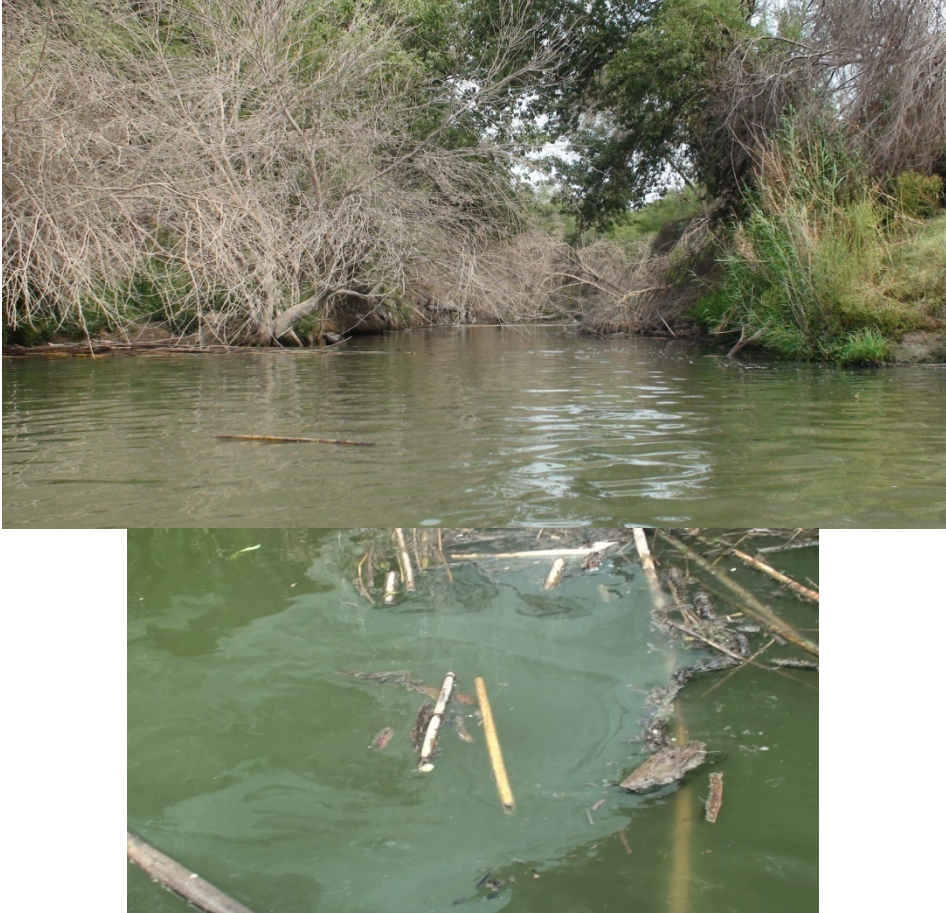
| | MEX | <p><b>Feature 15 –</b></p> <p>Tributary in Mexico. Extremely foul smelling with lots of trash and biofilm.</p> | 27.50458,<br>-99.52774 |

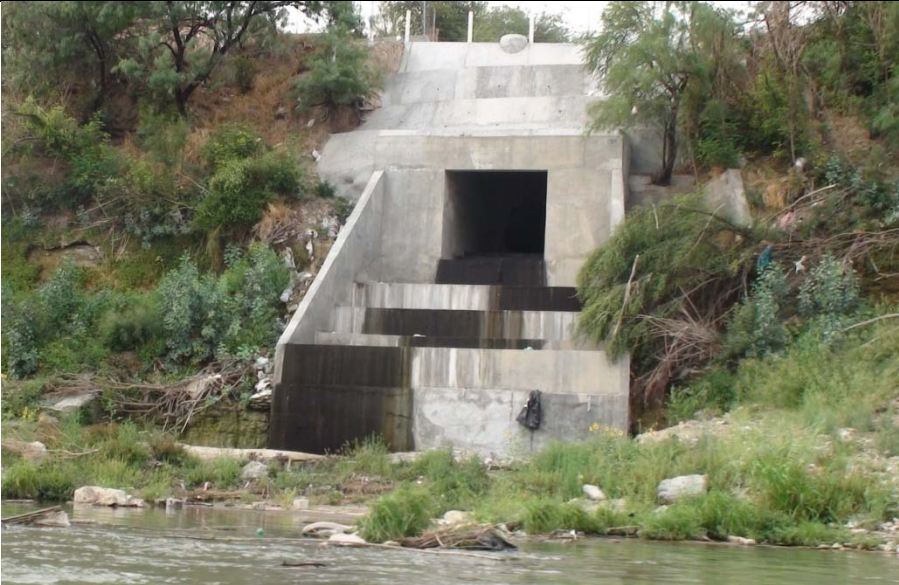
| | MEX | <p><b>Feature 20 –</b></p> <p>Large cement structure. In May, not discharging but wet. In August, this drain was discharging a trickle of clear water during, and crews collected a sample of the discharge.</p> | 27.49648, -99.52573 |

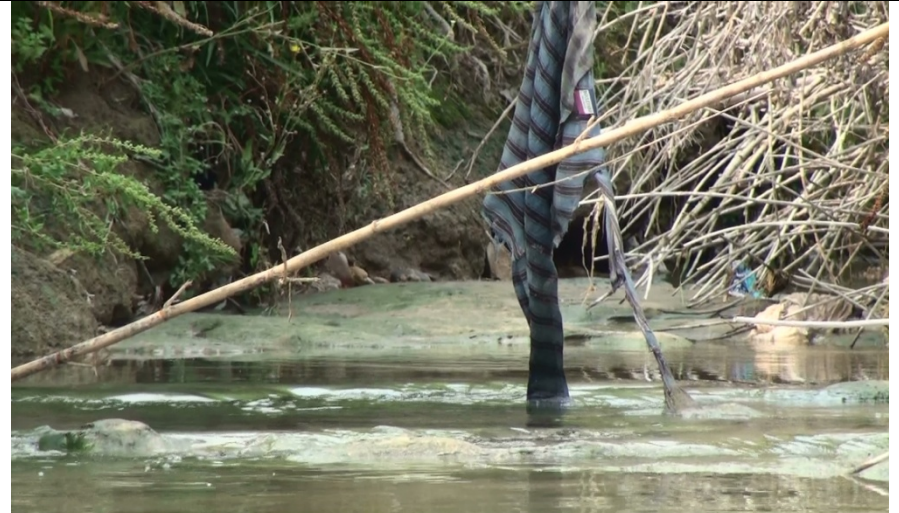
| | MEX | <p><b>Feature 22 –</b></p> <p>Small tributary in Mexico, or possible small drain. Trash and foam or biofilm. Milky, foul smelling discharge noted in August sampling.</p> | 27.49641, -99.52133 |

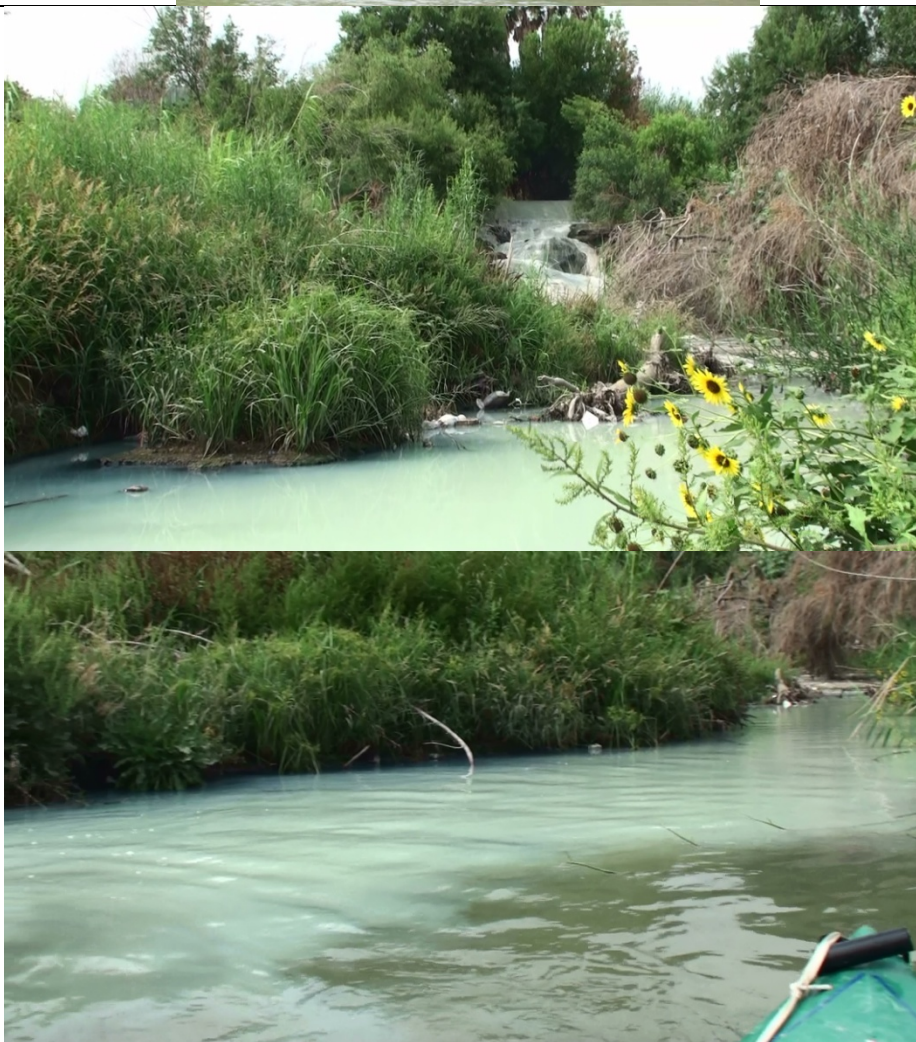
| | MEX | <p><b>Feature 23 –</b></p> <p>Cement chute on bank with murky green/white discharge visible entering river. Foul smell. Same as USIBWC CRP staff observed in April 2009 during U.S. cane removal projects. August sampling crews noted foam. Visual estimate flow is 100 lps. Later identified as “Dren America”</p> | 27.49644, -99.52066 | |

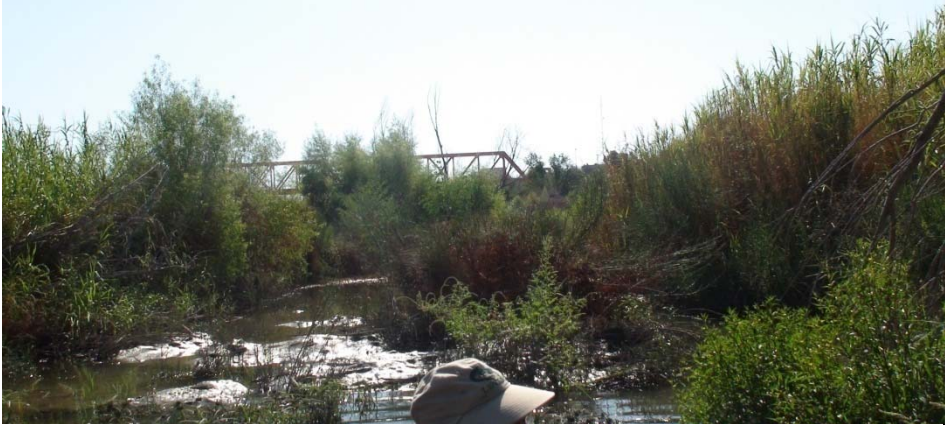
| | MEX | <p><b>Feature 24 –</b></p> <p>Entrance to island splitting river. Raw sewage observed on Mexican side by members of field crew during May sampling. Impassable with canoes. Sampling plan had sites named after historic Mexican drains on the other side of the island.</p> | 27.49647, -99.51967 |

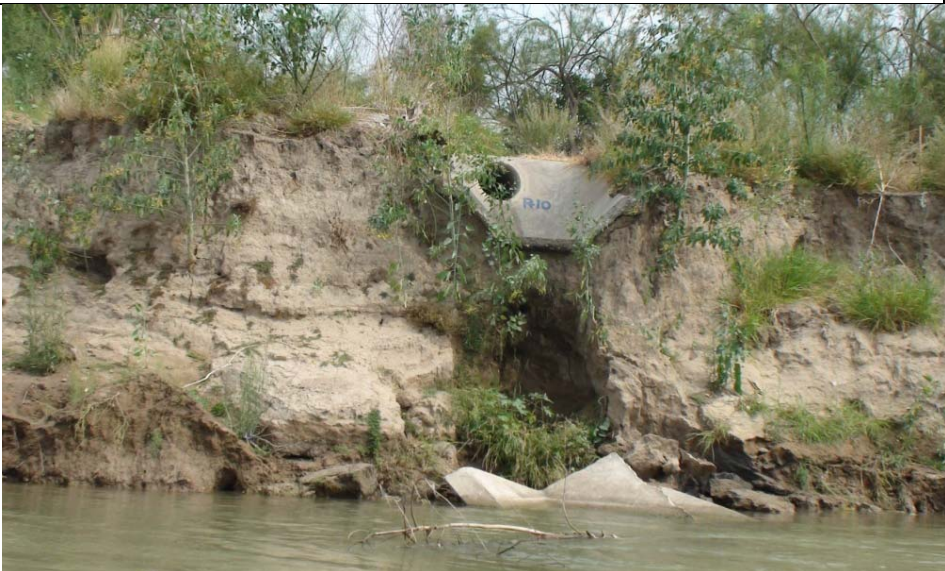
| | U.S. | <p><b>Feature 25 –</b></p> <p>Stormwater drain labeled R10. Cement debris in water.</p> | 27.49767, -99.51795 |

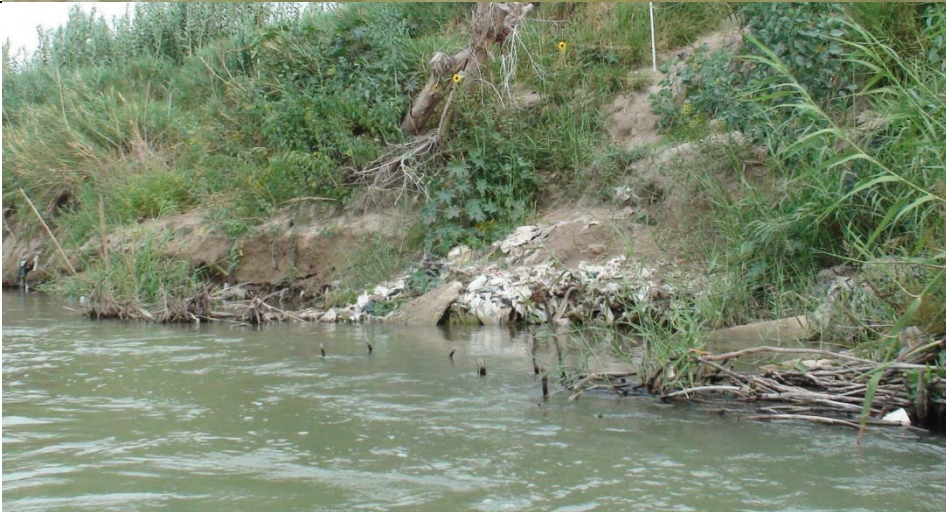
| | U.S. | <b>Feature 28a –</b><br><br>Trash pile at base of bank. | 27.4994,<br>-99.51289 |

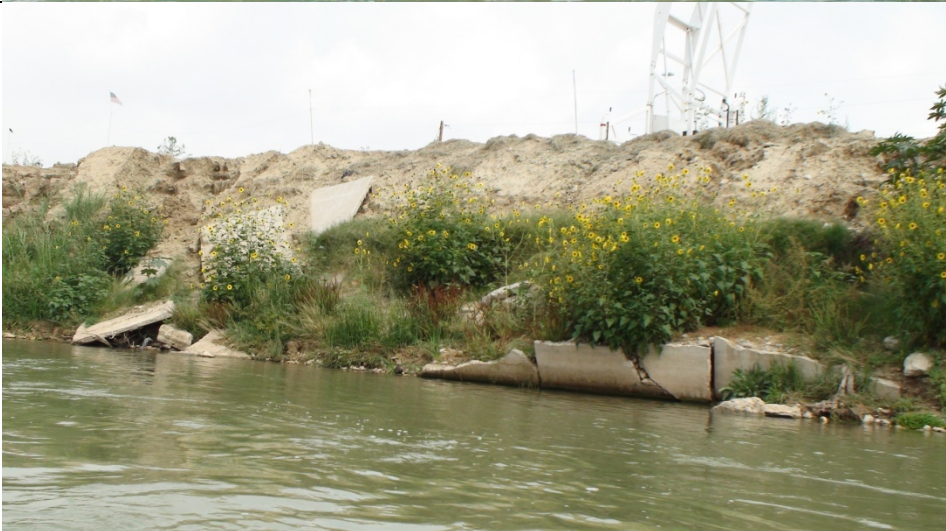
| | U.S. | <b>Feature 28b –</b><br><br>Cement blocks falling off U.S. banks, just downstream of Feature 28. Construction on bank after floods, loose sediment. | 27.49925,<br>-99.51278 |

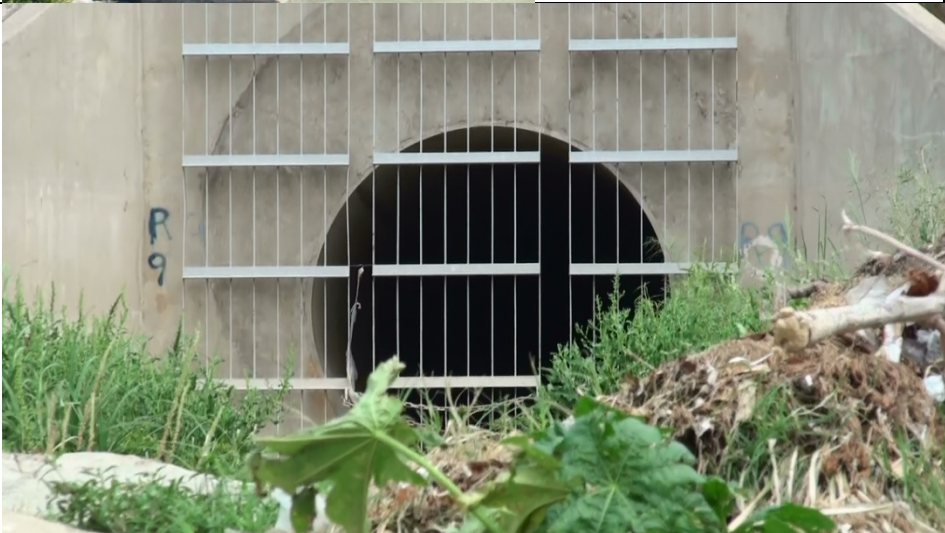
| | U.S. | <b>Feature 29a –</b><br><br>Stormwater drain labeled R-9. Large drain with grating. | 27.49944,<br>-99.5125 | |

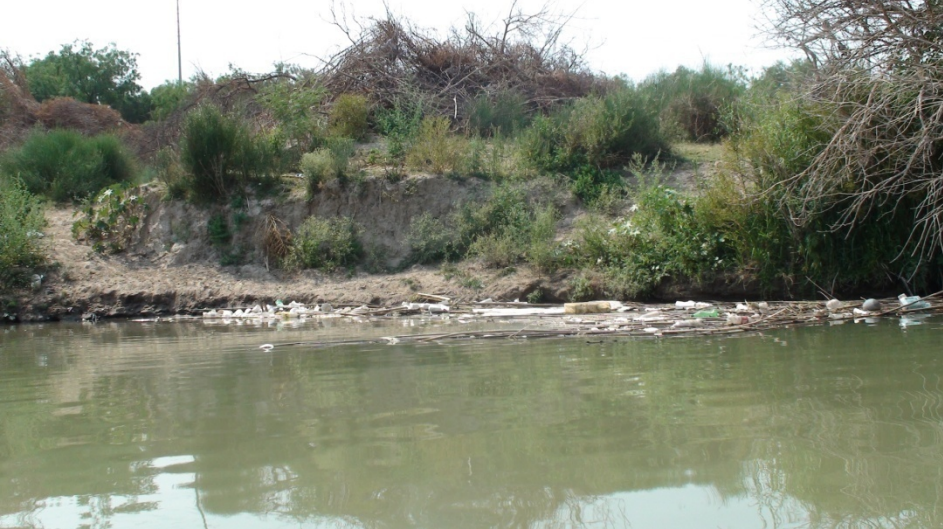
| | MEX | <b>Feature 56 –</b><br><br>Pathway to river<br>and lots of trash in<br>water. | 27.45664,<br>-99.49147 |

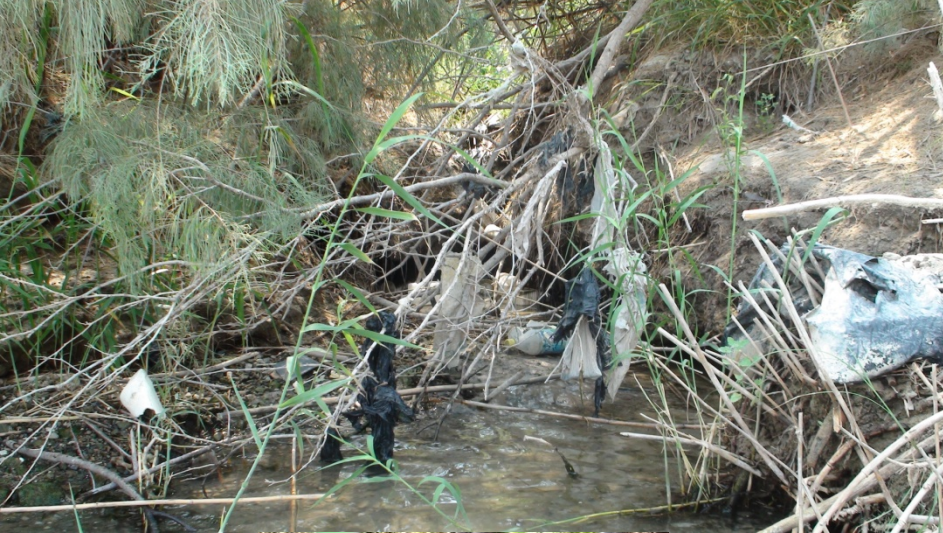
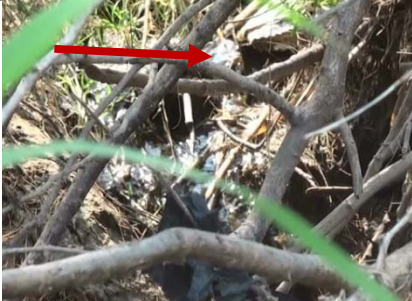
| <br> | MEX | <b>Feature 57 –</b><br><br>Small discharge.<br>No pipe visible but<br>flowing water (red<br>arrow) is visible<br>and audible.<br>Trash. | 27.45516,<br>-99.49267 |

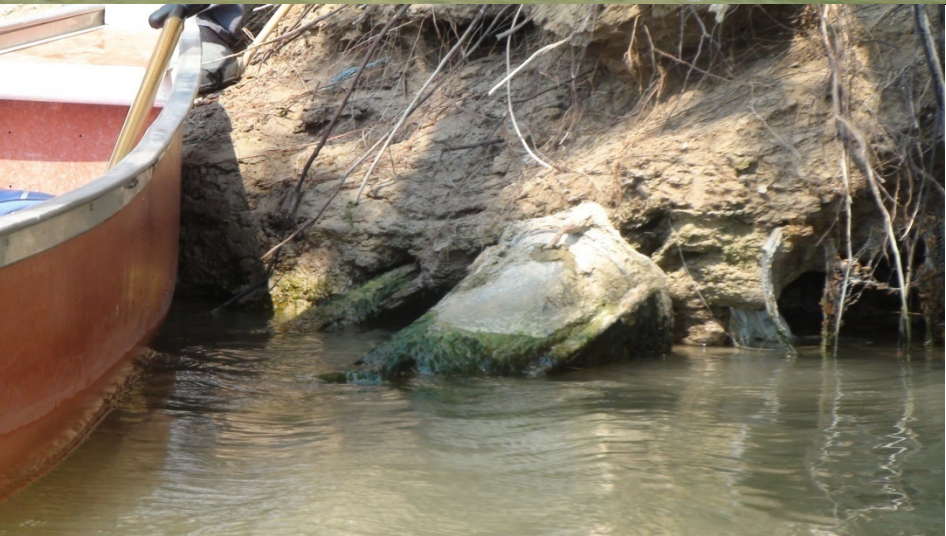
| | U.S. | <p><b>Feature 60 –</b></p> <p>Old broken rusted pipe at Masterson station 15815, appears to be intake not being used.</p> | 27.44965, -99.49408 |

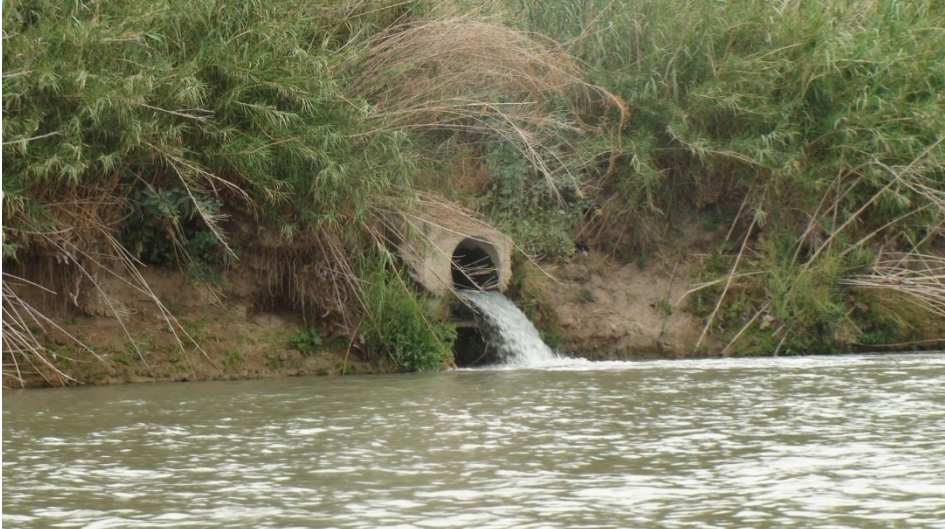
| | U.S. | <b>Feature 61 –</b><br><br>Laredo outfall, permitted facility. Discharging. | 27.44599, -99.49519 |

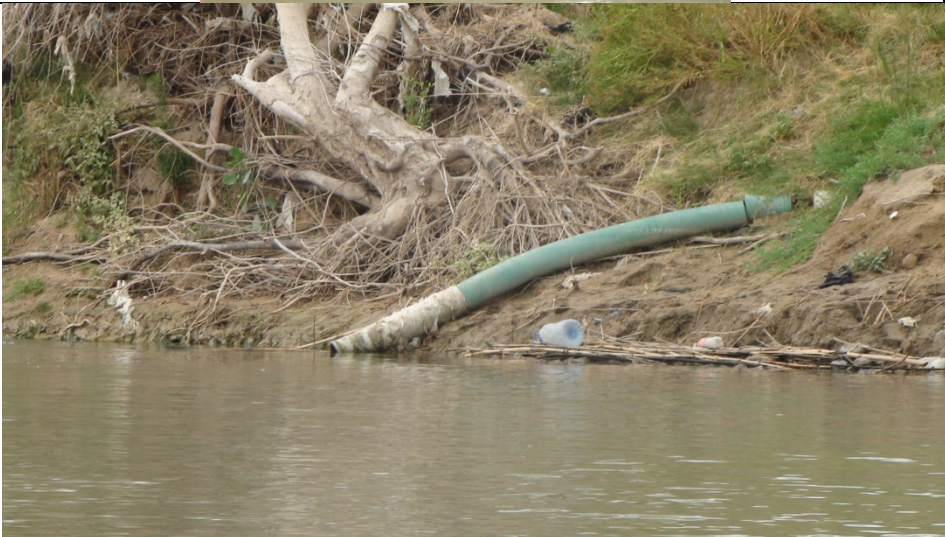
| | MEX | <b>Feature 64 –</b><br><br>Blue green pipe arching into river, looks broken and unused. | 27.43184, -99.49399 | |

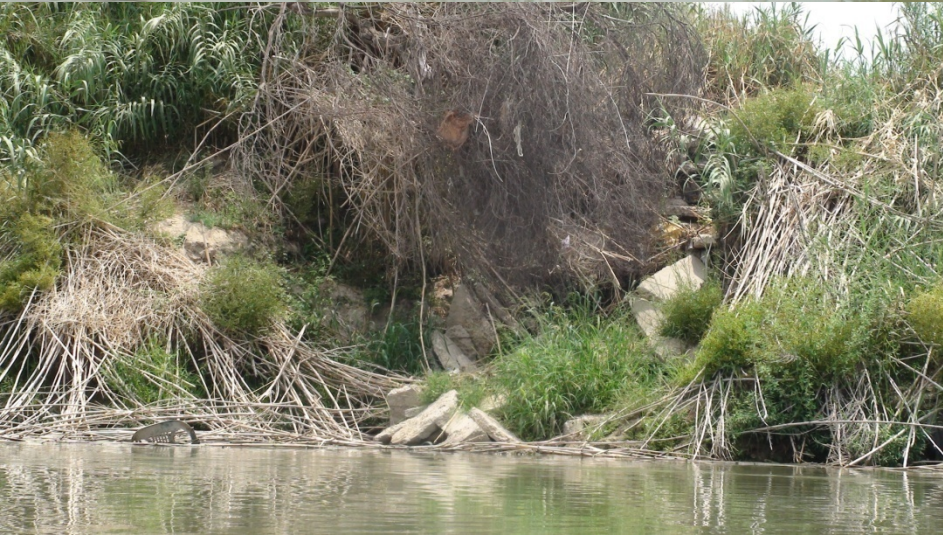
| | U.S. | <b>Feature 87 –</b><br><br>Concrete pile with trash. | 27.36294,<br>-99.50391 |

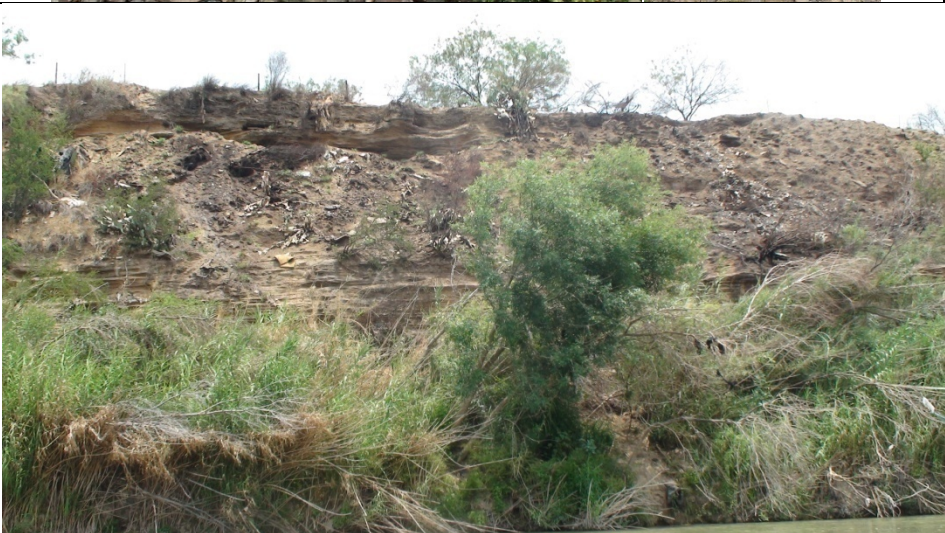
| | U.S. | <p><b>Feature 89 –</b></p> <p>Huge trash pile on cliffs at El Cenizo. Appears community dump trash over cliffs regularly.</p> | 27.33449, -99.5079 |

The study research team also recommends that local communities and regulatory entities in both countries pursue the trash issues documented in this study.
