Southeast Arizona Citizens Forum

Transboundary Flow Mitigation

Naco, Sonora

Sierra Vista, Arizona, March 21, 2019

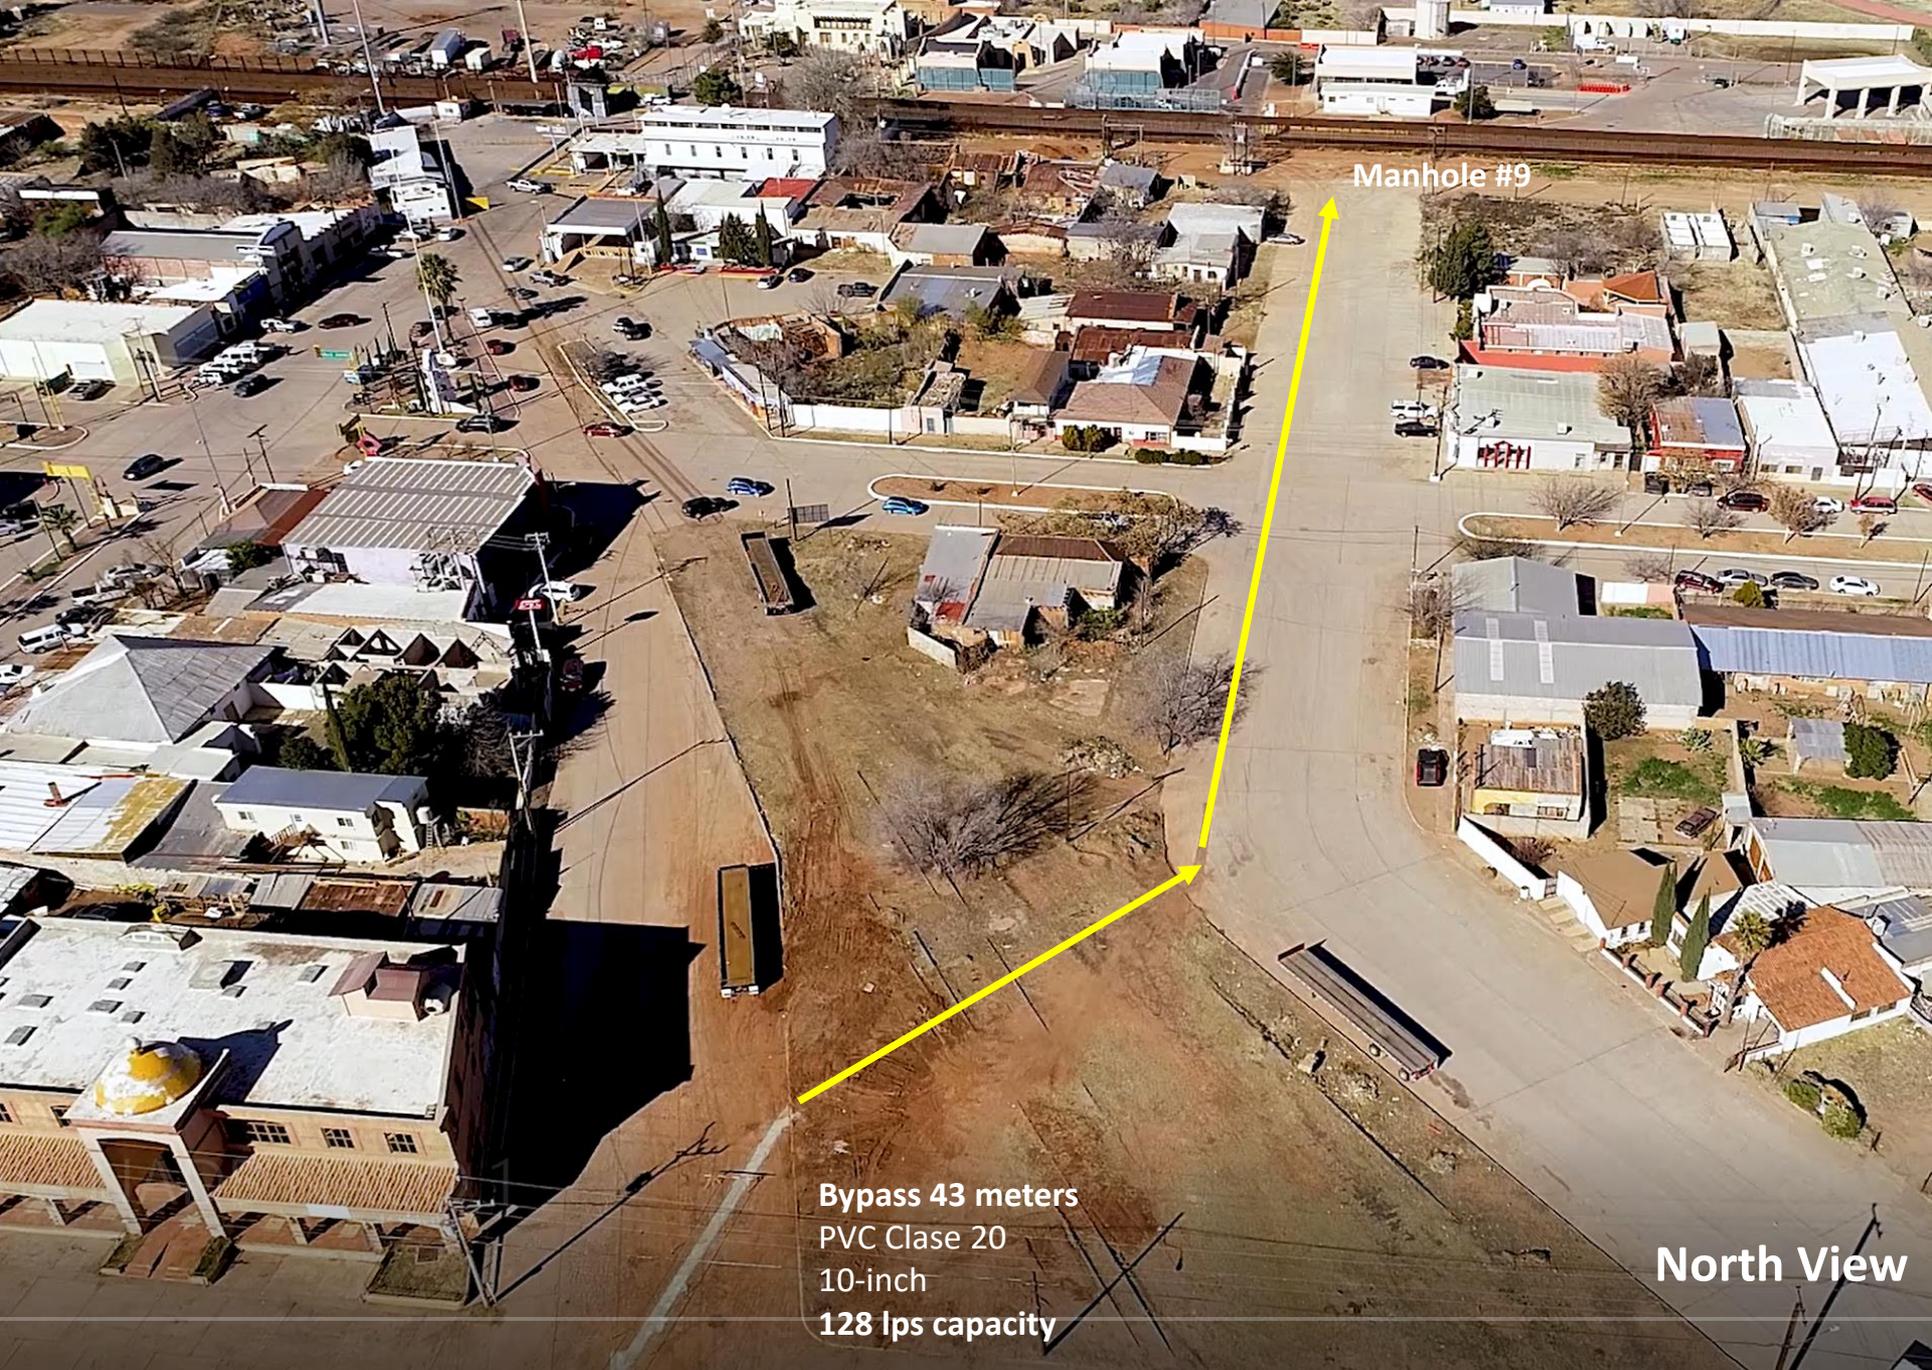
Manhole #9

Bypass 43 meters
PVC Clase 20
10-inch
128 lps capacity

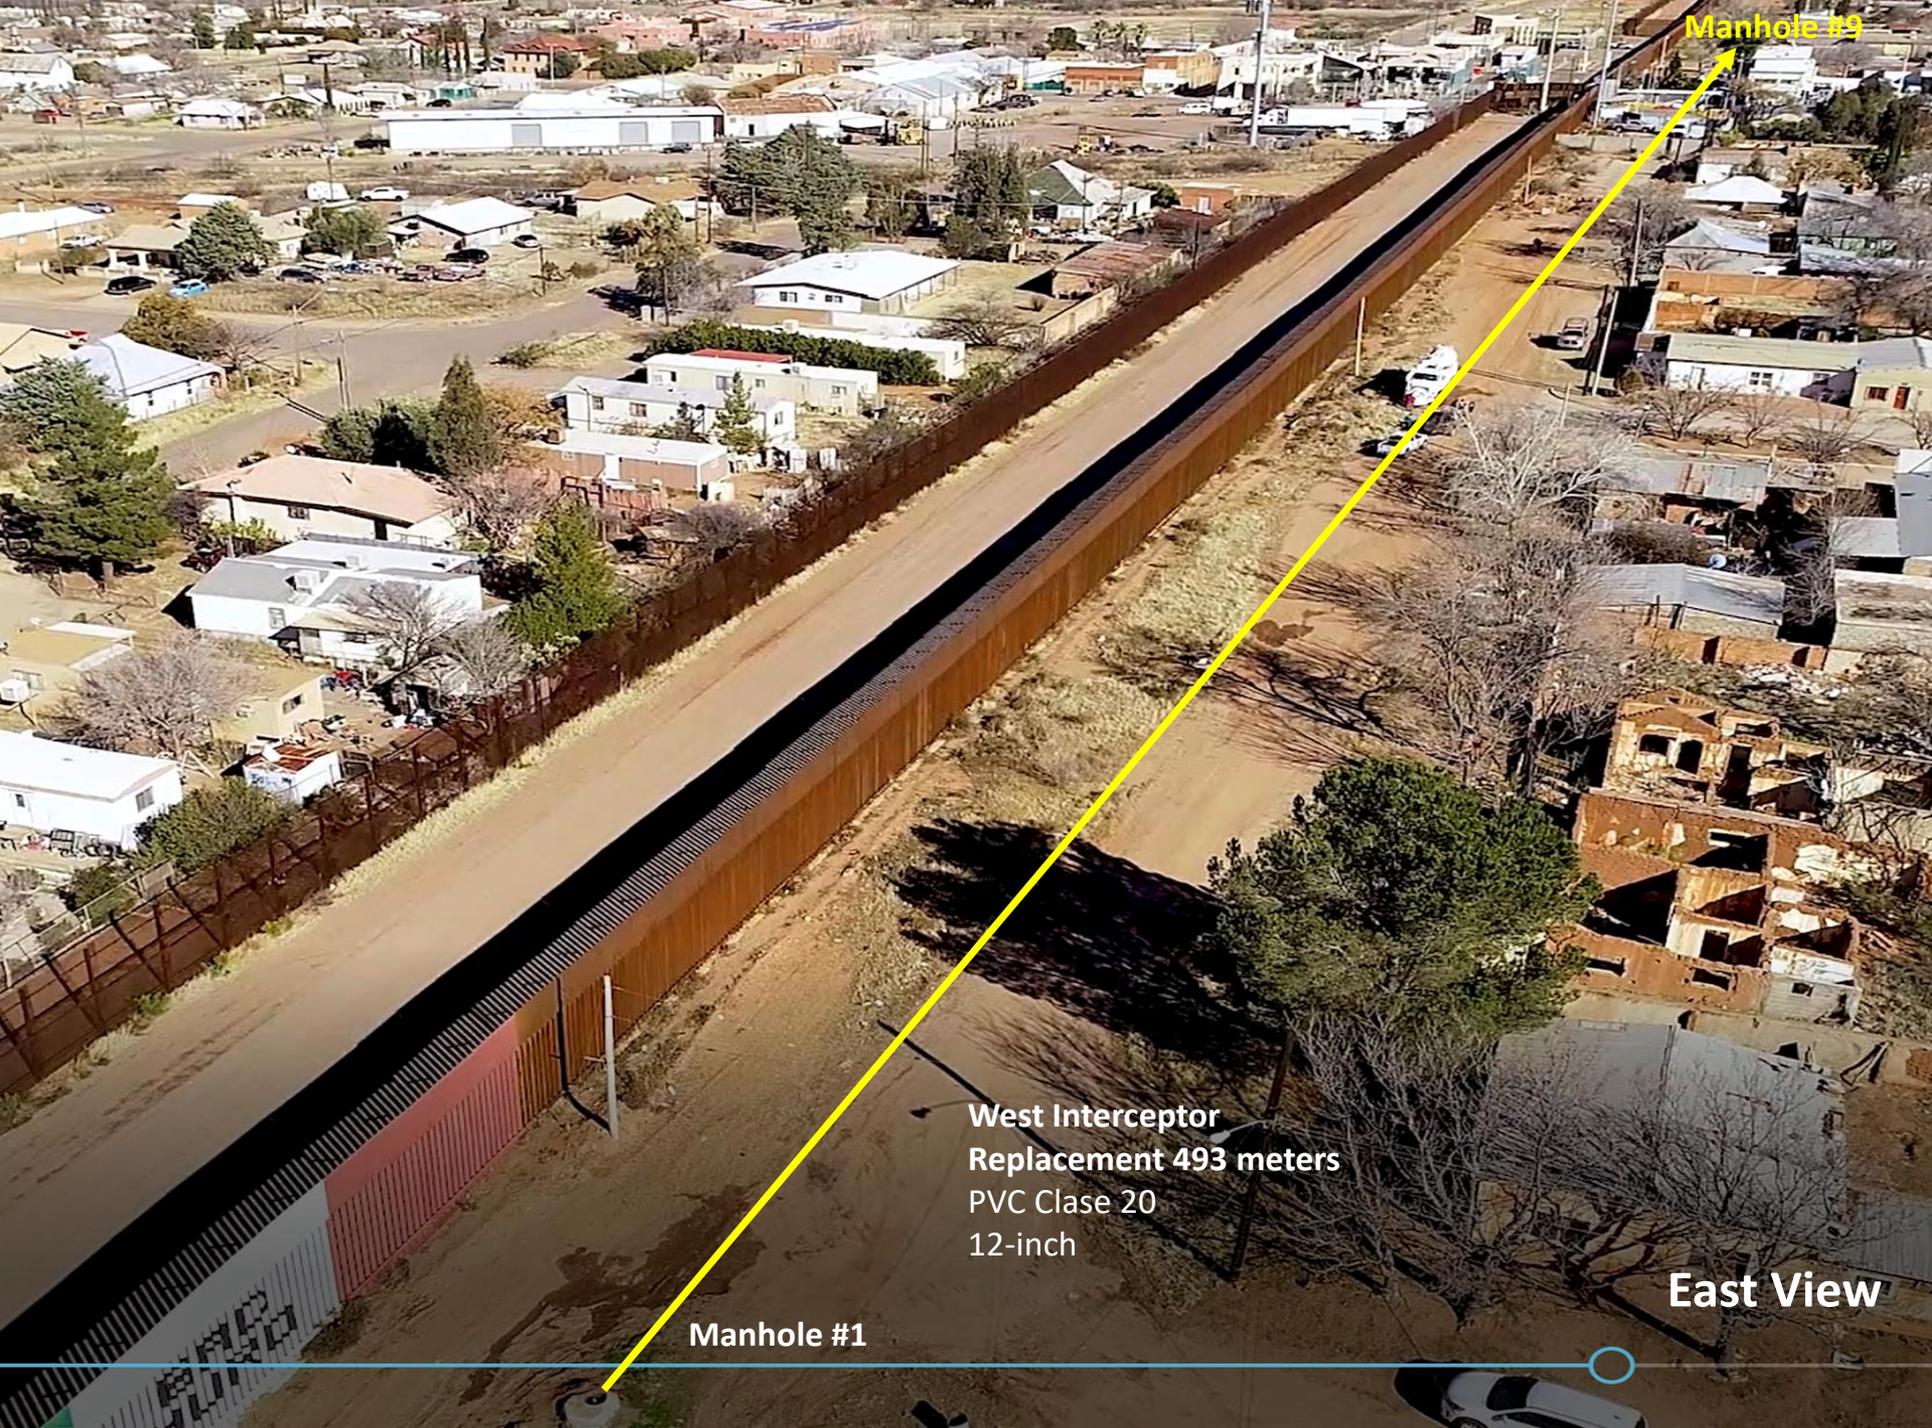
West Interceptor
Replacement 493 meters
PVC Class 20
12-inch

- Replace West Interceptor** (Manhole#1 to #9)
Open trench construction

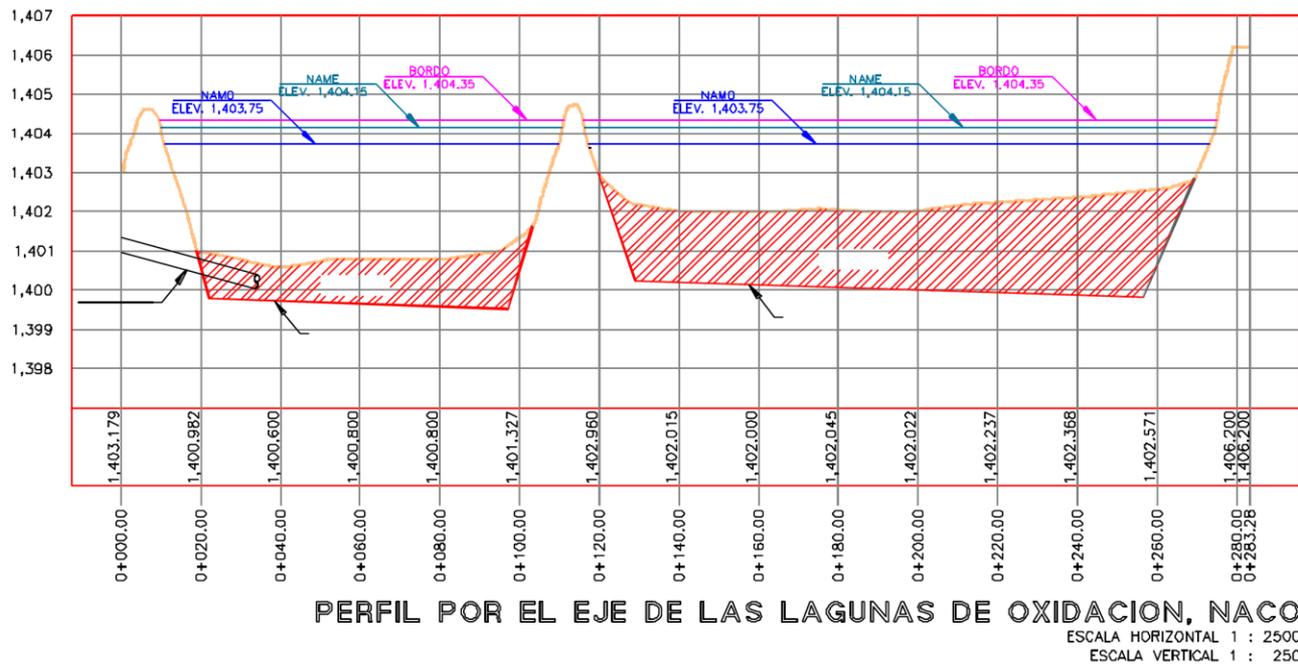
East Lagoon System – BATHYMETRY Study

1. Collapse of obsolete segment (MH#1 to MH#9) of West Interceptor.
2. Discharge caused by High water Levels of Facultative Lagoons and/or Insufficient inter-lagoon and effluent pumping.
