RIPARIAN HABITAT RESTORATION AT
FOUR SITES IN DOÑA ANA COUNTY,
NEW MEXICO: JARALOSA, YESO EAST,
YESO WEST, AND CROW CANYON C

FINAL MONITORING REPORT

CONTRACT # IBM15D0005/TASK ORDER # IBM16T0019

JULY 2018

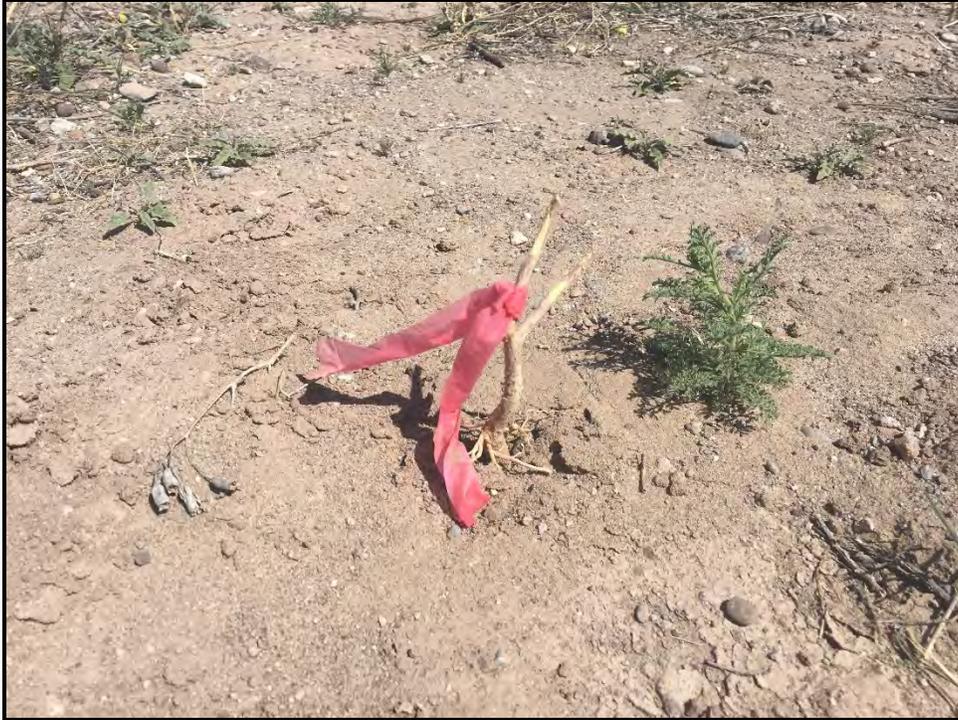
SWCA/GSRC biologists observed evidence of wildlife herbivory on planted poles, including American beaver (Figure 12) and mule deer (Figure 13). Other wildlife observed included kestrel, northern harrier, osprey, red-wing black bird, house finch, red-tail hawk, chipping sparrow, white-crowned sparrow, Gambel’s quail, and cottontail rabbit.

Figure 12. Evidence of beaver herbivory at Yeso East.

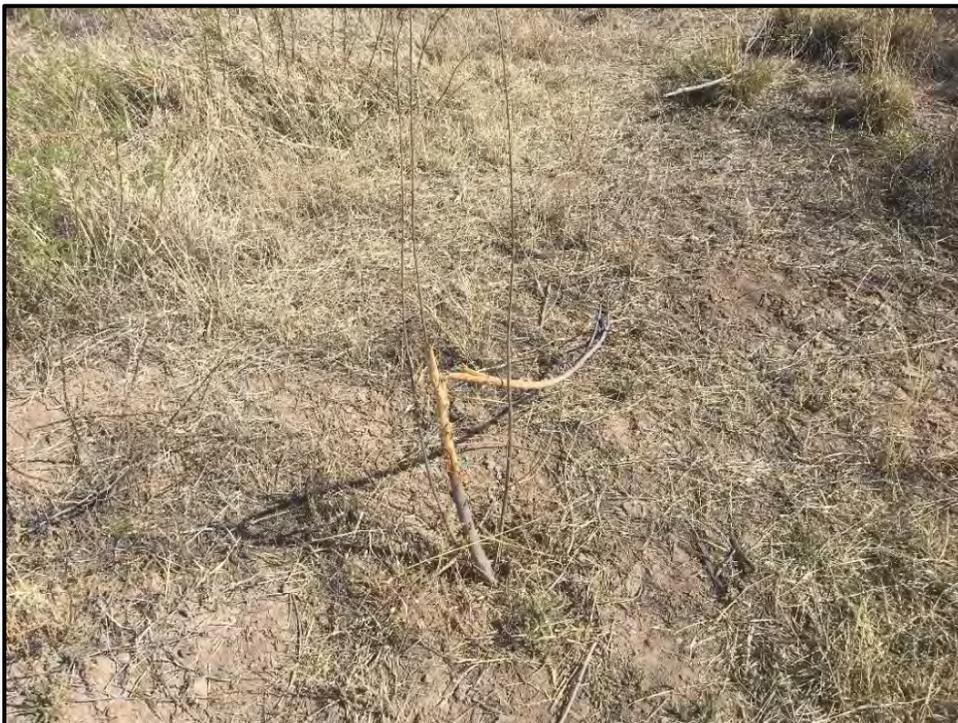
Figure 13. Evidence of damage caused by mule deer on a Goodding's willow plant at Jaralosa.

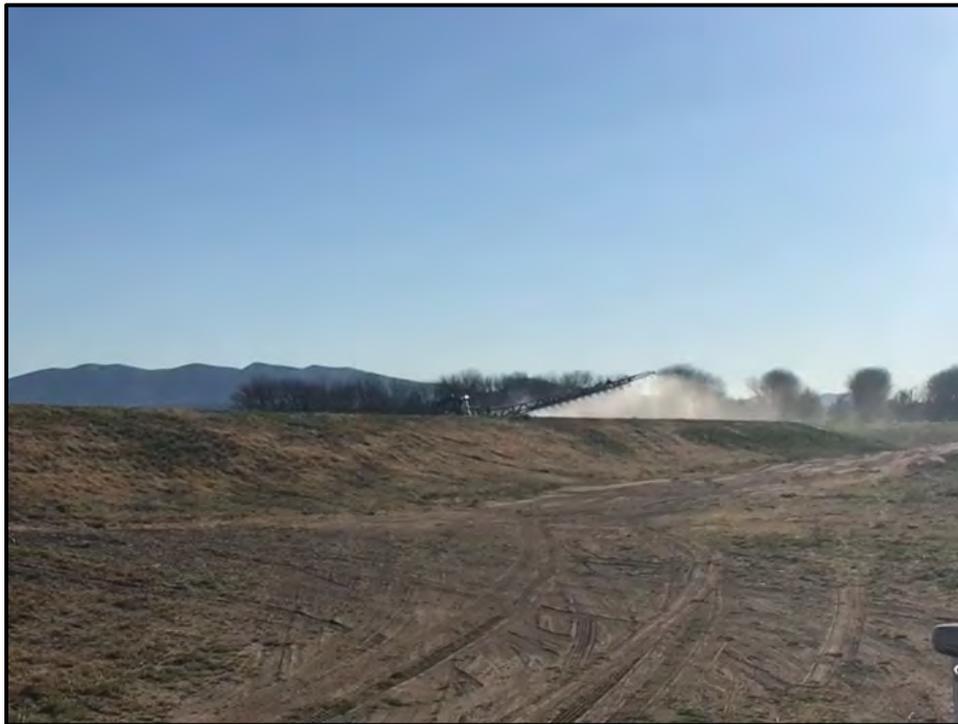
1 SWCA/GSRC biologists observed evidence of activities that created disturbance or otherwise affected
2 the restoration sites. These include herbicide drift, off-road vehicle use, and livestock grazing. In March
3 2017, SWCA and GSRC observed herbicide applied onto the levee road slopes adjacent to new pole
4 plantings at Yeso East (Figure 14). A video taken by SWCA biologist Ian Dolly shows herbicide mist
5 drifting over the levee road onto the habitat restoration site. Upon inquiry, GSRC biologist John Ginter
6 stopped the operator, asked what herbicide was being applied, and was informed that it was Roundup.
7 It is likely that additional unobserved herbicide applications may have occurred along the levee slopes
8 adjacent to the new plantings. Biologists observed evidence of off-road vehicle disturbance at Jaralosa
9 (Figure 15). Evidence of livestock damage was limited to the Yeso West site where livestock were able

11
12 **Figure 14. View of herbicide spraying incident at Yeso East, facing**
13 **southeast, March 2017. Note herbicide drift across the levee onto the site.**

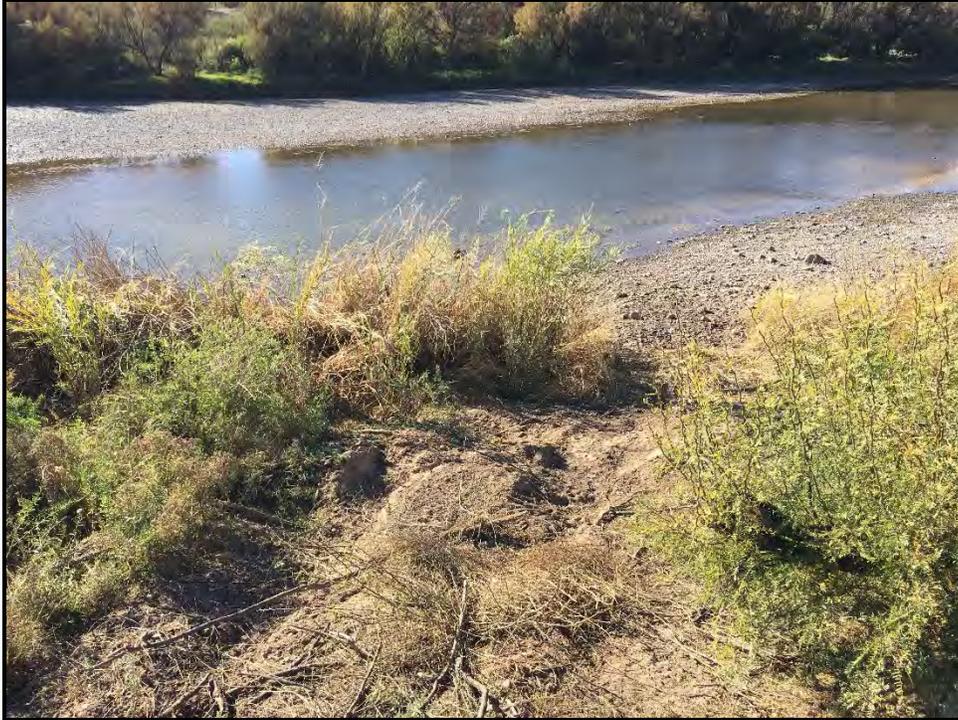
Figure 15. View of off-road vehicle disturbance on the bank of Jaralosa, facing west, November 2017.

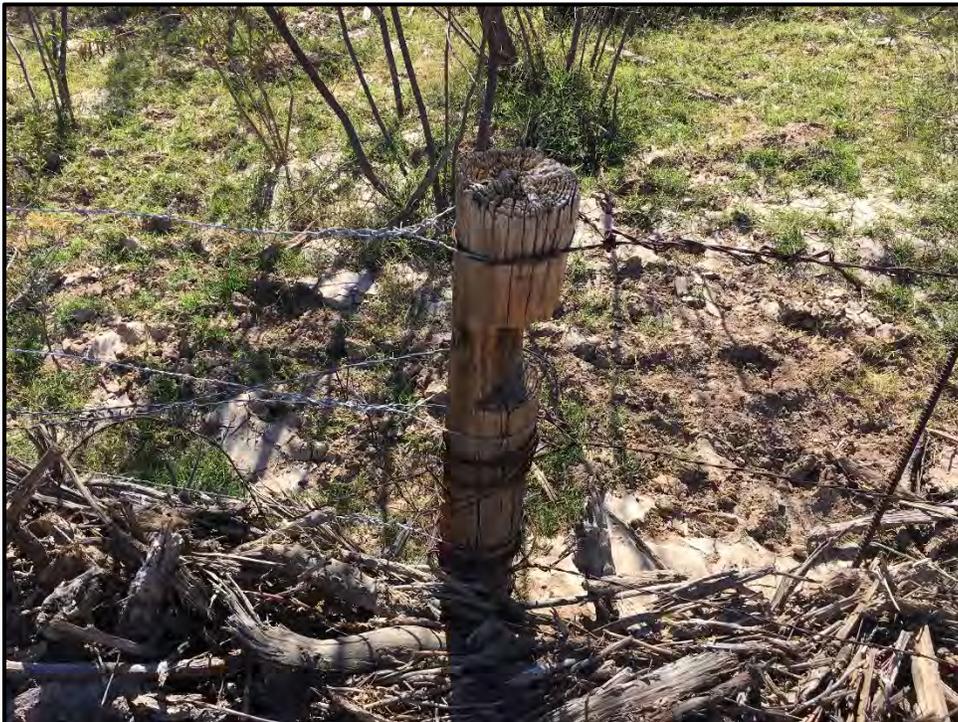
10 to access the site despite repair of the fence following excavation and planting (Figure 16 and Figure 17).

Figure 16. View of fence at the southern end of Yeso West showing new strand of barbed wire installed after the high-flow event, November 2017.

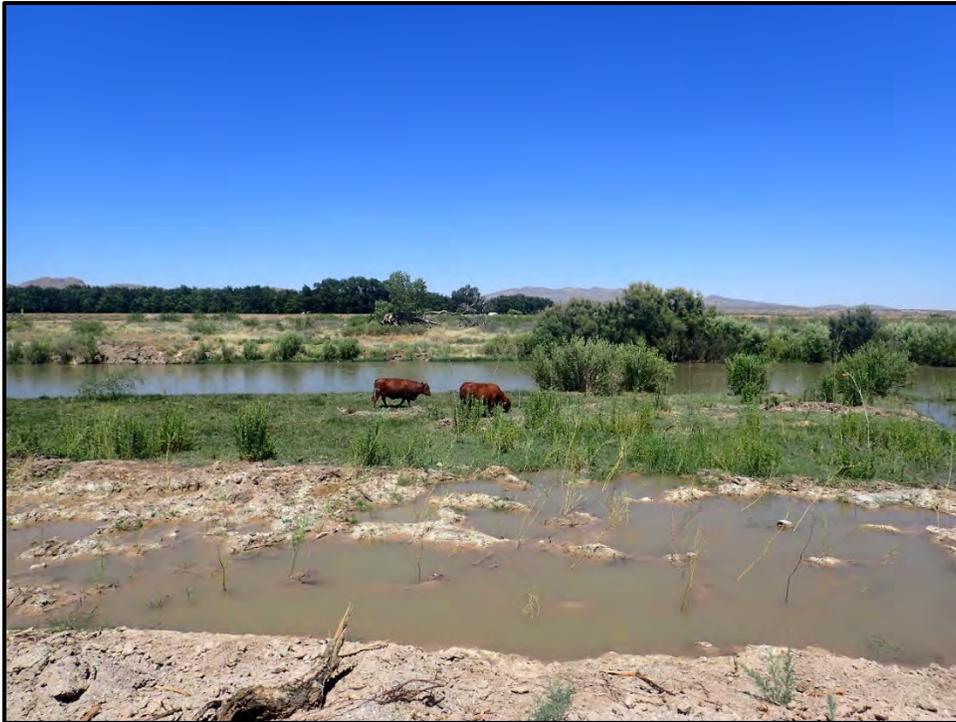
1 The Yeso West site remained inundated throughout much of the growing season, with estimated water
2 depths of approximately 3 feet or greater. Site inundation, during the June (Figure 17) and September
3 monitoring sessions hampered access and monitoring activities. Estimated water depths were 3 feet or
4 greater and salt crusts resulted as the site dried (Figure 18). Additionally, extreme high-water events
5 associated with monsoonal rain events scoured the site and deposited debris lines throughout the site
6 (Figure 19). High flow events were confirmed by a review of the hydrograph, which indicated a
7 monsoonal event on July 24 that resulted in a discharge of 104 cubic meters per second (cms)
8 (3,677 cubic feet per second [cfs]) (USIBWC, 2018).

Figure 17. Yeso West inundation; June 2017 discharge = 48.35 cms (1,707 cfs). Note livestock presence.

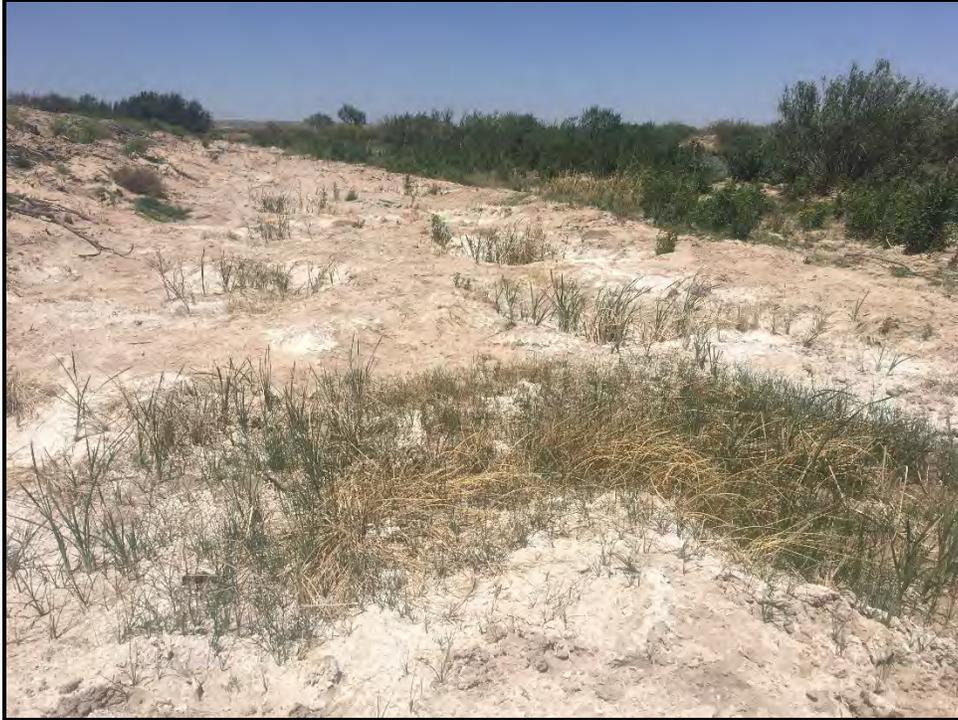
Figure 18. View of Yeso West showing high-water event damage and salt crusts, facing northeast, November 2017.

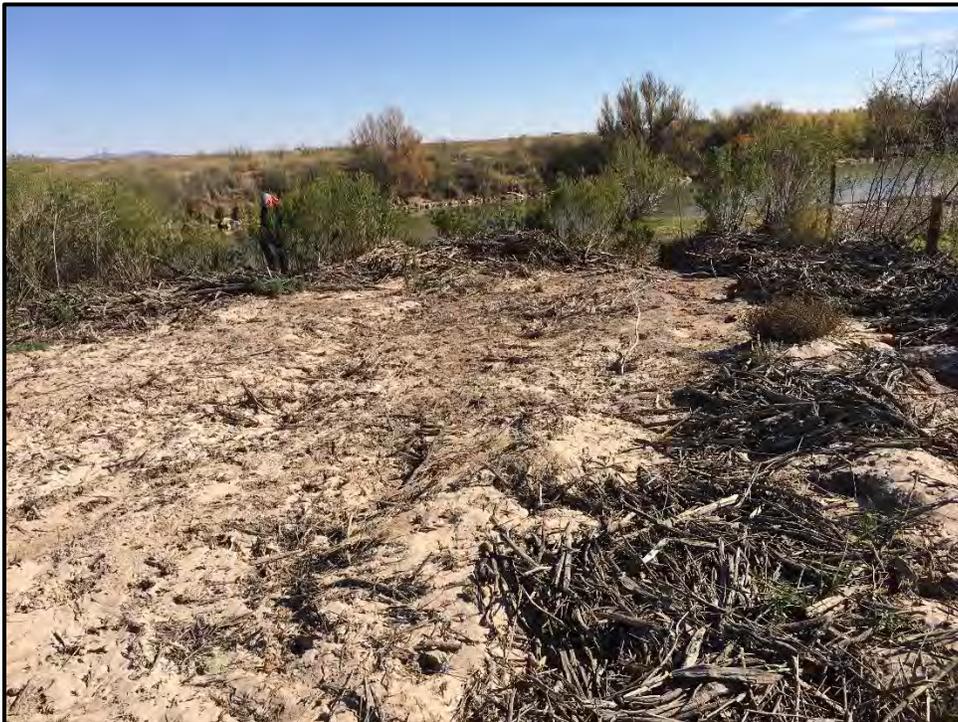
Figure 19. View of Yeso West showing woody debris accumulated at the southern end of the site, facing southeast, November 2017.

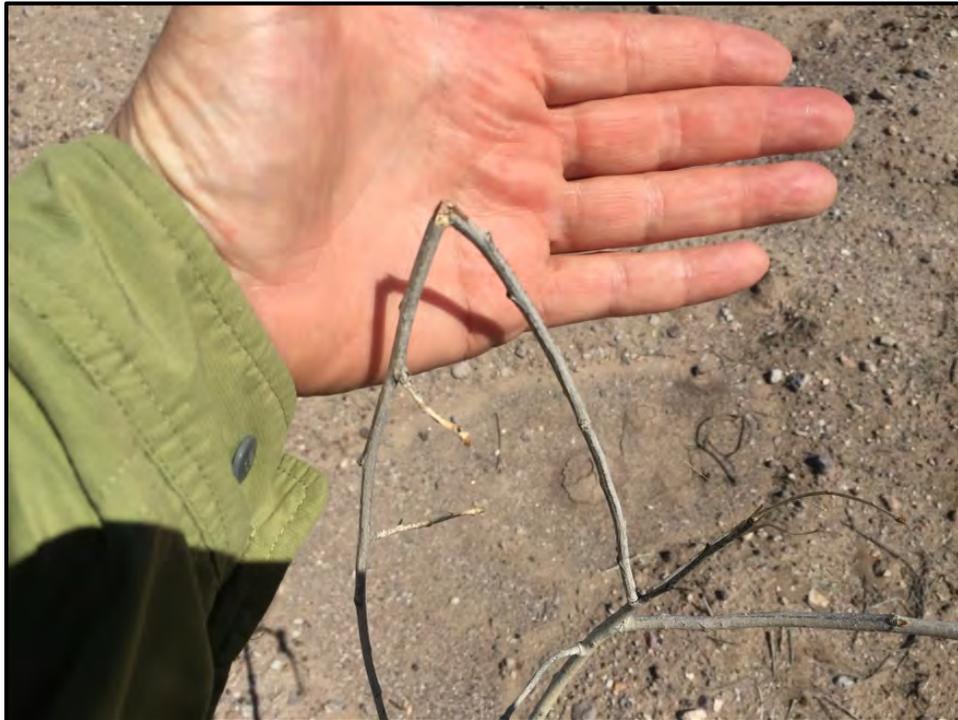
2 At each monitoring event, SWCA/GSRC biologists inspected the pole and long-stem shrub plantings
3 to evaluate their health status and document survival of all poles and shrubs planted. Individuals that
4 appeared to be dead or dormant were examined for any signs of resprouting or regrowth at the base, and
5 a “snap test” was applied to outer stems. This test consisted of flexing branches to the point of breaking.
6 Plants that showed no signs of regrowth and easily cracked or broke during snap tests were recorded as
7 mortalities (Figure 20). Many of the plants that showed signs of stress or top growth dieback displayed
8 some signs of regrowth, often at the base (Figure 21).

9
10 **Figure 20. The outer stems of a willow (*Salix* sp.) pole planting snap easily**
11 **when dead. Some of these plantings that have dead upper growth may still**
12 **survive with growth of tissues at the base of the pole planting.**

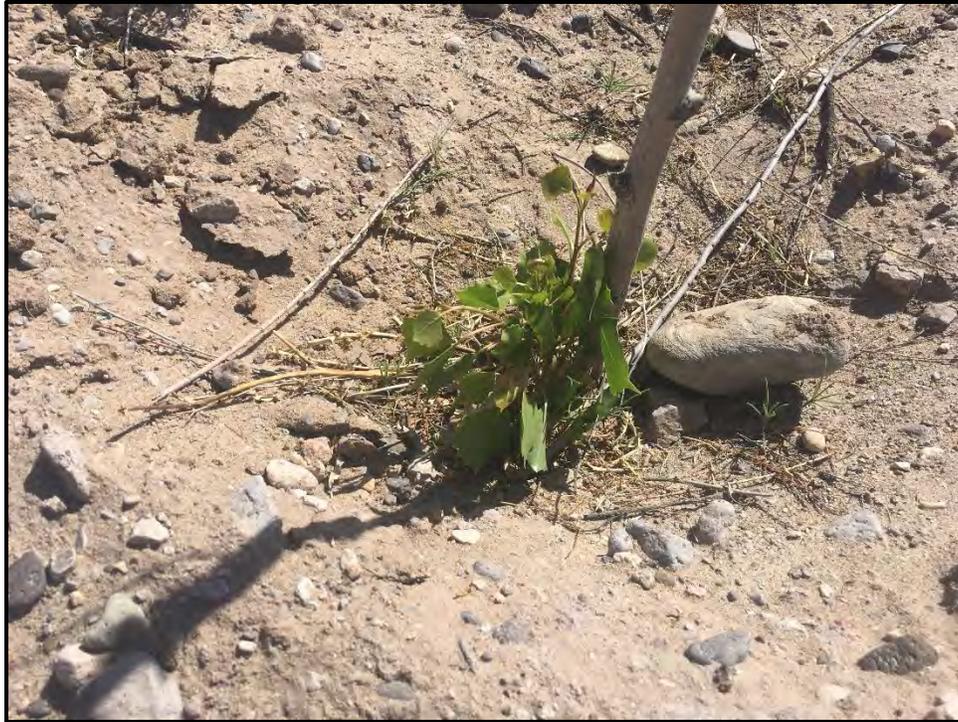
1
2
3
4 **Figure 21. Some plantings displayed partial or complete dieback of aboveground growth with vigorous resprouting at the base, such as this Rio Grande Cottonwood, April 2018.**

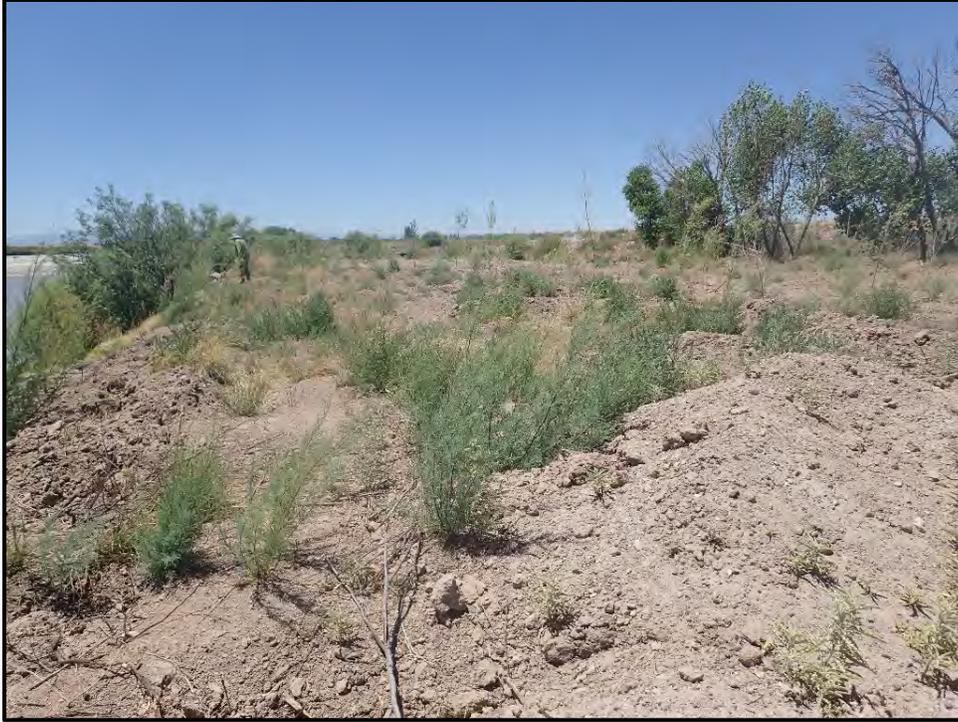
25 Saltcedar resprouting was documented across all four sites and was particularly notable at the Crow
 26 Canyon C and Jaralosa sites (Figure 22). GPS mapping of the densest saltcedar patches was conducted
 27 during the November 14 and 15, 2017, monitoring session, which yielded an approximate retreatment
 28 acreage of 2.5 acres, not including the sporadic occurrence of resprouts throughout each project area.
 29 Saltcedar chemical treatment was conducted April 16, 2018, using a brush cutter and Garlon 4 applied
 30 as a basal bark application (Figure 23 and Figure 24). This treatment method is regarded as effective and
 31 was approved by the USIBWC. Saltcedar resprouts missed during the April retreatment period were
 32 hand-pulled in May.

Figure 22. Saltcedar resprouts at Crow Canyon C, June 2017.

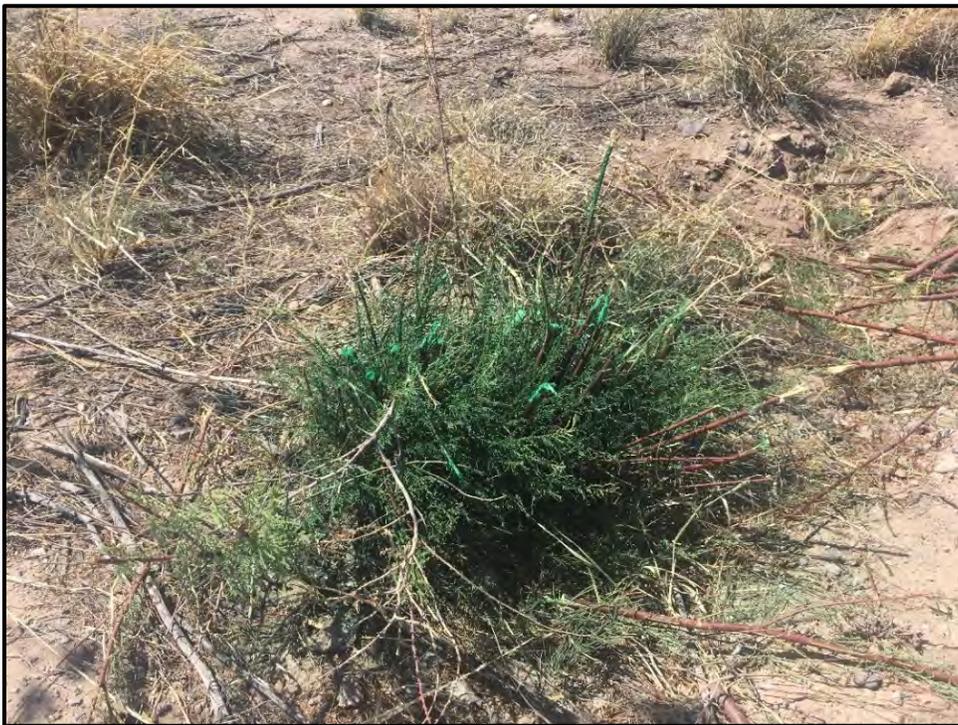
Figure 23. View of treated saltcedar resprouts at Crow Canyon C, April 2018.

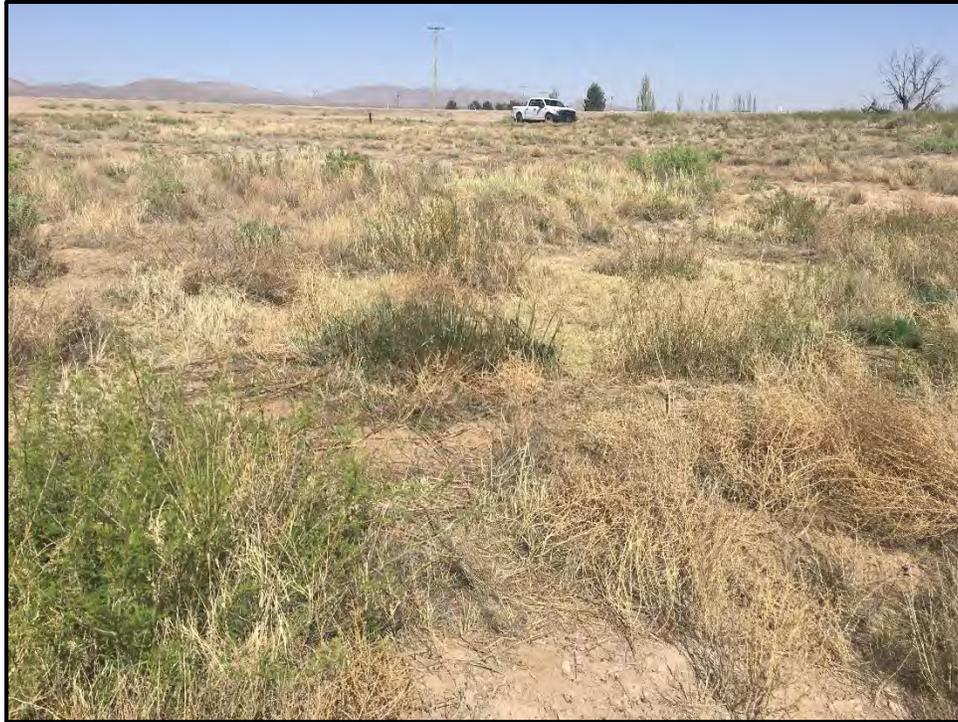
Figure 24. View of treated saltcedar resprouts at Jaralosa, facing southwest, April 2018.

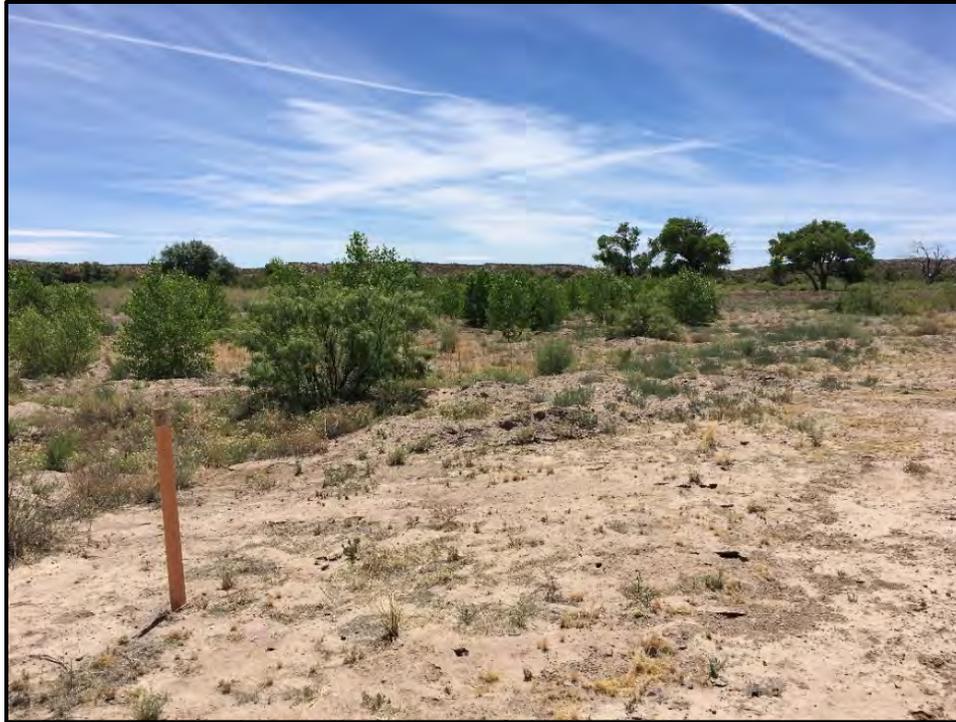
Plant vigor for cottonwood and Goodding's willow poles varied across the site. The northern planting, planted in an excavation area, showed good plant vigor (Figure 26). In the remaining areas, the vigor of the planted poles was not great. This site also experienced a high mortality for cottonwood and Goodding's willow poles, which may have resulted from the herbicide drift documented in the June monitoring session. Similar to the Jaralosa site, SWCA/GSRC focused planting in abandoned meander swales located some distance from the river. The northern planting is closest to the irrigation return and may benefit from hyporheic water. The remaining planting areas may not receive the same benefit. The plantings would benefit from supplemental irrigation. The USIBWC recently acquired water rights and is currently designing a supplemental irrigation system. SWCA/GSRC recommends a system to provide water to the southern, downstream planting areas. Similar to the Jaralosa site, coyote willow poles display good vigor and should continue to expand, providing good flycatcher habitat.

Figure 26. Cottonwood trees showing excellent vigor at Yeso East; repeat photo Y1, looking northwest, May 2018. Trees were planted in a swale excavated in an abandoned meander.
