**International Boundary And Water Commission  
United States And Mexico  
United States Section**

**2018 Upper Rio Grande Field Office O&M  
Critical Mission Directives and Responsibilities**

July 12, 2018

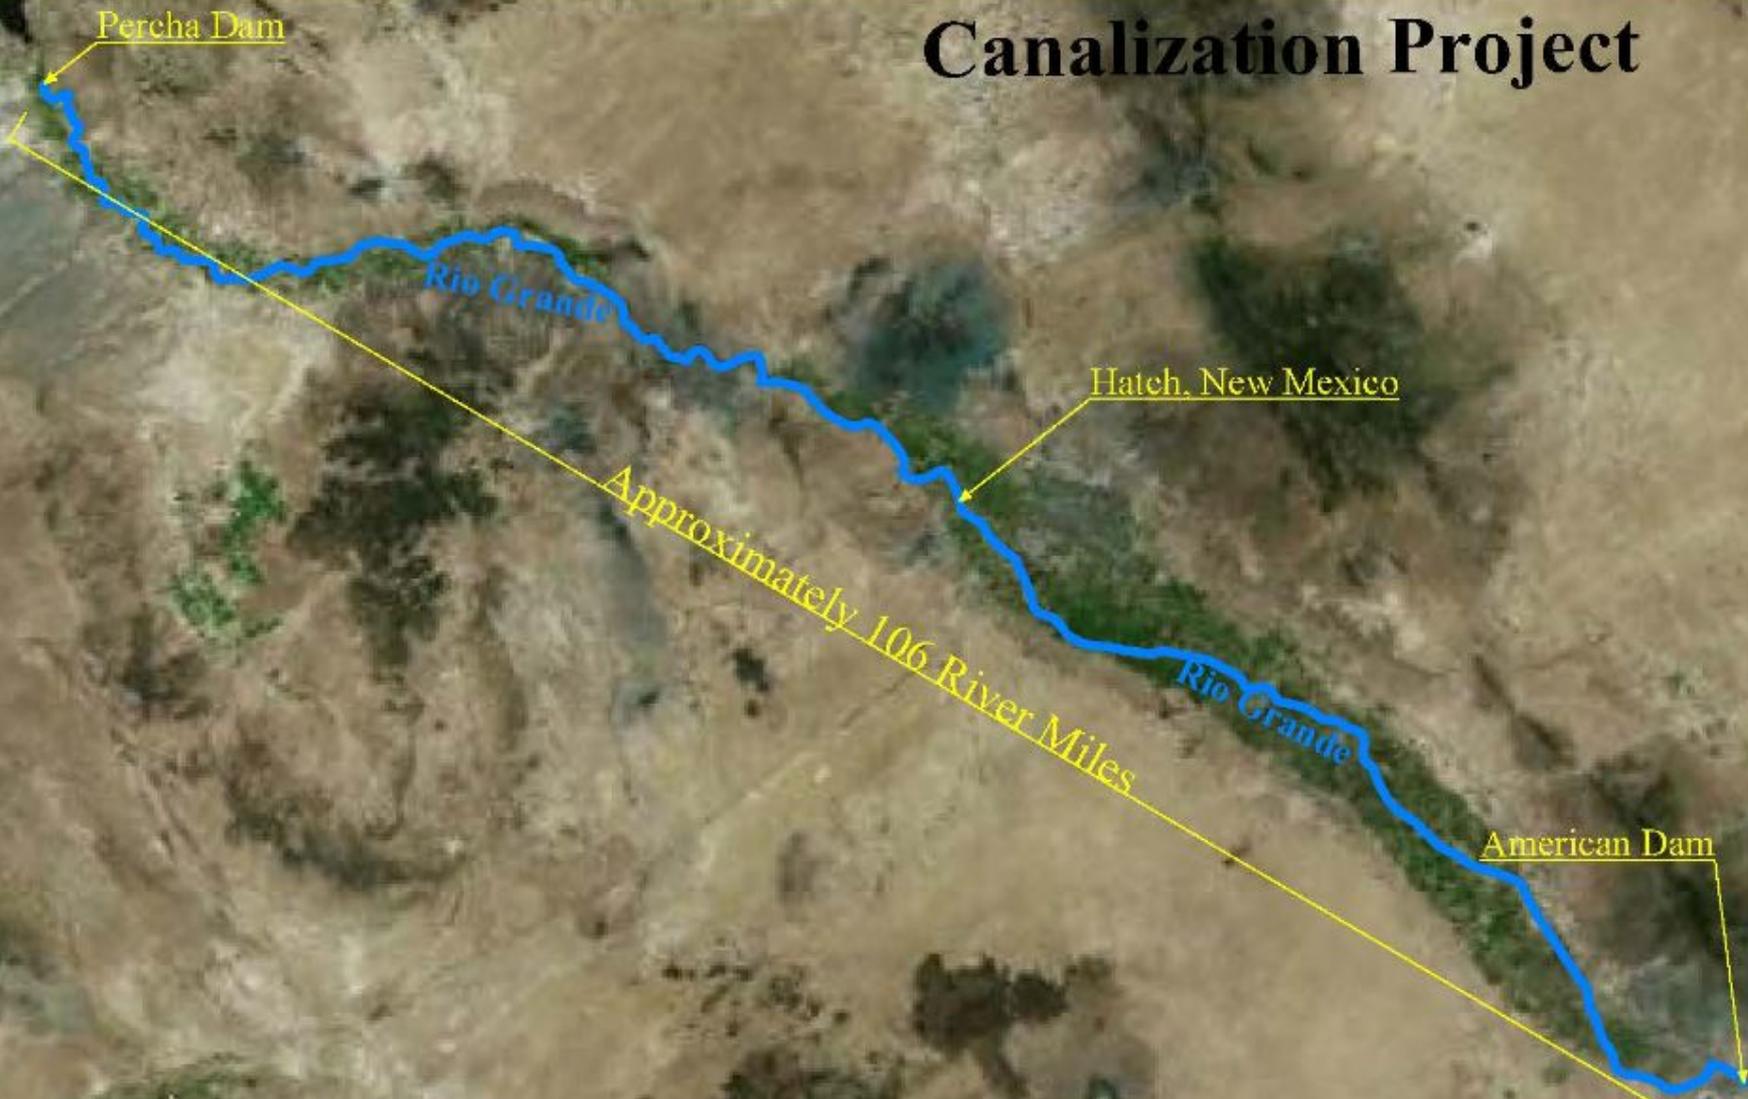
## Canalization Project

# URGFO FLOOD CONTROL CANALIZATION PROJECT LIMITS

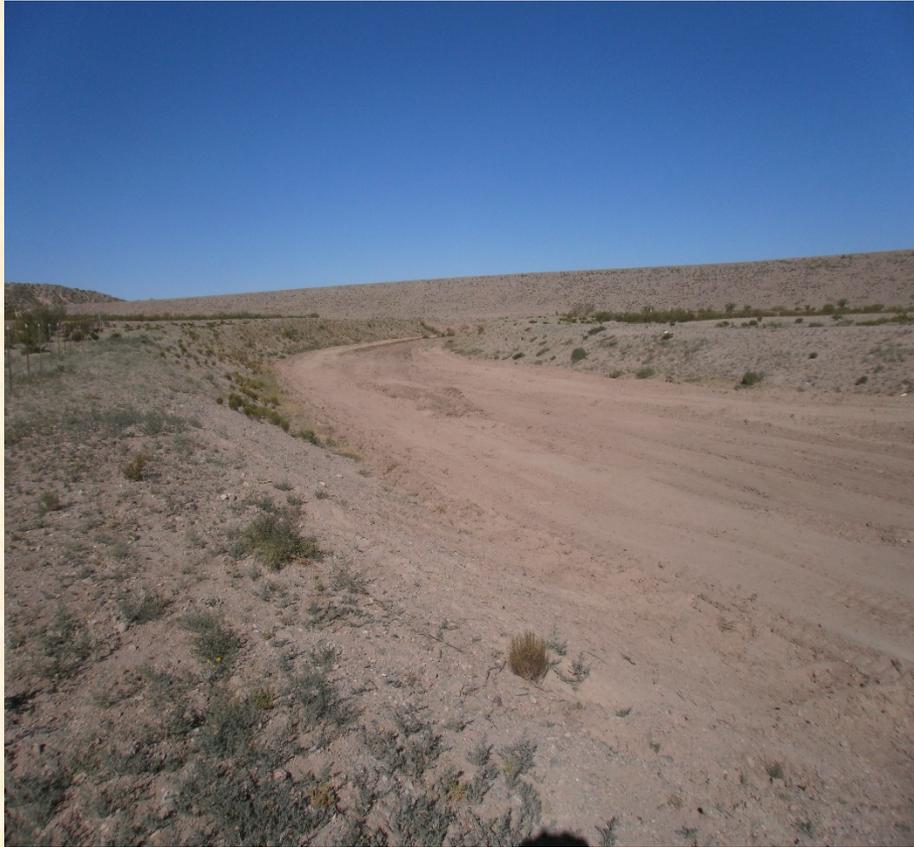
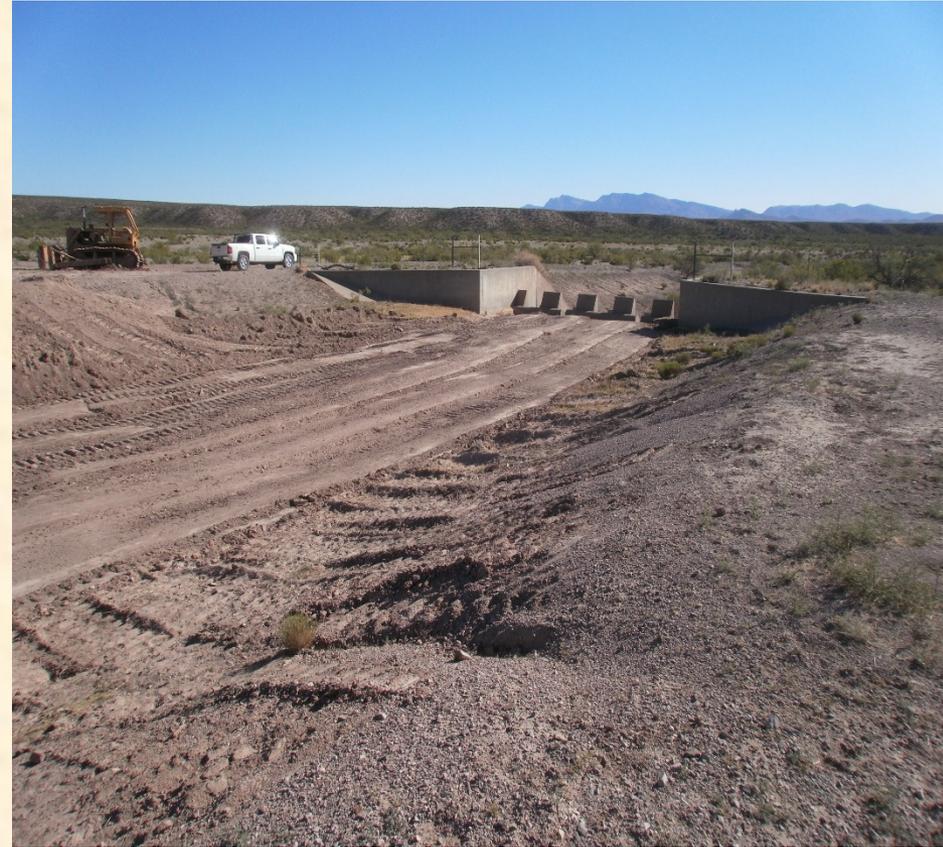
- Berrenda Sediment Control Dam-Maintenance work.
- Berrenda Sediment Control spillway maintenance work.

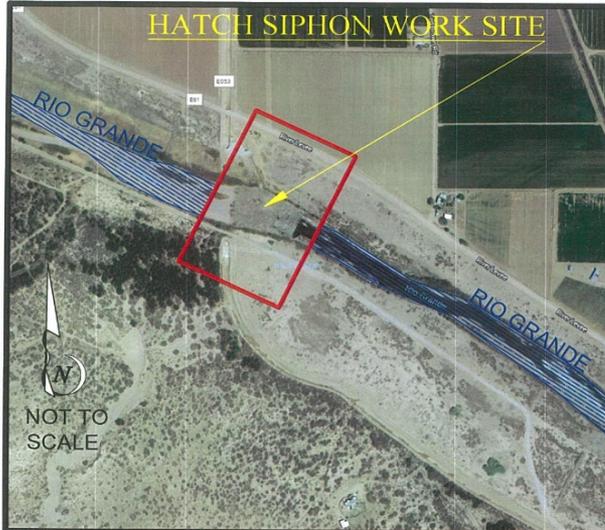
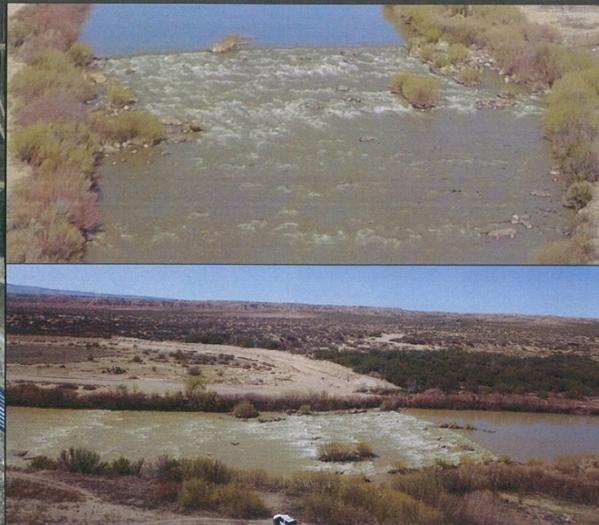
### HATCH SIPHON

During the 2018/19 non-irrigation season approximately 4,000 cubic yards of sediment anticipated to be removed from the area at the Hatch Siphon.

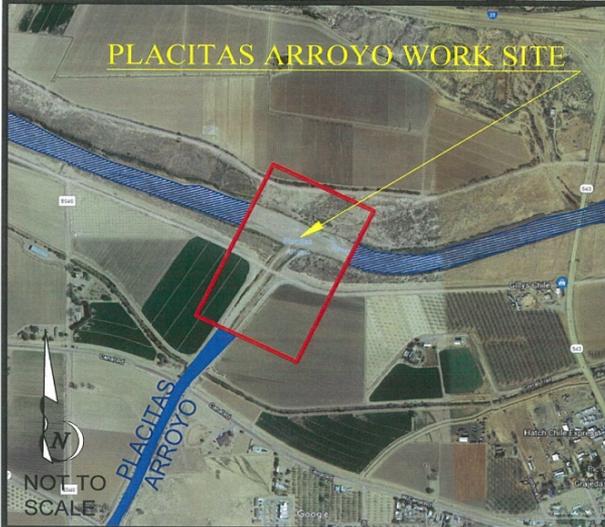
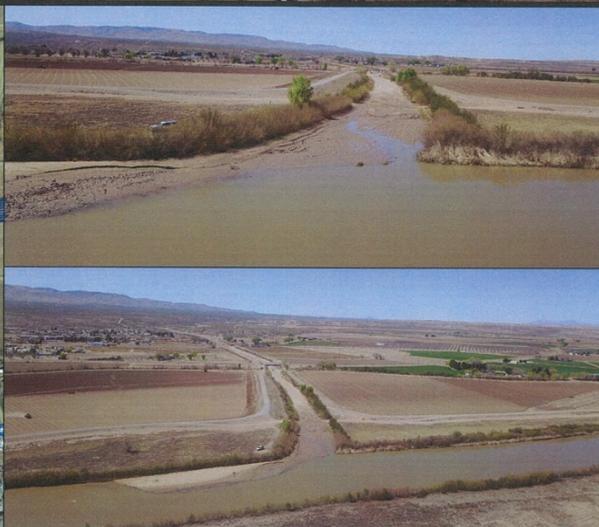
### PLACITAS ARROYO

During the 2018/19 non-irrigation season approximately 13,000 cubic yards of sediment anticipated to be removed from the area at the Placitas Arroyo.

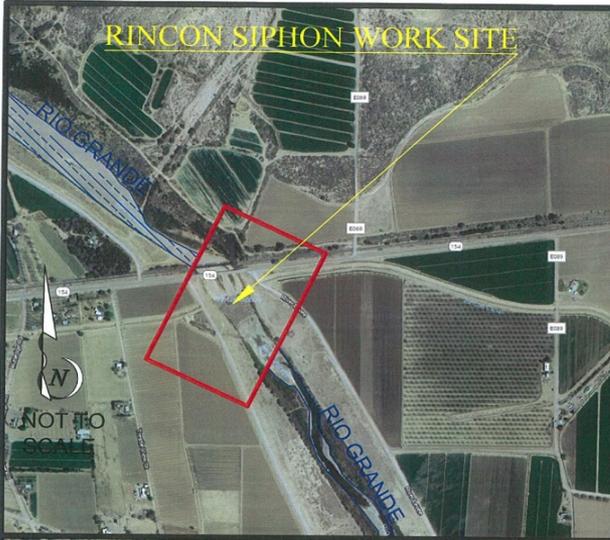
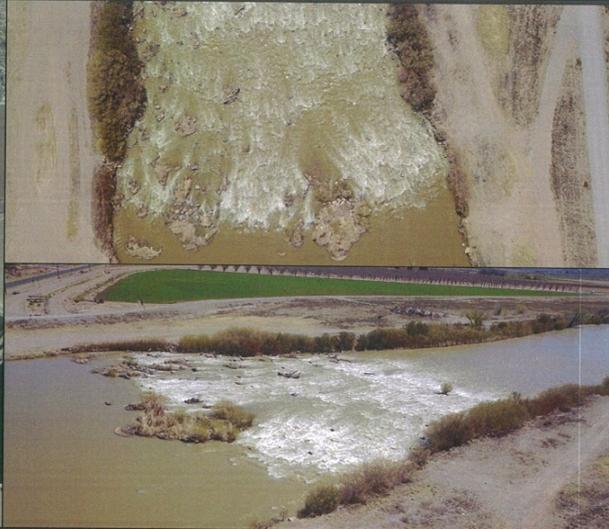
### RINCON SIPHON

During the 2018/19 non-irrigation season approximately 15,000 cubic yards of sediment anticipated to be removed from the area at the Rincon Siphon.

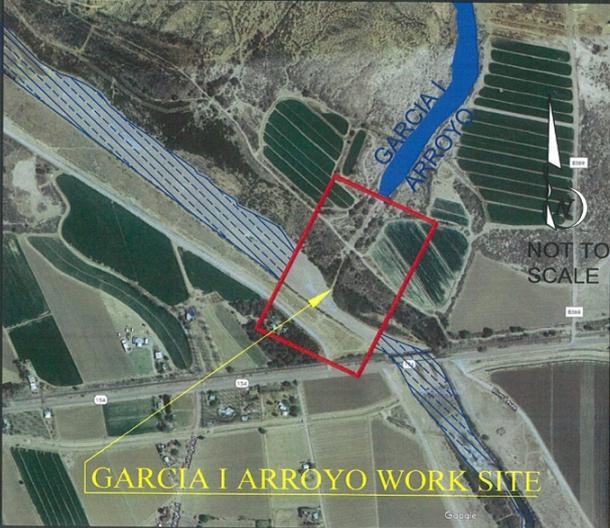
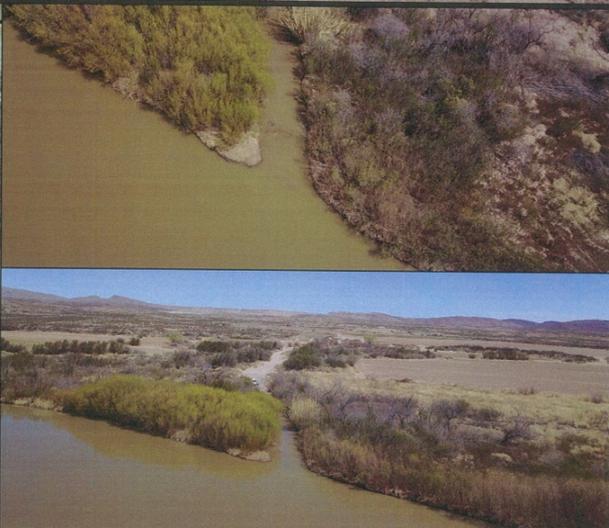
### GARCIA I ARROYO

During the 2018/19 non-irrigation season approximately 12,000 cubic yards of sediment anticipated to be removed from the area at the Garcia Arroyo.

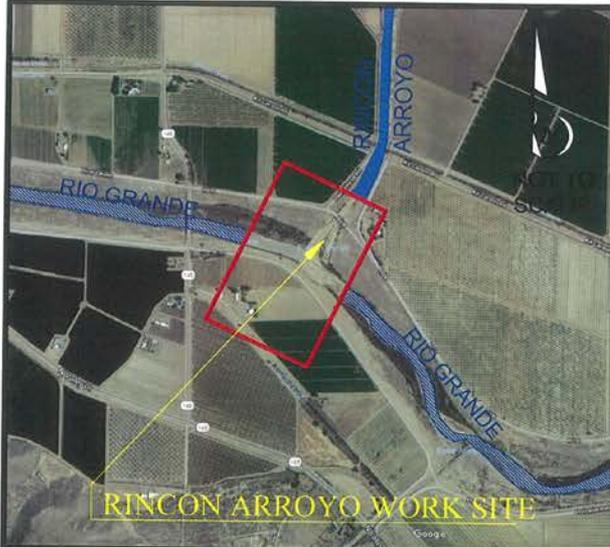
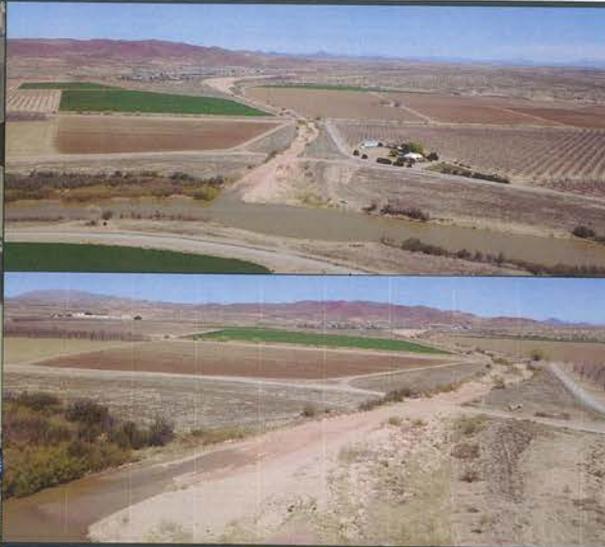
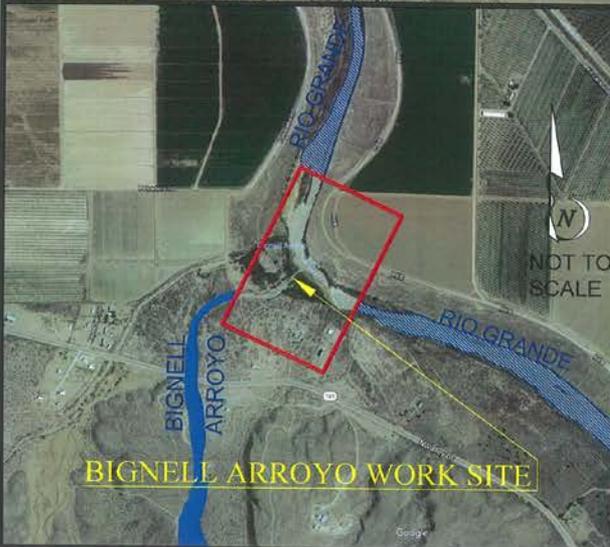
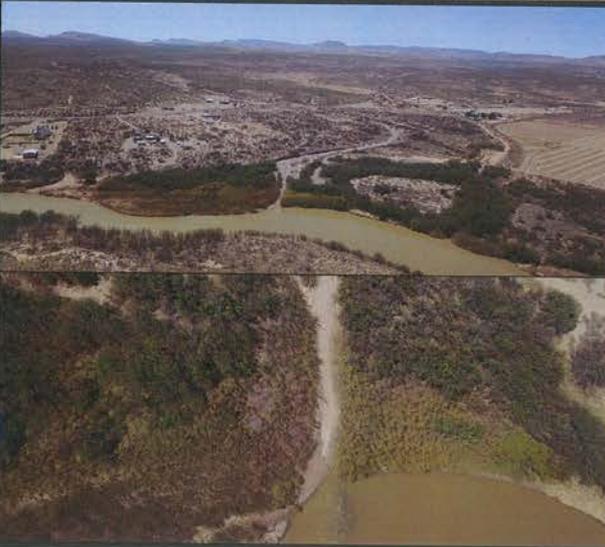
### RINCON ARROYO to BIGNELL ARROYO

During the 2018/19 non-irrigation season approximately 56,000 cubic yards of sediment anticipated to be removed from selected areas between Rincon and Bignell arroyos.

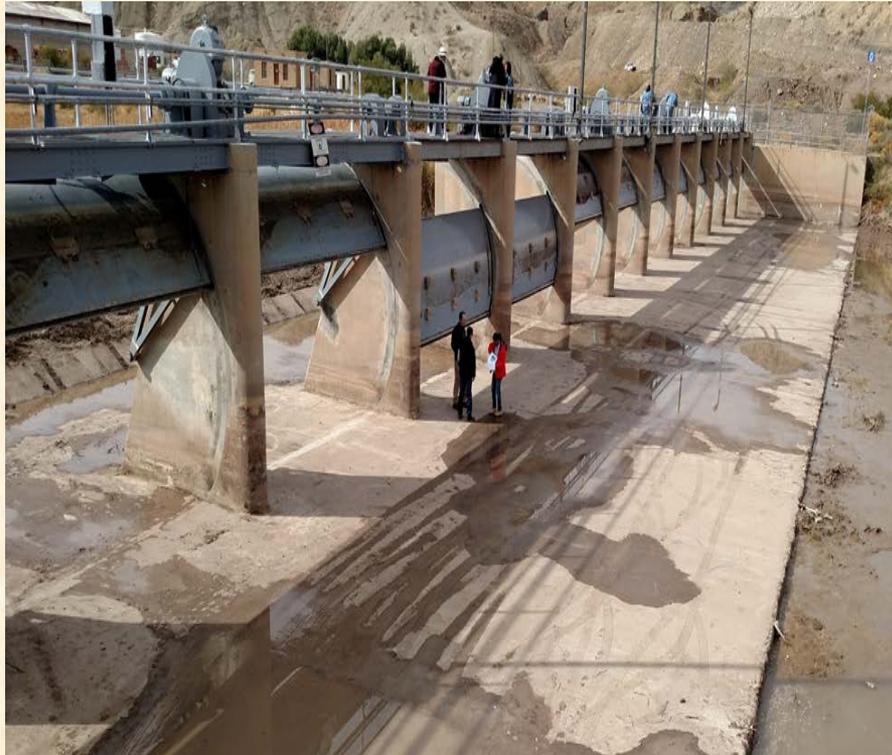
- American Dam during USACE five year inspection Dec. 2016.

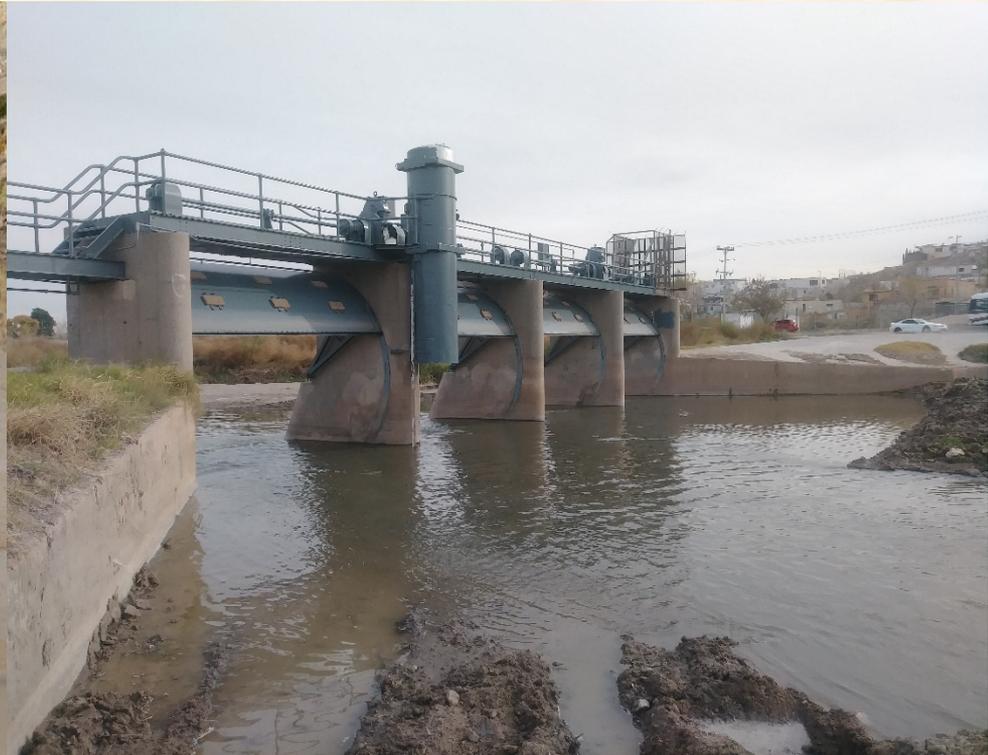
- International Dam Winter Maintenance completed Dec. 1<sup>st</sup>, 2017. Cables replaced, gates exercised, dam power washed, cleaned, scraped, and painted. Limit switches adjusted.

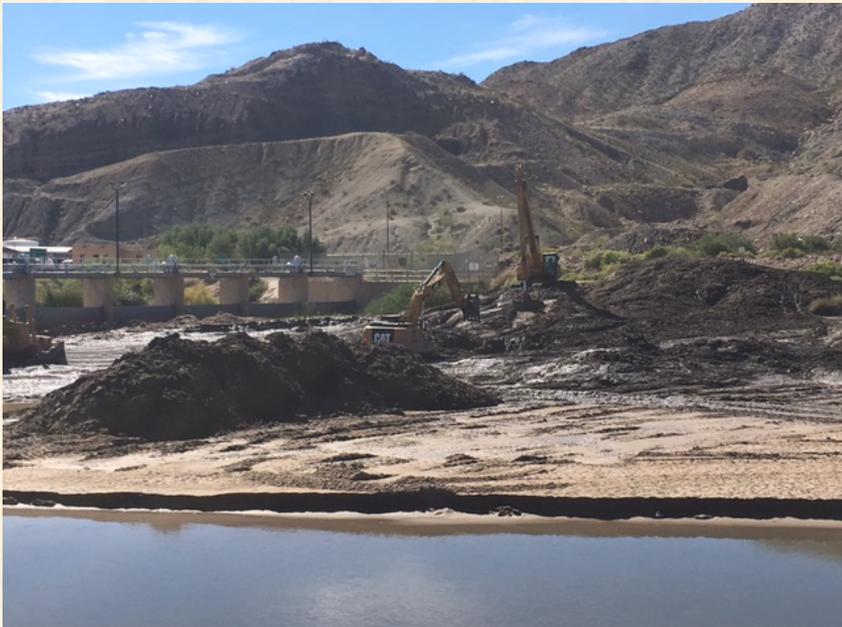
In order to perform the 5 year USACE Diversions Dams inspections it is necessary to remove all of the silt from the upstream and downstream aprons of the dams.

At American Dam 30,000 cy of material was removed.

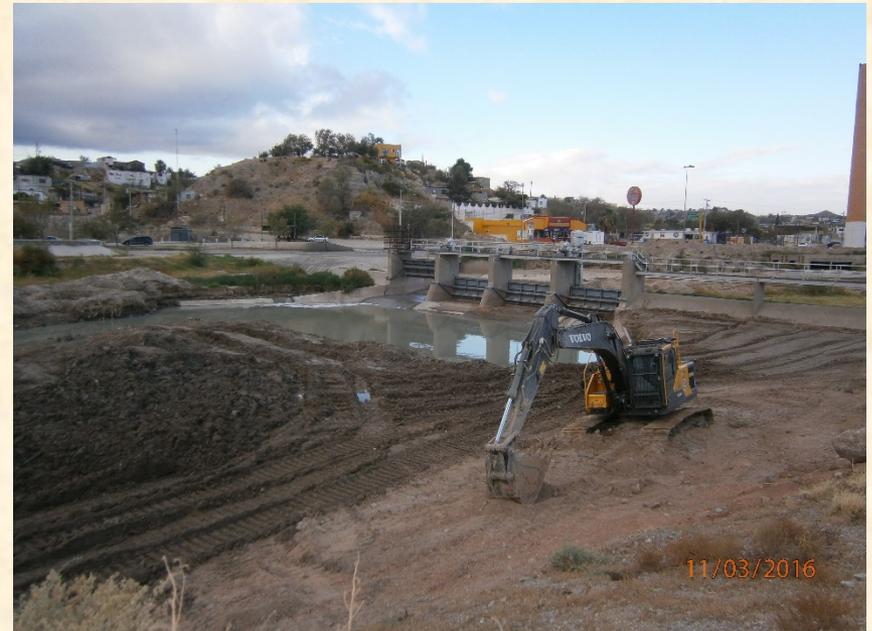
At International Dam 20,000 cy of material was removed.

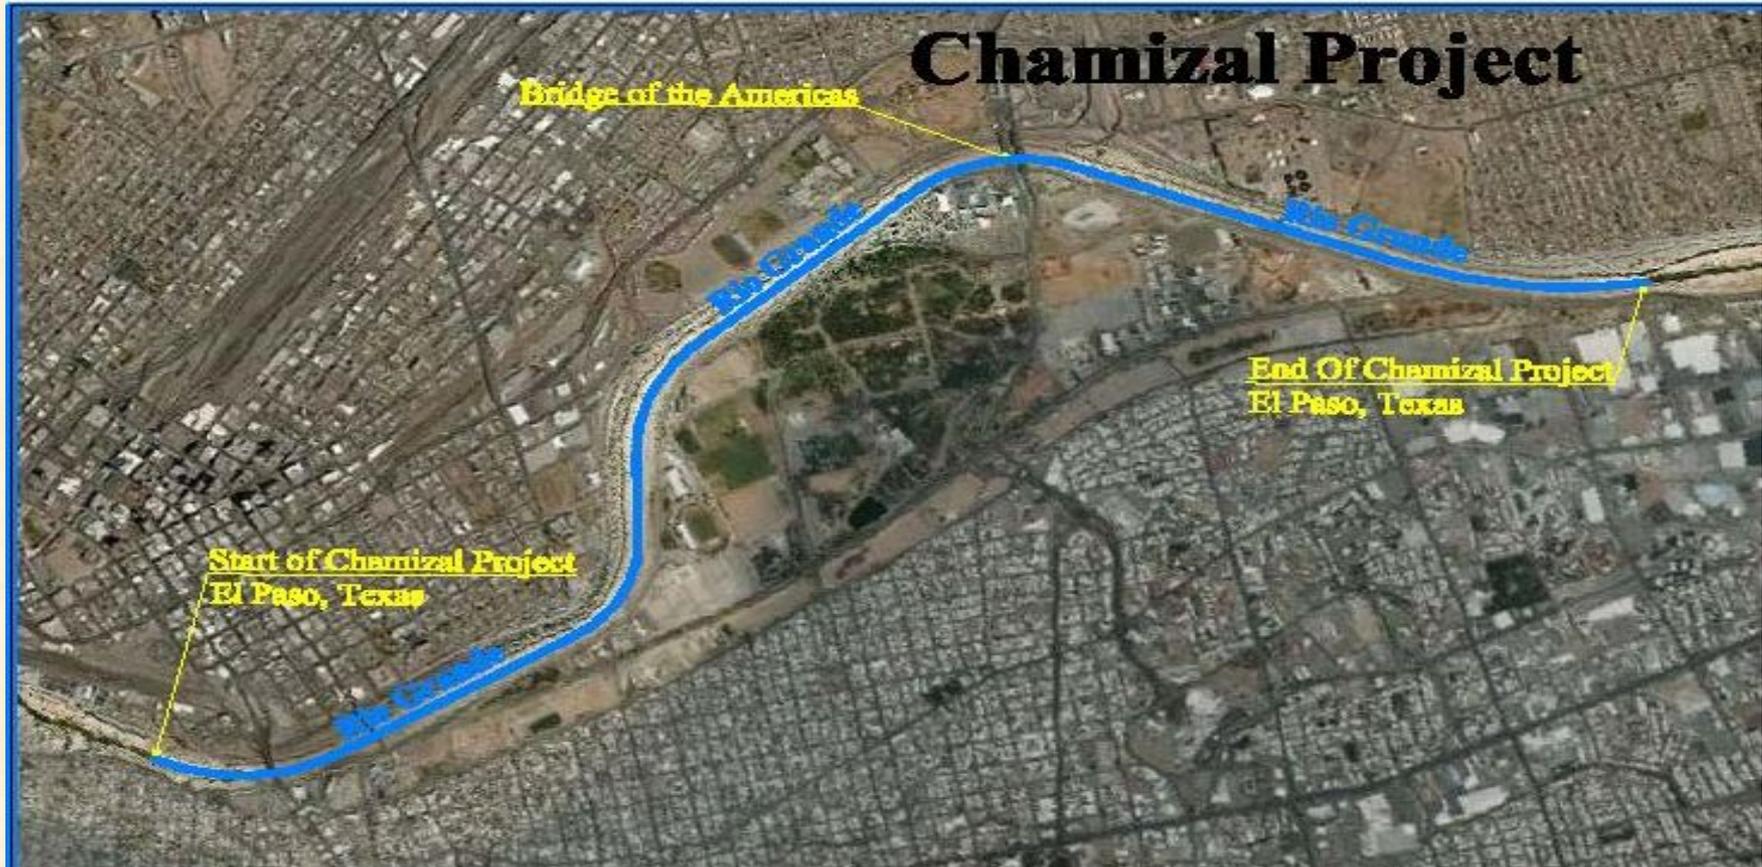
## CHAMIZAL CONCRETE CHANNEL AREA

- Project area is from start of Chamizal concrete channel @ Chihuahuita to 2.5 miles downstream.(Remaining 2.5 miles downstream are under CILA maintenance responsibility.

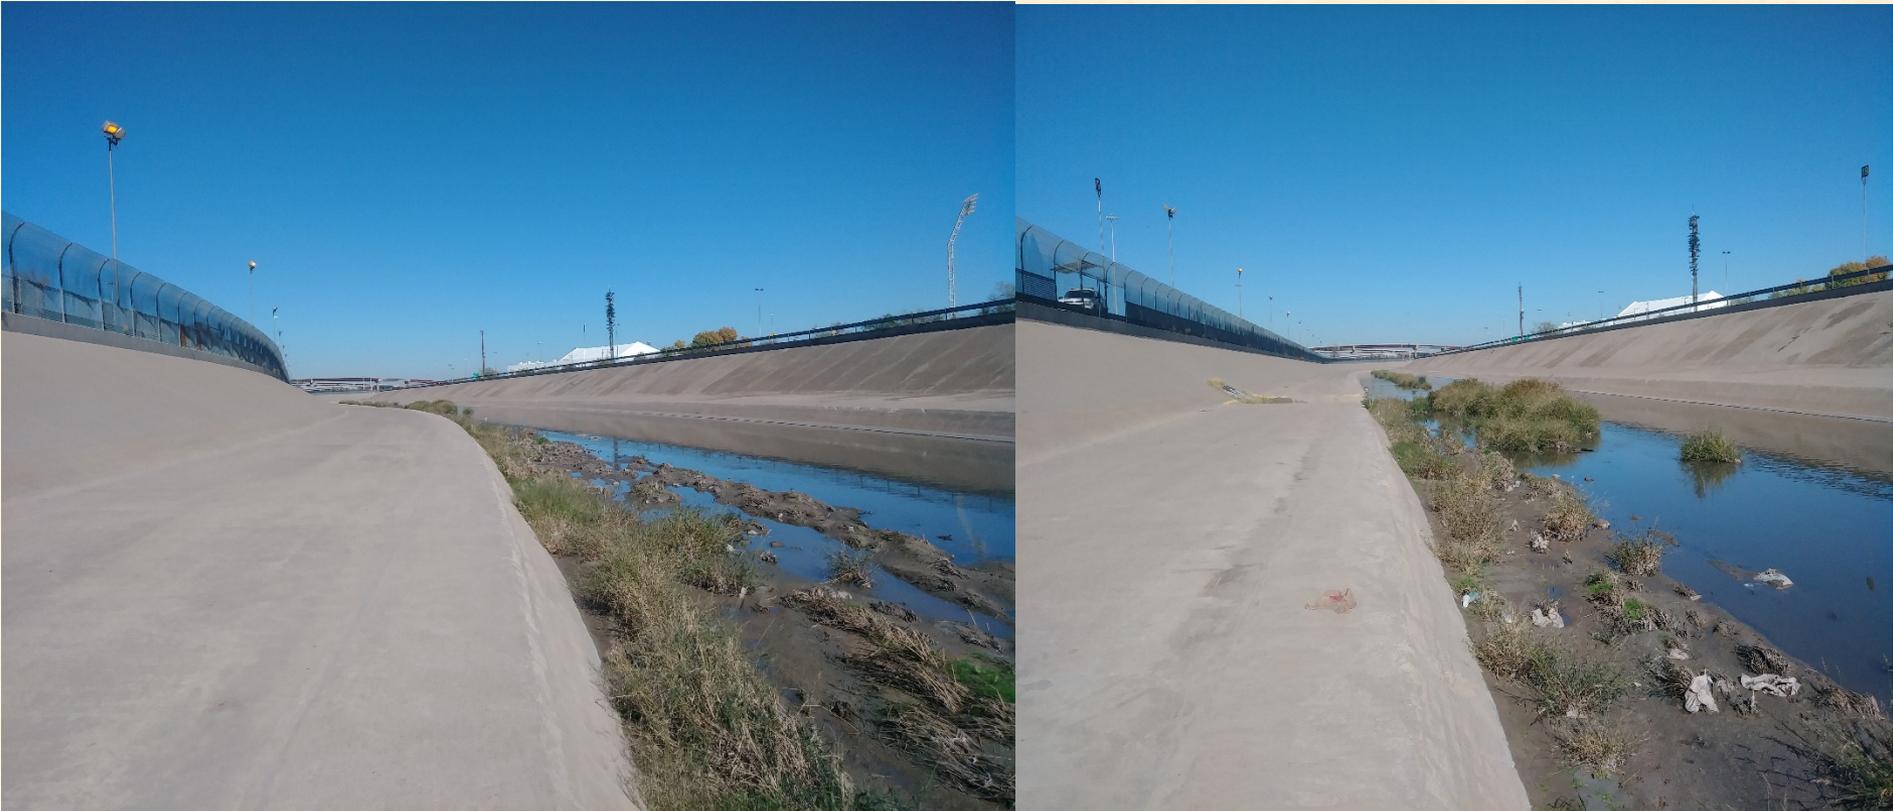
# RECTIFICATION PROJECT CHAMIZAL CONCRETE CHANNEL AREA

- Schedule for July-August, perform required maintenance on silt and vegetation removal from start of Chamizal concrete channel @ Chihuahuita to 2.5 miles downstream.

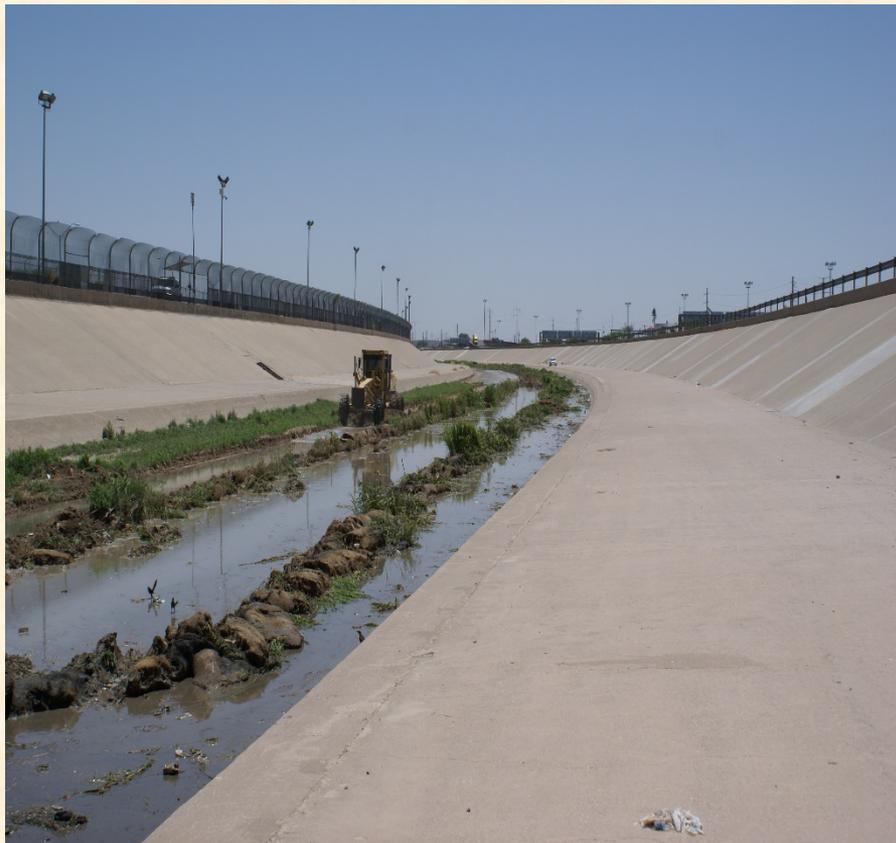
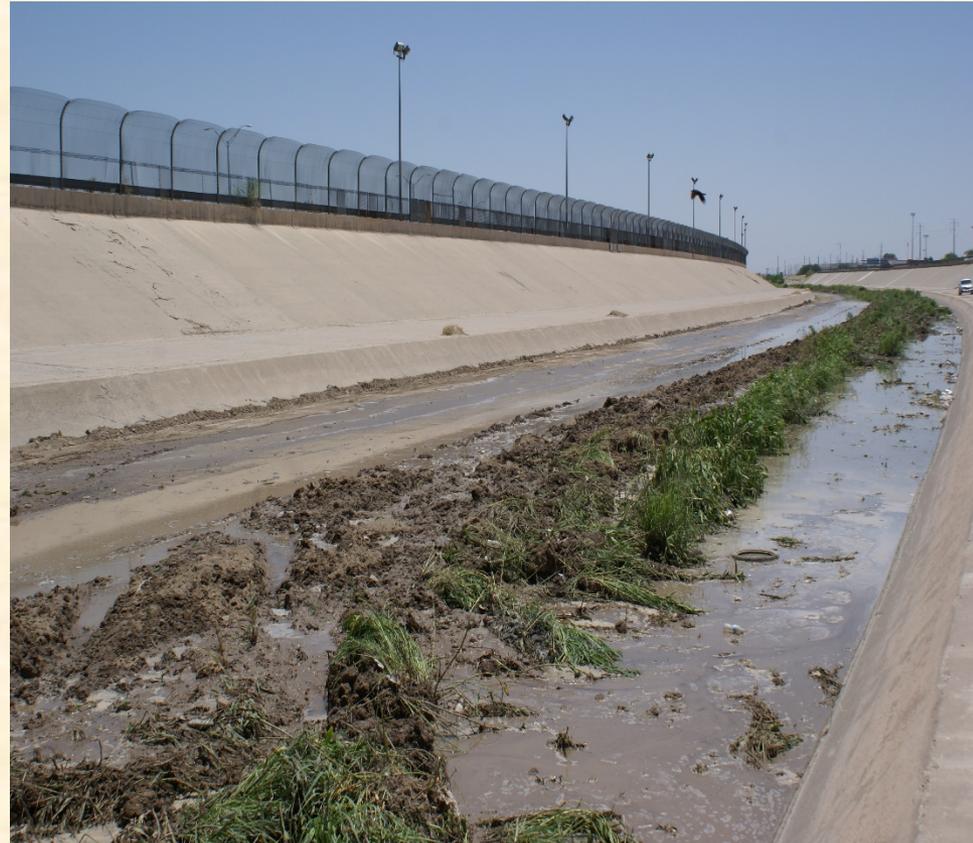
- Mexico-CILA contractor has already started their downstream end of required maintenance on silt and vegetation removal on Chamizal concrete channel.

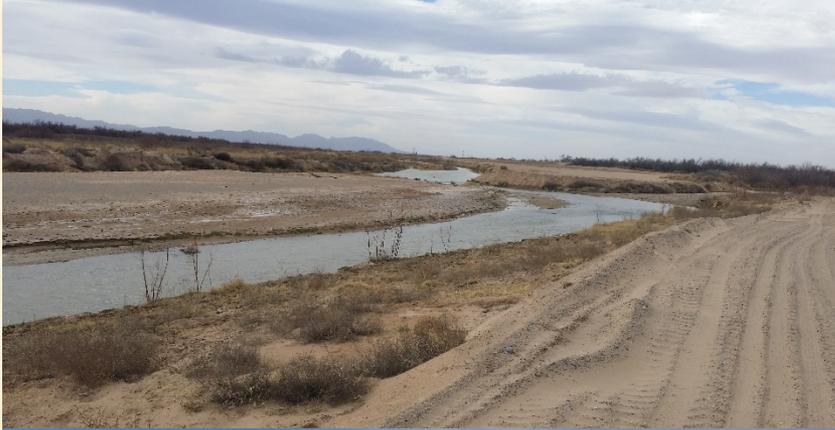
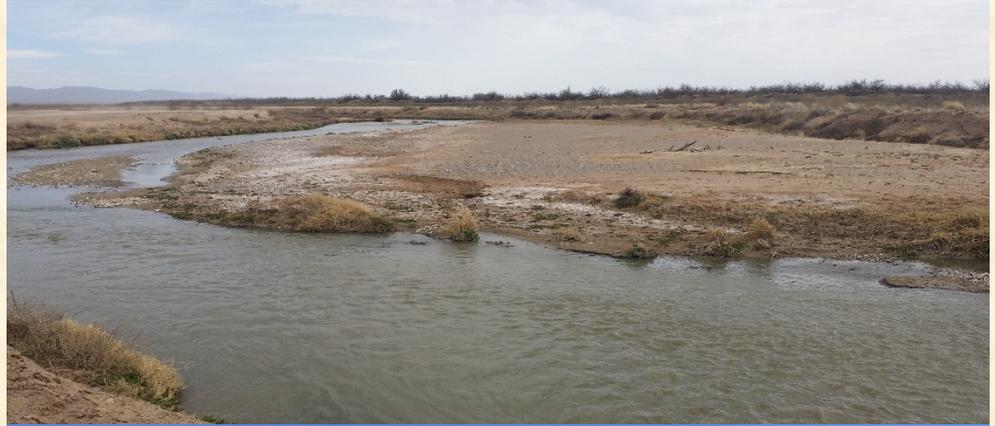
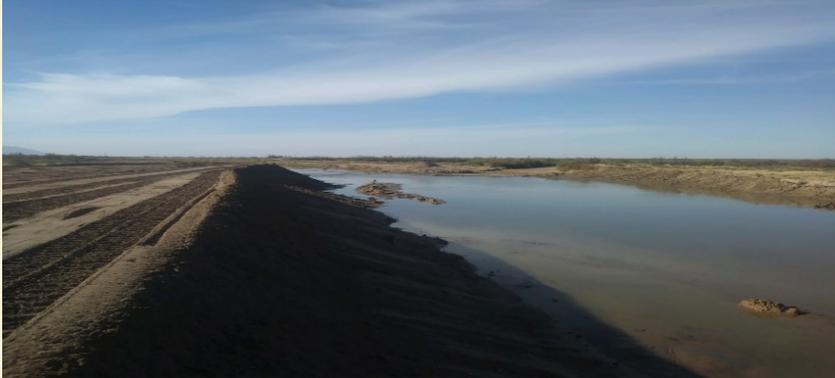
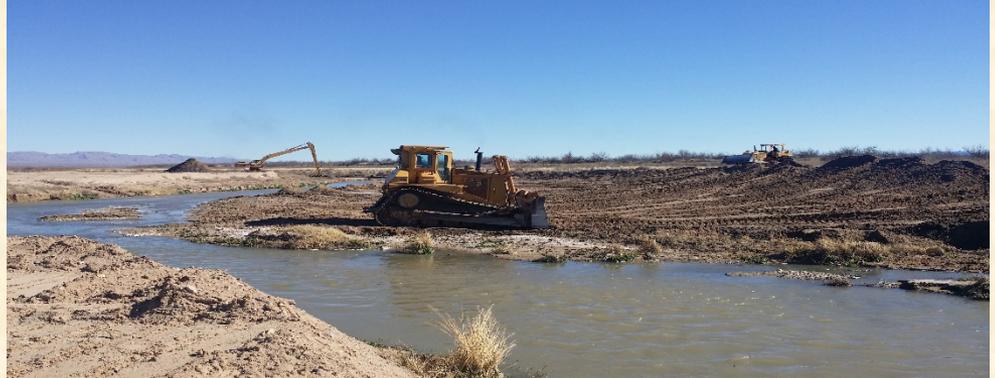
## Major Maint. Project: Guayuco Arroyo

- In 2017- 42,944 CY of sediment were removed. This is a major arroyo requiring continual, regular maintenance.
- In 2018- Approx. 8,000 CY have been removed from this Arroyo, just recently. Coordinated w/CILA Rep. to request permission to work from Mexico side. Will address as 2018 rain events require.

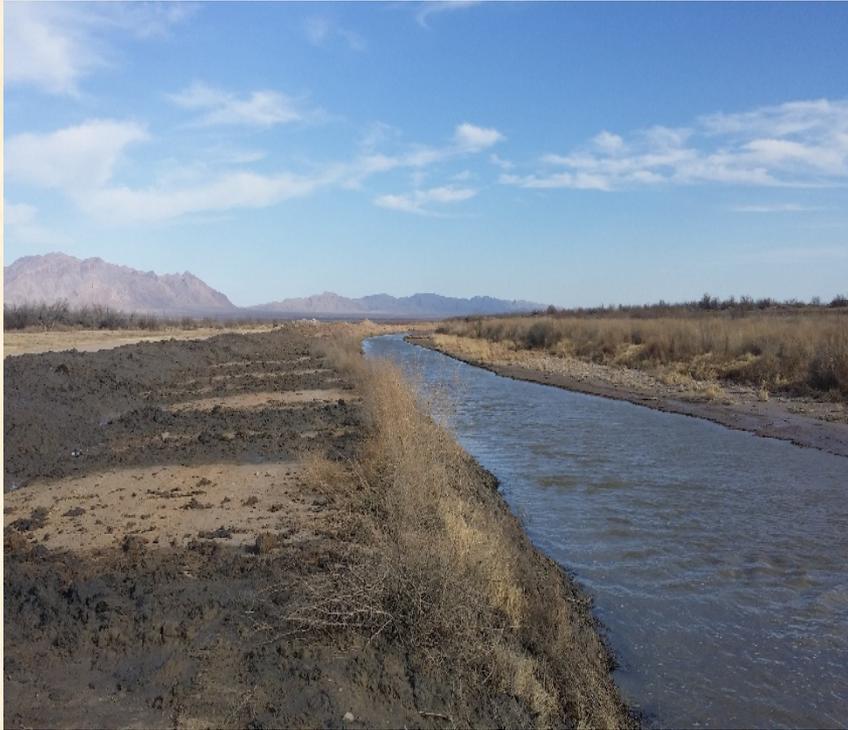
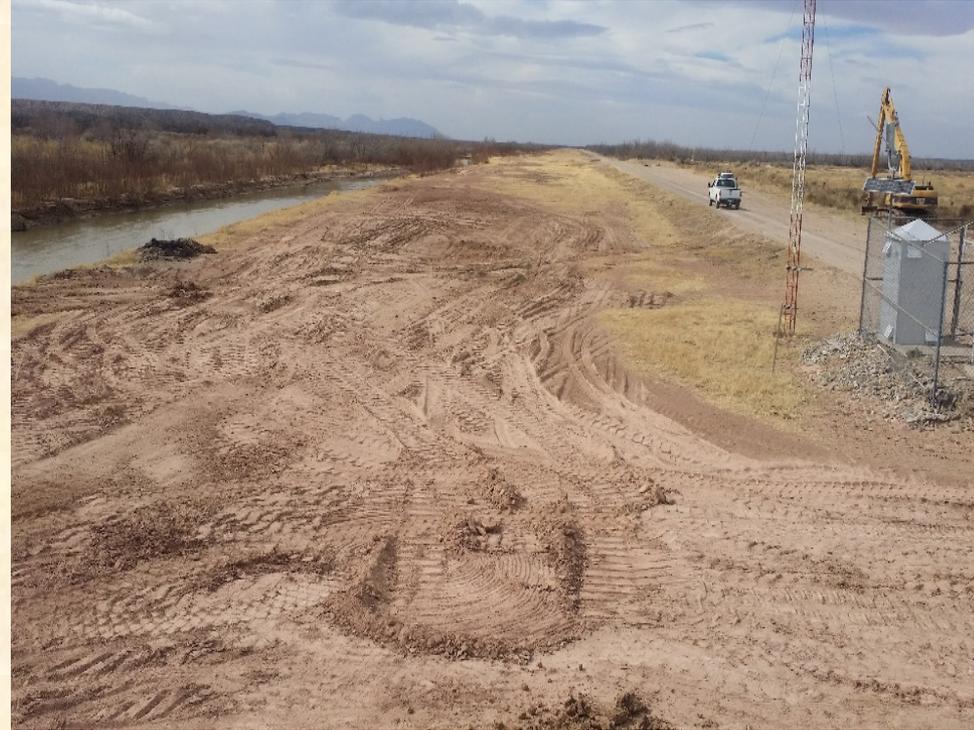
## Fort Quitman Gaging Station

Removal of silt at this critical site required, in order to improve the ability to accurately measure flow at the Fort Quitman Gaging Station site. Approximately 15,000 cubic yards of material was removed.

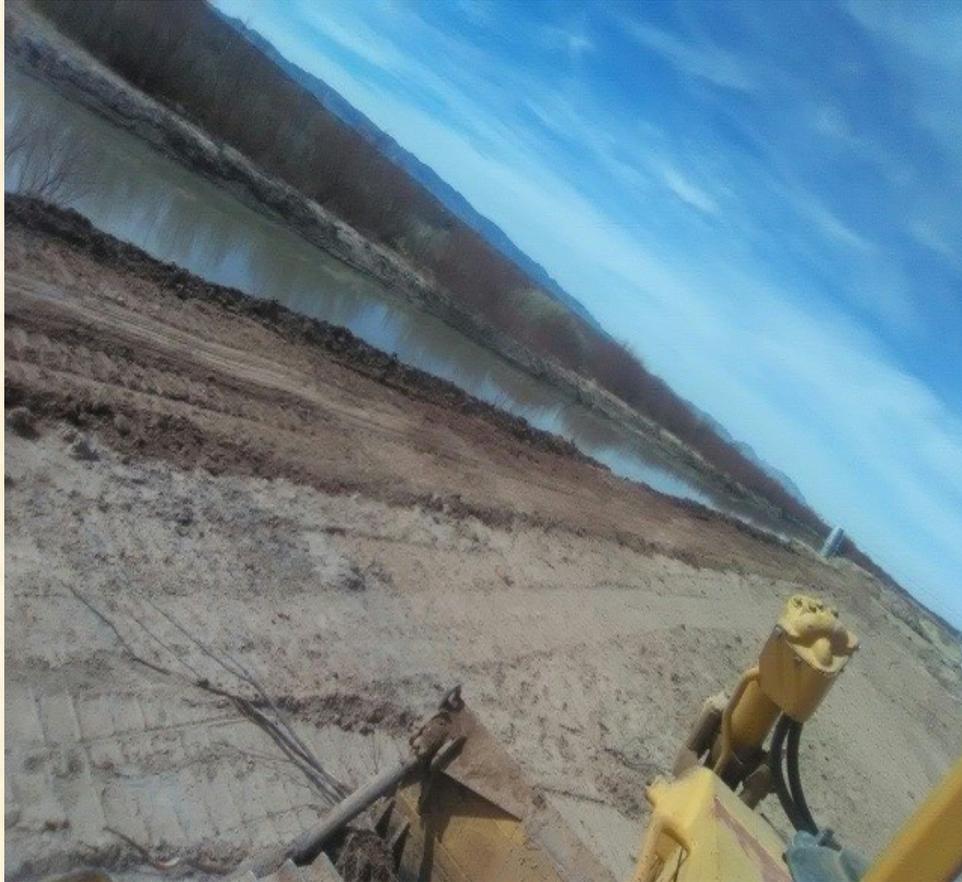
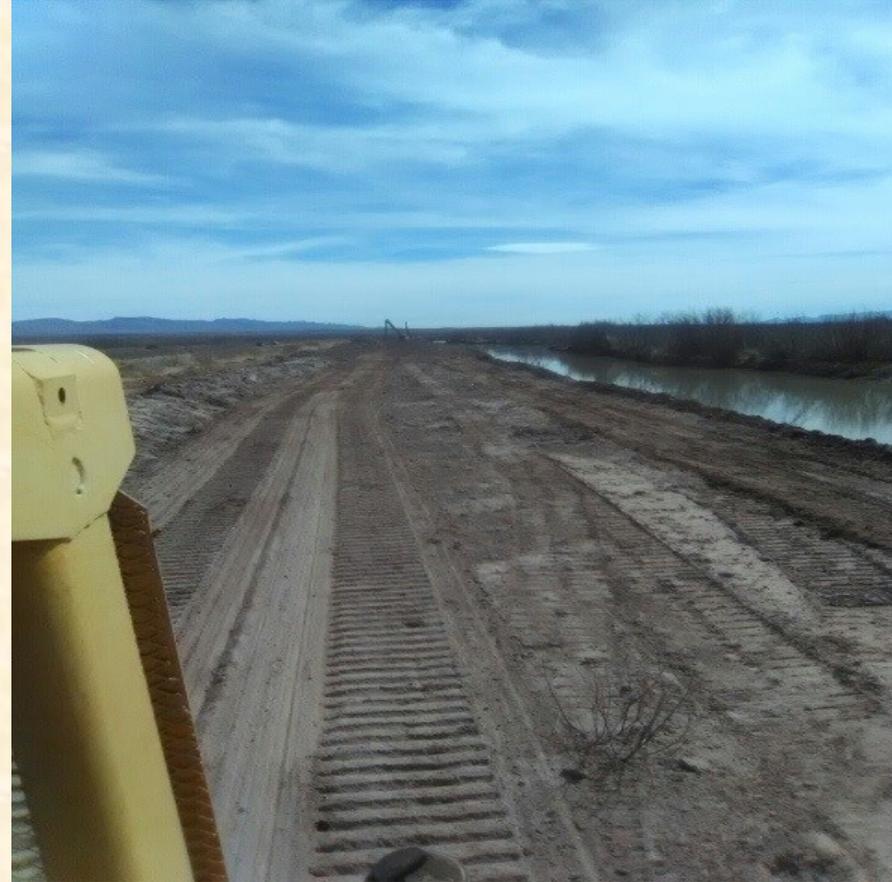
Ft Quitman Gaging Station to Neely Arroyo

- Critical local flooding downstream at Neely Arroyo. Working upstream of area from Ft Quitman Gaging downstream to Neely. Already 3 miles downstream.

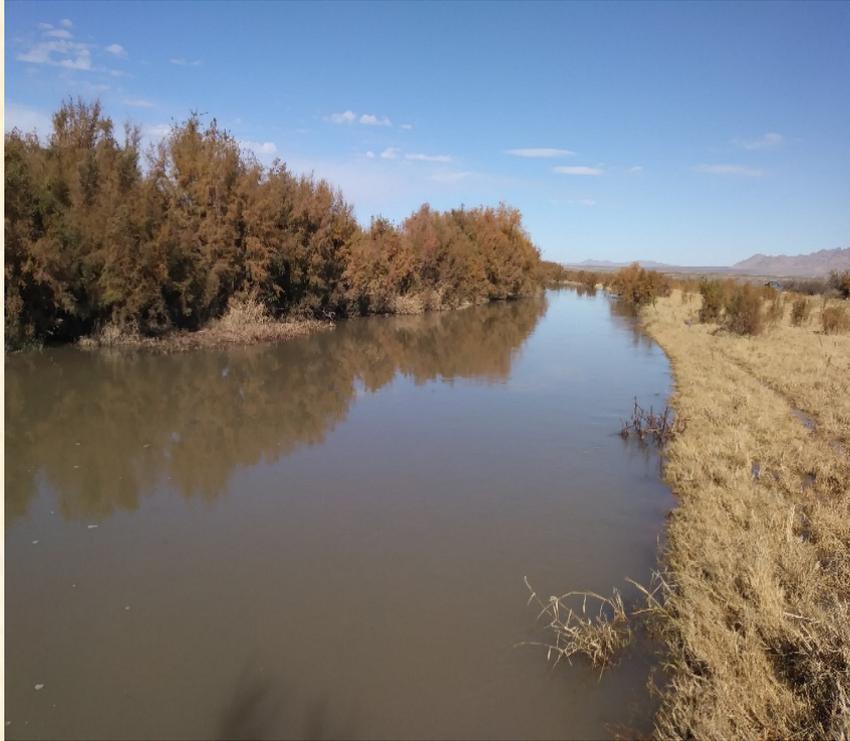
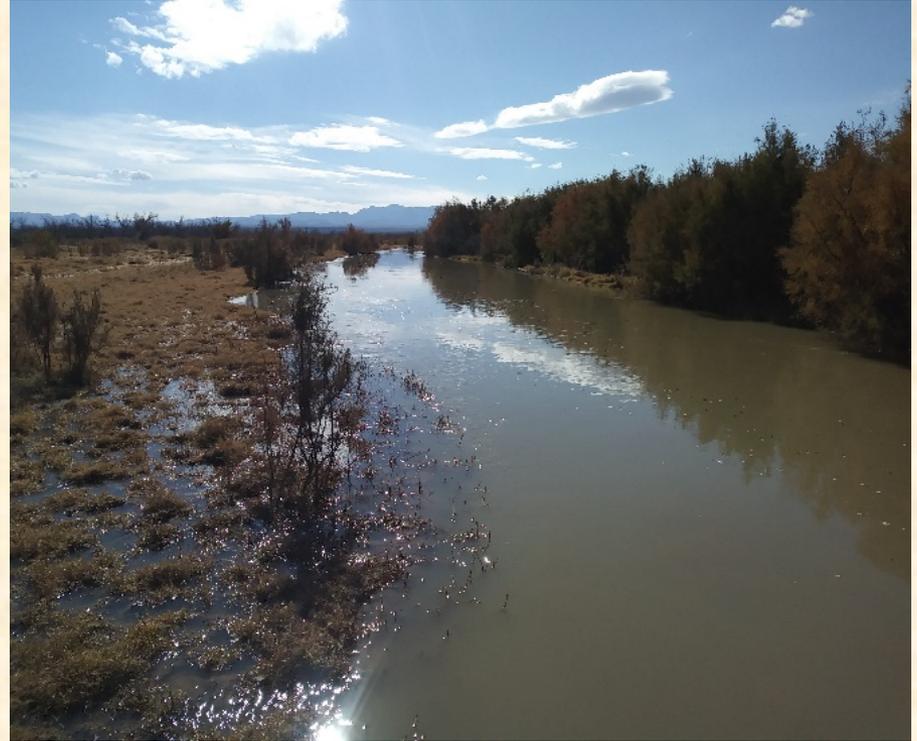
## Neely Arroyo- Local Flooding Problem Area

- Levee repairs and grading at Neely Arroyo, to assist in addressing adjacent local flooding to extent possible.
- River flow covering floodplain. This entire general area needs to be addressed as a total separate river dredging project, as it has not been addressed for a number of years.

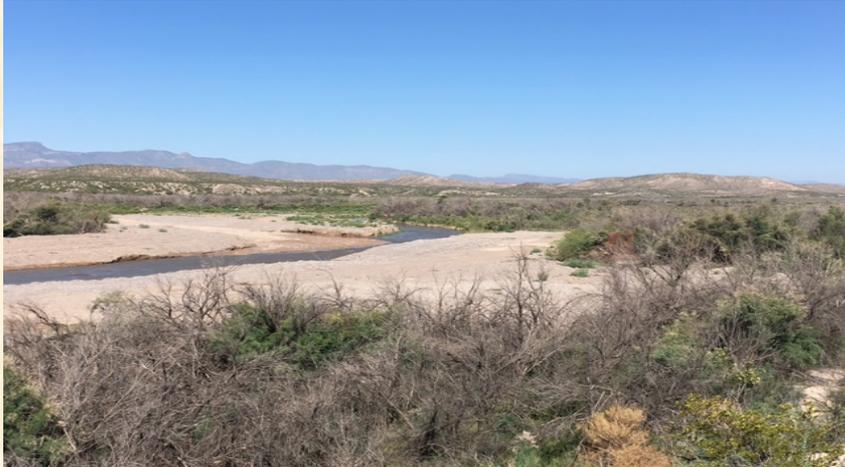
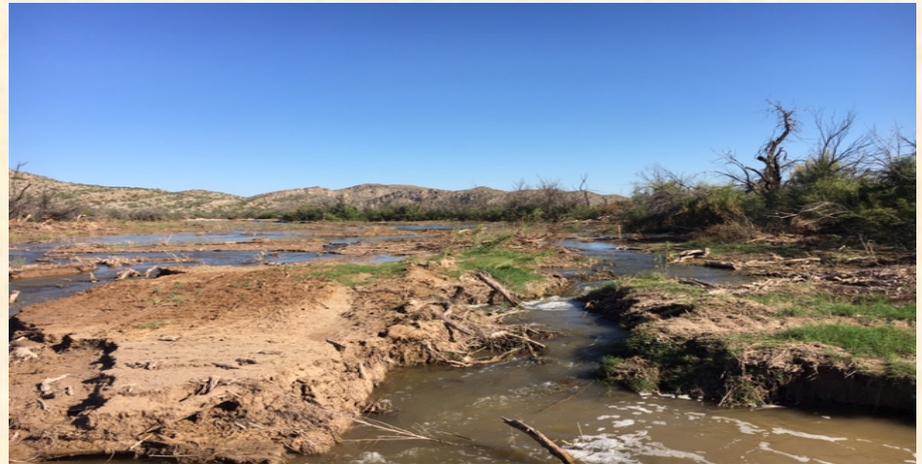
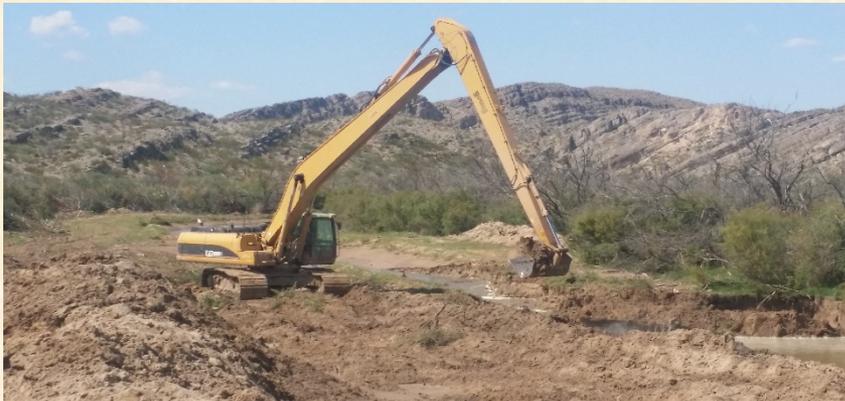
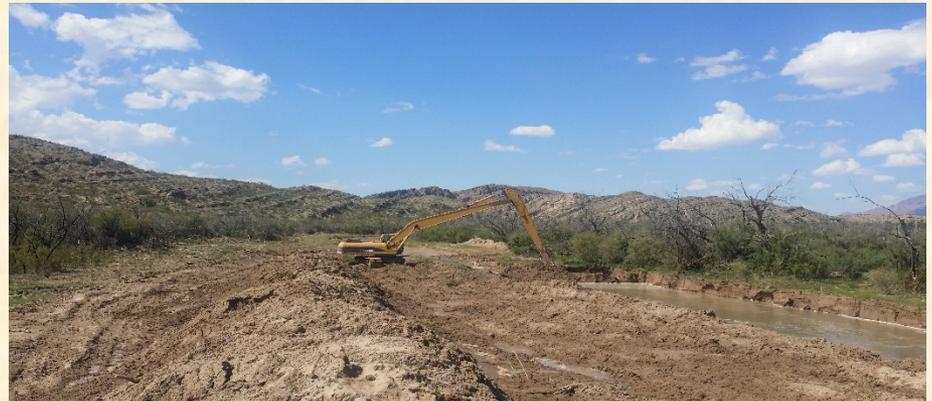
## Arroyo Del Fraile Problem Area and Upstream

- Widened and re-established pilot channel to approx. 38’.
- Removed an avg. of 3’ of sediment. Totaling approx. 55,736 CY. to date.

- Have re-established pilot channel for approx. 2.5 miles upstream of Del Fraile. Presently approx. 1500’ below Little Box Canyon.
