DRAFT ENVIRONMENTAL ASSESSMENT

IMPROVEMENTS TO THE ARROYO COLORADO SOUTH LEVEE, HIDALGO AND CAMERON COUNTIES, TEXAS

**United States Section,
International Boundary and
Water Commission**

April 2010

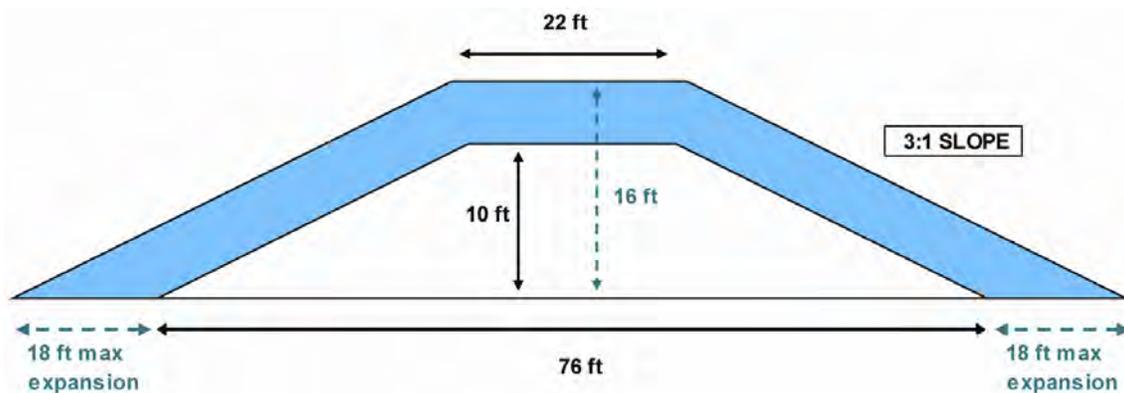
Figure 2-1: Typical Cross-section of a Levee Illustrating Footprint Expansion

Typically, footprint expansion would occur on each sides of the levee, retaining the horizontal alignment of the centerline. Up to 6 feet of fill material would be placed on top of the levee, extending the levee footprint up to a maximum of 18 feet from the current toes of the levee. In some reaches of the levee system, if required by the presence of irrigation structures or other constraints, expansion would be made with an offset centerline, placing the additional footprint on only one side of the existing levee. If the option to offset is selected, the levee slope can be changed from a 3:1 to a 2.5:1 slope. A typical cross-section of a levee is shown in Figure 2.1, illustrating the footprint expansion for a 6-foot increase in height.

Footprint expansion would occur entirely within the flood control project ROW. Structural improvements (e.g., seepage remediation) may be needed in some sections of the levee. These improvements would not contribute to footprint expansion of the current levee footprint. Structural improvements could include the following.

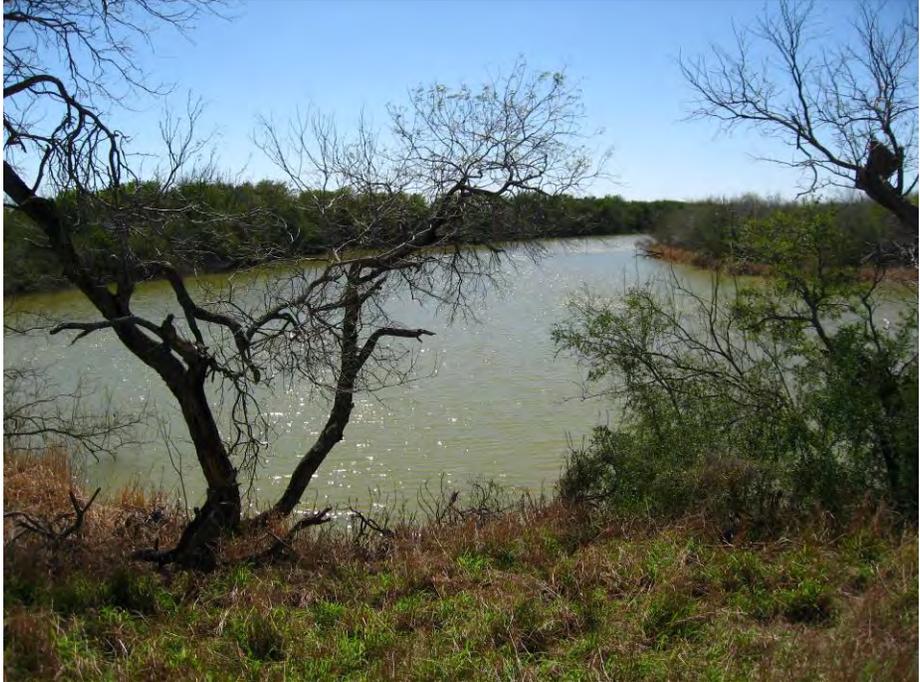
Client: United States Section, International Boundary and Water Commission	Project Number: 174293
Project Name: Arroyo Colorado South Levee Rehabilitation	County, State: Cameron County, Texas
Photograph ID: 7

Feature: Impounded drainage canal	
Date: 2/22/2010	
Comments: Impounded drainage canal at levee mile 15. Facing south.	
Photograph ID: 8

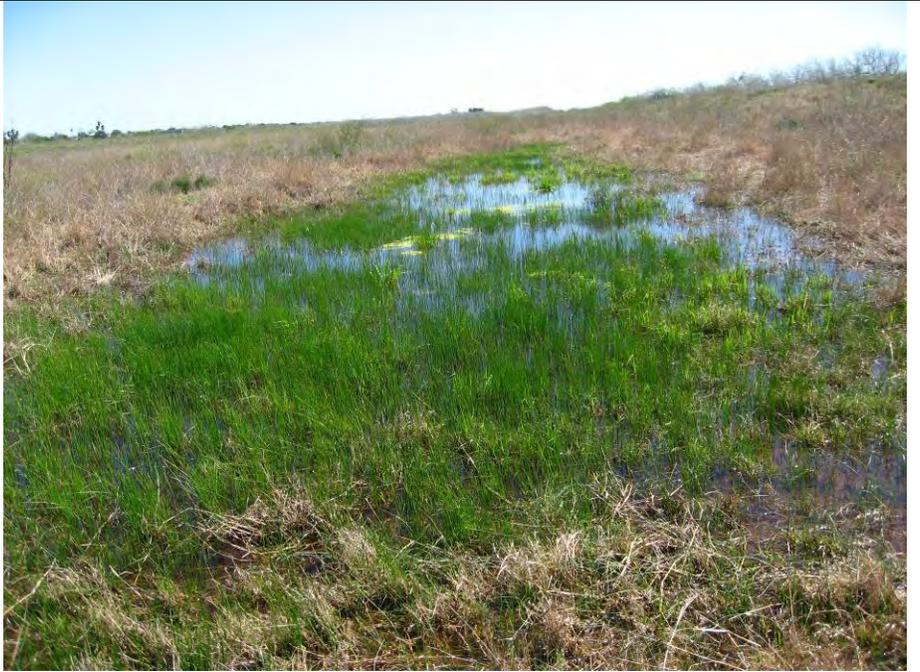
Feature: Wetland A – Levee borrow pit	
Date: 2/25/2010	
Comments: Wetland A, Levee construction borrow pit. Facing east.

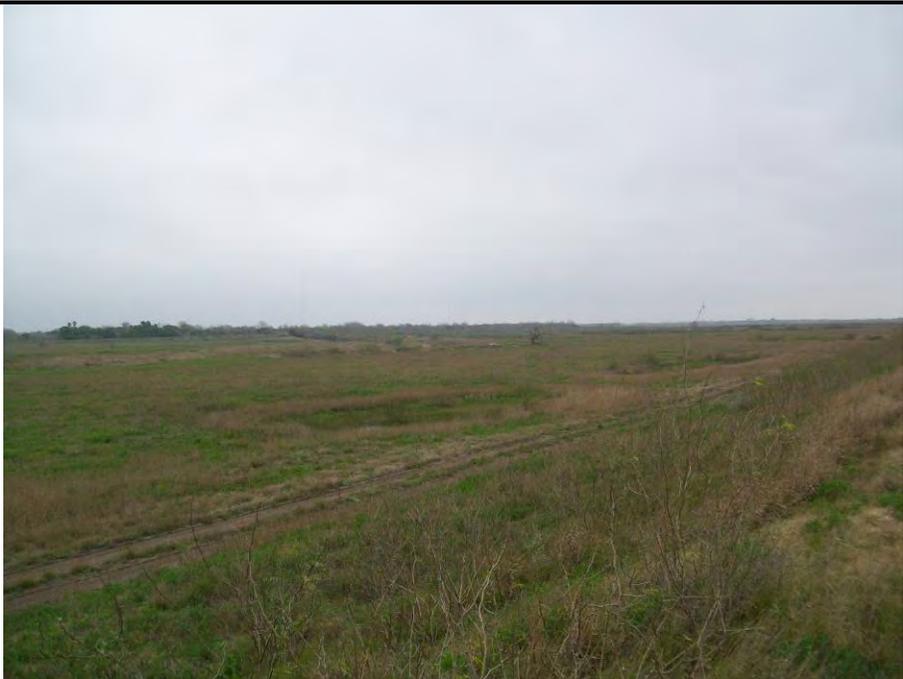
Feature: Levee borrow pits.	
Date: 2/24/2010	
Comments: Non-wetland levee borrow pits within old- field/rangeland. Facing northeast.

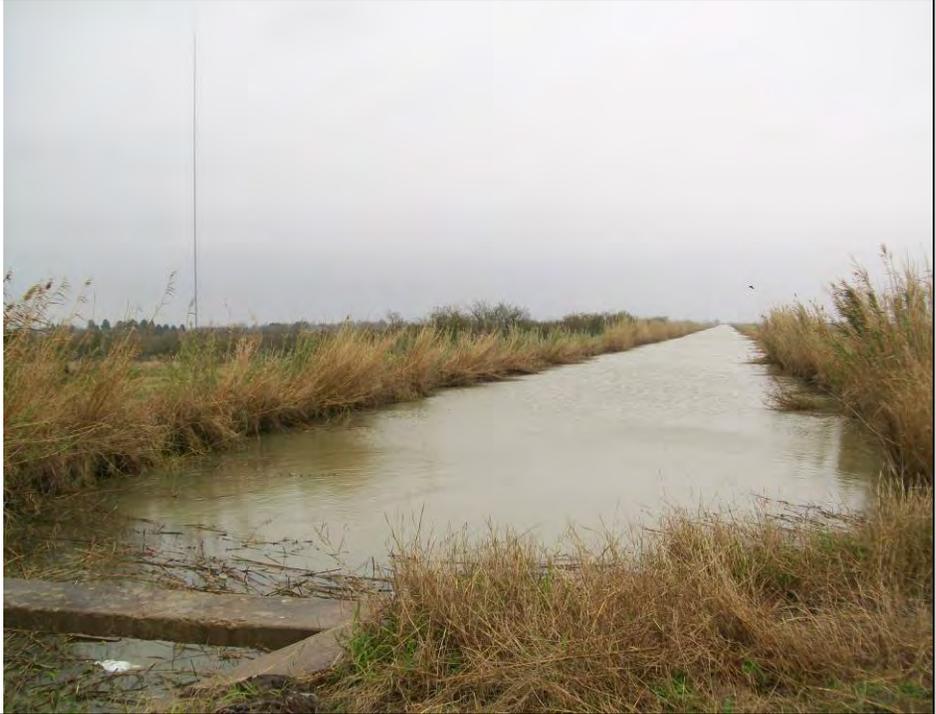
Client: United States Section, International Boundary and Water Commission	Project Number: 174293
Project Name: Arroyo Colorado South Levee Rehabilitation	County, State: Hidalgo County, Texas
Photograph ID: 9

Feature: Irrigation canal	
Date: 2/24/2010	
Comments: Irrigation canal at levee mile 9. Facing south.
