# **Minute 319**

# **Colorado River Limitrophe and Delta**

# **Environmental Flows Monitoring**

# **Final Report**

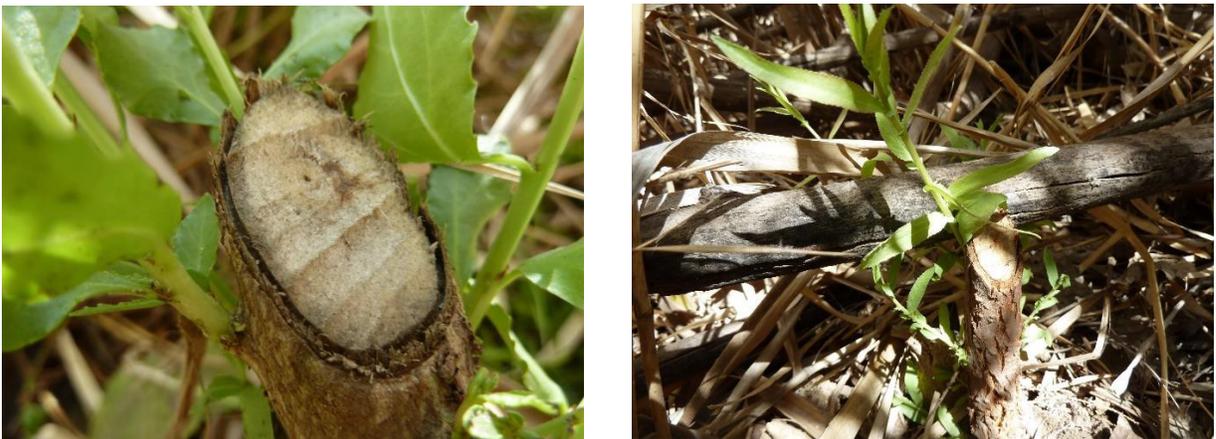
**Figure 4-4.** Cottonwood (left) and willow (right) seedlings in 2016 found in Reach 1, showing signs of herbivory. Diameter of cottonwood stump is approximately 3.2 cm; willow stump is approximately 2.3 cm diameter.

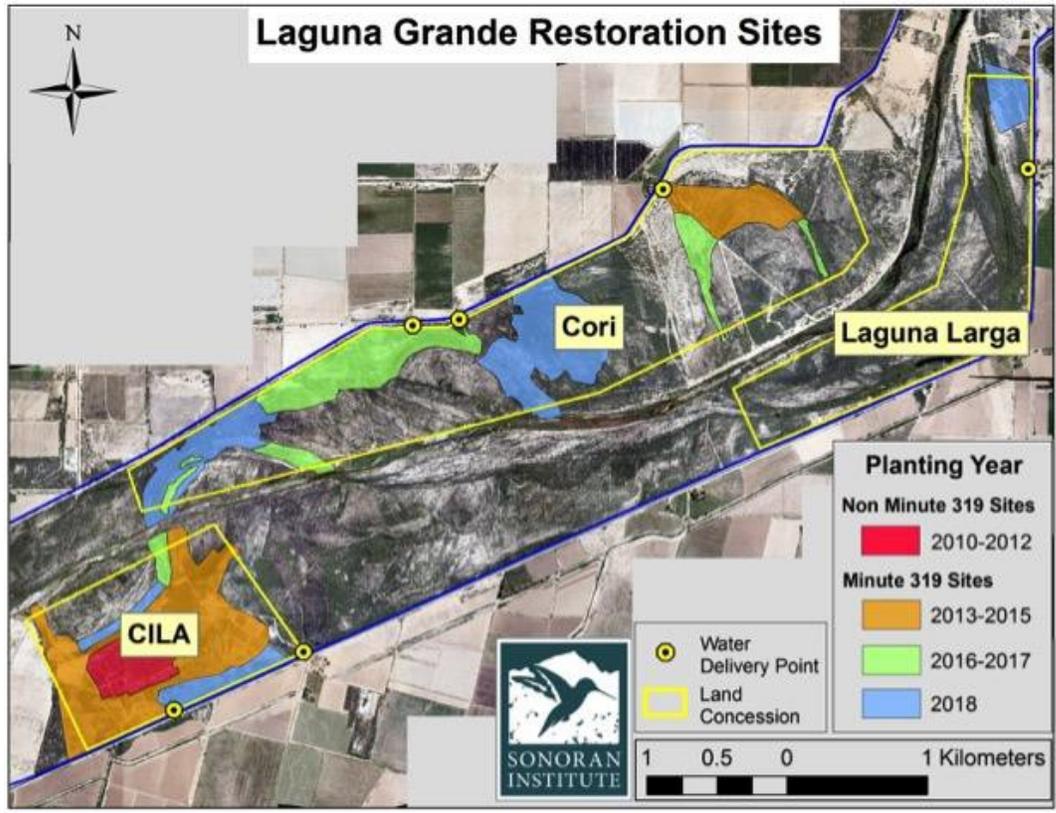
Figure 5-5. Restored areas at the Laguna Grande restoration site.

From 2013-2018, Sonoran Institute will have restored a total of 207 ha (512 acres) of riparian habitat at the Laguna Grande Restoration Site in Reach 4 (Table 5-5). Funding was provided by Minute 319 and private sources and water was supplied by the pulse flow and subsequent base flows. Restoration was implemented at three land concession areas within Laguna Grande: CILA, Cori, and Laguna Larga (Figure 5-5). Species planted from 2013-2018 included cottonwood, willow, coyote willow, and screwbean and honey mesquite trees. Additional areas were hydro-seeded and planted with diverse native herbaceous and grass species. Hydro-seeding native tree, shrub, and herbaceous species' seed was a successful re-vegetation method for creating species-diverse and genetically-diverse native habitat, particularly when applied in irrigated plots.

By the end of 2018, an estimated 201,950 trees will have been planted at Laguna Grande, with an average planting density of 976 trees/ha (394 trees/acre). From 2013-2017, the average tree survival rate was 91.5%. Planted and hydro-seeded sites were irrigated using flood irrigation in furrows or plots, water deliveries to meanders (indirect irrigation), or drip irrigation. Sites were weeded 2-3 times per year. In the 2016-2017 water cycle, 4.04 mcm (3,278 acre-feet) were scheduled for delivery. In the 2017-2018 water cycle, 4.7 mcm (3,810 acre-feet) are scheduled for delivery to restoration sites in Laguna Grande.

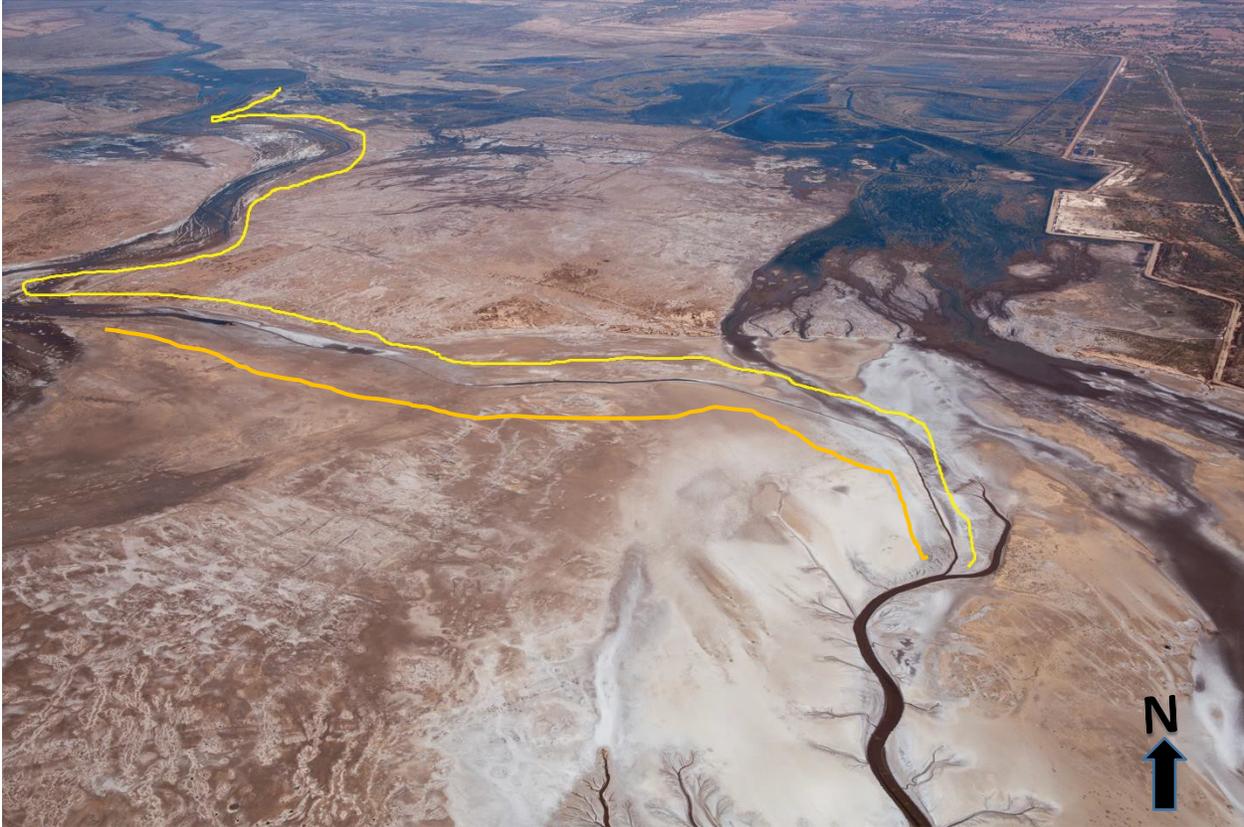
**Figure 8-8.** Aerial image of dredged channel, November 2016. Hardy-Colorado River is located top-left, and a tidal channel is located bottom right. Dredged channel connects the two. Yellow line parallels trace of the dredged channel.

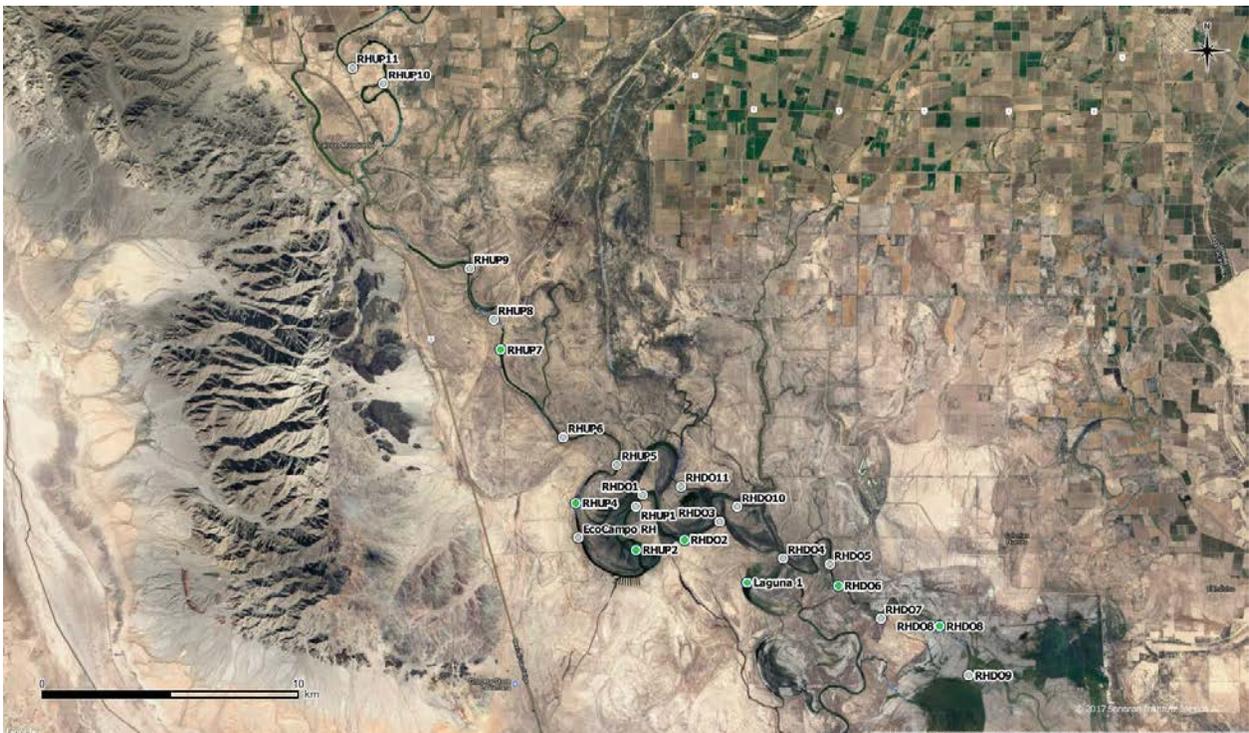
**Figure 8-13.** Map of fish survey points from 2005-2017. The green points were surveyed in 2014-2017.

Fish surveys were conducted three times per year from 2014-2017 at seven points along the Hardy River and upper estuary (Figure 8-13). Surveys used a net designed to capture medium and large-sized fish (see Yáñez-Arancibia (1978) for methods). Prior to 2014, Sonoran Institute conducted surveys once at nine points in 2005, monthly at 21 points from 2009-2010 and monthly at nine points from 2011-2012. Seven of the original survey locations were used in 2014-2017 to maintain a long-term dataset.
