# 2022

# Basin Highlights Report

Rio Grande Basin Program Update  
International Boundary and Water Commission,  
U.S. Section  
Texas Clean Rivers Program

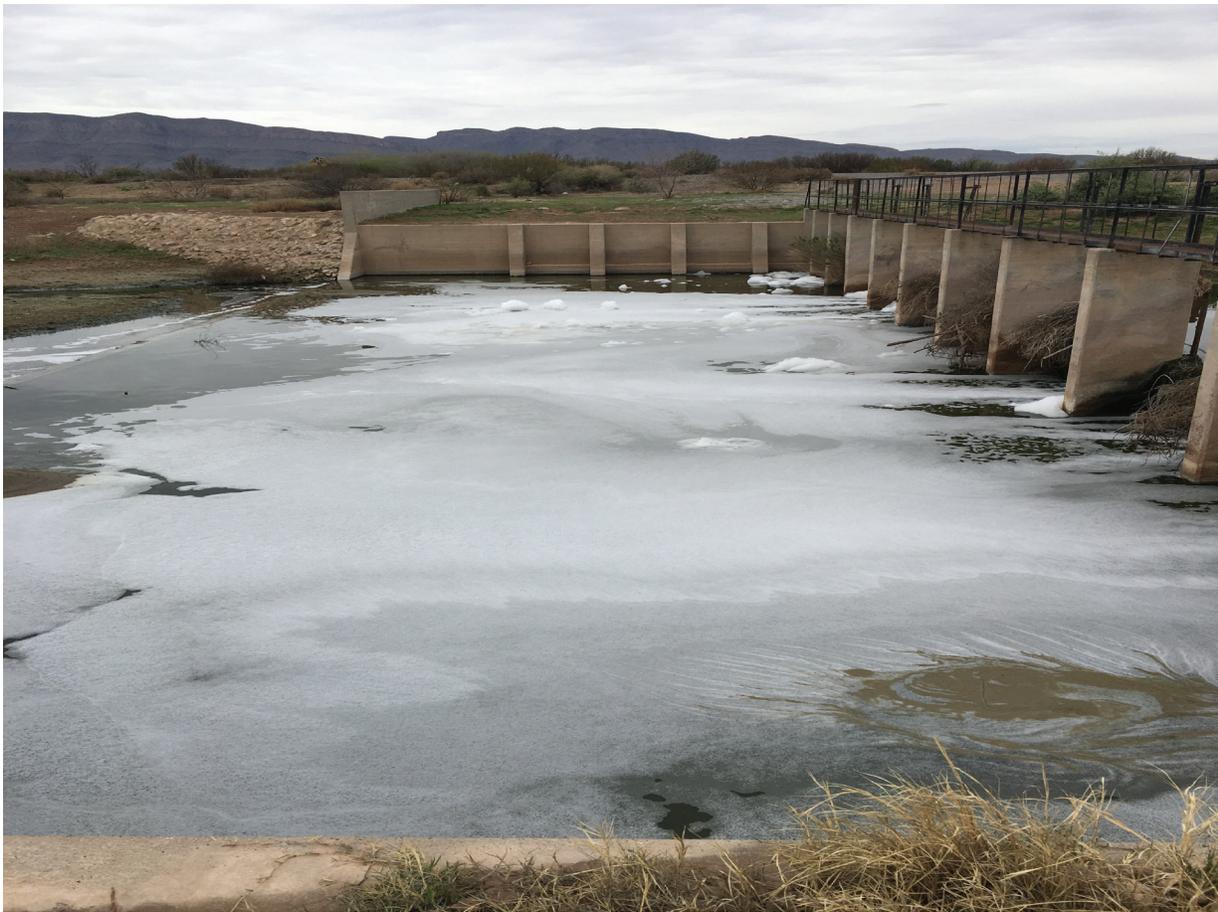
Pictured: Foam in the Rio Grande at Station 15795, Rio Grande at Alamo Grade Control Structure, Ft. Hancock, just outside of El Paso, TX. Photo by Leslie Grijalva

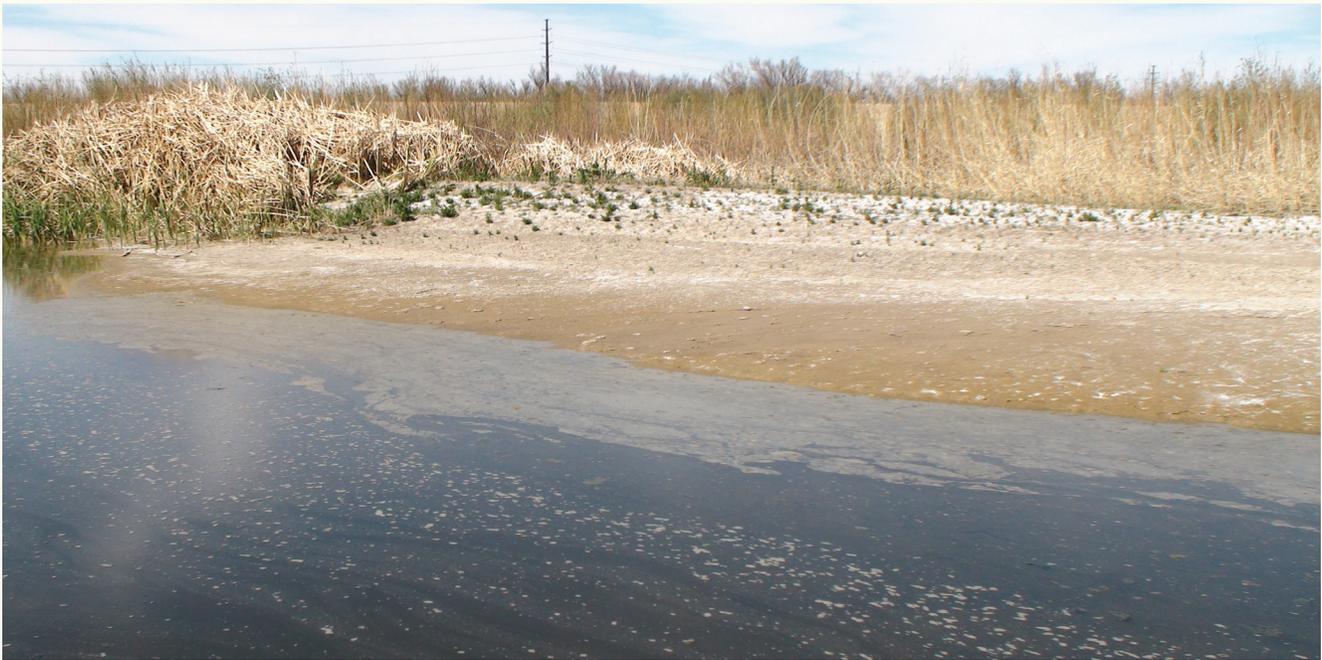
Pictured Above: Sewage spill upstream of Station 17040, Rio Grande at Anapra Bridge, El Paso, TX. Photo by Leslie Grijalva

On August 13, 2021, the City of El Paso crews were performing maintenance work in the upper El Paso, TX area when they accidentally ruptured a major sewage line. This initial break, coupled with significant rainfall the area experienced during the month of August, caused a second rupture of the sewage line. This led to the release of approximately one billion gallons of untreated sewage directly into the Rio Grande that continued through January 2022. El Paso Water (EPW), TCEQ, and the USIBWC started a joint effort to monitor the spill while EPW worked on fixing the line ruptures. The USIBWC CRP was onsite days after the spill collecting samples, both routinely and as needed, to monitor the water quality of the area directly downstream of the spill. USIBWC CRP monitored the water quality at 8 stations, with two immediately downstream of the spill and six moving downstream toward Fort Quitman, about 60 miles outside of El Paso. The detrimental effects of the sewage spill could be seen along the river almost immediately after the spill. Within the first few weeks after the spill, USIBWC CRP staff recorded the lowest dissolved oxygen levels ever in the two sites immediately downstream. (See tables below) Dead fish were recorded in the water all the way downriver at the Fabens/Tornillo POE site (Station 15704), which is about 38 miles away from the spill site. In October 2021, EPW began discharging additional treated effluent from one of their wastewater treatment plants into the river to dilute the contaminated water until line repairs were completed. Conditions have only begun to improve recently, with dissolved oxygen levels rising but still well below required water quality standards. The broken lines were fully repaired as of January 2022 and current plans are in place to address the biosolids that remain in the river now that the water is low.

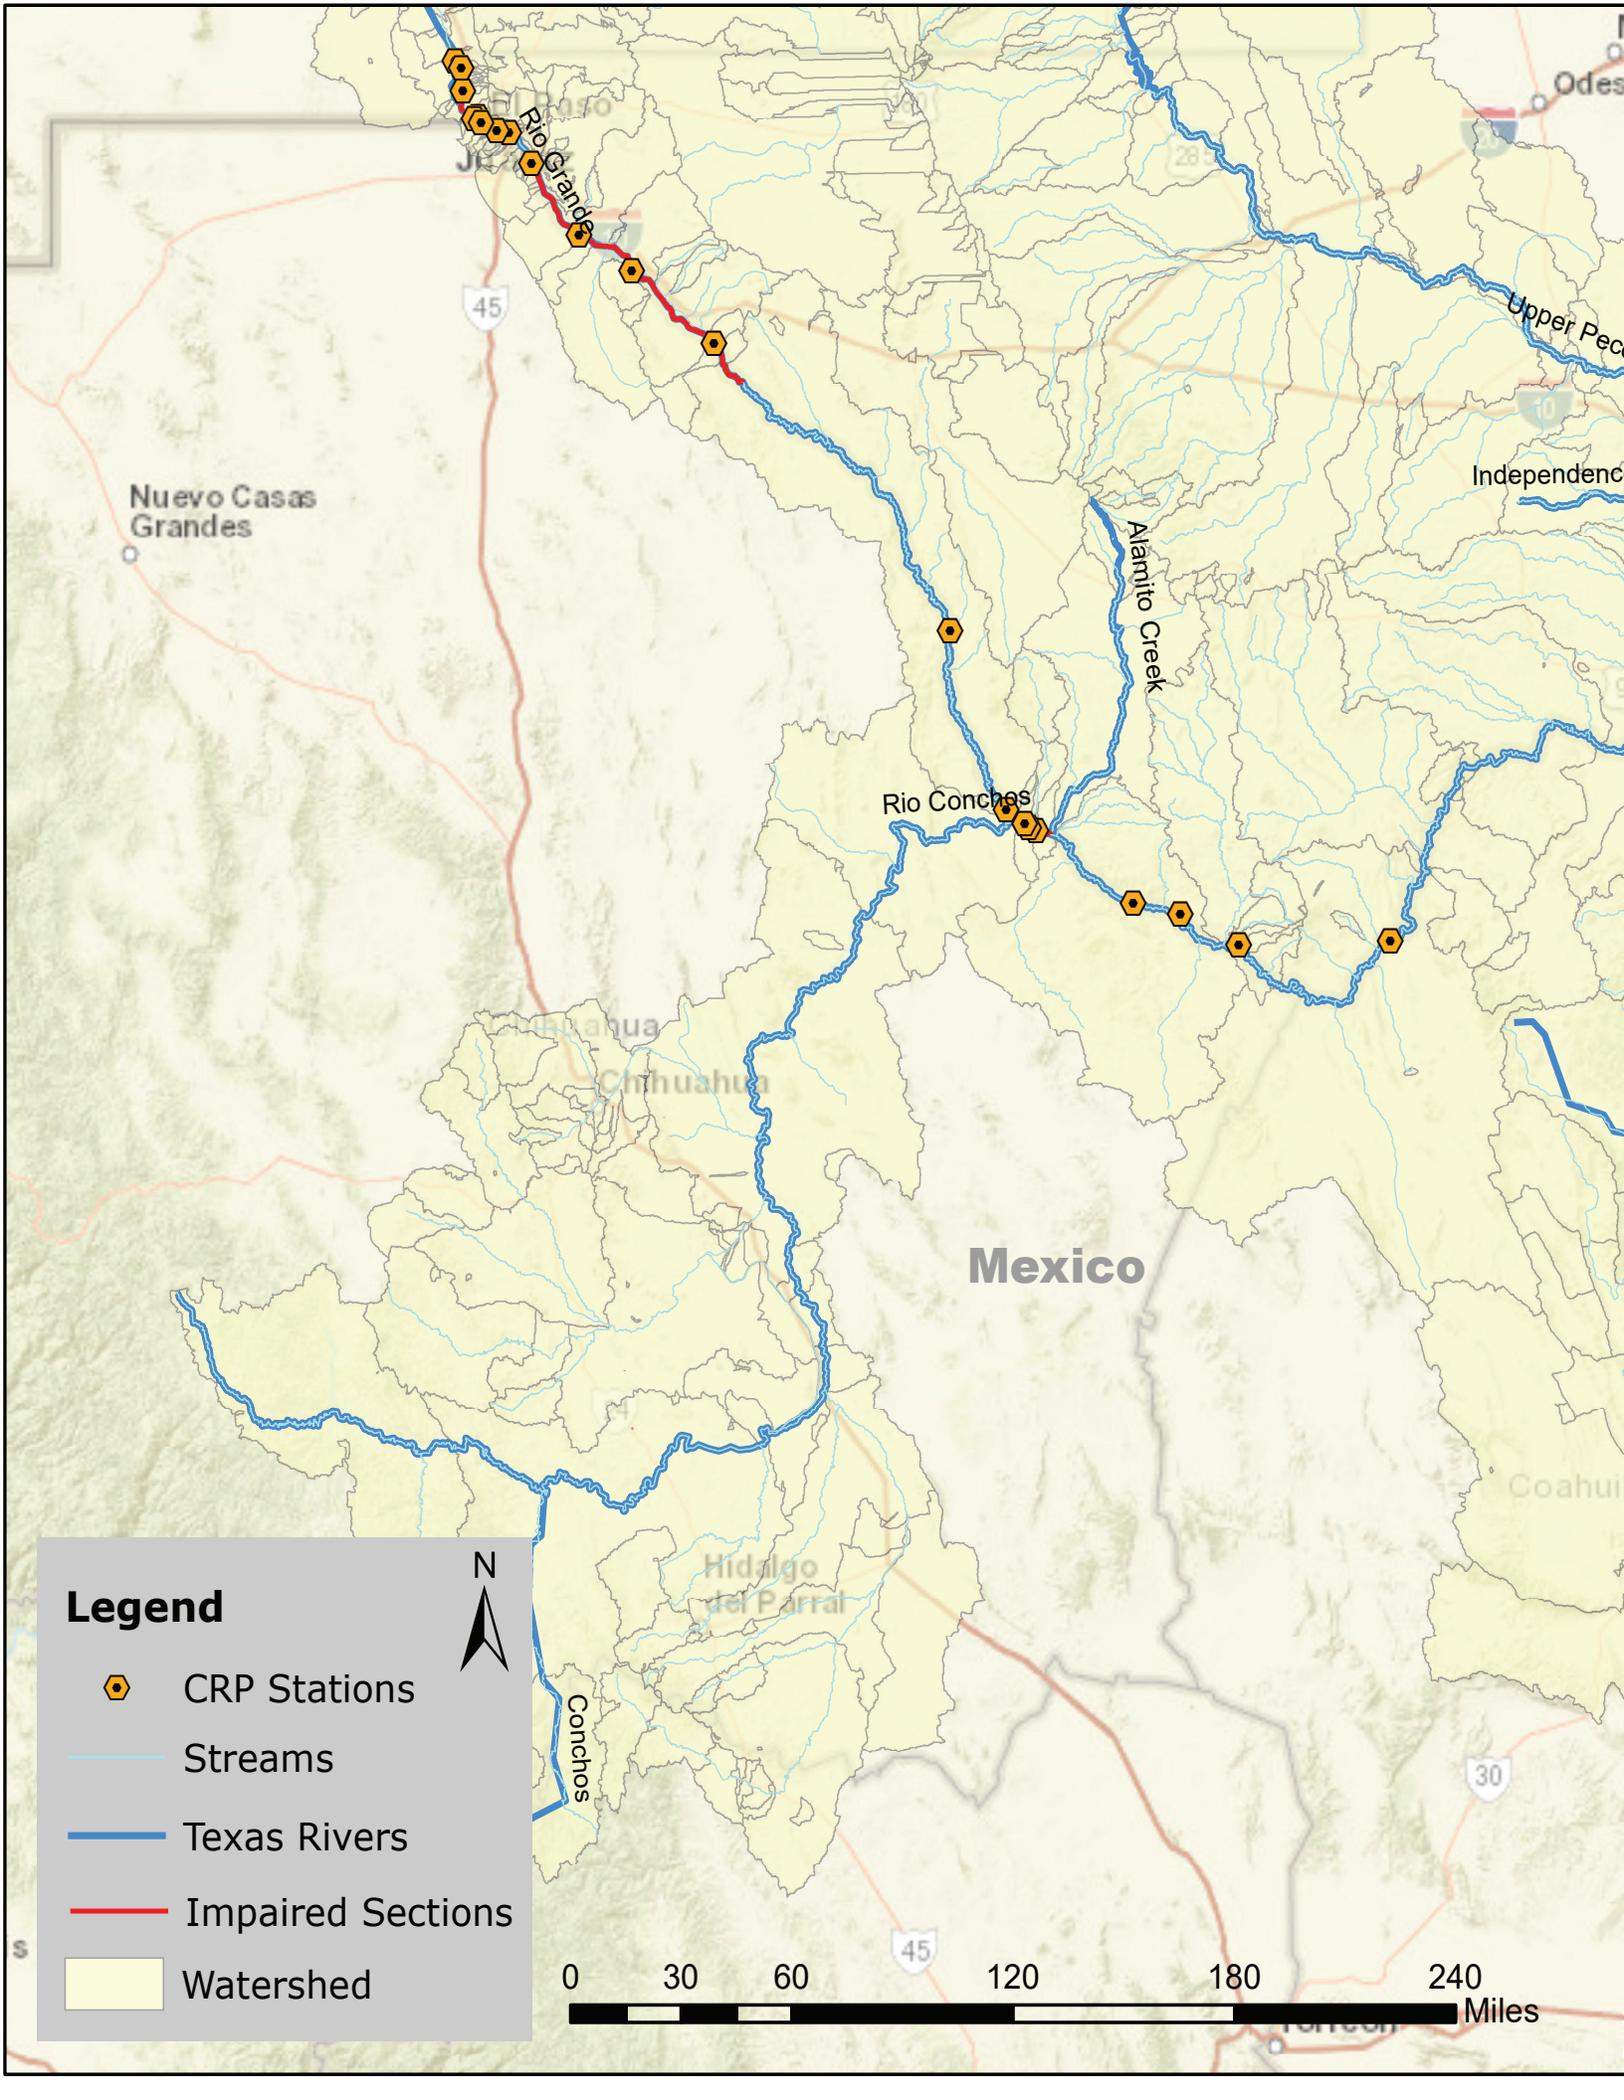
Figure 2

# Texas Clean Rivers Program Bacteria Impaired River Sections

Seven segments (out of 14) in the Rio Grande are impaired for bacteria. Although there have been vast improvements since the mid- 90's, bacteria impairments are still an issue of great concern. In many parts of the basin, aging infrastructure, population growth and lack of sanitation services altogether are all commonly seen when bacteria levels are high. High levels of bacteria can cause illness or skin infections in people or pets that come in contact with the water.

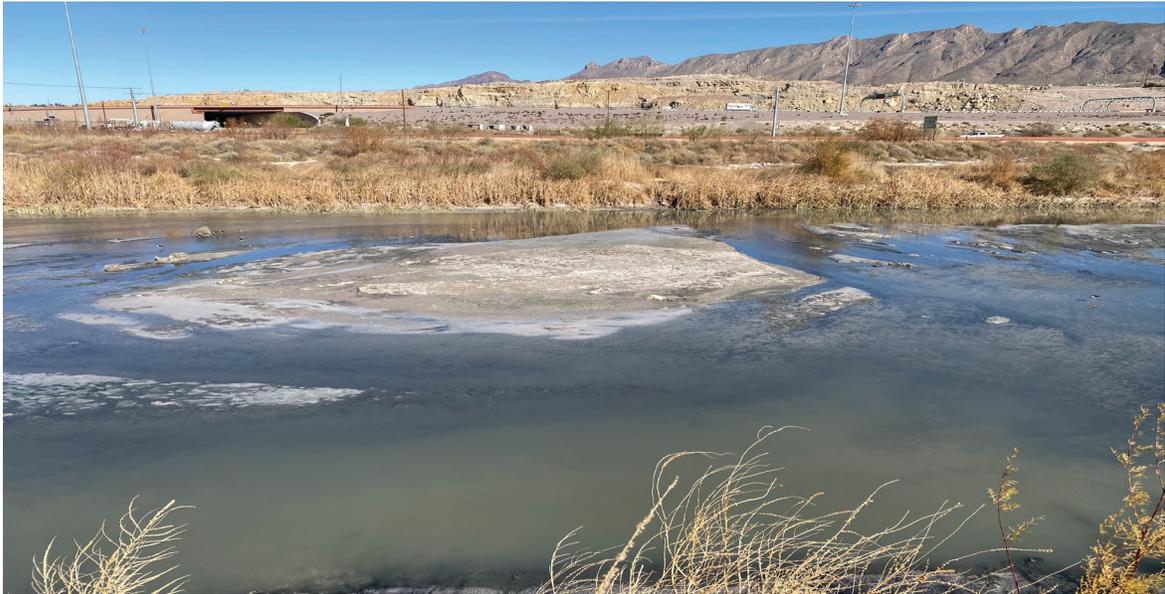
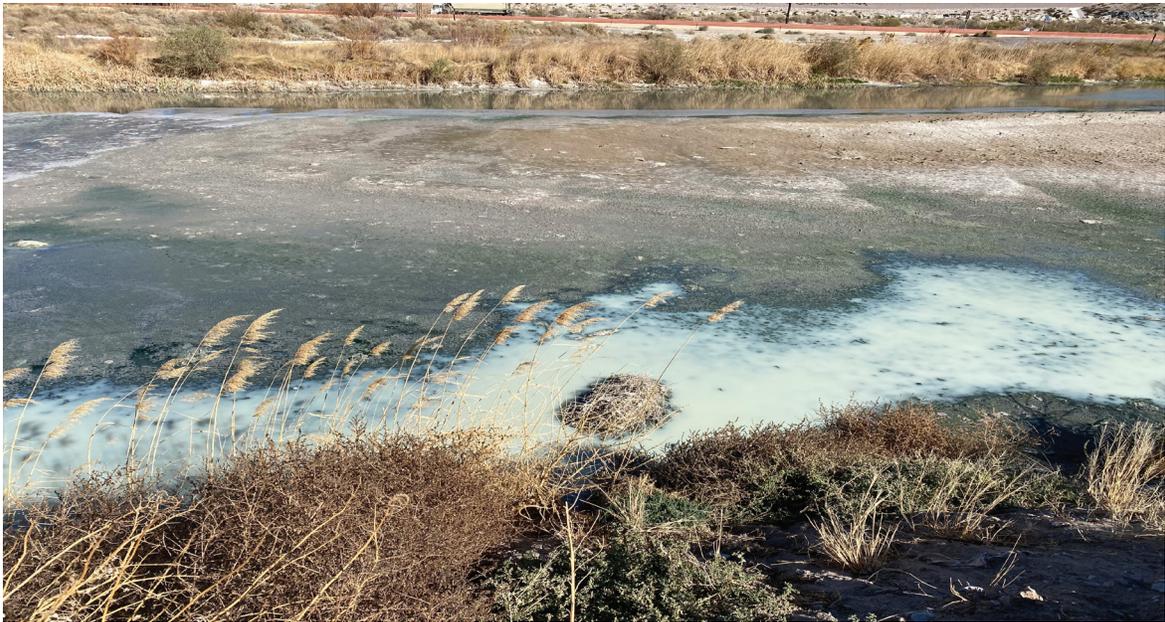
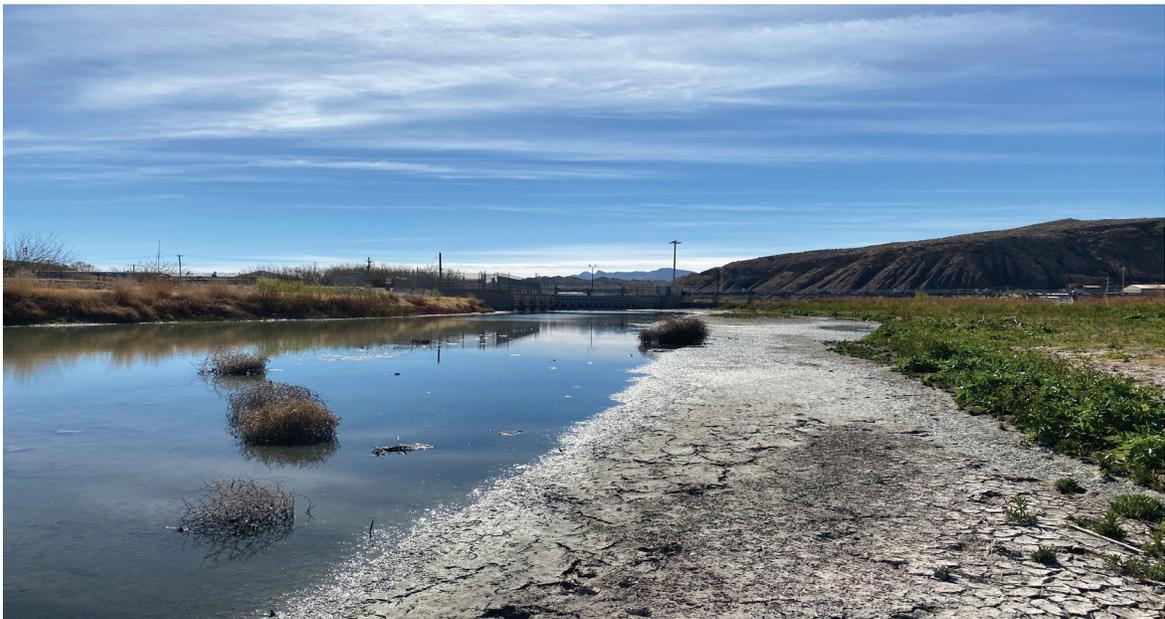
Pictured on page 19: Rio Grande at Courchesne Bridge, Station 13272, immediately downstream of the site of the sewage spill. Pictures taken in January 2022 and sewage is still clearly visible in the water. Photos taken by Leslie Grijalva

8/27/2021 at Station 13272	41,060	Data not collected, water sample only
8/27/2021 at Station 15089, about 0.5-1 mile downstream of 13272	6,310	Data not collected, water sample only

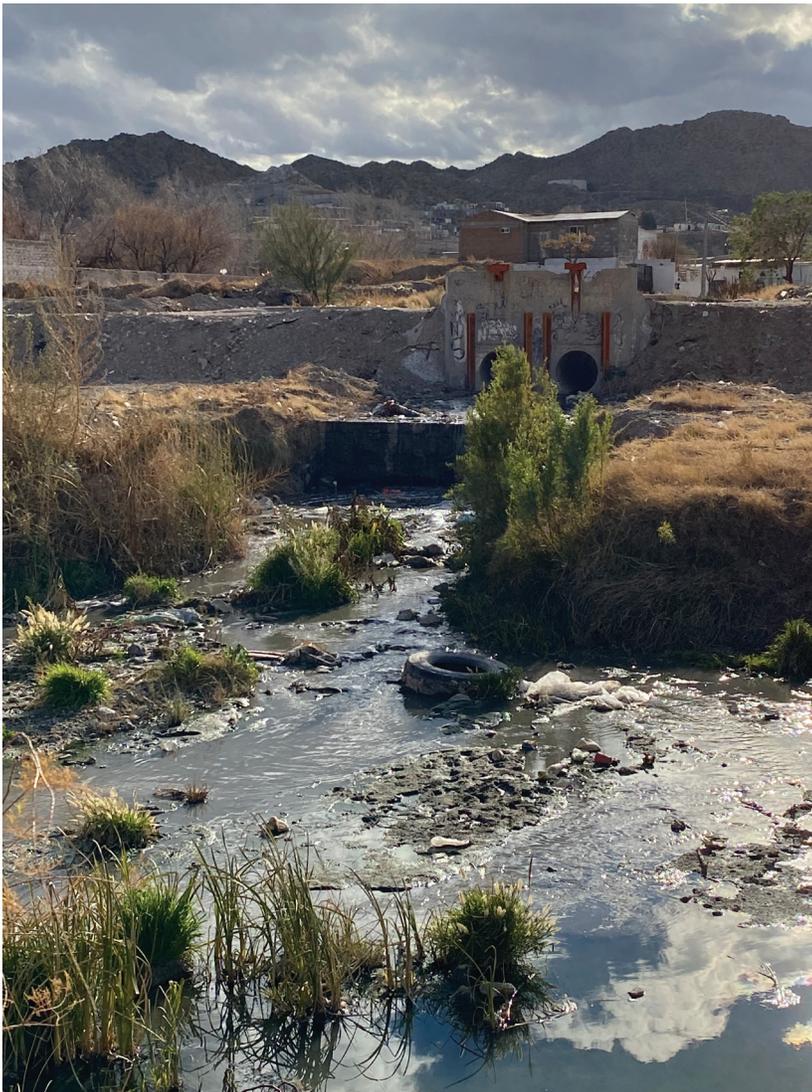
Pictured: USIBWC staff conducting a visit of a drain located on the Mexican side of the river across from El Paso, TX. Lots of trash and bad quality water always visible. Photo taken by Leslie Grijalva

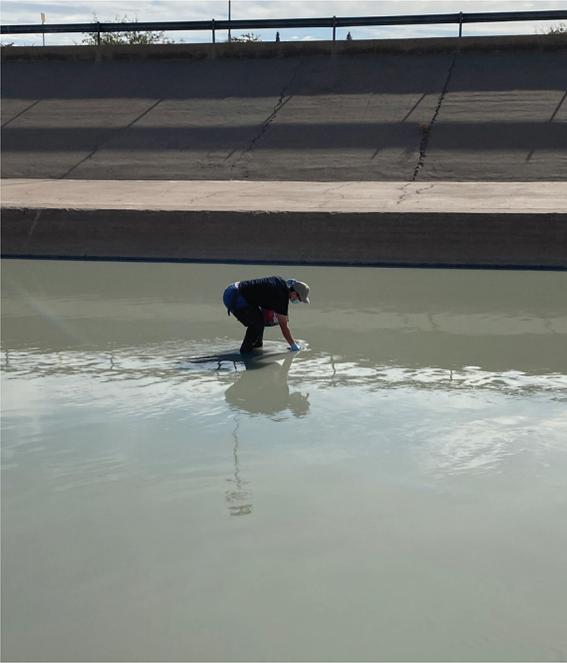
Pictured: USIBWC CRP staff Lisa Torres collecting samples at Station 15528 in the channelized portion of the Rio Grande. Photo by Leslie Grijalva

Segment 2308 is the only segment in the Texas portion of the Rio Grande Basin that is not classified for contact recreation. It is also not considered as a potable water source. This segment is located in the only concrete-lined portion of the 1,255 mile segment of the Rio Grande that creates the US-Mexico boundary. The 4.3 mile stretch of the river is famous for its part in the Chamizal Convention of 1963.

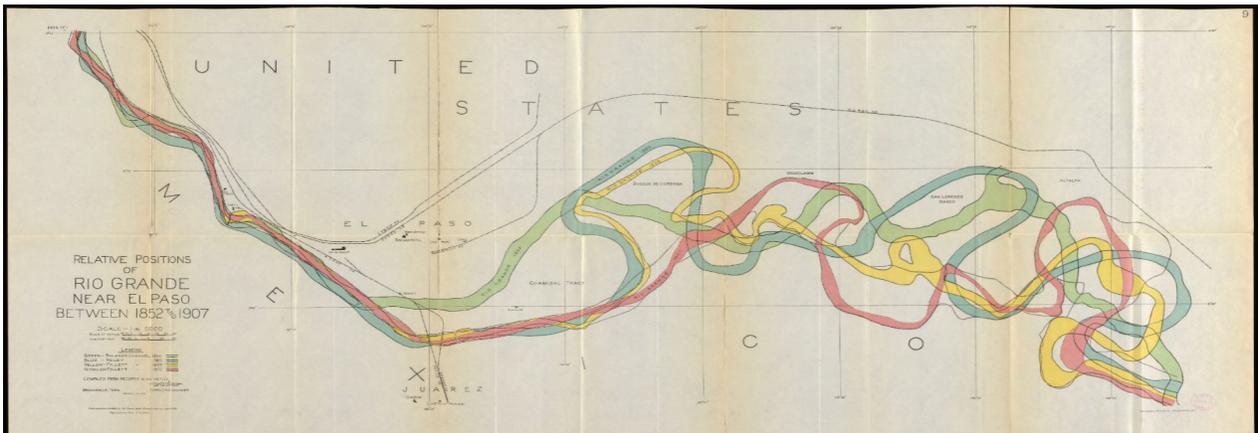
Pictured: Relative positions of the Rio Grande near El Paso between 1852 and 1907 showing how the river meandered before the channelization. Map provided by USIBWC Records Management Division

In the old days, the Rio Grande was a large, wild river affected by summer monsoons and flooding in the desert landscape. Its course changed continuously and, at times, rather drastically (see picture below). This becomes an issue if that river is an international boundary. In 1848, the Treaty of Guadalupe Hidalgo was signed, which ended the Mexican-American War and also defined the international border as the “line along the middle of the deepest part of the channel in the Rio Grande, continuously and in tandem with any fluctuation in its channels or its banks.” In 1864, a major flood radically shifted the Rio Grande, causing conflict

over land between the two countries for many years, from the mid-1800’s until the Chamizal Convention of 1963. In 1884, another treaty modified this definition, stating that the line of a river-defined border would follow the changing path of the boundary river in response to gradual changes caused by flowing waters.

The Chamizal Convention of 1963 ended the dispute over territory between the U.S. and Mexico and called for the river channel to be cemented and made into a concrete-lined channel to prevent the Rio Grande from changing course again. This channel is what became Segment 2308 in the Rio Grande Basin. Diversions from the river at American Dam into the American Canal for use by the U.S., and into International Dam for use by Mexico, means that this section of the river, by treaty, should always be dry. The only water in this section is from stormwater runoff, seepage or wastewater effluent. For these reasons, Segment 2308 has different designations under the Texas State Water Quality Standards for contact recreation and domestic water supply, and much higher standards for bacteria levels. For more information on this Treaty, please visit the USIBWC website or contact USIBWC CRP staff.
