BASIN HIGHLIGHTS REPORT

WATERSHED CHARACTERIZATION OF THE UPPER RIO GRANDE SUB-BASIN

PROGRAM UPDATE
INTERNATIONAL BOUNDARY
AND WATER COMMISSION,
U.S. SECTION
TEXAS CLEAN RIVERS
PROGRAM FOR THE RIO
GRANDE BASIN

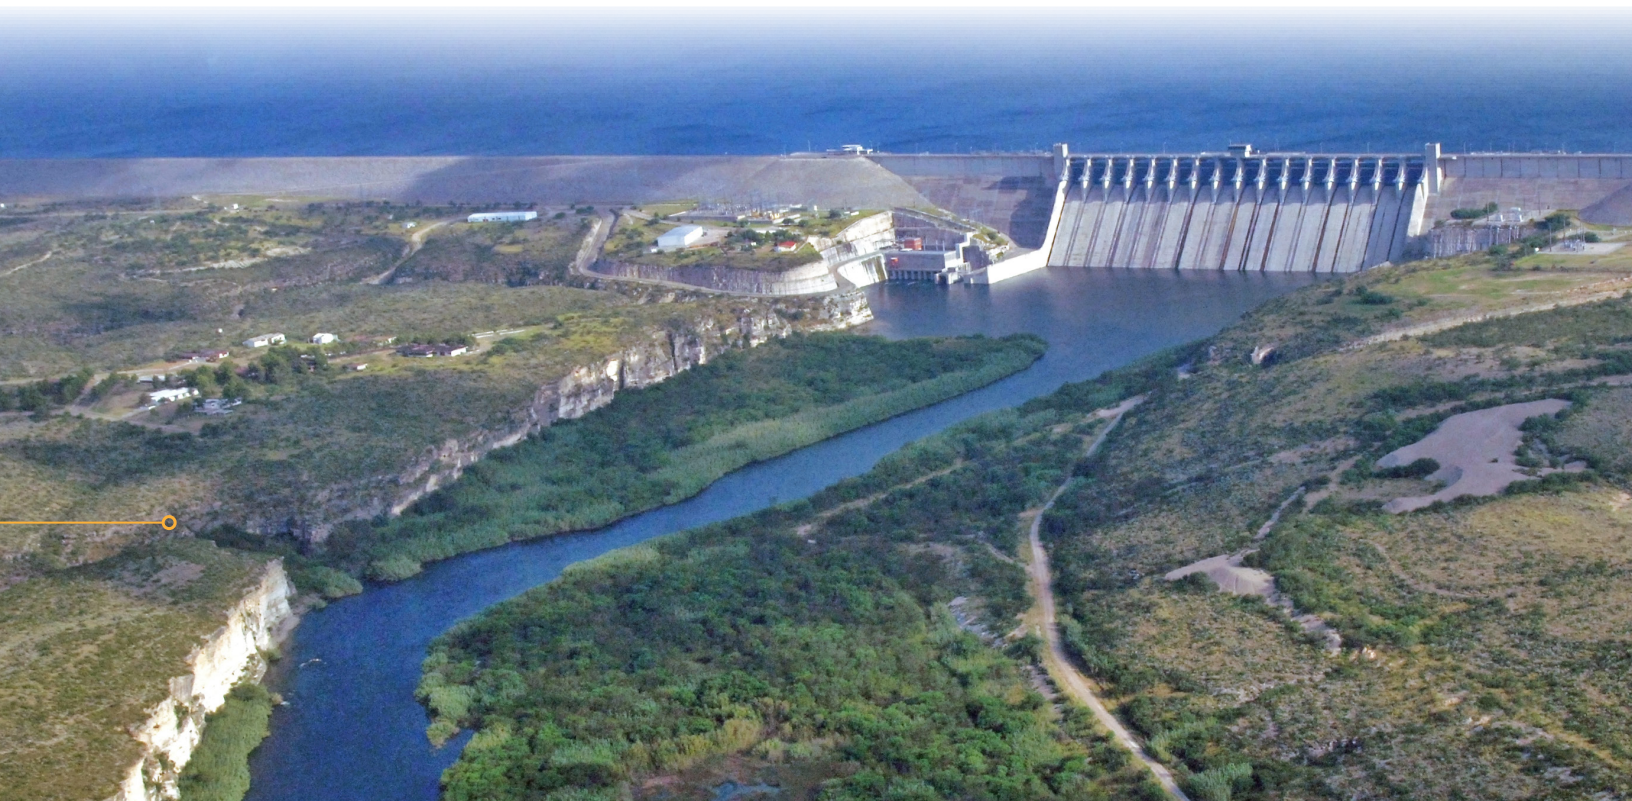
Table 1. Primary Surface Water Quality Standards for the Rio Grande Basin

2018 Texas Surface Water Quality Standards for the Rio Grande Basin											
SEGMENT		USES			CRITERIA						
Segment	Segment Name	Recreation	Aquatic Life	Domestic Water Supply	Cl ⁻ (mg/L)	SO ₄ ²⁻ (mg/L)	TDS (mg/L)	DO (mg/L)	pH Range (SU)	Indicator Bacteria ¹ (#/100 mL)	Temperature (F)
2301	Rio Grande Tidal	PCR1	E					5.0	6.5-9.0	35	95
2302	Rio Grande Below Falcon Reservoir	PCR1	H	PS	270	350	880	5.0	6.5-9.0	126	90
2303	International Falcon Reservoir	PCR1	H	PS	200	300	1,000	5.0	6.5-9.0	126	93
2304	Rio Grande Below Amistad Reservoir	PCR1	H	PS	200	300	1,000	5.0	6.5-9.0	126	95
2305	International Amistad Reservoir	PCR1	H	PS	150	270	800	5.0	6.5-9.0	126	88
2306	RG Above Amistad International Reservoir	PCR1	H	PS	200	450	1,400	5.0	6.5-9.0	126	93
2307	RG Below Riverside Diversion Dam	PCR1	H	PS	300	550	1,500	5.0	6.5-9.0	126	93
2308	RG Below International Dam	NCR	L		250	450	1,400	3.0	6.5-9.0	605	95
2309	Devils River ²	PCR1	E	PS	50	50	300	6.0	6.5-9.0	126	90

health of the river ecosystem and what potential human and ecological issues we should focus on. Data is compared with Texas Surface Water Quality Standards (TSWQS) criteria and screening levels in Tables 1, 2 and 4; these steps are described in the next sections.

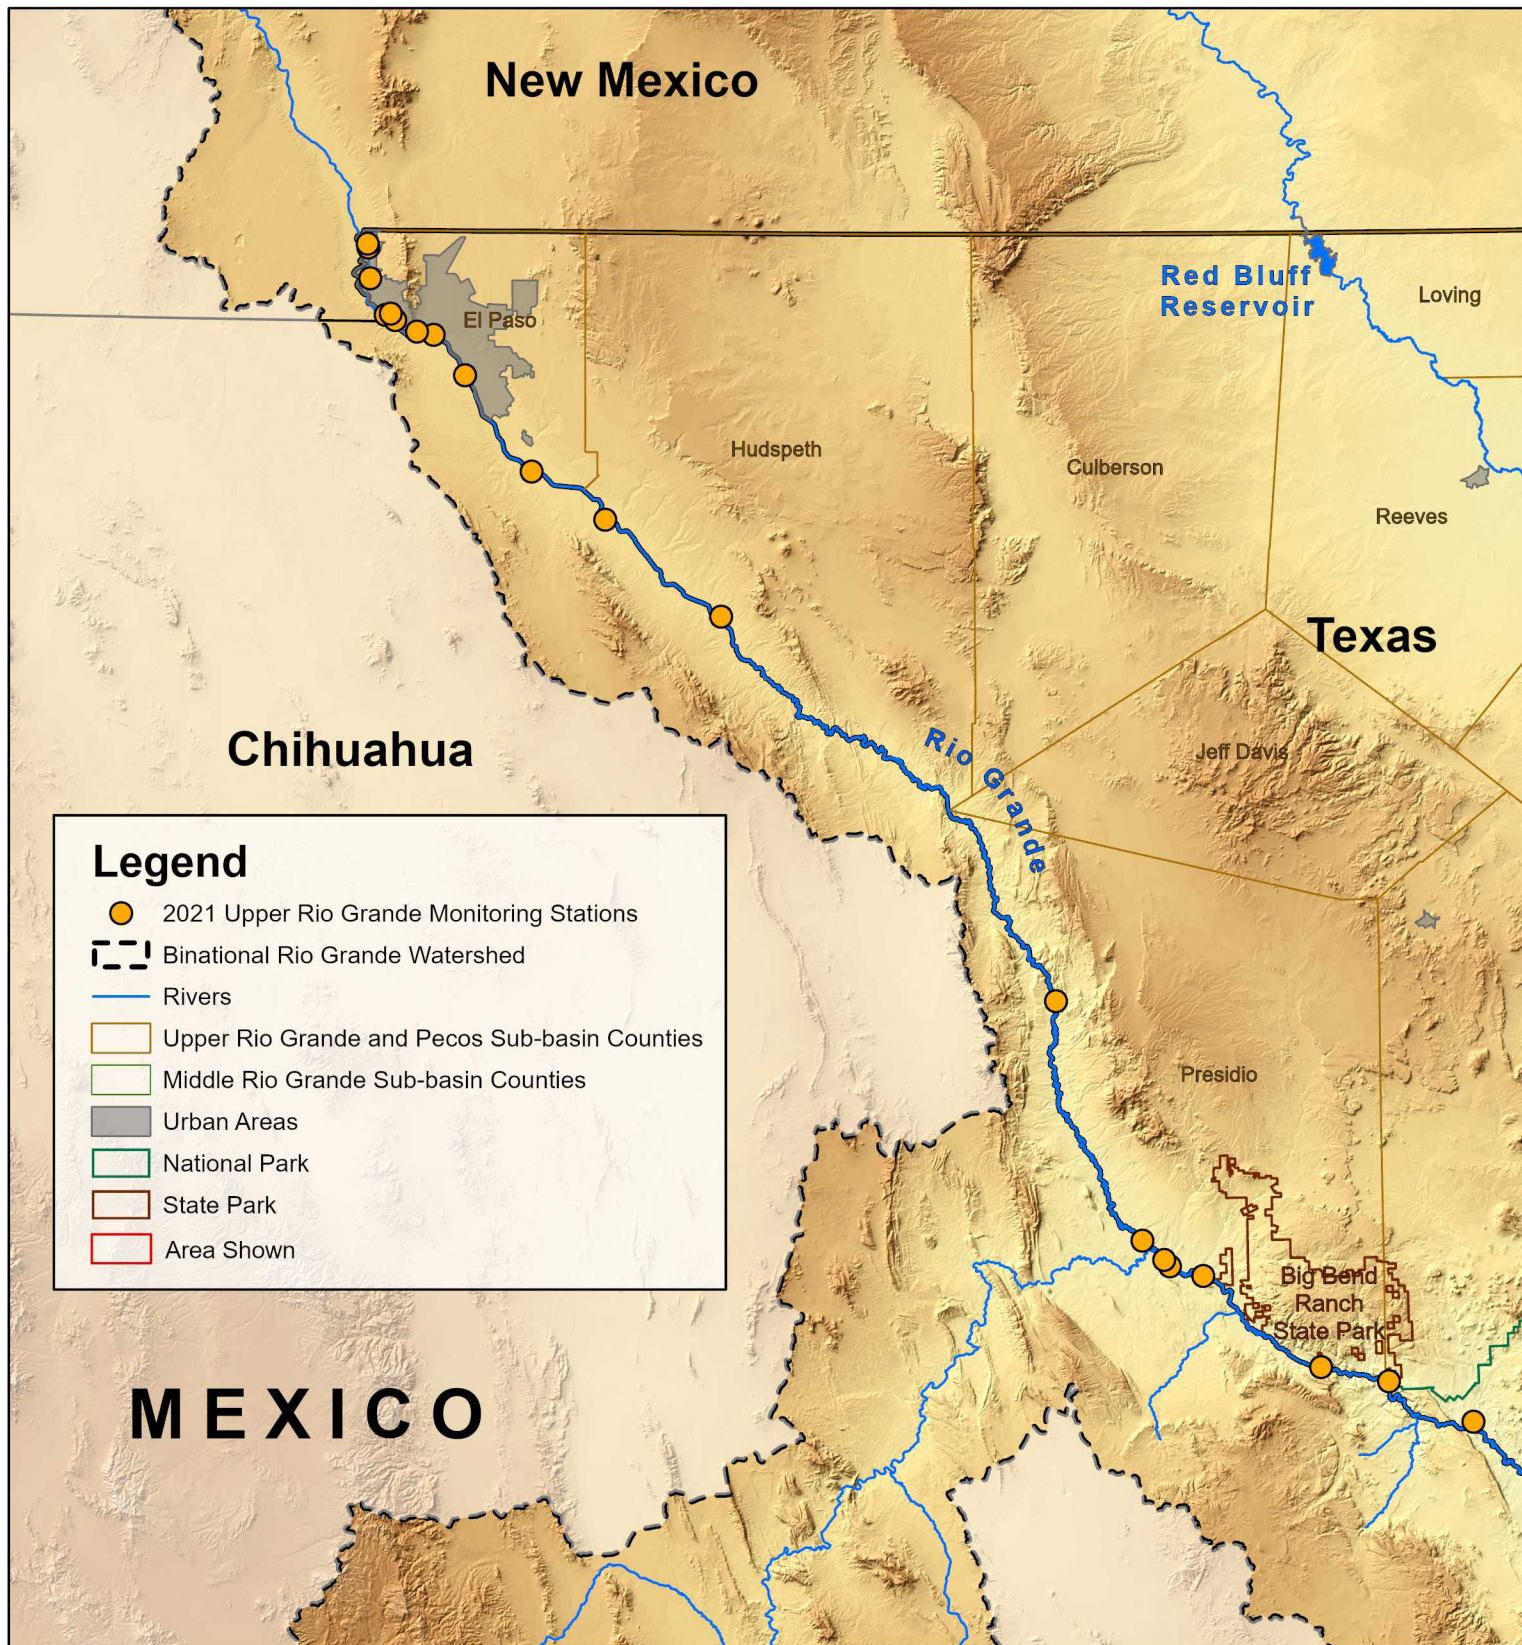
Figure 1. Map of the Upper Rio Grande Sub-Basin in Texas

Map of the Upper Rio Grande Sub-Basin

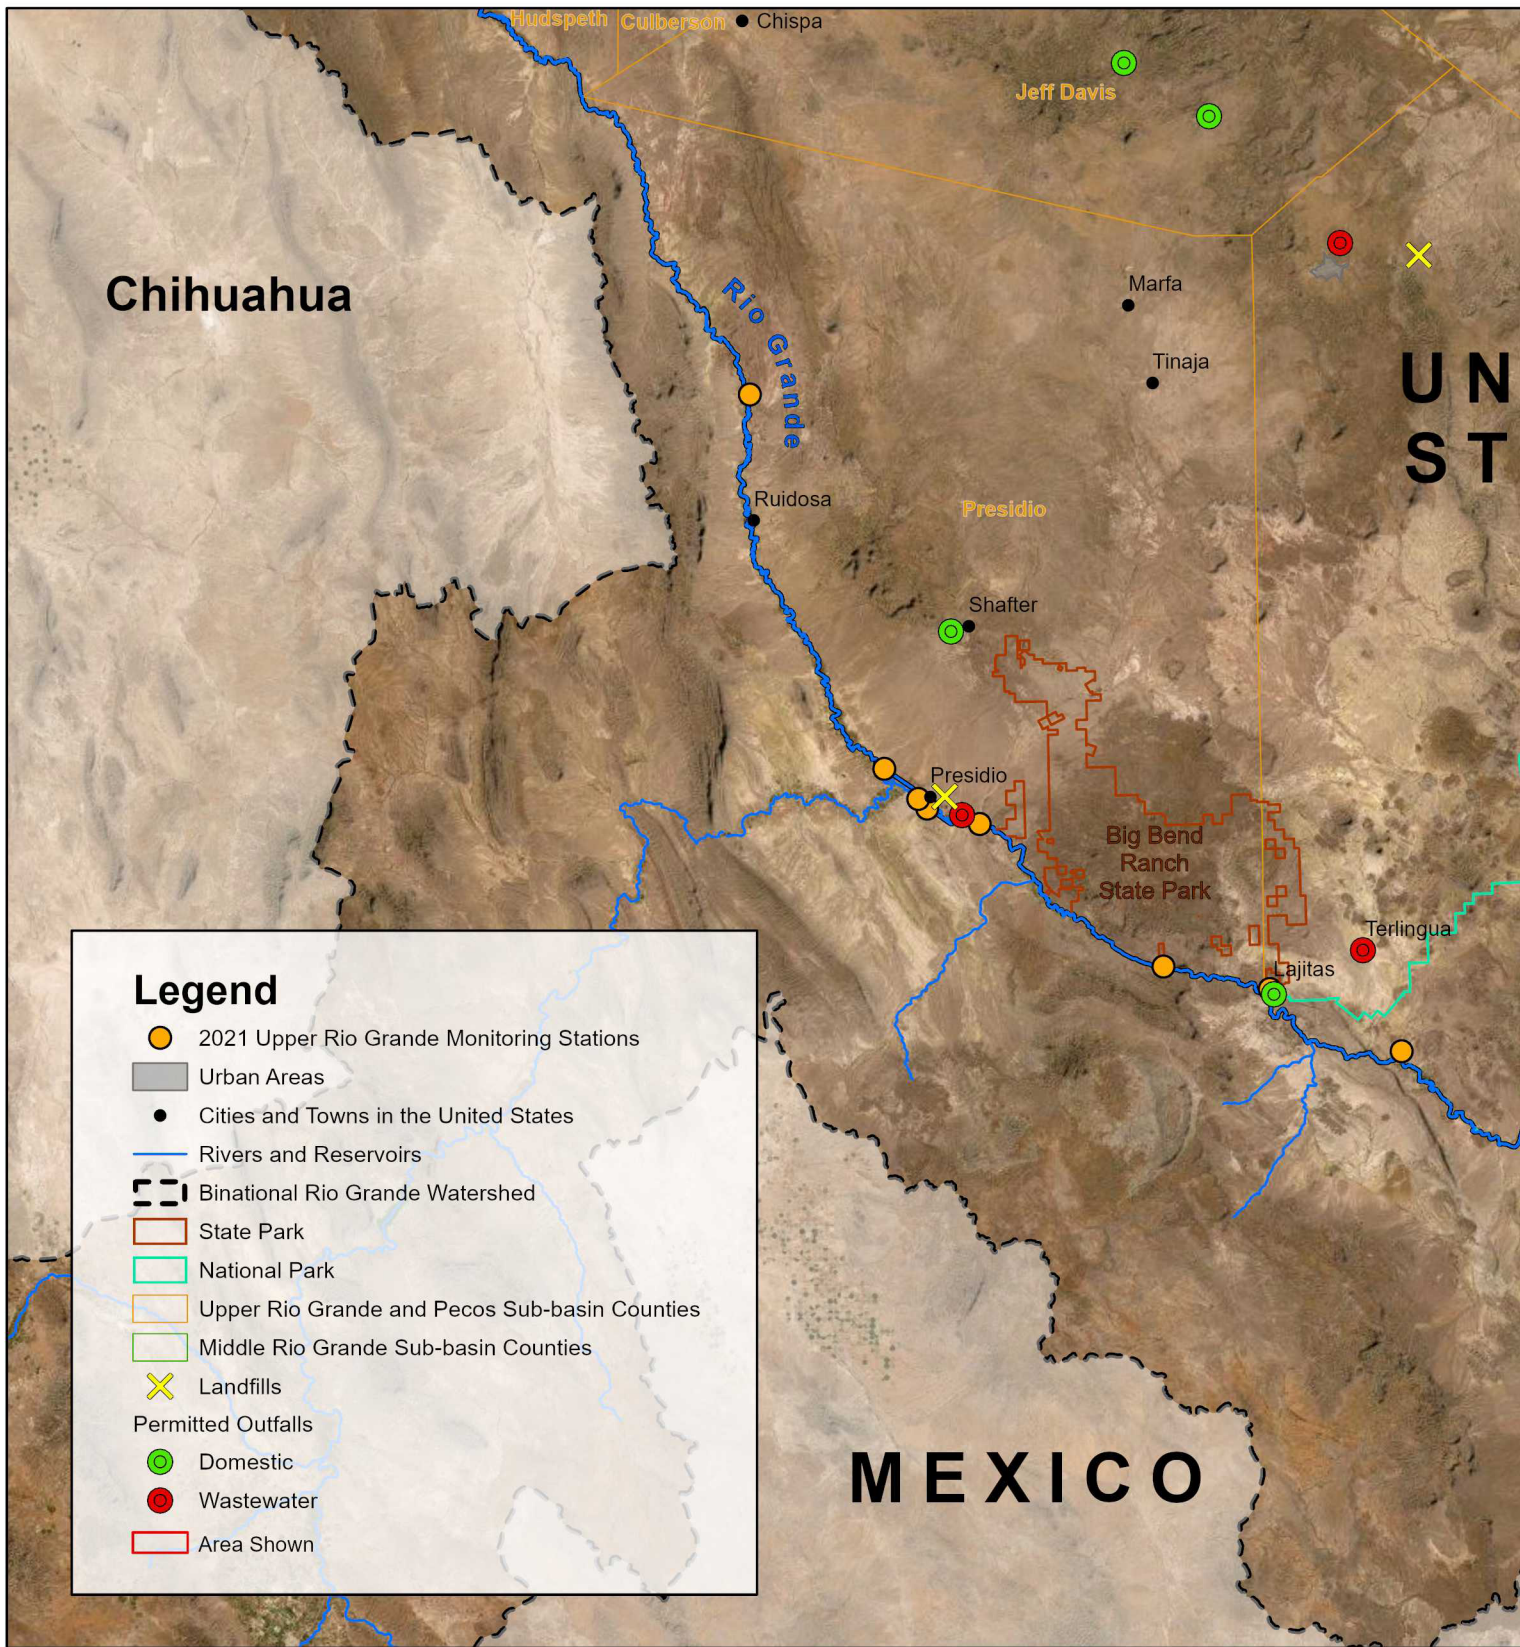
Figure 5. Map of Permitted Outfalls and Landfills in the Upper Rio Grande Sub-Basin - Section 2

Permitted Outfalls and Landfills in the Upper Rio Grande Sub-Basin, Section 2

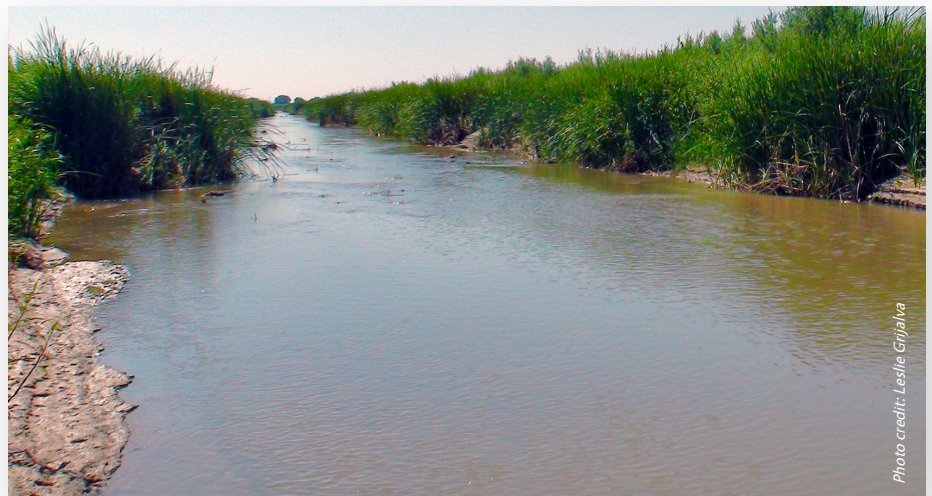
Figure 13. Segment 2307, Station 15704; River during irrigation.

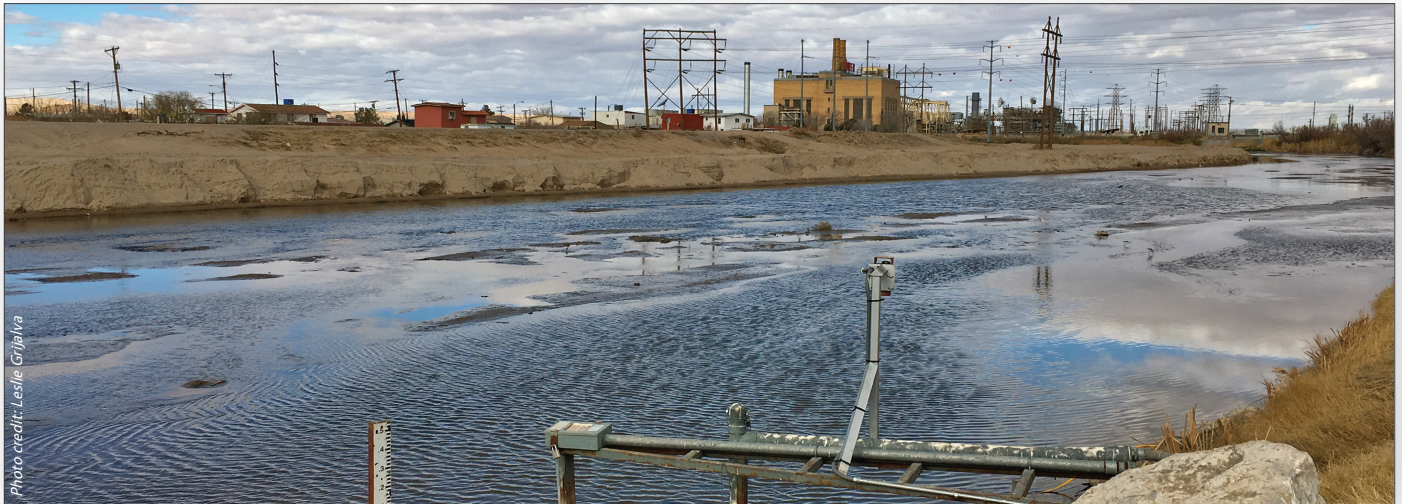
Figure 16. Segment 2314, Station 13272; Rio Grande at Courchesne Bridge, during drought.

This stream segment is affected by drought and water diversions. It is in one of the driest portions of the Upper Rio Grande Subbasin in Texas. Much of the Rio Grande in this stream segment runs dry when water is not being diverted for irrigation or drinking water for use by the city of El Paso. The amount of water available in the Rio Grande in stream segment 2314 depends largely on the needs of water rights holders, as most of the water is contractually obligated to the States of New Mexico and Texas, irrigation districts, water rights holders, and Mexico. Water diversion for irrigation in the U.S. is diverted at American Dam into the Rio Grande American Canal Extension.

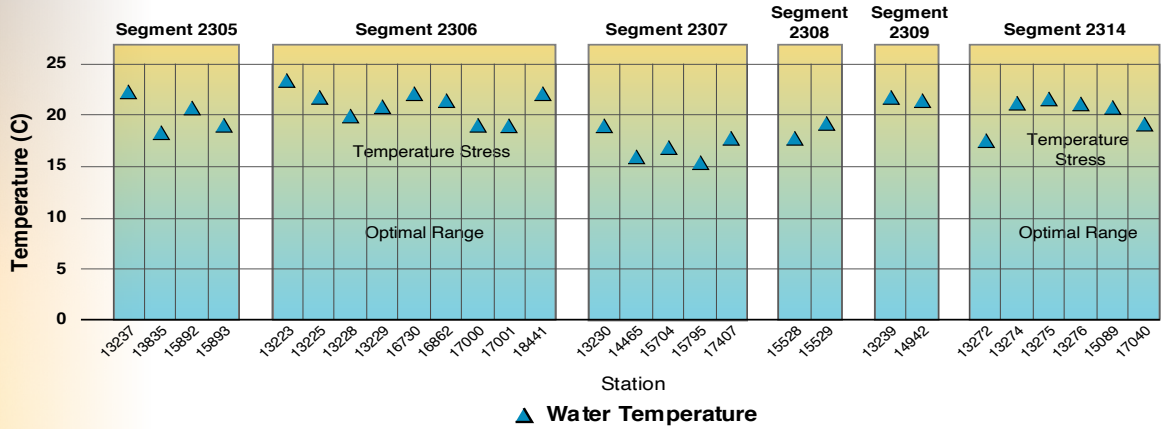
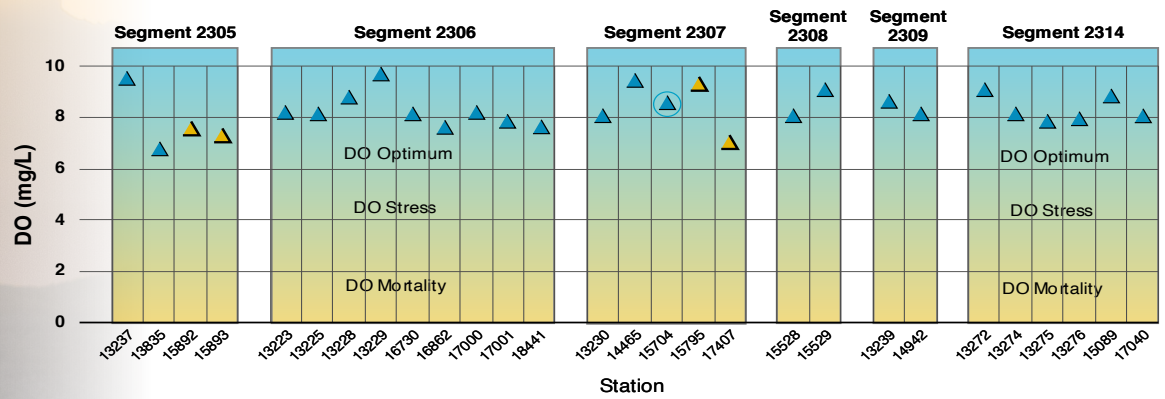
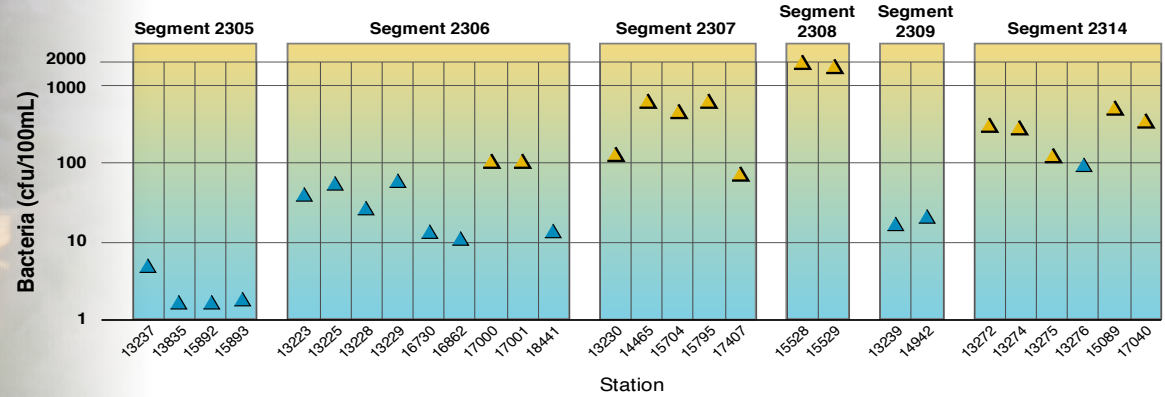
Figures 19-22. Graphs Representing Statistical Analysis of all Stations

▲ Water Temperature

▲ Dissolved Oxygen (DO)

▲ DO Exceedance
More than 10% of the data exceeds the Texas State Water Quality Standard

⊙ DO - No Flow Correlation
Does not meet sample size requirement (> 10) for correlation to streamflow

▲ Bacteria

▲ Bacteria Exceedance
More than 10% of the data exceeds the Texas State Water Quality Standard
