2011 Basin Highlights Report for the Rio Grande Basin in Texas

An update on Water Quality and Basin Activities

International Boundary and Water Commission, U.S. Section,
Texas Clean Rivers Program

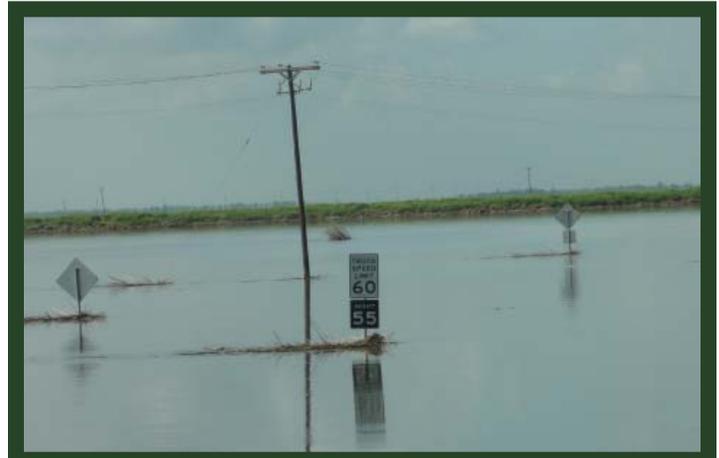
Emergency Floodway of the Lower Rio Grande near Harlingen, Texas, August 3, 2010

At the end of June 2010, Hurricane Alex, and a week later, Tropical Depression #2, brought heavy rainfall throughout the Rio Grande Basin. IBWC went into 24-hour flood operations as it operated the releases from both Amistad and Falcon Dams. In early July, IBWC released floodwater into the interior floodway for the first time since 1988, which includes channels known as the Banker Floodway, Main Floodway, North Floodway, and Arroyo Colorado through portions of Hidalgo, Cameron, and Willacy Counties.

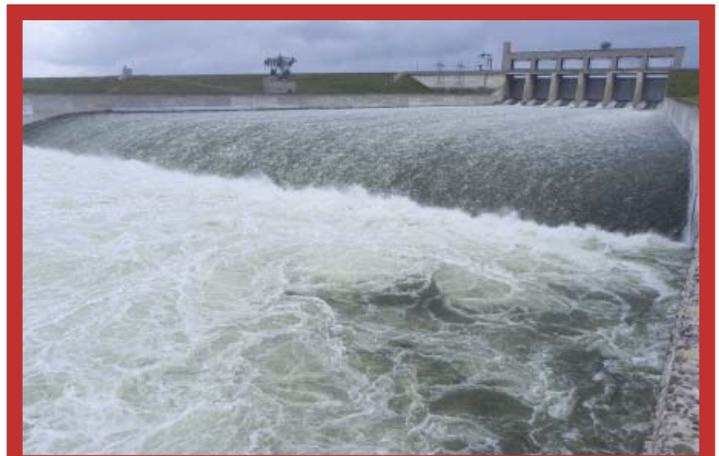
Release of floodwaters from Falcon Dam, July 2010

During the course of the flood, peak flows in the river at Laredo reached 126,000 cubic feet per second (cfs) and those at Rio Grande City almost 94,000 cfs. Flood conditions were experienced from near Amistad Dam at Del Rio, TX downstream some 600 miles to the Gulf of Mexico. USIBWC CRP collected bacteria data from the floodwaters and levee structures, but high bacteria levels were not detected due to the volume of water.

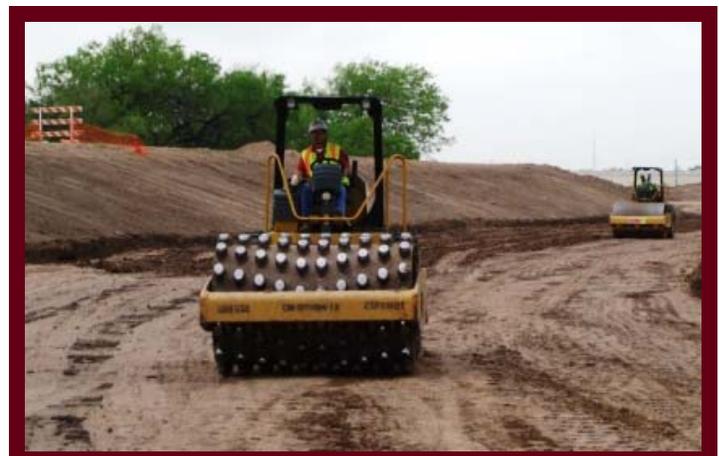
Recovery Act levee construction in Hidalgo County, Texas, March 2010

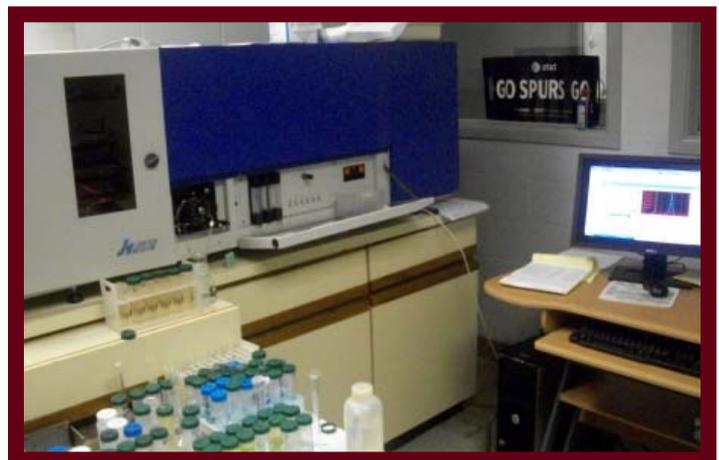
A mass spectrometer used to analyze metals and inorganic compounds at Alamo Analytical Laboratories

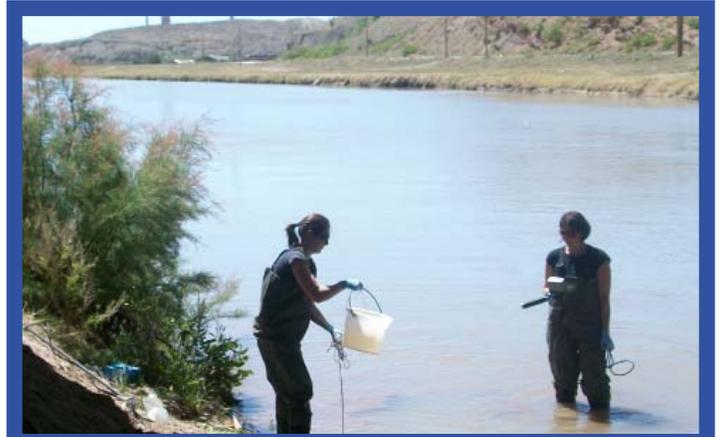
USIBWC staff collect water samples and field parameters at Station 13272 in El Paso, TX

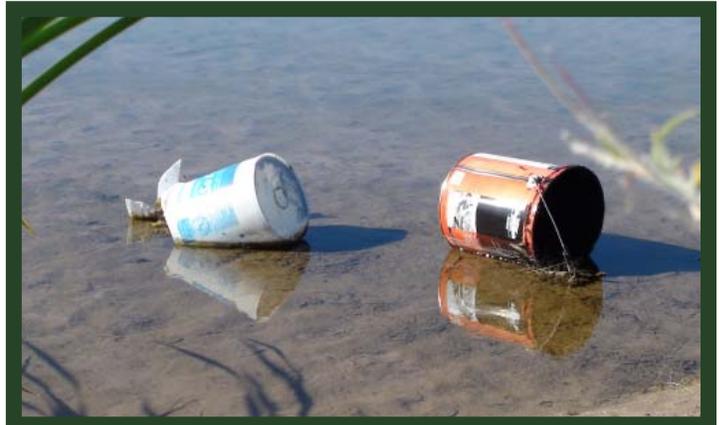
Trash in the river near Canutillo, Texas, October 2010. Trash may deteriorate water quality and negatively affect aquatic organisms.

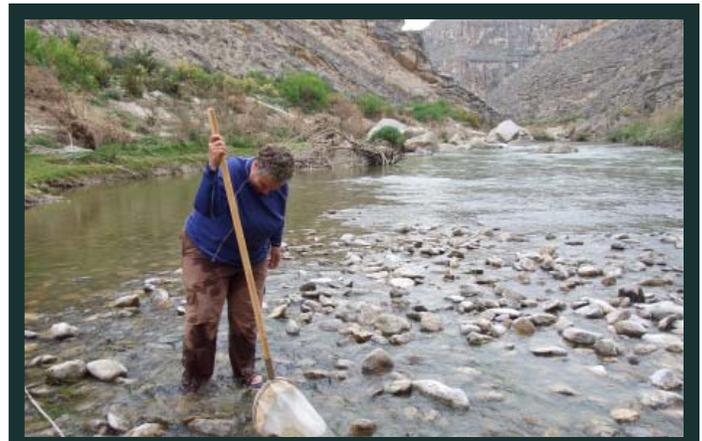
Collecting benthic macroinvertebrate samples in the Lower Canyons in March of 2009. Data is being used to revise the TSWQS in Segment 2306.

In the past several years, BBNP, the USGS, TCEQ and the USIBWC have conducted a special study in Big Bend to track the source of nutrient and salinity contamination between Presidio and Amistad Dam. Some portions of the study have concluded and a report is currently being prepared by USGS. In addition, TCEQ has been collecting benthic macroinvertebrate samples and water quality data from Presidio to the lower reaches of Segment 2306 just upstream of Lake Amistad. Water quality and benthic macroinvertebrate data will be used by TCEQ to revise the TSWQS for TDS, chloride, and sulfate for Segment 2306.

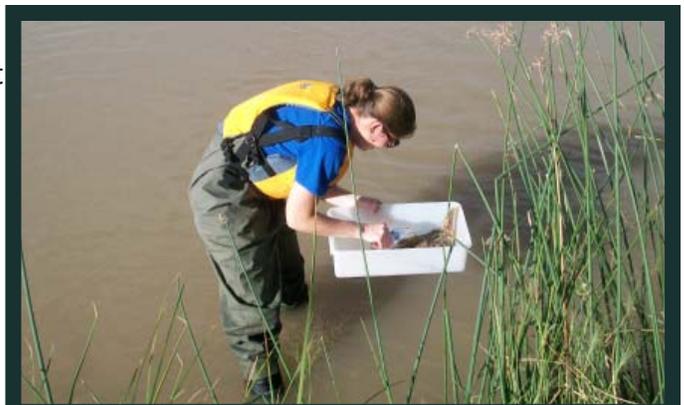
USIBWC CRP collects sediment to test for organics at Station 13272 in El Paso, Sept. 2010

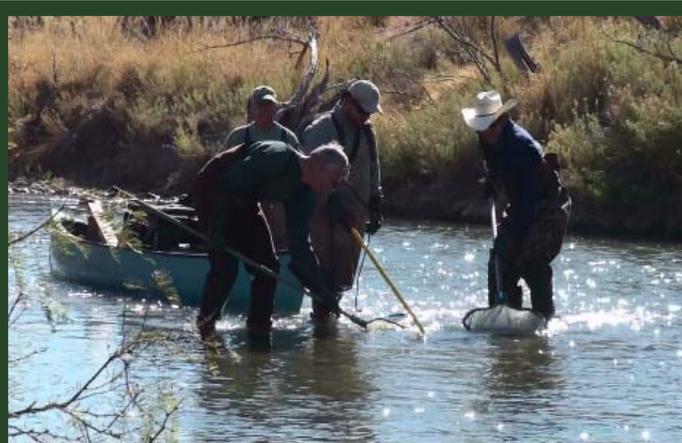
Field crews collect fish via electrofishing method at Station 13249 near Sheffield, December 2010

The Upper Pecos River (Segment 2311) is currently listed as impaired on the draft 2010 Texas 303(d) List for depressed 24-hr DO. In December 2010 and January 2011, TCEQ, TPWD, and USIBWC CRP conducted aquatic life monitoring (ALM) at four stations in the Upper Pecos during winter low flow when releases from Red Bluff Dam stop. This study will include analysis of fish and macrobenthic assemblages, habitat quality, 24-hr DO, conventional water analyses, field measurements, and instantaneous flow, at the same stations as the previous aquatic studies conducted in this stretch of the Pecos River. This ALM will be used to review water quality standards, determine the appropriate aquatic life use and develop the Use Attainability Analysis (UAA) for the Upper Pecos River.

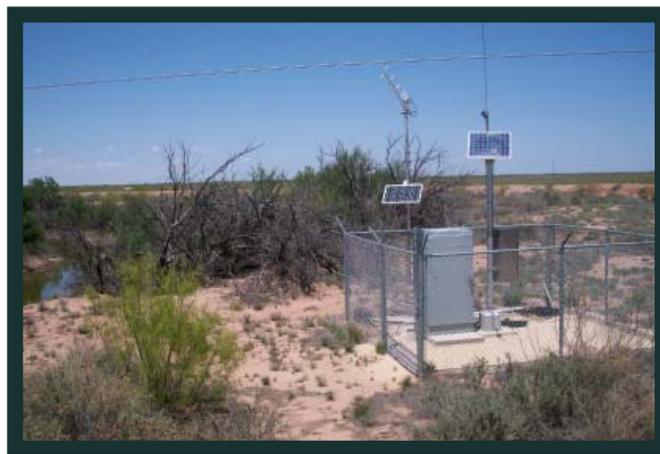
The continuous water quality monitoring station on the Pecos at Pecos, TX, April 2010

The TCEQ currently operates six CWQM stations on the Pecos River and will soon be expanding its network to eight. The data generated is being used to monitor changes in salt concentrations (using specific conductance) and surface water flow associated with salt cedar removal, to collect data to support research on the cause of toxic golden alga blooms, to provide data for the Integrated Report, and to support the Pecos River WPP by monitoring dissolved oxygen. The two new sites will be installed at Girvin, TX and Red Bluff, NM in support of the WPP.

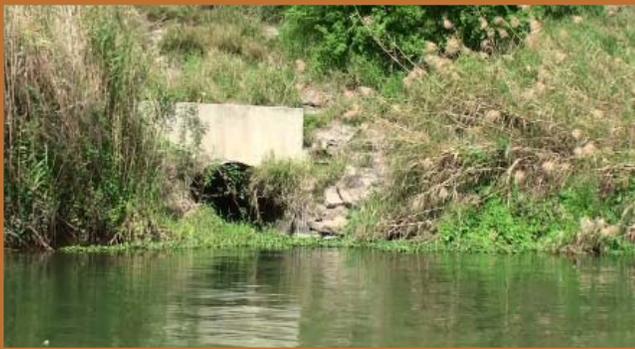
Part of the Brownsville study included a survey of all structures and drains on both banks of the river in the study area.

In March and April 2010, USIBWC CRP and the University of Texas at Brownsville (UTB) conducted field work for the Brownsville Bacteria Special Study. The study was designed to characterize the bacteria contamination in a 20-mile stretch of the Rio Grande in Brownsville, TX through intensive water quality monitoring and to conduct a survey of all structures along the river to help identify possible point sources of pollution. The results were inconclusive since high bacteria values were not detected during the March and April sampling events; however, the study was successful in identifying all the structures along the bank. A final report will be posted on the USIBWC CRP website by summer of 2011, and USIBWC will work towards addressing issues arising from the survey.

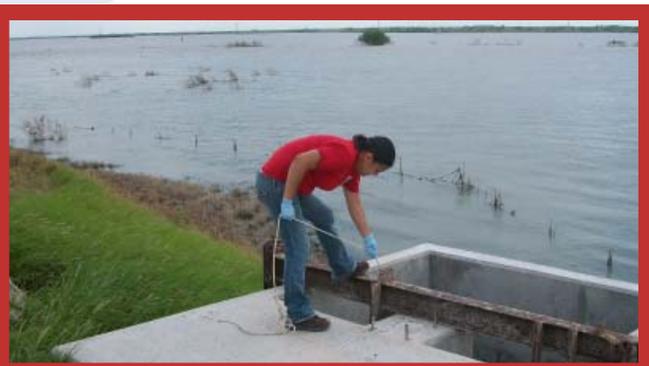
USIBWC CRP collected water samples for bacteria analysis at levee structures along the emergency floodways of the LRGV, August 2010

first week of August 2010 to sample floodwaters in the Rio Grande and its emergency floodways resulting from Hurricane Alex and subsequent rain events. USIBWC CRP and Mercedes staff collected 59 samples in levee structures, floodway waters, and Rio Grande flood waters. Analysis of *E. coli* was performed to assist safety officers to assess the human health affects of USIBWC staff working on the levee structures. High levels of *E. coli* indicate the possible presence of other disease-causing organisms. Despite foul odors at many sites, bacteria levels at most sites were not particularly high, due to the sheer volume of water.
