2024

Basin Highlights Report Rio Grande Basin

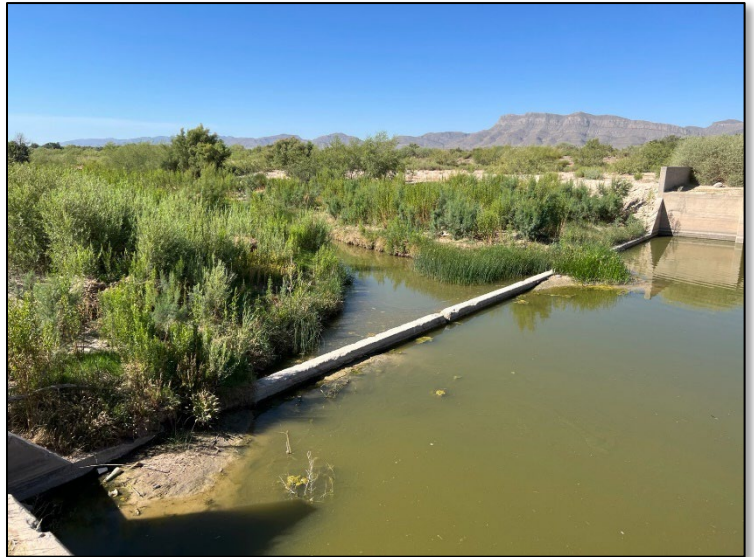
Station 15795 located in Ft. Hancock facing the Mexican side.

Partners collect water quality samples at approximately 54 routine monitoring stations throughout the basin. Sediment samples are also collected at some stations. In addition to collecting samples for laboratory analysis, personnel also make field observations to record conditions at the time the sample were taken. Field observations include things such as weather conditions, recent rain events in the area, watercolor, and other general notes pertinent to water quality and stream uses. Quantitative field measurements are made using specialized equipment. The parameters taken include water and air temperature, water depth, water clarity, stream flow, and how that flow compares to the normal flow for that water body. Table 3 describes field parameters in more detail.

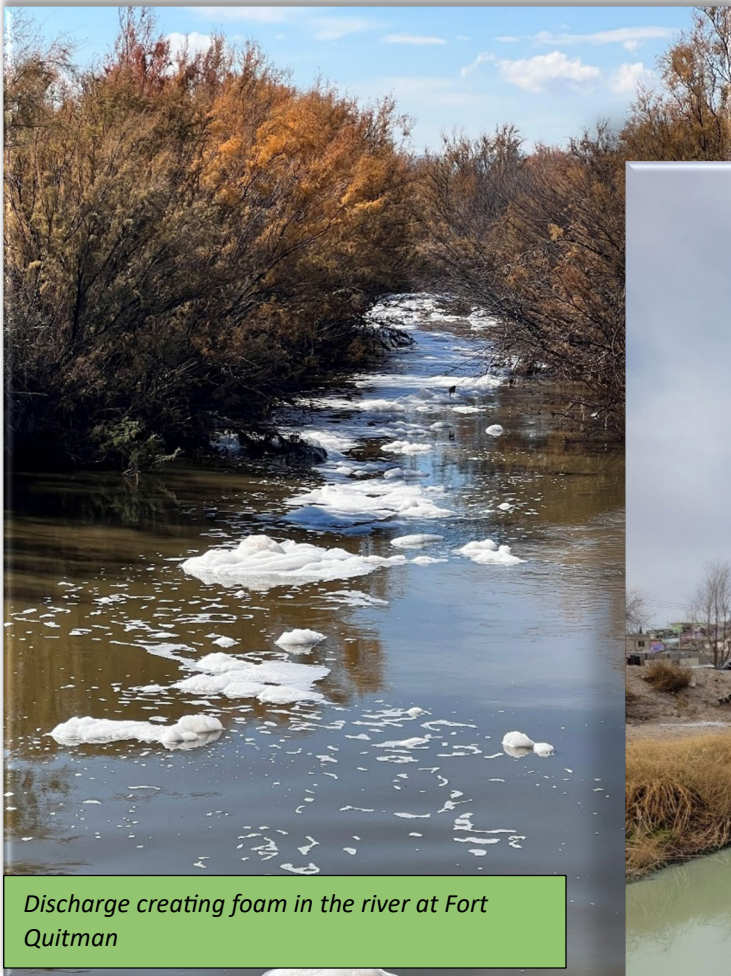
Discharge creating foam in the river at Fort Quitman

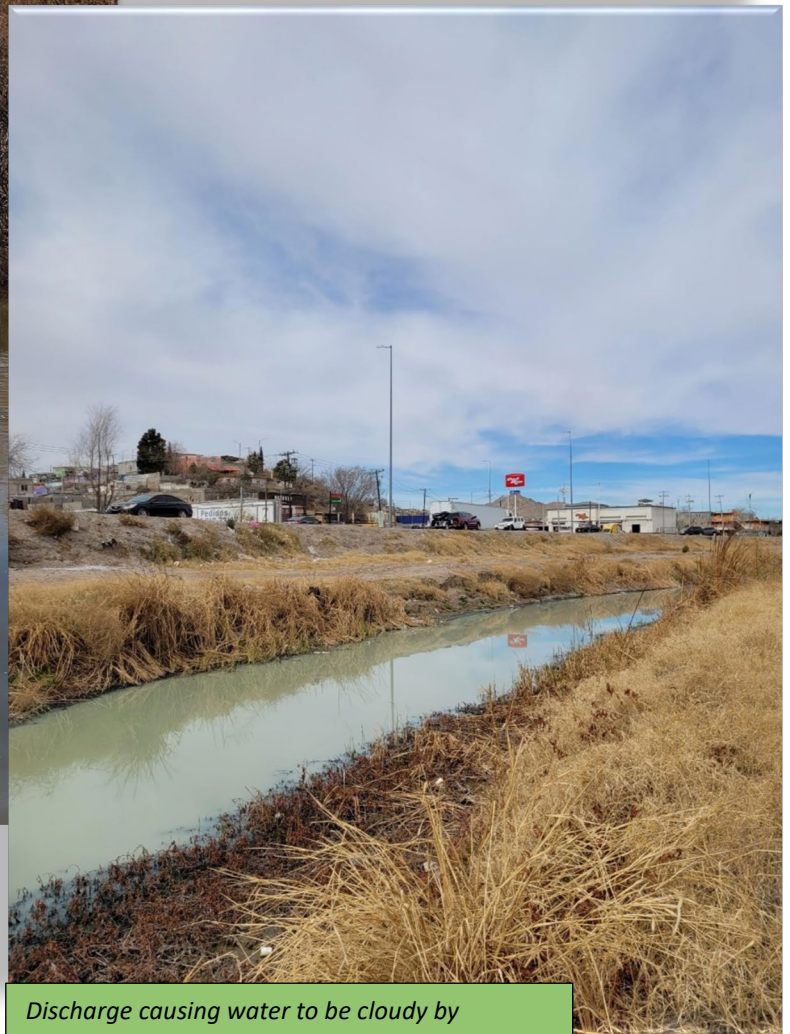
Discharge causing water to be cloudy by International Dam

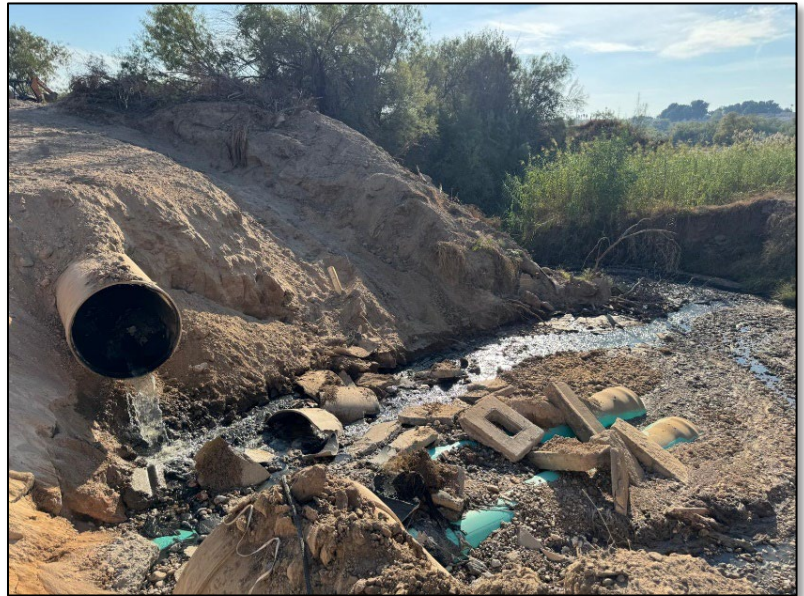
Sewage spill past Chacon Creek in Laredo Tx.

A wastewater pipeline break occurred on November 25, 2024, downstream of Chacon Creek, TX. dumping over 100,000 gallons of raw sewage near the river by South Zapata Highway. The city of Laredo addressed the situation, containing the spill, and initiated cleanup efforts. The city also announced plans to investigate whether repeated patrols by border agents and erosion issues contributed to the pipe's rupture (KGSN, 2024). The pipeline was bypassed with a temporary line restoring service to prevent further contaminants from entering the river. At time of writing the restoration of the pipeline is still underway (KGNS, 2024). This poses a risk to the public health of communities downstream and negatively affects aquatic life. The sewage can introduce harmful pathogens, chemicals, and nutrients into the river.

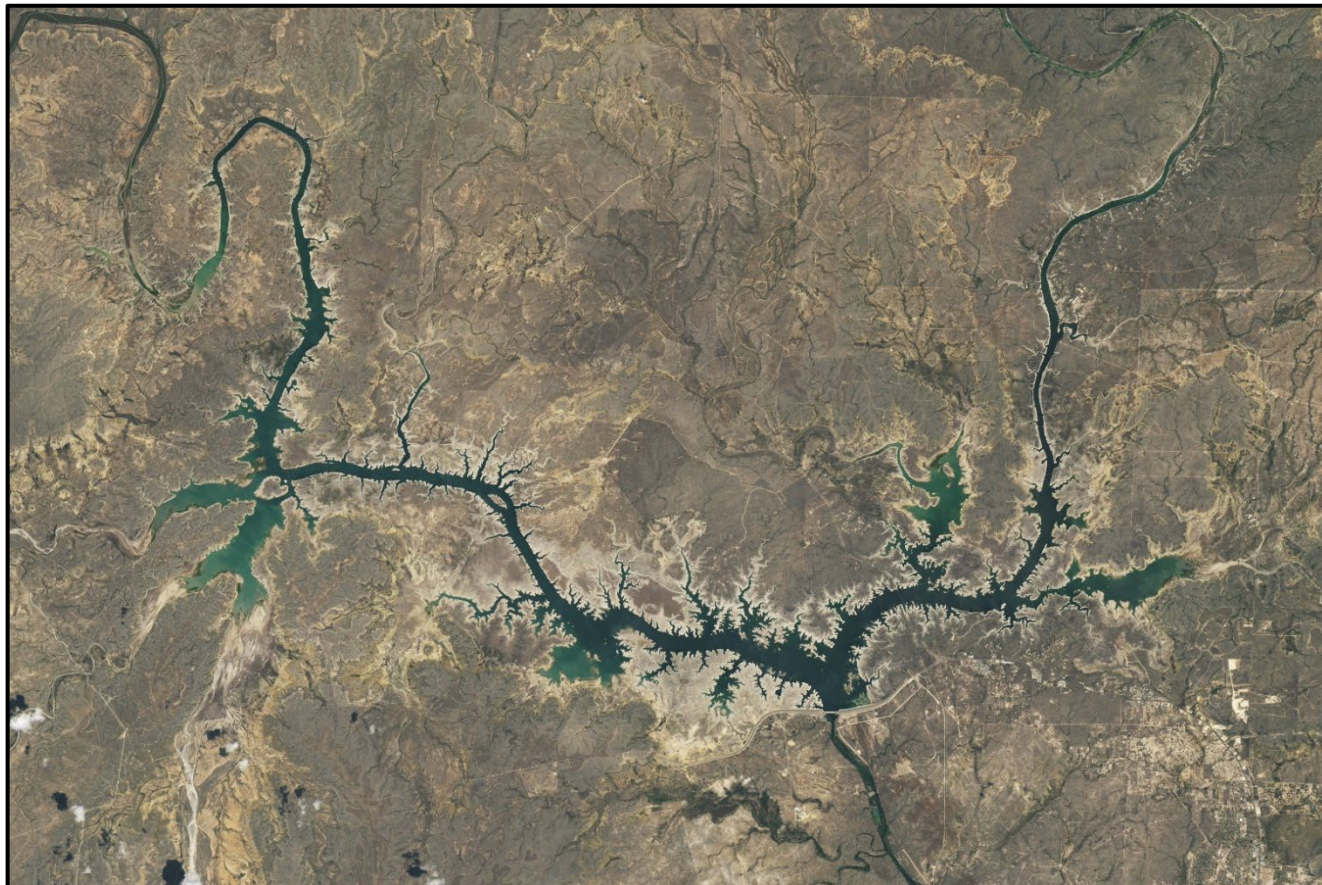
Figure 12: August 19, 2024. Landsat 8 OLI satellite imagery, Amistad Reservoir.

visualize the effects and severity of the drought, see the satellite imagery depicting the Amistad Reservoir from Figure 13. August 2016 and Figure 12. August 2024, respectively.

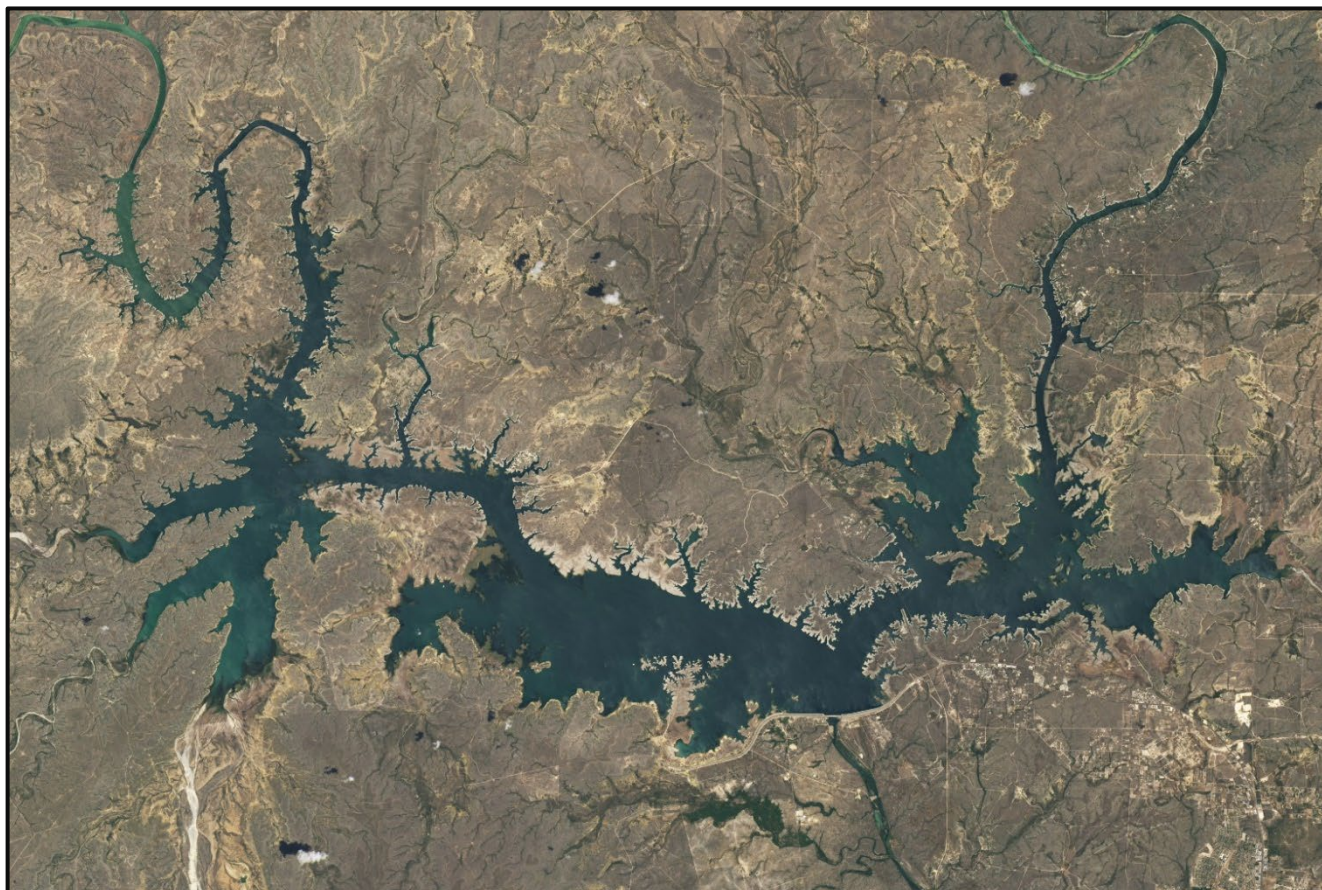
Figure 13: August 6, 2016. Landsat 9 OLI-2 satellite imagery, Amistad Reservoir.

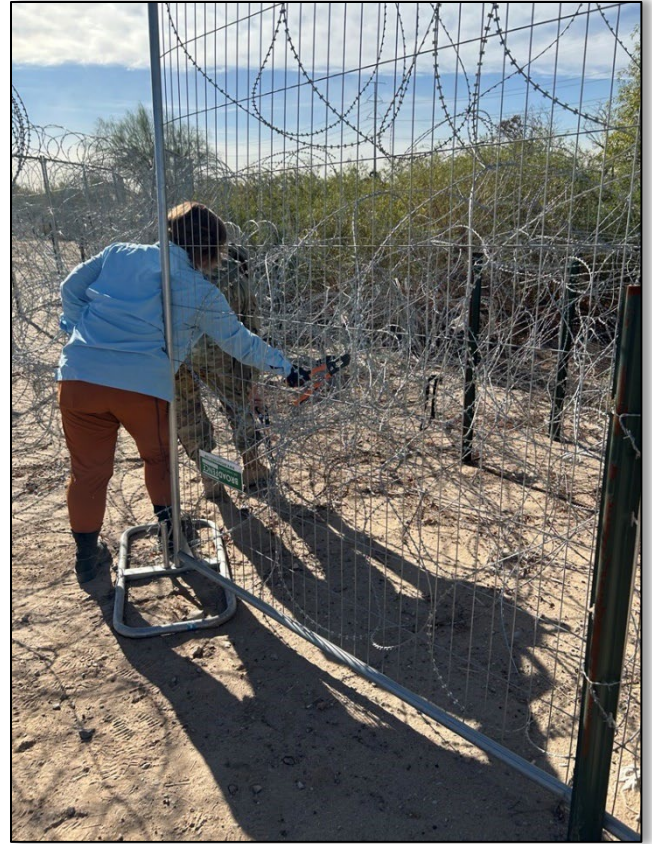
American Dam Hydrotech cutting through concertina wire to access sampling station.

Border safety is a critical issue at the Rio Grande. In recent years, the border has seen an influx of migrants from various parts of the world entering the United States through Texas. This increase has made sampling more challenging for IBWC CRP partners. Border cities have experienced a rise in law enforcement. In El Paso, for example, the deployment of National Guard Troops has reduced access to sampling sites. These sites are located behind the border wall, which was already a challenge. However, the National Guard has now set up concertina wire along the river, further impeding access. The picture to the right shows an American Dam Hydrotech alongside a National Guardsman, cutting the wire to access a sampling site. This was made possible through various discussions and engagements between IBWC, the National Guard, and immigration authorities. To provide accurate assessments of water quality and collect representative samples, CRP needs continuous access to its permanent sites.
