International Boundary and Water Commission United States Section

Lower Rio Grande Flood Control Project
Arroyo Colorado Post Flood Cleanup
June 22, 2011

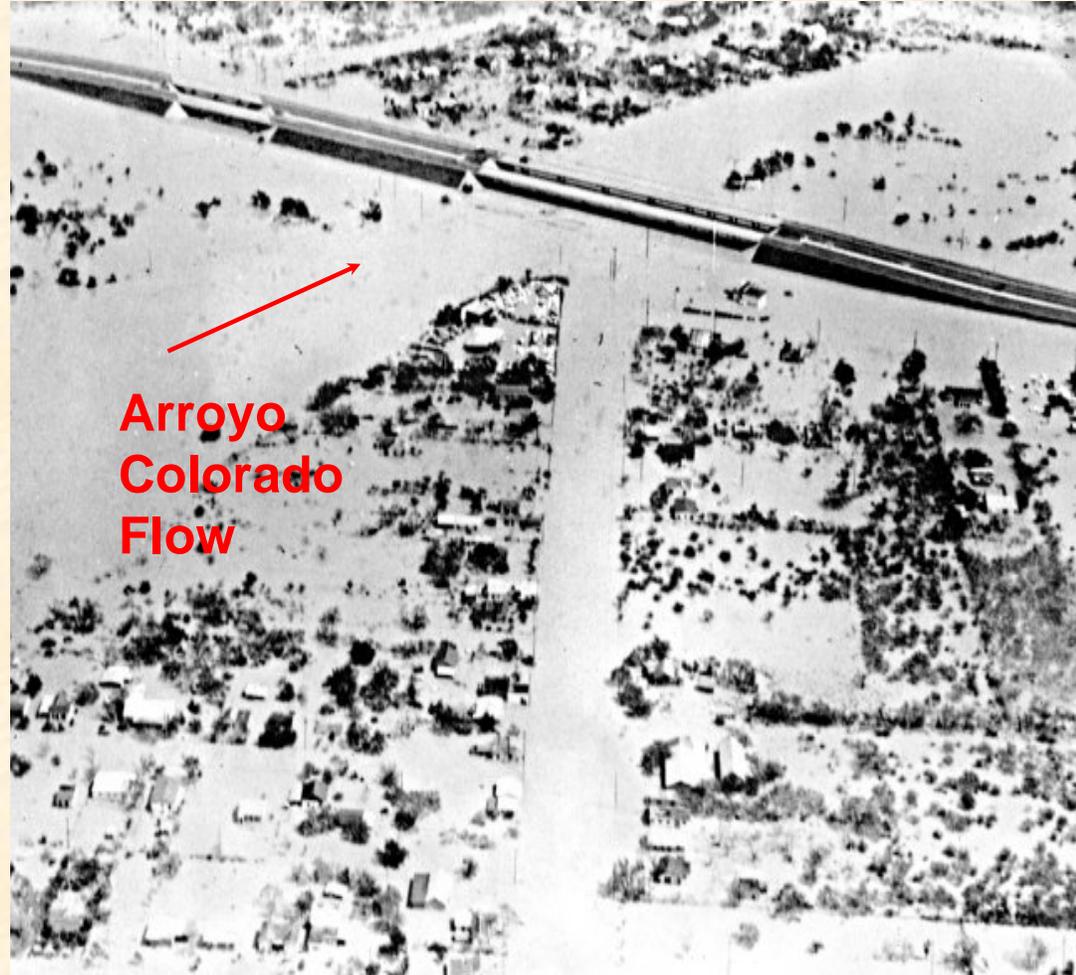
Hwy 77 At Arroyo
Colorado

- Hurricane Beulah
September 1967
flooded Harlingen
via the Arroyo
Colorado

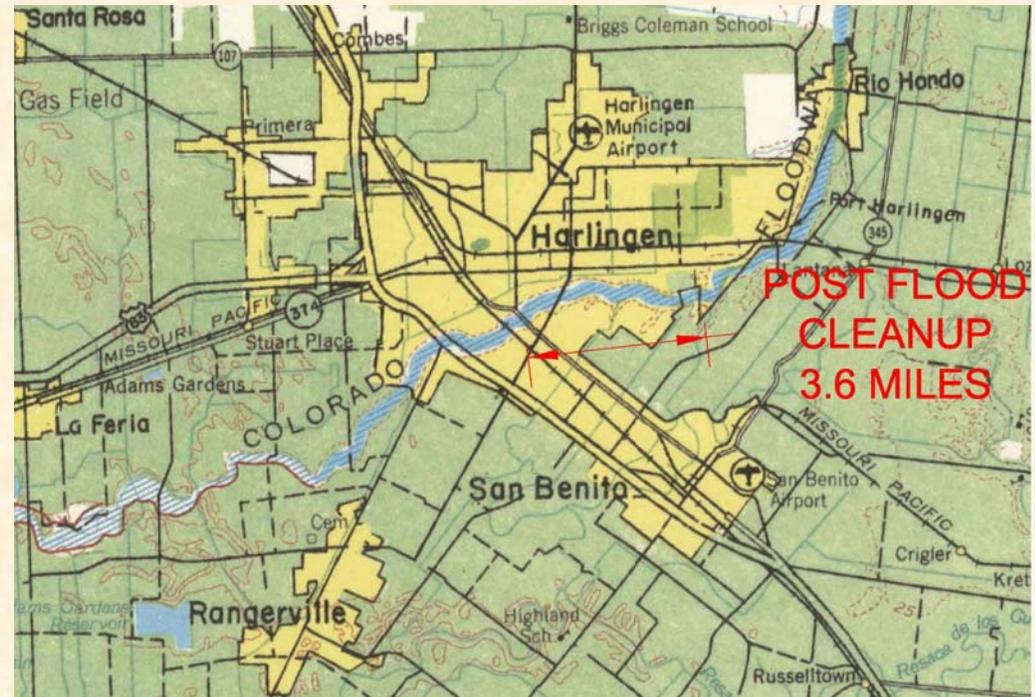
Arroyo Colorado Hwy 77 to FM 509
3.64 miles

Remove Dead Trees

- USIBWC removed 15 truck loads of dead trees and debris below the 21,000 cfs flow line
- USIBWC notified land owners of the cleanup
- During the cleanup USIBWC had an onsite environmental monitor
