Hurricane Alex Flood Operations Lower Rio Grande Flood Control Project

Lower Rio Grande Citizens Forum

August 25, 2010

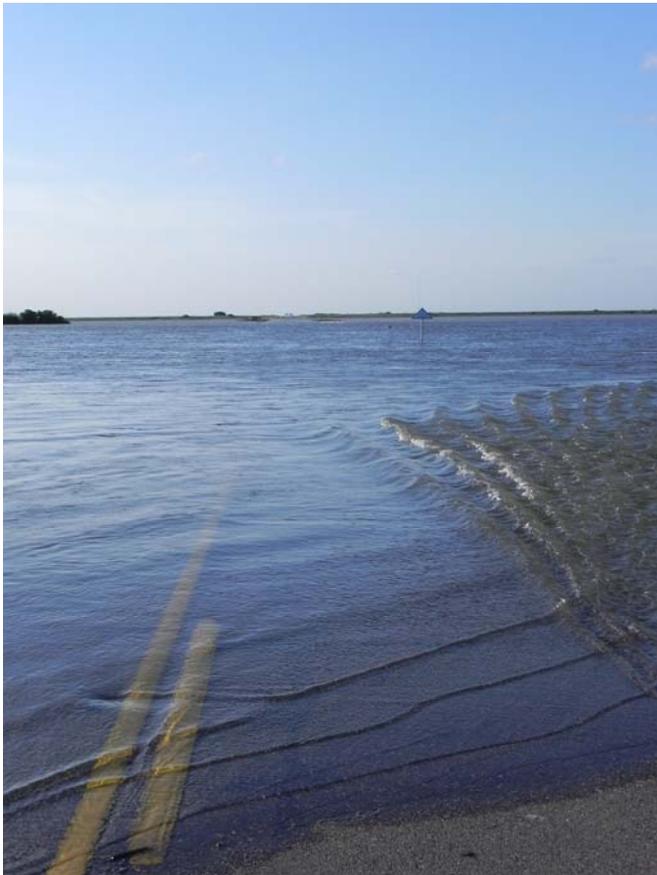
FM 507 at North Floodway

- Floodway is designed to convey flood flows even though there is some development in it
- Flood flows affected:
 - Roads across the floodway
 - Homes and businesses in the floodway
 - Parks, golf courses
 - Crops
- Entities with structures in the floodway are well aware of flood risks

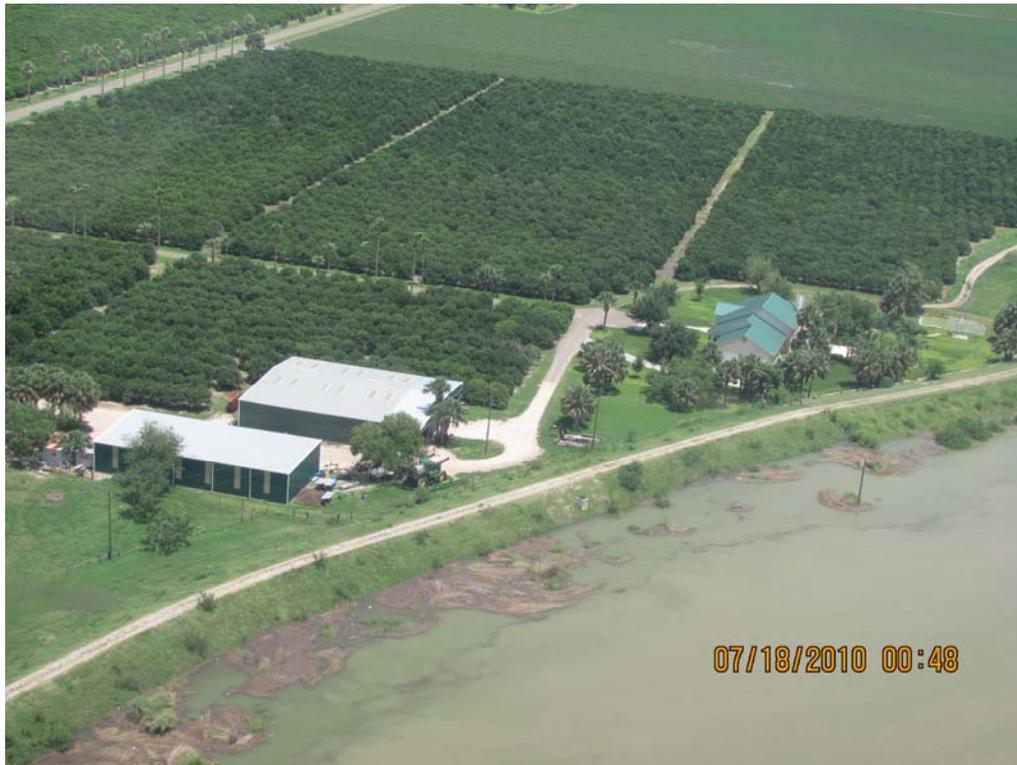
- Levees performed very well
- Recent improvements ensured levees were in the best condition in years

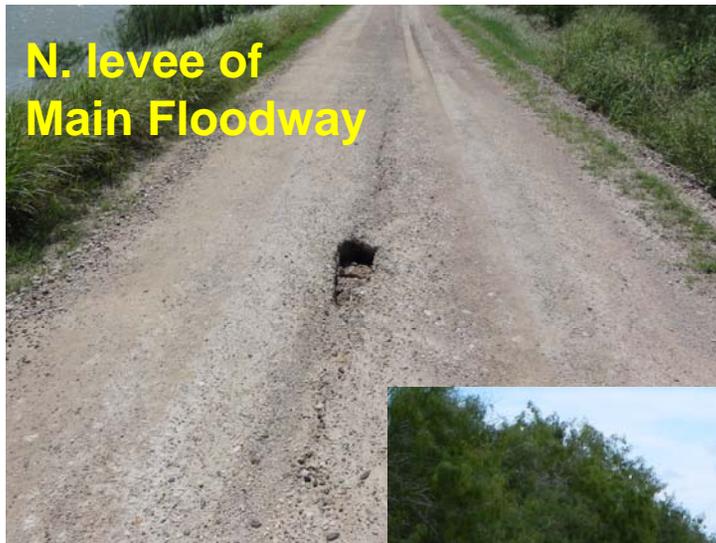
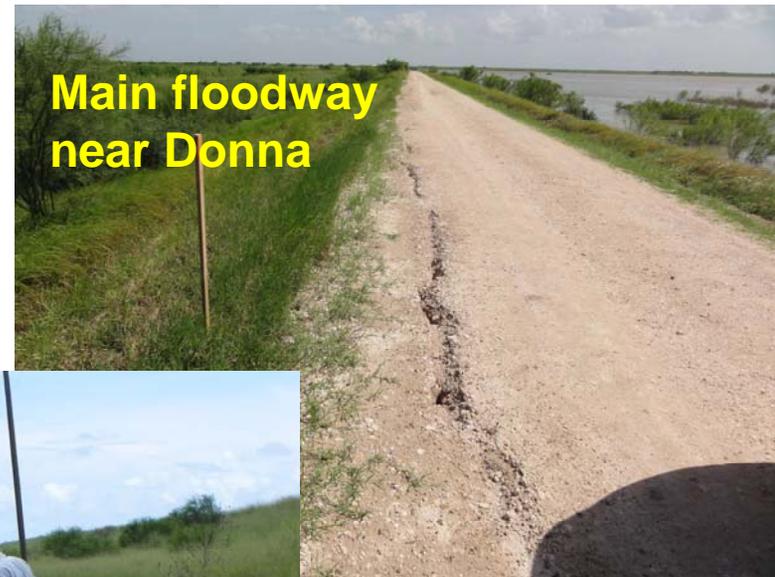
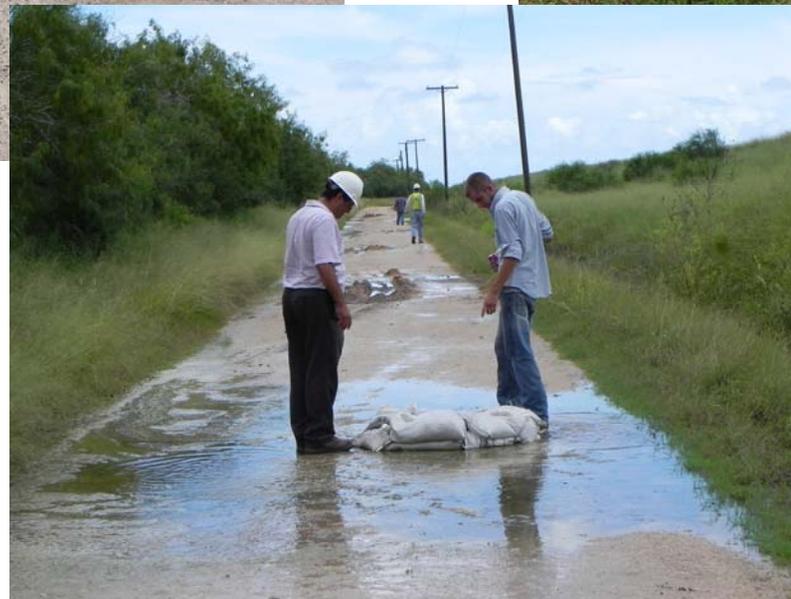
- Minor problems experienced
 - Sand boils - Near McAllen and Santa Monica.
 - Seepage - Santa Monica area
 - Cracks - near Donna, Santa Rosa, and Sebastian
- Levee-Wall
 - Cracks - downstream of the Edinburg (Peñitas) Pump House on the river levee

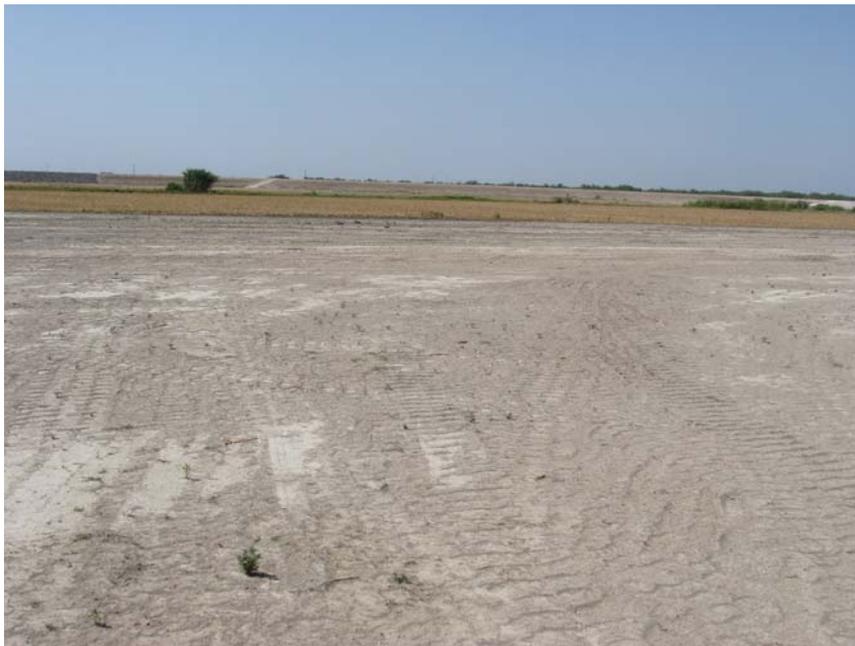
**Floodway downstream from
Granjeno summer 2009**

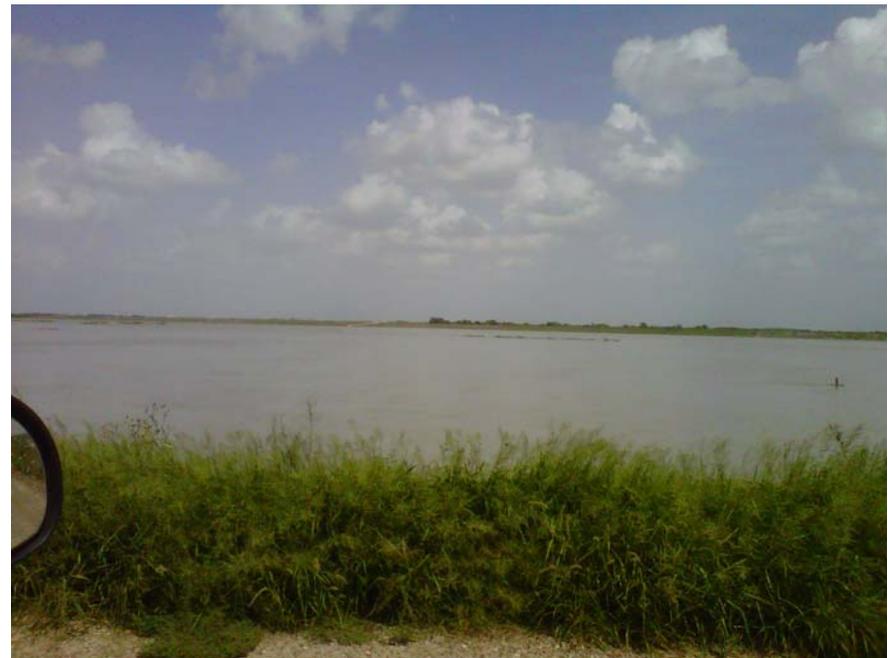
**Floodway downstream from
Granjeno July 2010**

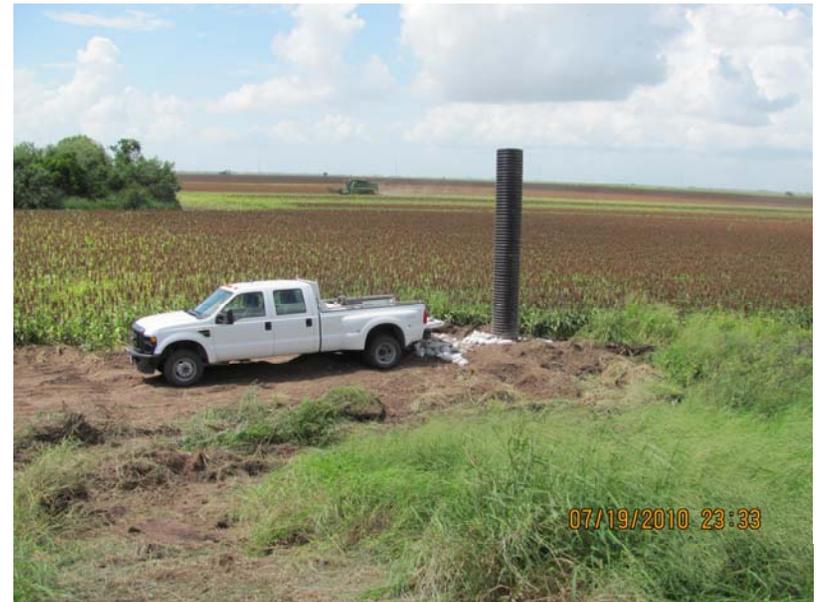
- USIBWC began effort in 2008 to work more closely with licensees to ensure proper O & M
- Problems occur when vandals damage structures or unauthorized individuals open or close them
- Tampering with gates is a criminal offense

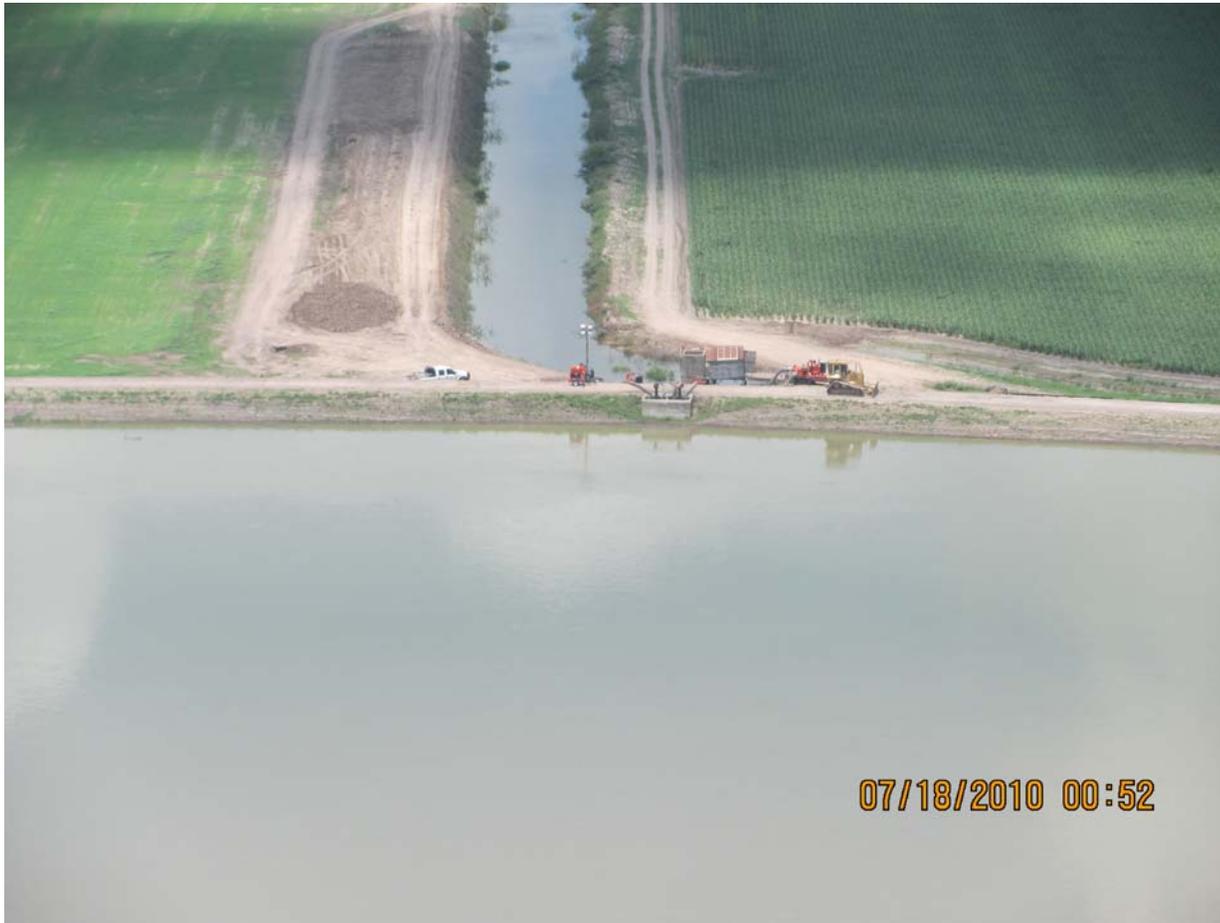
- Sometimes there is leakage even when gates are closed
- Structure problems occurred:
 - D/S of 23rd St. and Alamo Rd on north levee of the Main Floodway
 - D/S of FM 88 on the south levee of the Main Floodway
 - 9 structures in Peñitas and Mission levees
 - Some problems with structures where Recovery Act construction was underway
