# **Upper Brownsville Geotechnical Site Investigation Update**

**International Boundary and Water Commission**  
**United States Section**  
Engineering Services Division

**May 13, 2015**

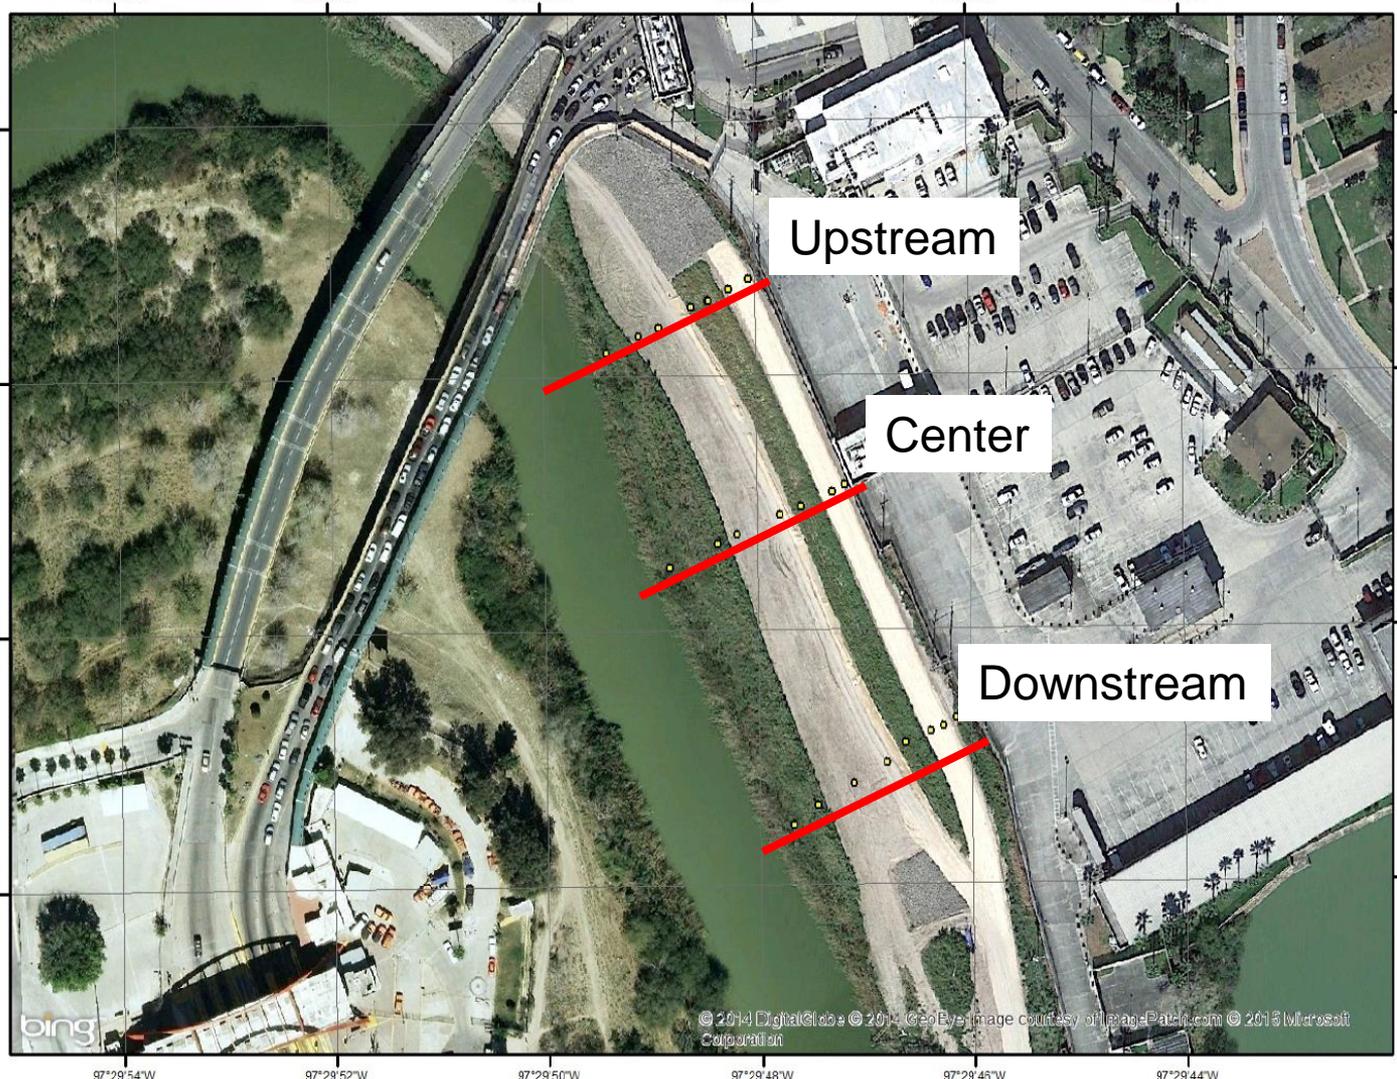
# Elevation Monitoring

- Requires total station survey for accuracy needed to determine movements.

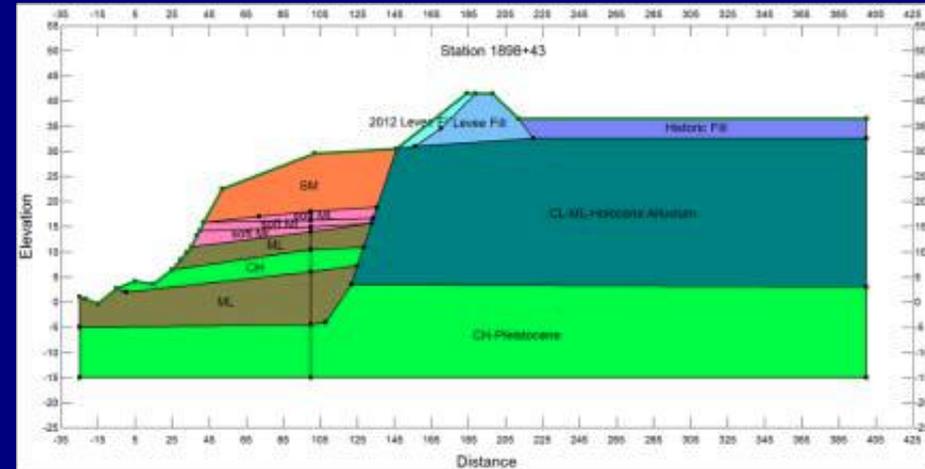
### Cross Section 111

*Three sections analyzed:*  
Coincide with instrumentation  
Piezometers, Inclometers, and  
Survey monuments.
