# **State Public Utility Commission of Mexicali Water and Sanitation Division Department of Wastewater**

## **RAW WASTEWATER SPILL DUE TO FAILURES AT PUMP STATION No. 4**

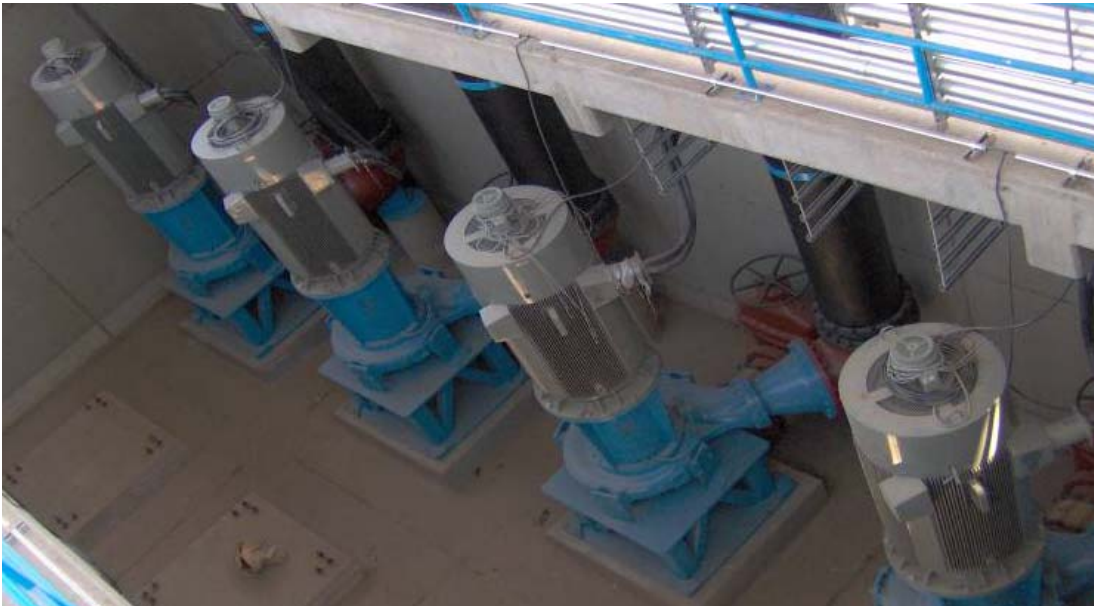
Wastewater Pump Station No. 4 officially went online in March 2007, capturing around 23,700,000 m<sup>3</sup> (626.1 MG) per year through the Mexicali II sewage network, which is equivalent to 42% of all wastewater from the City of Mexicali.

The wastewater is pretreated removing any floating debris and sediment and is then pumped to the Las Arenitas Wastewater Treatment Plant (WWTP).
