Southeast Arizona Citizens Forum

Transboundary Flow Mitigation

Naco, Sonora

Sierra Vista, Arizona, March 21, 2019

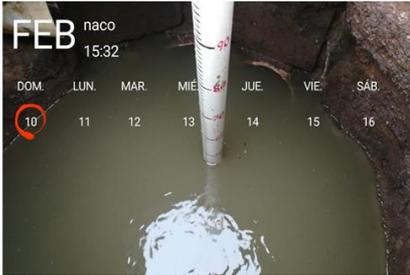
Proposed West Interceptor Replacement (mh#1 to mh#9)

- Replace West Interceptor** (Manhole#1 to #9)
Open trench construction

West Interceptor
Replacement 493 meters
PVC Class 20
12-inch

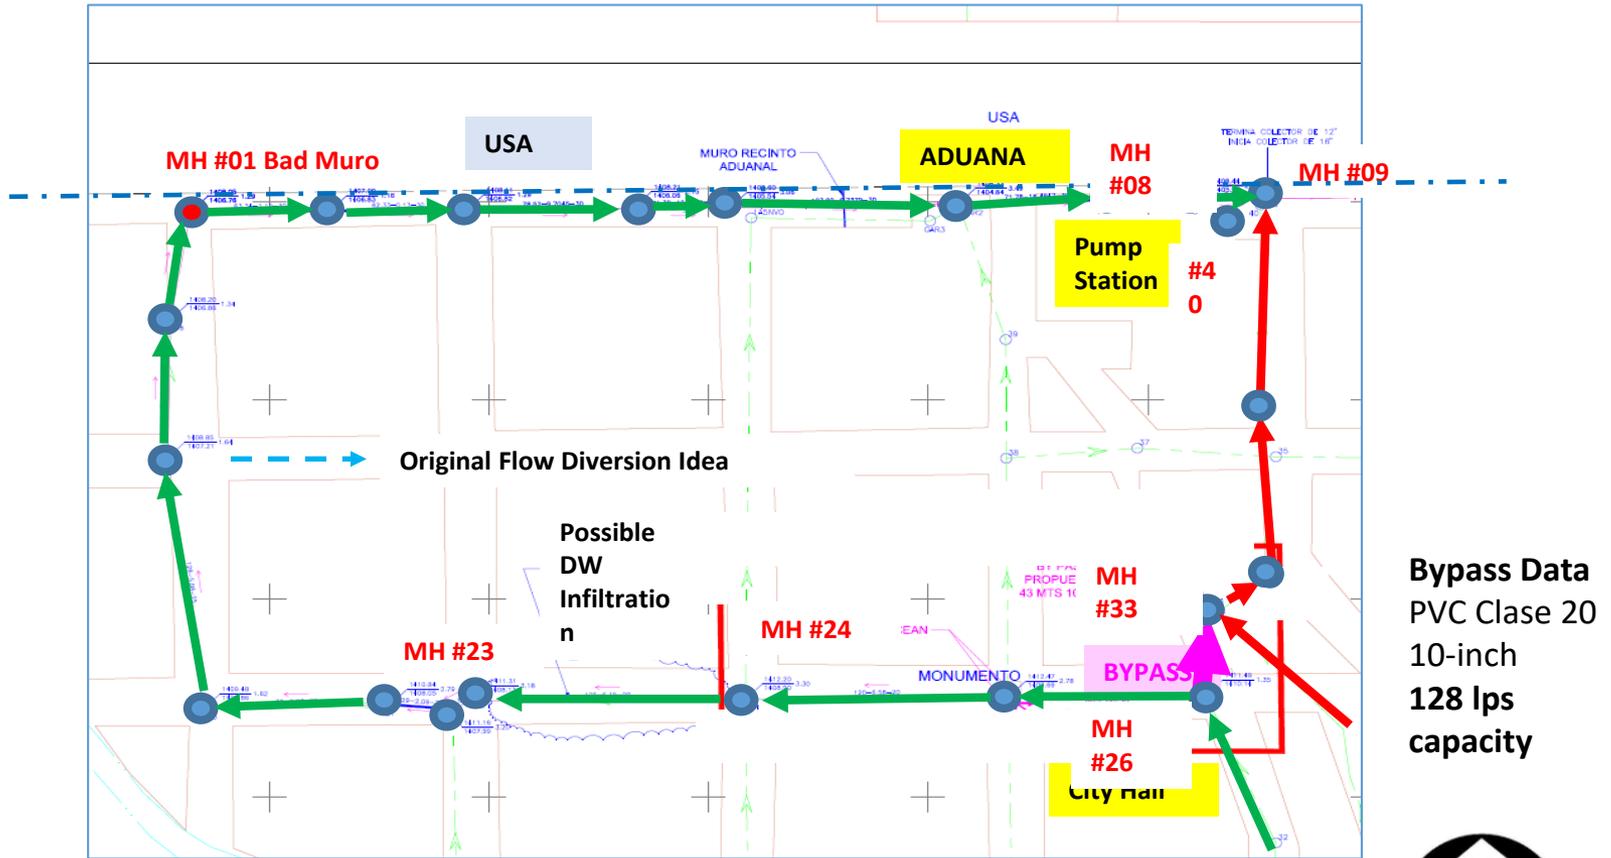
North West Area WW Flow Diversion

Bypass Data
 PVC Clase 20
 10-inch
 128 lps
 capacity

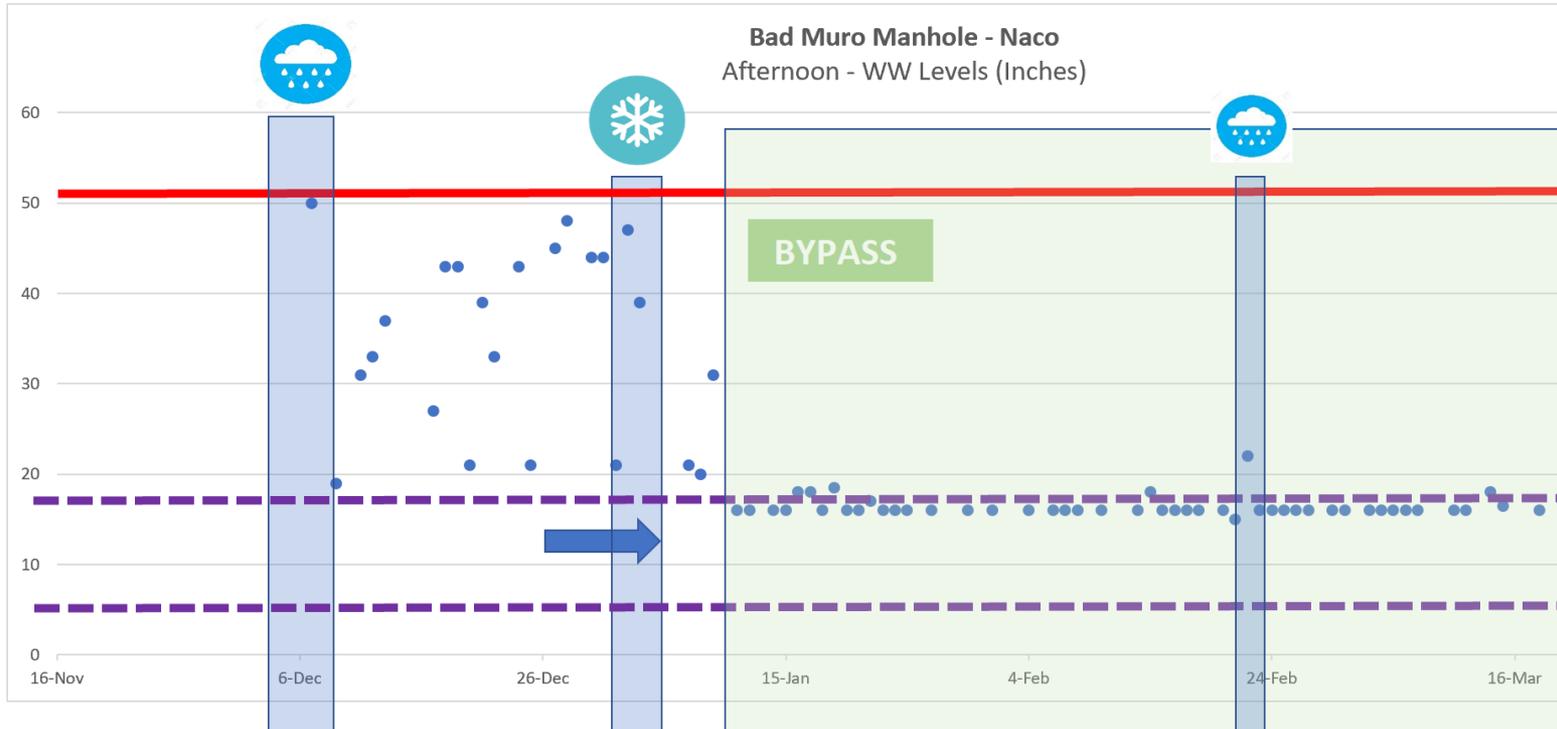
East Lagoon System
Area 9 acres

Measurement	Target	Comments	Trend
Man hole #01 "Bad Muro"	16-inches (0.4 meters)	12-inches (0.3 meters)	Stable since 1/11	↔
East Lagoon	24-inches	Level Zero (1,414 m SL)	Stable	↔

1. Collapse of obsolete segment (MH#1 to MH#9) of West Interceptor.
2. Discharge caused by High water Levels of Facultative Lagoons and/or Insufficient inter-lagoon and effluent pumping.
