# Naco Sonora Wastewater Discharges to Naco Arizona Emergency Repairs

Southeast Arizona Citizens Forum  
VTC February 11, 2021

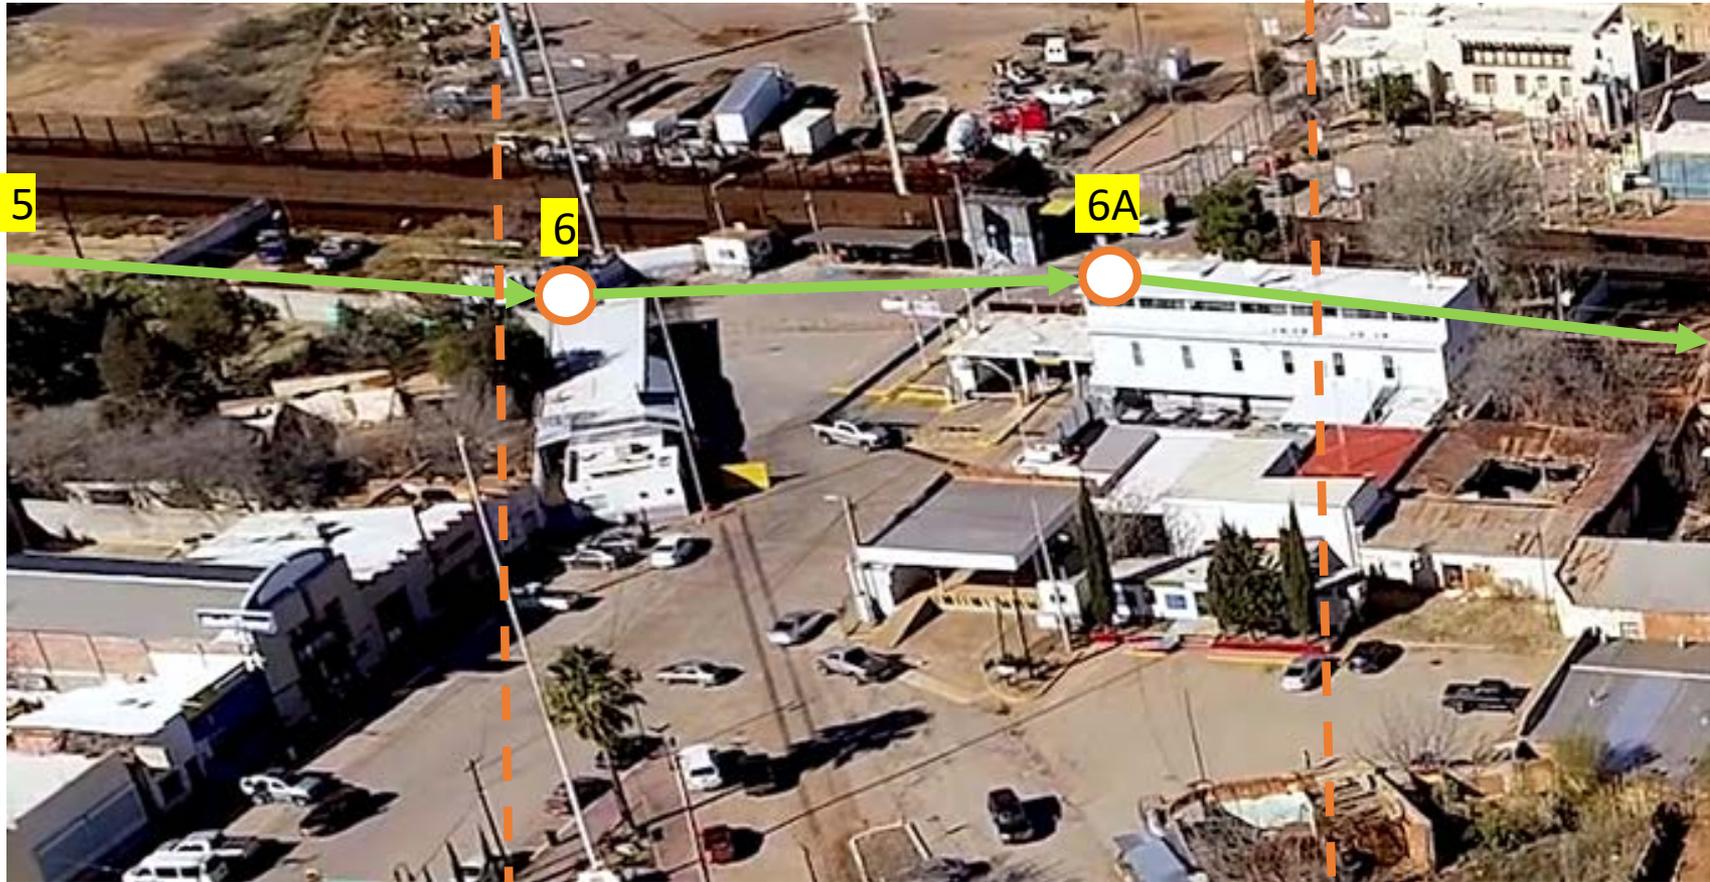
## Main Interceptor – Aduana Area Construction / Incidentals

Downstream of MH#5
