# **Bacteria Characterization in Rio Grande Segment 2304 near Laredo, Texas/ Nuevo Laredo, Tamaulipas**

**A Texas Clean Rivers Program Special Study  
FINAL REPORT**

**Field Work May and August 2011; Final Report November 2012**

**International Boundary and Water Commission, U.S. Section, Texas Clean Rivers Program**

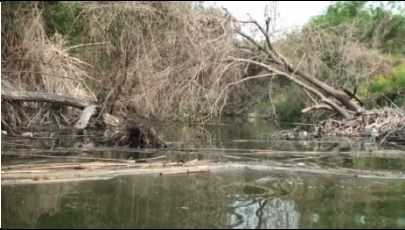
| Feature ID | Coordinates | Country | Confirmed Drain? | Description/<br>Field Notes | Photo | Bacteria Counts from August (#/100ml) |
|---|---|---|---|---|---|---|
| Feature 15 | 27.50458, -99.52774 | Mexico | Not confirmed<br>Mexican tributary | Tributary (Arroyo La Joya). Extremely foul smelling with lots of trash and biofilm. No visible drains. | | 120,000 (FC)<br>> 9,680 ( <i>E. coli</i> ) |

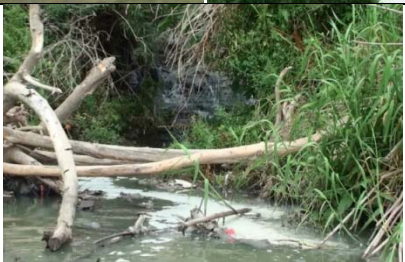
| Feature ID | Coordinates | Country | Confirmed Drain? | Description/<br>Field Notes | Photo | Bacteria Counts from August (#/100ml) |
|---|---|---|---|---|---|---|
| Feature 18 | 27.49752, -99.52784 | Mexico | Confirmed discharge<br>Drain not confirmed | Drain on stone, discharging into a waterfall on river bank. Discharge audible before sighting. Foul smell. Biofilm and trash. | | 2,900 (FC)<br>4,840 ( <i>E. coli</i> )<br>(sample diluted with river water and is likely biased low) |

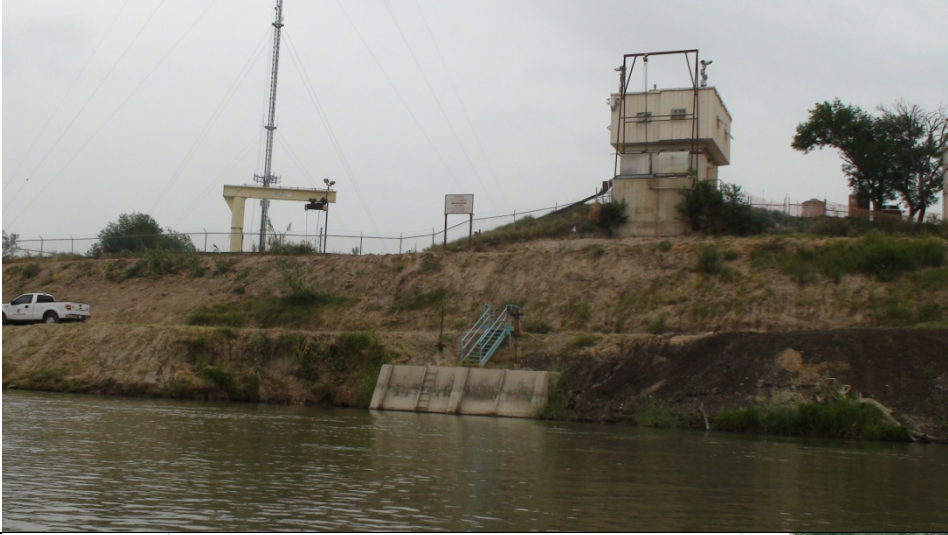
| Photo | Coun<br>try | Feature ID and<br>Field Description | Coord<br>inates |
|---|---|---|---|
| | U.S | <b>Feature 1 –</b><br><br>Jefferson Street<br>drinking plant<br>intake. | 27.52392,<br>-99.52431 |

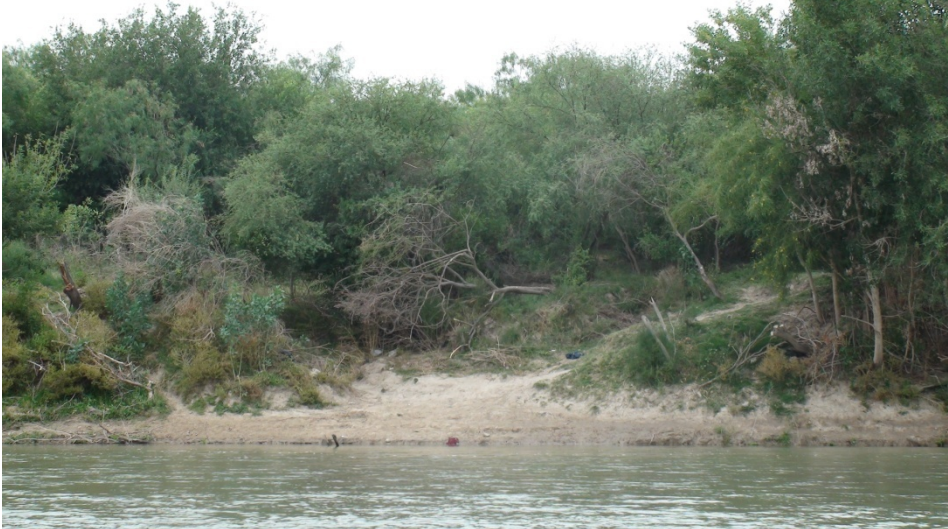
| Photo | Coun<br>try | Feature ID and<br>Field Description | Coord<br>inates |
|---|---|---|---|
| | MEX | <b>Feature 2 –</b><br><br>Road on bank<br>with trash.<br>Electric lines,<br>suspected intake,<br>but no pipes<br>visible. | 27.52261,<br>-99.52539 |

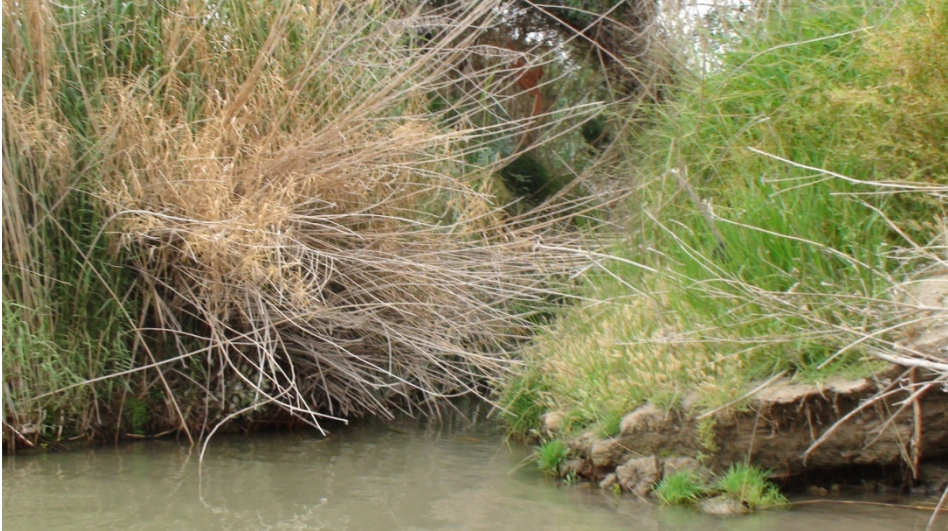
| | U.S. | <b>Feature 3 –</b><br><br>Erosion channel on U.S. side with some trash (tire in water). Trash downstream. | 27.51997, -99.52497 |

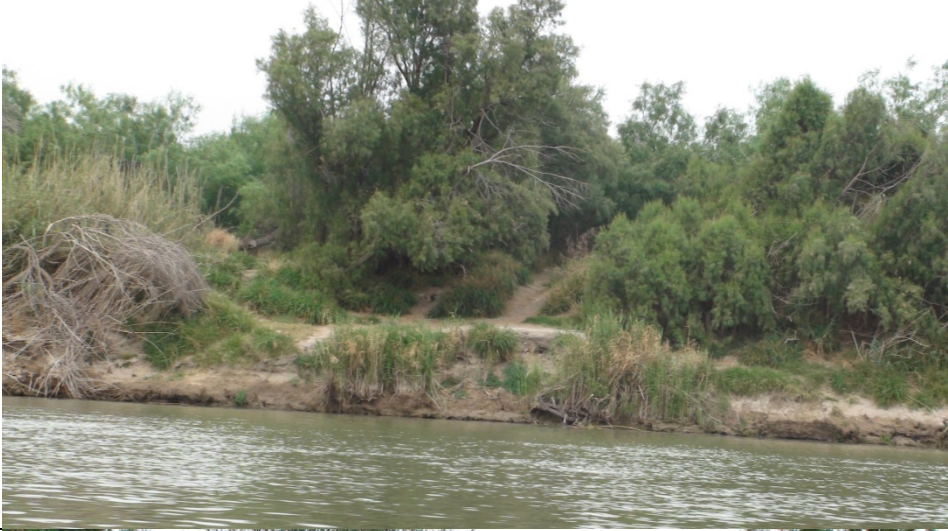
| | U.S. | <b>Feature 4 –</b><br><br>Footpath down to river on US side. | 27.51761, -99.52556 |

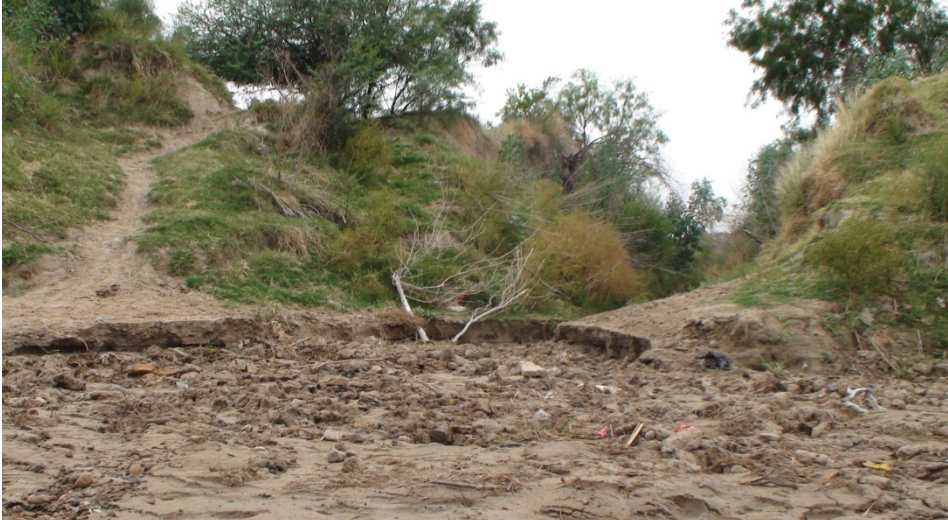
| | MEX | <b>Feature 5 –</b><br><br>Side channel with sediment bar, lots of trash and some foam. Footpath down to river beside side channel. | 27.51697, -99.52565 |

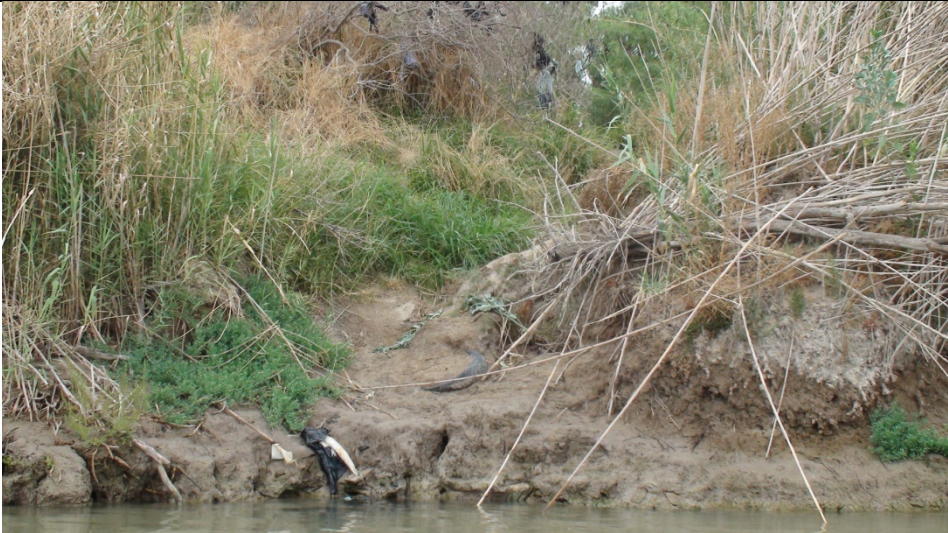
| | U.S. | <b>Feature 6 –</b><br><br>Footpath to river with trash and tires. | 27.51618<br>-99.52469 |

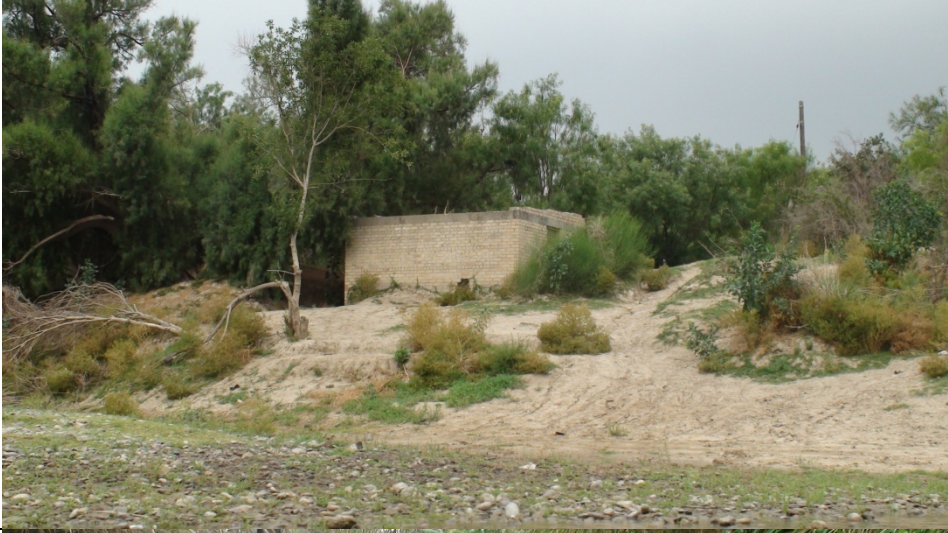
| | MEX | <b>Feature 7 –</b><br><br>Old brick building, (perhaps old pump house). | 27.51367,<br>-99.52536 |

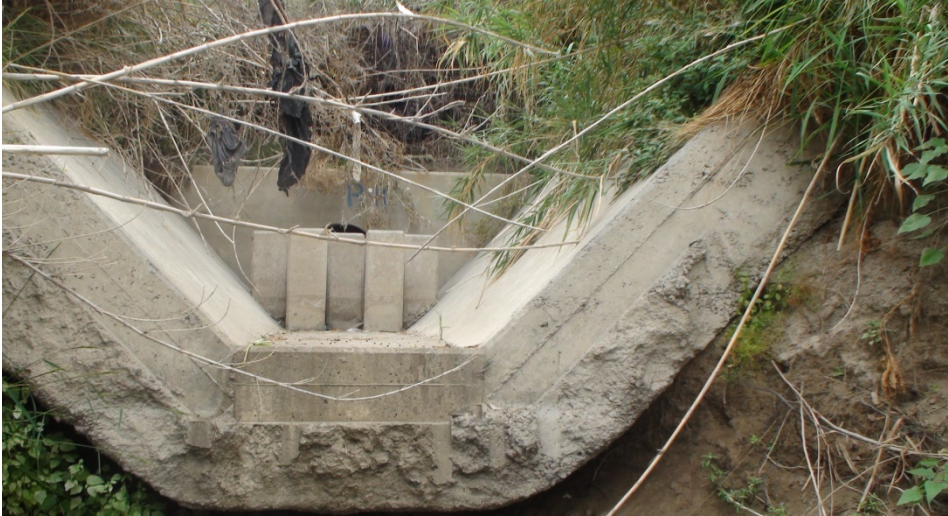
| | U.S. | <b>Feature 8 –</b><br><br>Stormwater drain on U.S. bank labeled R-10. Probably old Laredo Community College stormwater drain constructed in the 1930s WPA. Some trash. | 27.51187<br>-99.52475 |

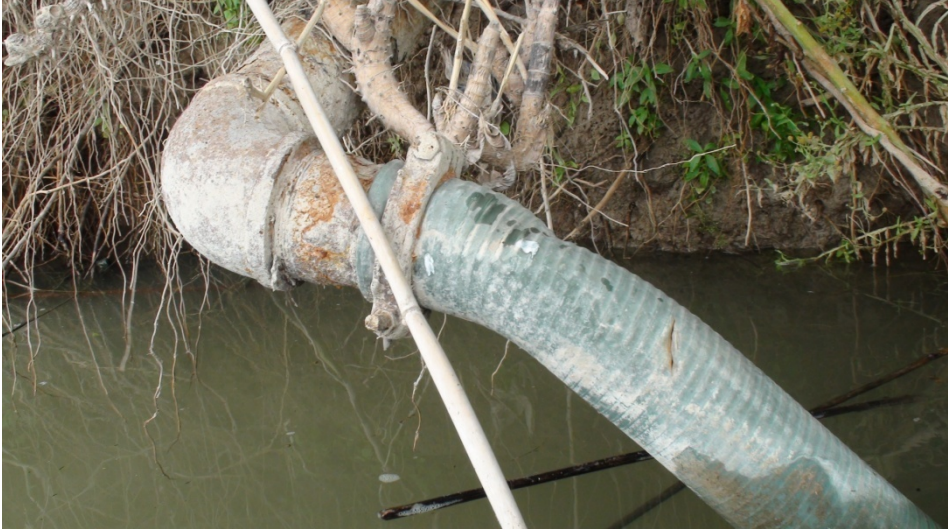
| | U.S. | <p><b>Feature 9 –</b></p> <p>Intake pipe, small and hidden on bank. Probably part of old farm project that ran on wind turbines.</p> | 27.50936, -99.52537 |

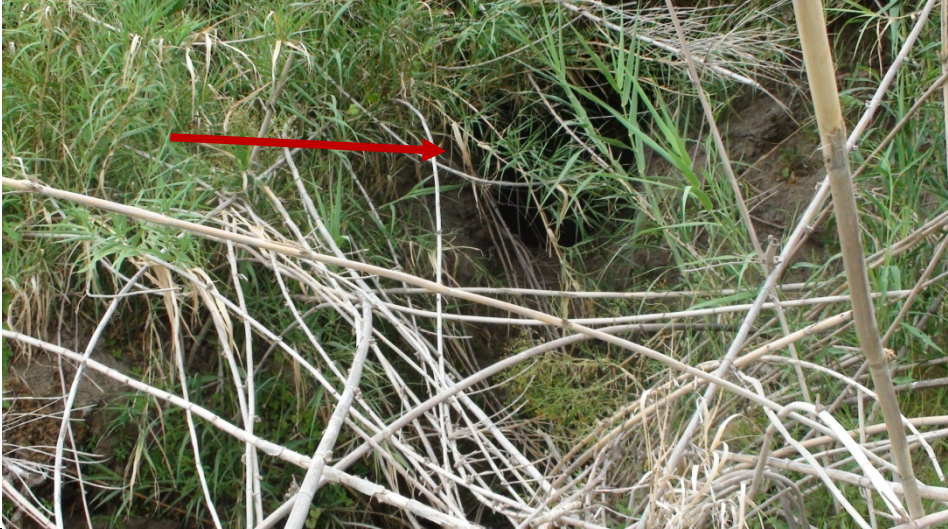
| | U.S. | <p><b>Feature 10 –</b></p> <p>Drain, hard to see on bank. Probably old drainage ditch from WPA.</p> | 27.50918, -99.52543 |

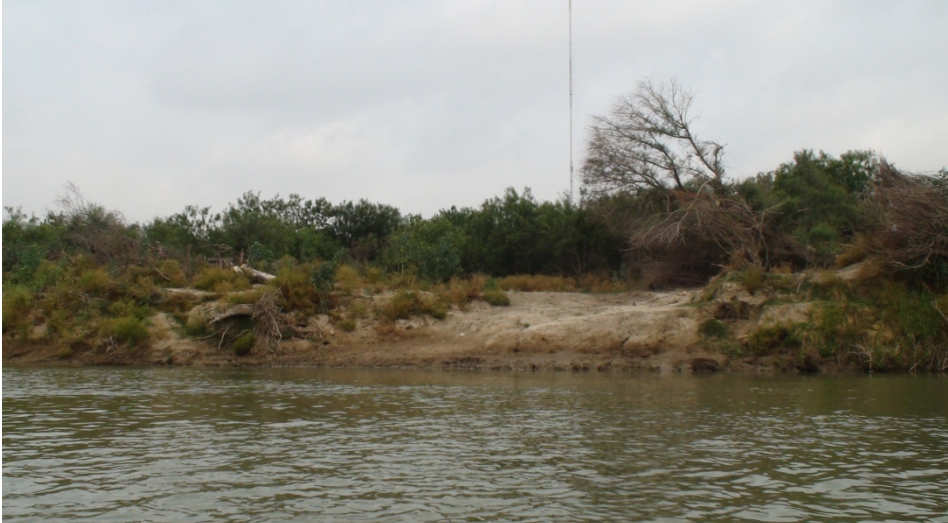
| | MEX | <p><b>Feature 11 –</b></p> <p>Road to the river across from Laredo Community College.</p> | 27.50829 -99.52631 |

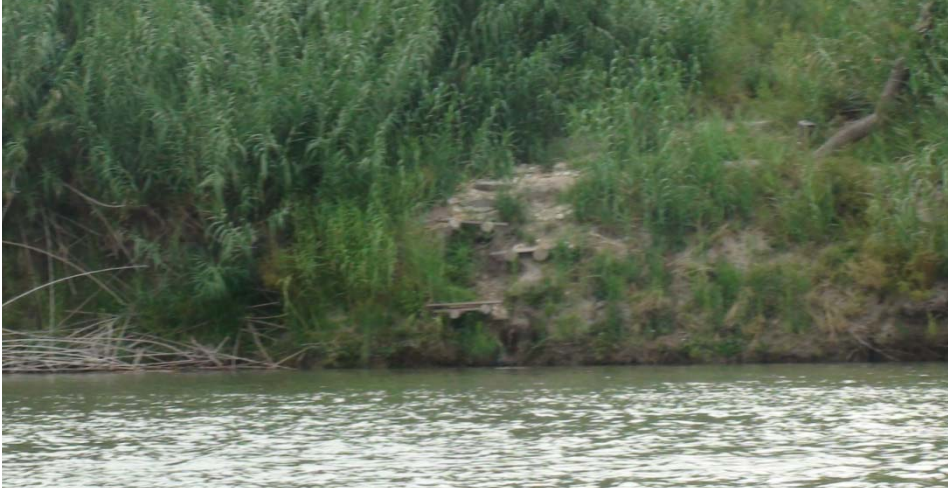
| | U.S. | <b>Feature 12 –</b><br><br>Steps to river on LCC campus directly across from Feature 11. | 27.50811, -99.52575 |

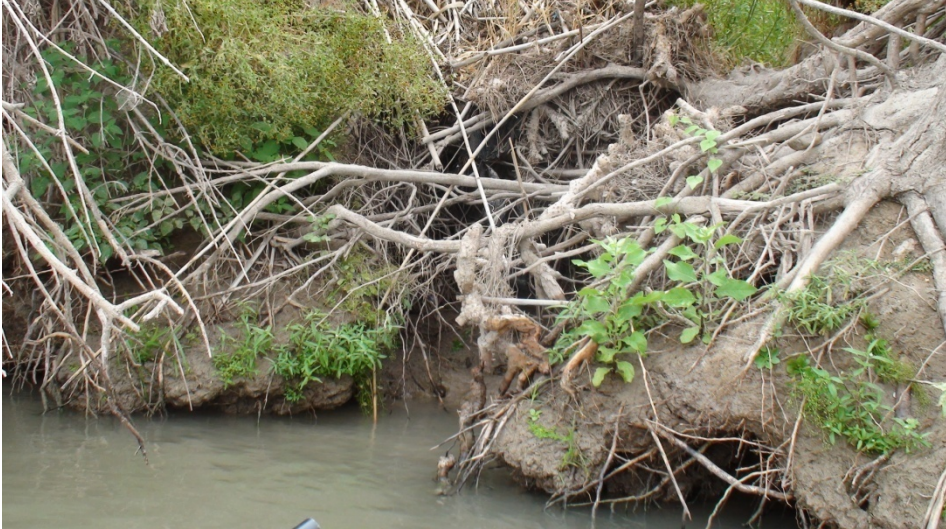
| | U.S. | <p><b>Feature 14 –</b></p> <p>Possible drain.<br/>Not visible or accessible. Crew thought there was a second old WPA drain in this area.</p> | 27.50467,<br>-99.52673 |

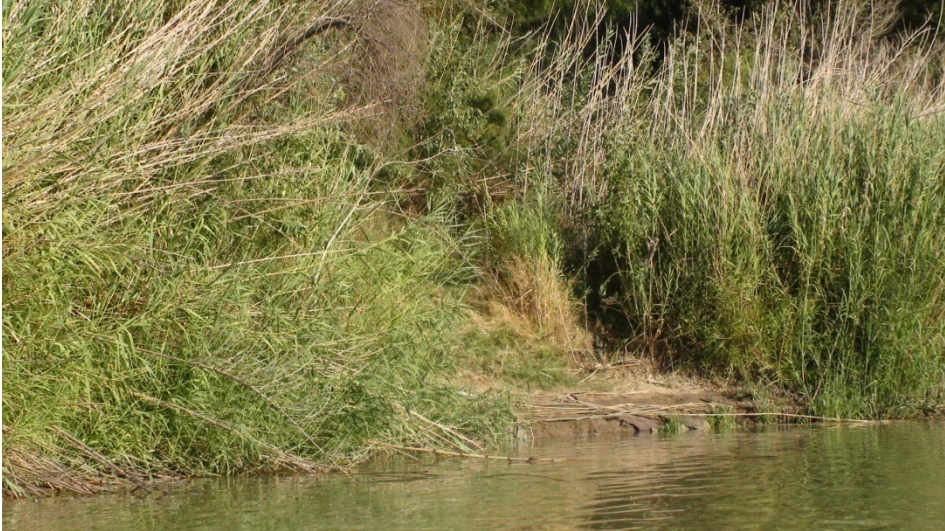
| | MEX | <p><b>Feature 16a –</b></p> <p>Clearing on bank, unsure if this is footpath or possible dry arroyo?</p> | 27.49964, -99.52858 |

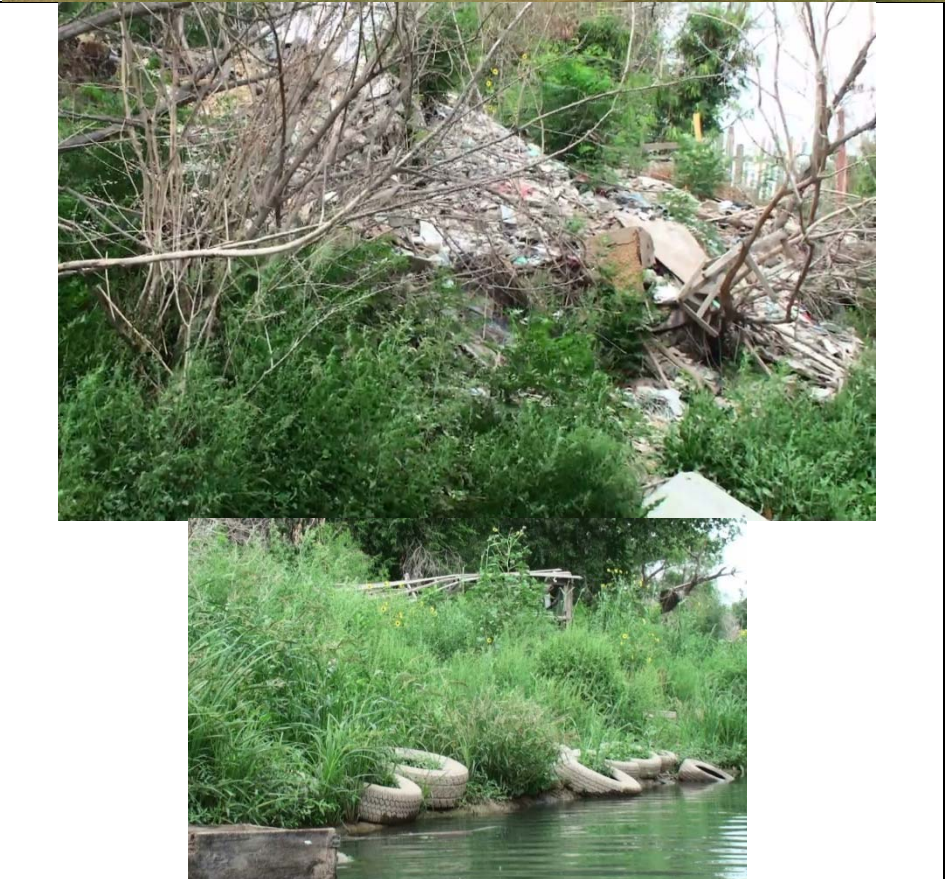
| | MEX | <p><b>Feature 16b –</b></p> <p>Tributary with trash/landfill on banks. Foul smell. Later referenced to “Arroyo Las Alazanas”</p> | 27.49966 -99.52914 |

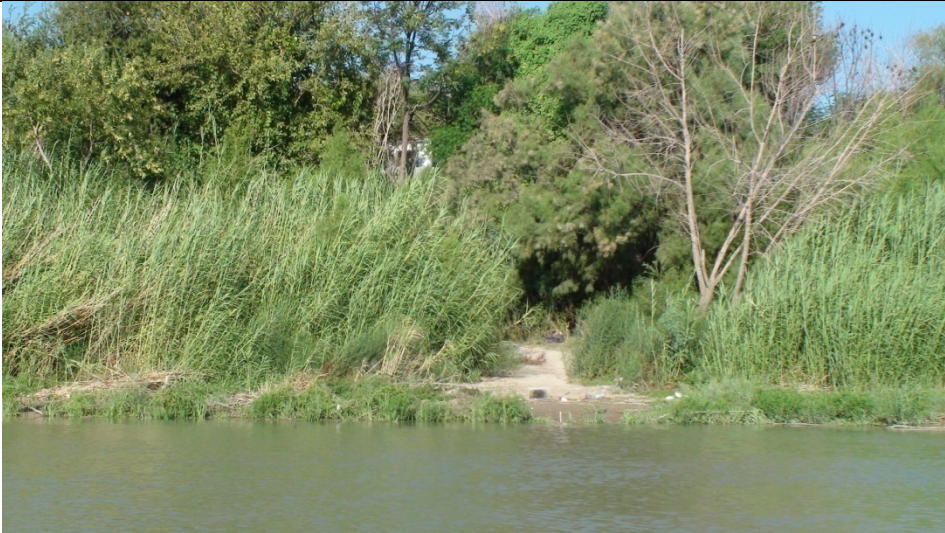
| | MEX | <p><b>Feature 17a –</b></p> <p>Path to river and small building/tower on bank.</p> | 27.49825, -99.52817 |

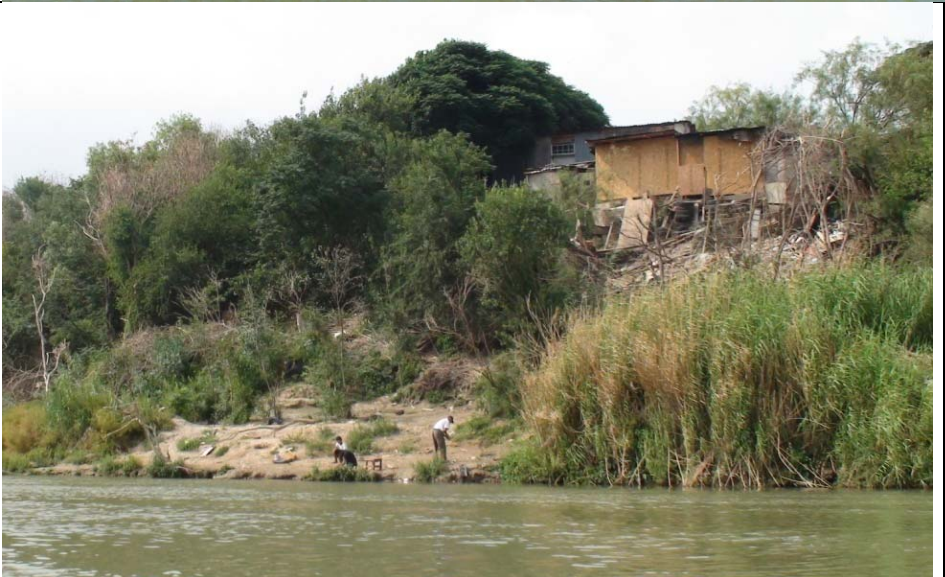
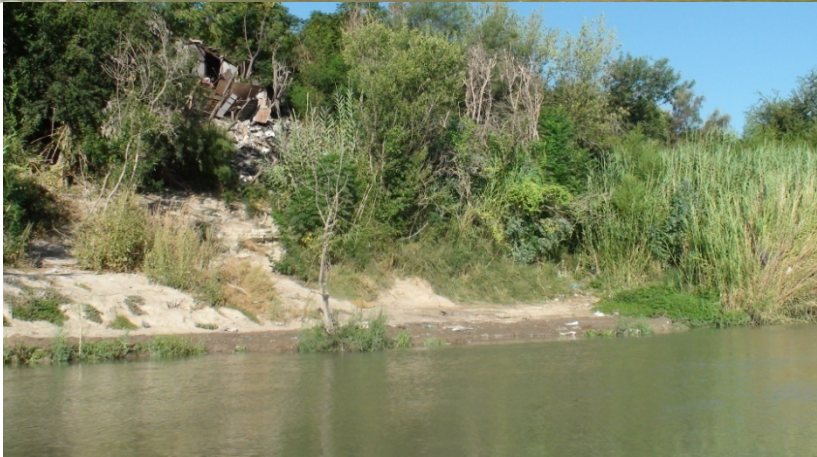
| | MEX | <p><b>Feature 17b –</b></p> <p>Large residential buildings at top of bank, lots of trash. Appears to be a Colonia. Fishermen on bank.</p> | 27.49797, -99.52809 |

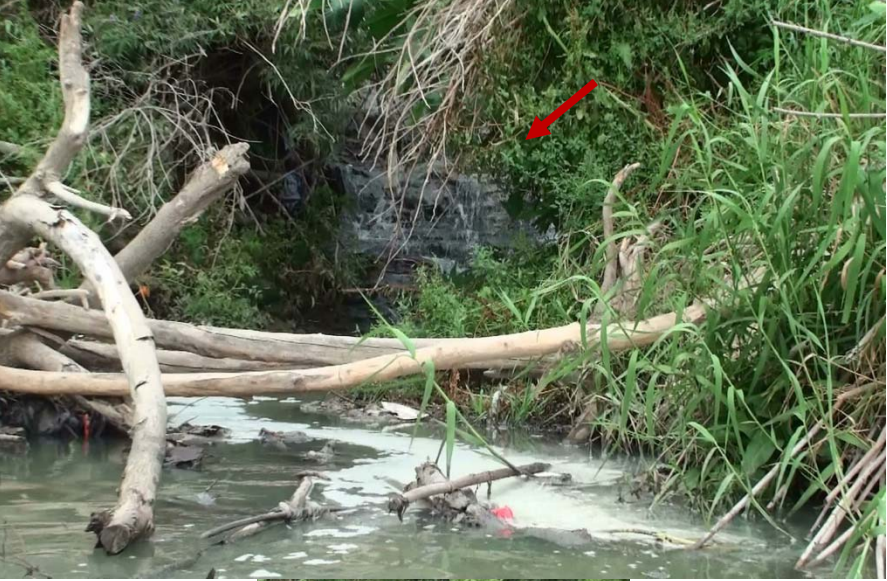
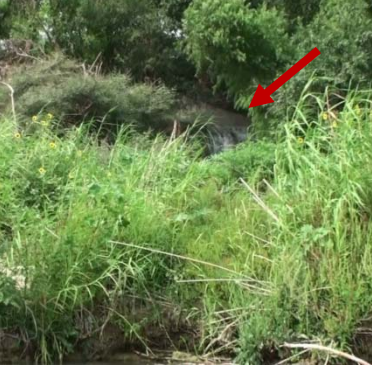
| <br> | MEX | <p><b>Feature 18 –</b></p> <p>Discharging drain on stone, waterfall on bank to river (red arrow). Foul smell.</p> <p>Later identified as “Dren Monterrey”</p> | 27.49752, -99.52784 |

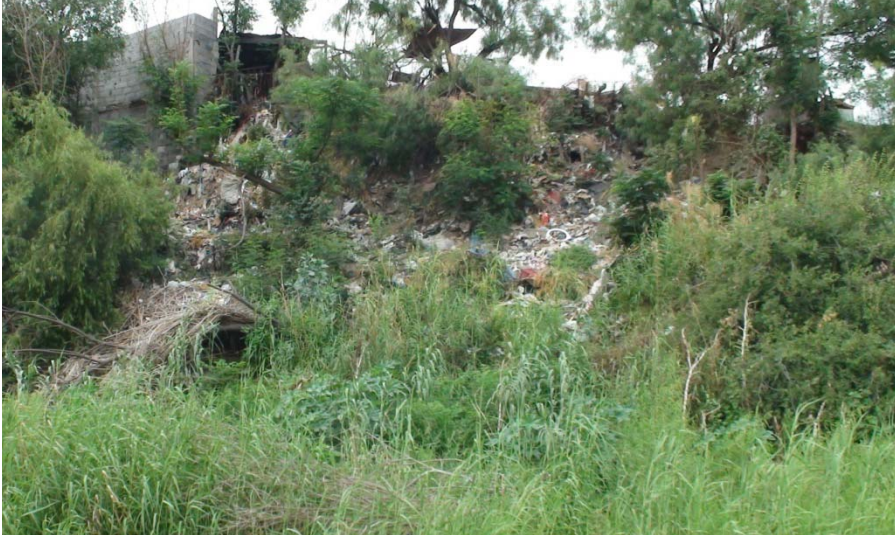
| | MEX | <p><b>Feature 19 –</b></p> <p>Trash pile on bank.</p> | 27.4973, -99.52749 |

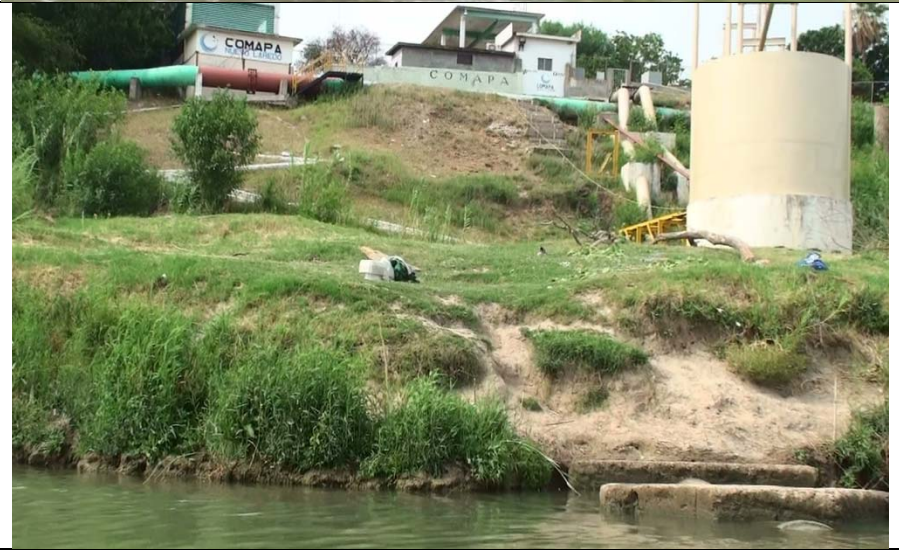
| | MEX | <p><b>Feature 21 –</b></p> <p>COMAPA intake. Several intake structures on bank.</p> | 27.49638, -99.52221 |

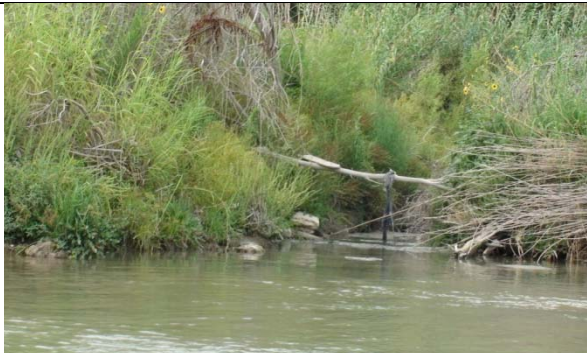
| | MEX | <p><b>Feature 22 –</b></p> <p>Small tributary in Mexico, or possible small drain. Trash and foam or biofilm. Milky, foul smelling discharge noted in August sampling.</p> | 27.49641, -99.52133 |

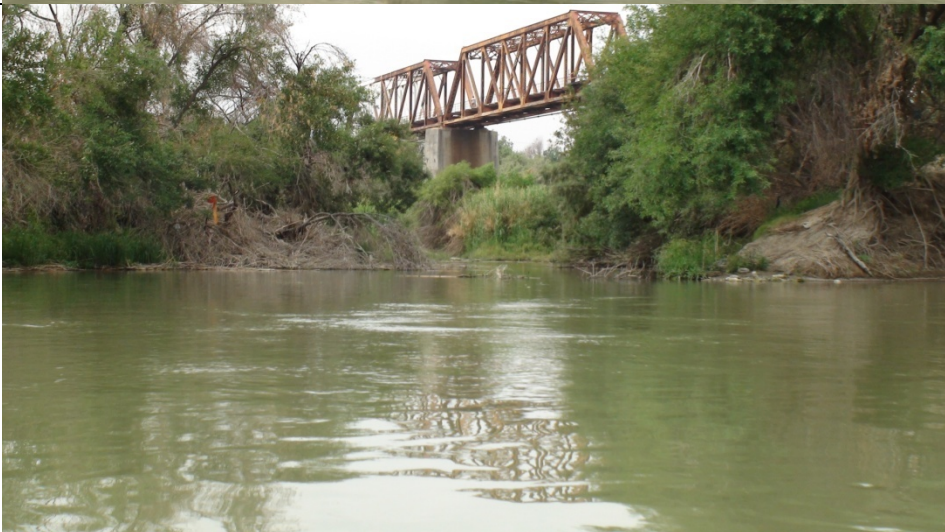
| | Both U.S. and MEX | <p><b>Feature 26 –</b></p> <p>Railroad bridge. In August the bridge was freshly painted on the Mexican side.</p> | 27.49861, -99.51598 |

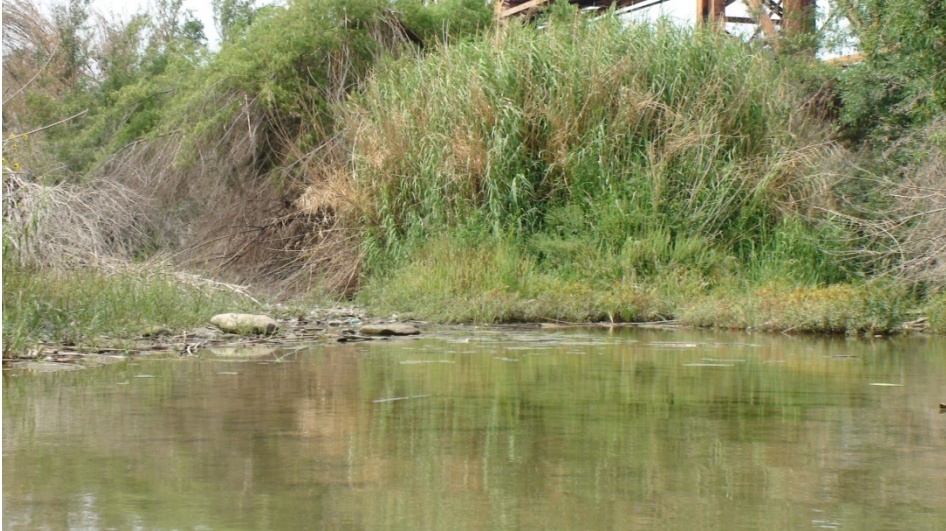
| | Both<br>U.S.<br>and<br>MEX | <b>Feature 27 –</b><br><br>Channel between islands. Lots of birds, including kingfishers. | 27.49798,<br>-99.51578 |

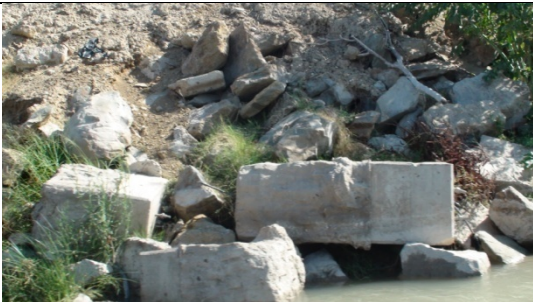
| | U.S. | <b>Feature 28b –</b><br><br>Cement blocks falling off U.S. banks, just downstream of Feature 28. Construction on bank after floods, loose sediment. | 27.49925,<br>-99.51278 |

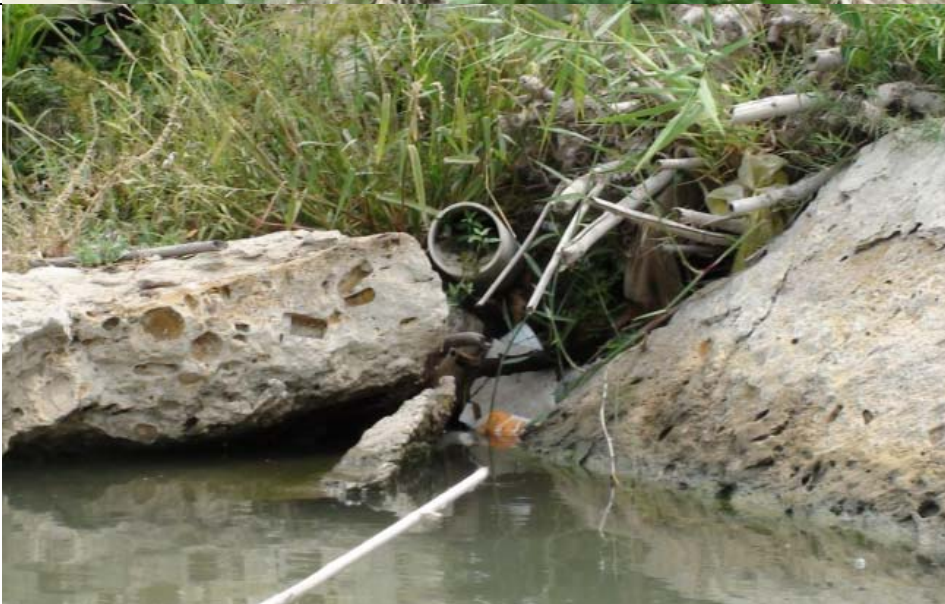
| | U.S. | <b>Feature 29b –</b><br><br>Small pipe directly to the right of Feature 29. | 27.4995,<br>-99.51242 | |

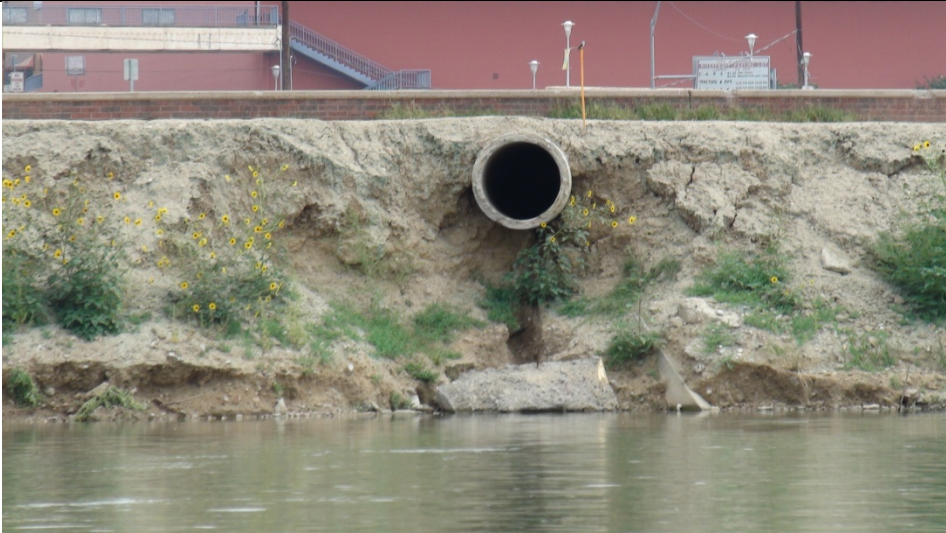
| | U.S. | <b>Feature 30 –</b><br><br>Stormwater drain,<br>large round pipe<br>on bank in dirt. | 27.49877,<br>-99.51111 |

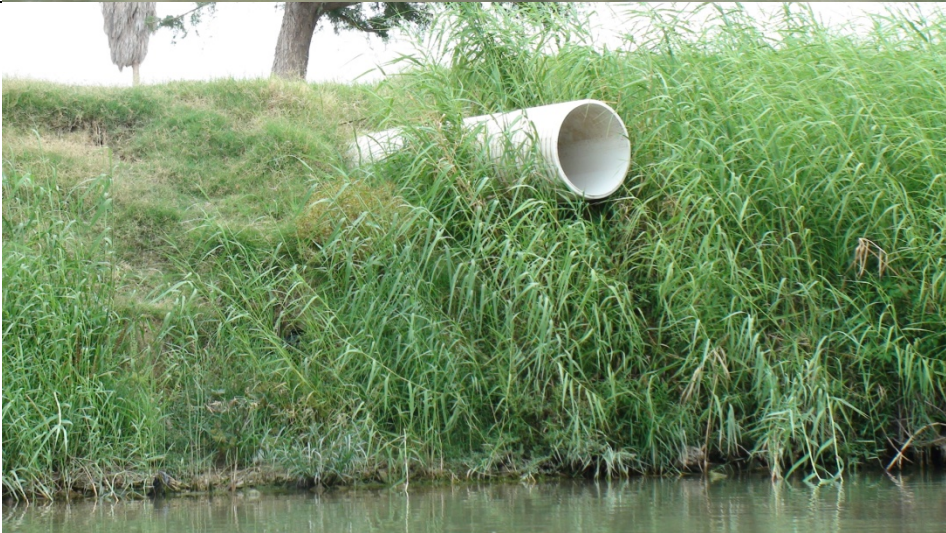
| | U.S. | <b>Feature 31 –</b><br><br>White stormwater<br>plastic pipe. | 27.49919,<br>-99.50906 |

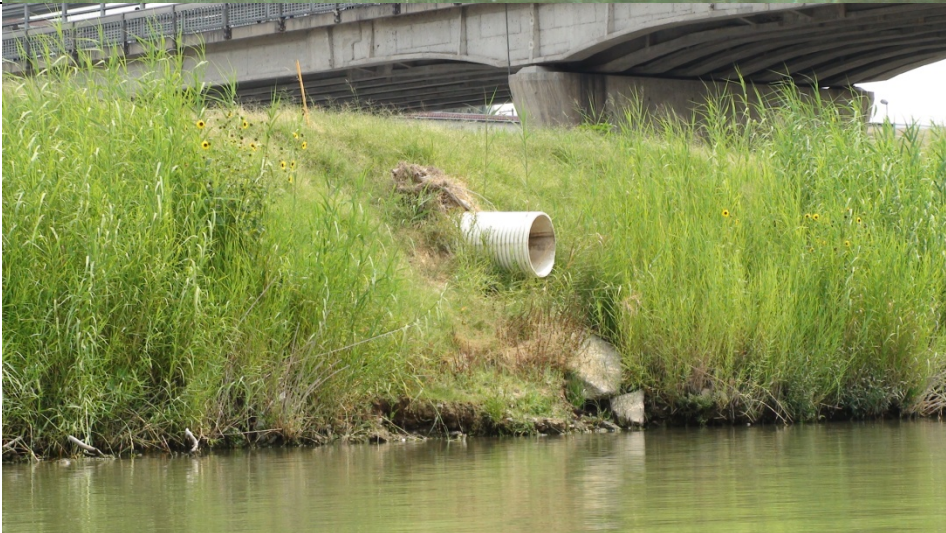
| | U.S. | <b>Feature 31b –</b><br><br>Second white<br>stormwater<br>plastic pipe. | 27.49953,<br>-99.5081 |

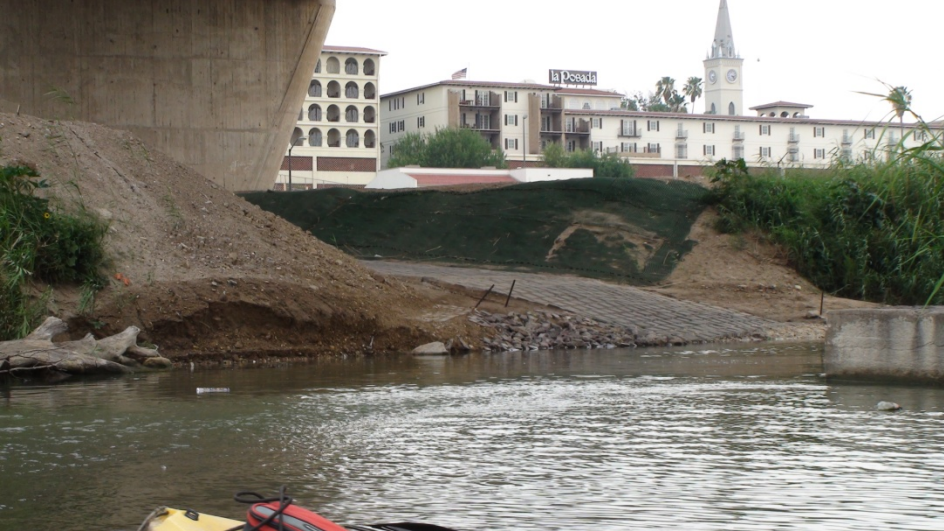
| | U.S. | <b>Feature 32a –</b><br><br>Boat ramp at Bridge I. | 27.49969,<br>-99.50769 |

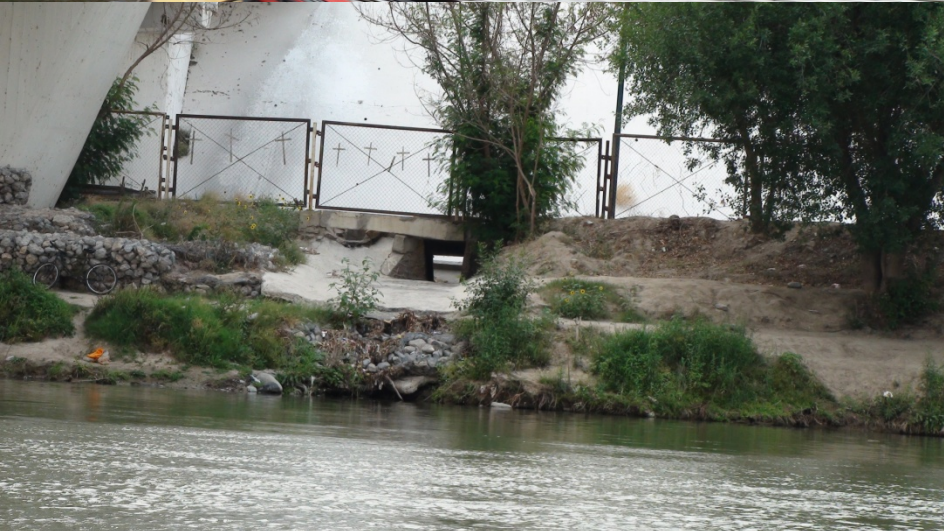
| | MEX | <b>Feature 32b –</b><br><br>Cement drain on Mexican side of Bridge I. | 27.49899,<br>-99.50766 |

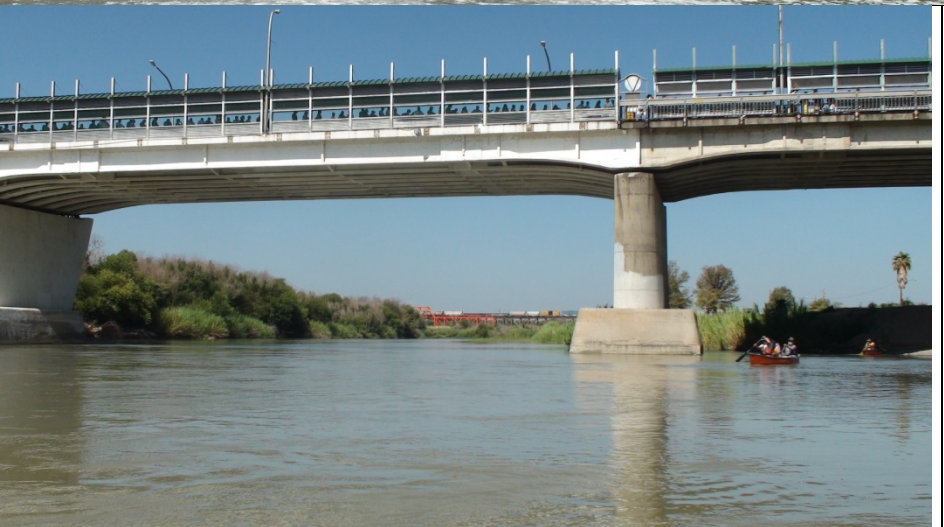
| | Both<br>U.S.<br>and<br>MEX | <b>Feature 32c –</b><br><br>International Bridge I | 27.49965,<br>-99.50763 |

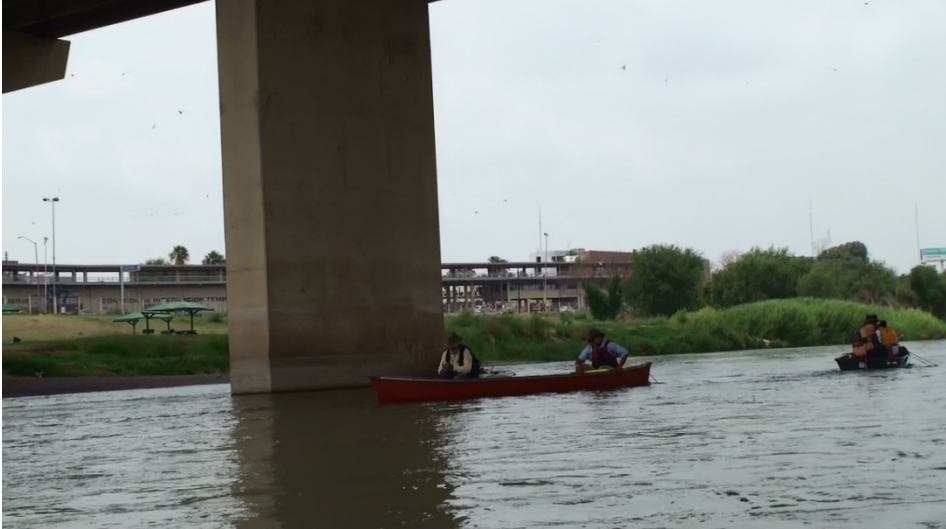
| | Both<br>U.S.<br>and<br>MEX | <b>Feature 33 –</b><br><br>International<br>Bridge II. | 27.50028,<br>-99.50248 |

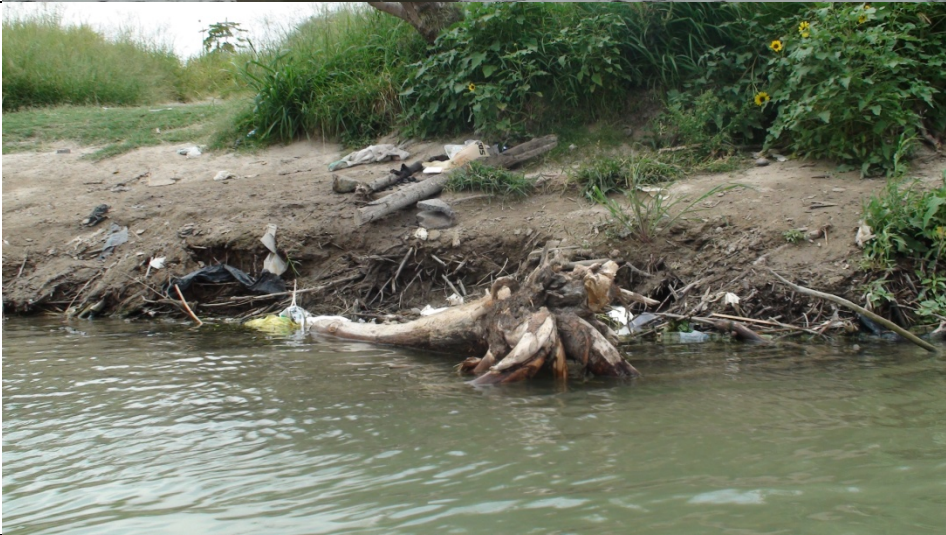
| | MEX | <b>Feature 34a –</b><br><br>Trash and clearing<br>on Mexican bank<br>just upstream of<br>34a. Fishermen<br>here. | 27.49969,<br>-99.50119 |

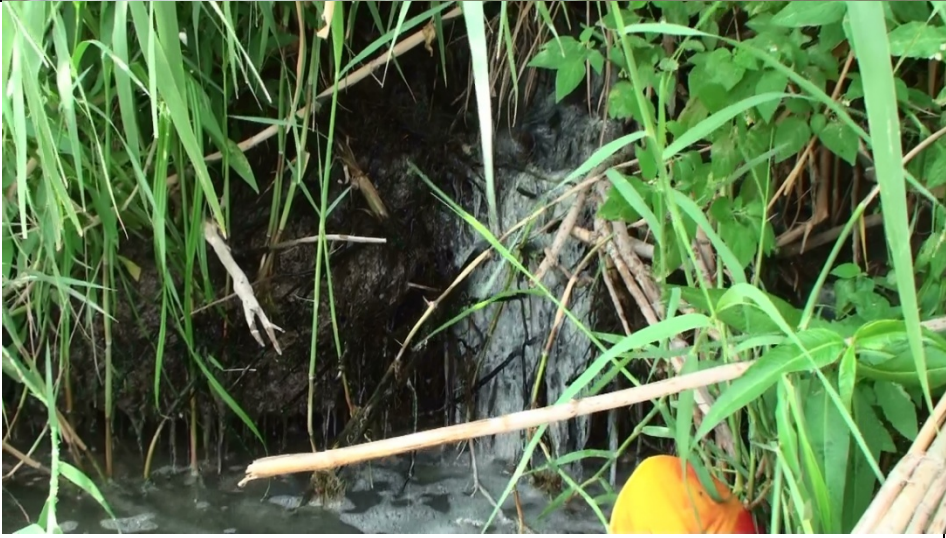
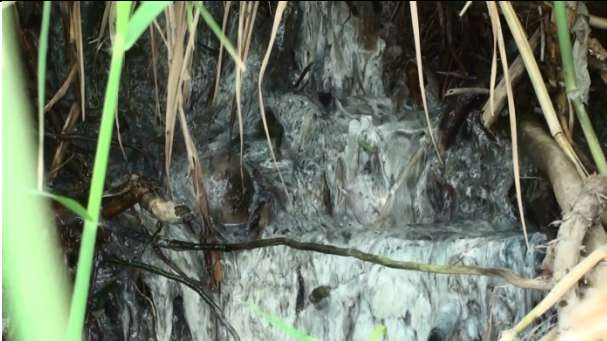
| | MEX | <b>Feature 34b –</b><br><br>Discharge on<br>Mexican bank, no<br>pipe visible.<br>Discharge also has<br>a white stringy<br>material that<br>looks like a taffy<br>or plastic<br>consistency. Foul<br>smell, foam. Suds<br>in the sample<br>bottles in August. | 27.49964,<br>-99.50098 |

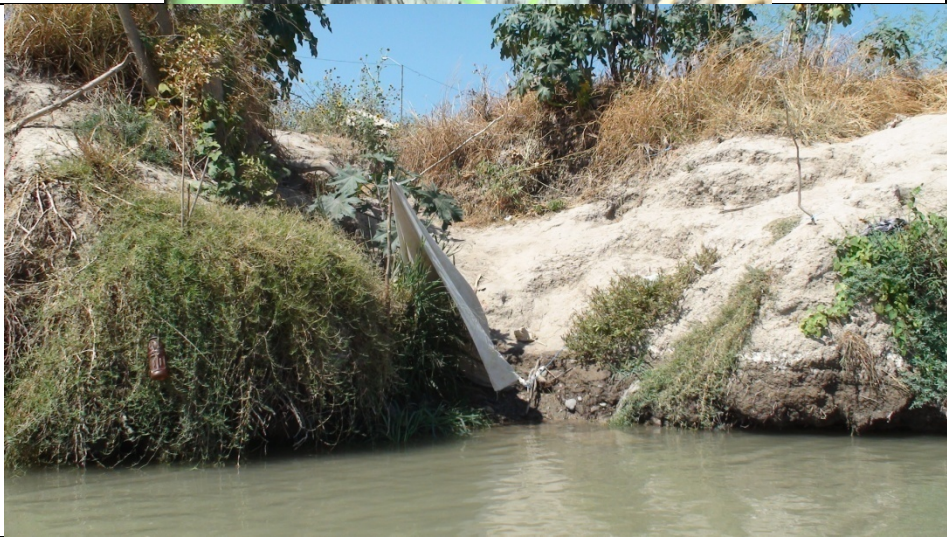
| | MEX | <p><b>Feature 34c –</b></p> <p>Clearing on bank and possible arroyo with some trash, possibly a tent.</p> | 27.49919, -99.50044 | |

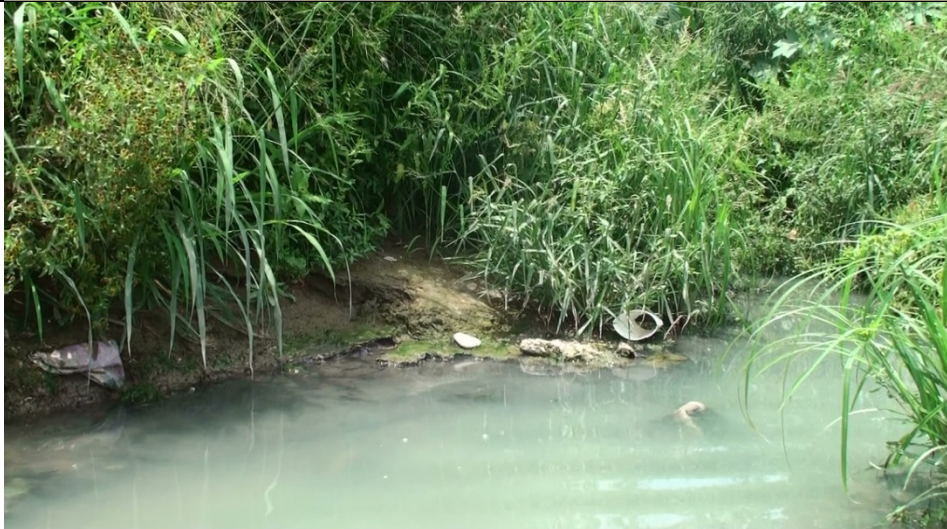
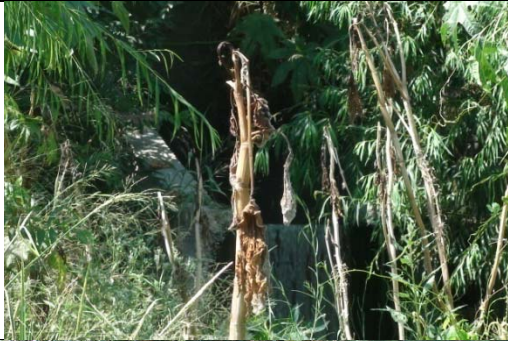
| | MEX | <p><b>Feature 35 –</b></p> <p>Drain in bank. Discharging is audible. Discharge is a blue/green murky. Cement structure with pipe high on bank seen during August sampling (bottom photo). Suds in the sample bottles.</p> | 27.49895, -99.49957 | |

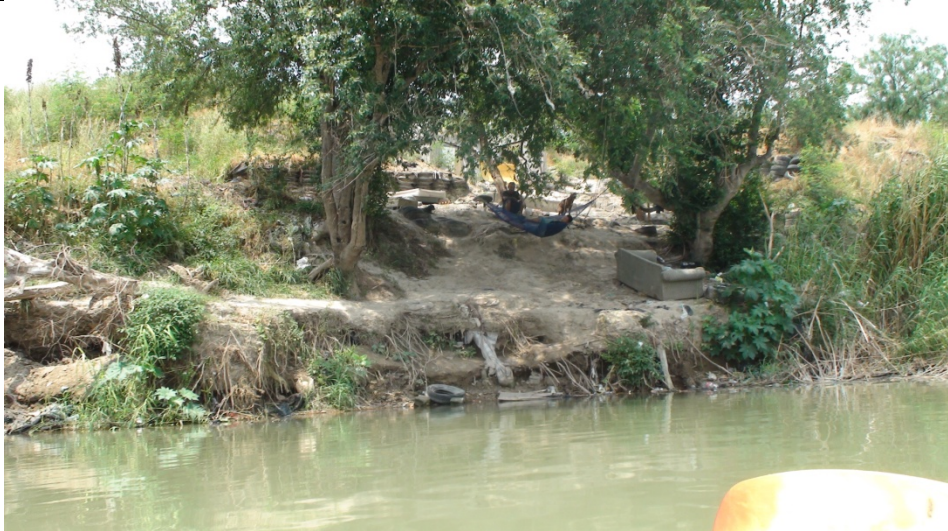
| | MEX | <b>Feature 36 –</b><br><br>Makeshift rest-stop on bank. Men on bank, trash in river. | 27.49856, -99.49817 | |

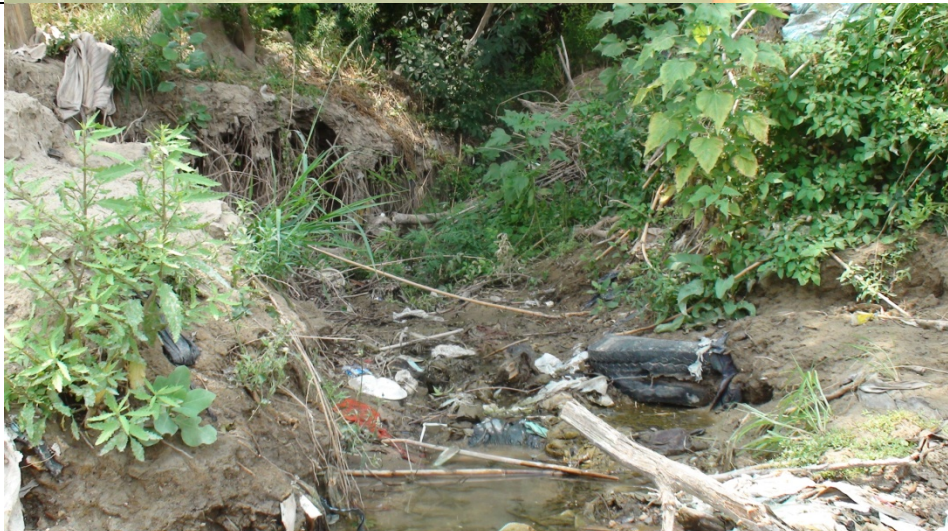
| | MEX | <b>Feature 37 –</b><br><br>Small tributary or drain. No pipe visible. Lots of trash. | 27.498, -99.49748 | |

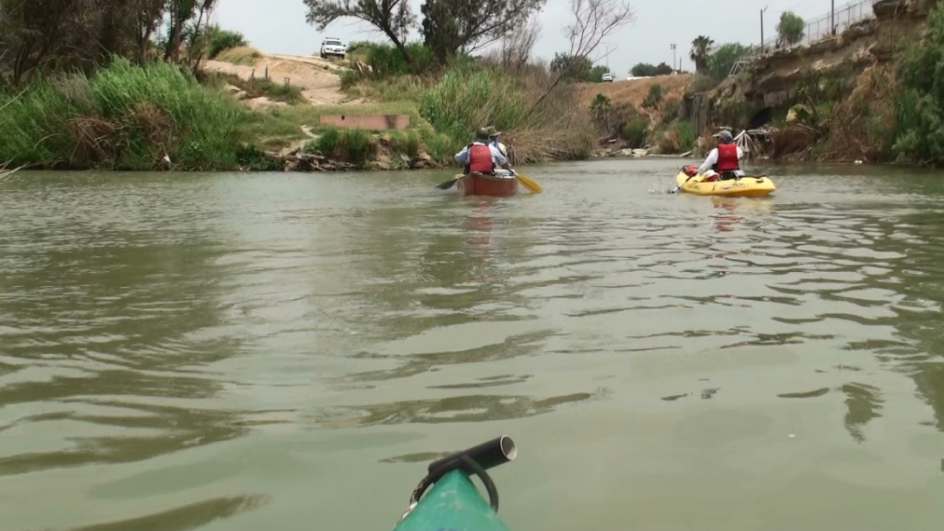
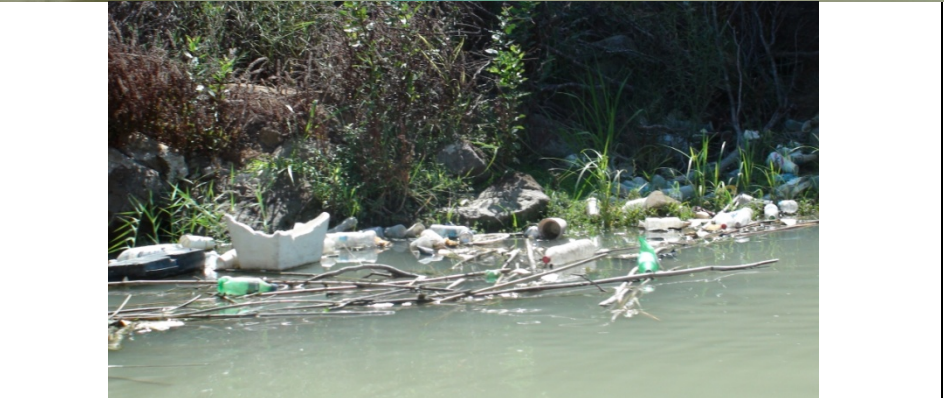
| | U.S. | <b>Feature 38a –</b><br><br>Zacate Creek. Lots of trash (bottom photo). | 27.49831, -99.49436 |
