# **Bacteria Characterization in Rio Grande Segment 2304 near Laredo, Texas/ Nuevo Laredo, Tamaulipas**

**A Texas Clean Rivers Program Special Study  
FINAL REPORT**

**Field Work May and August 2011; Final Report November 2012**

**International Boundary and Water Commission, U.S. Section, Texas Clean Rivers Program**

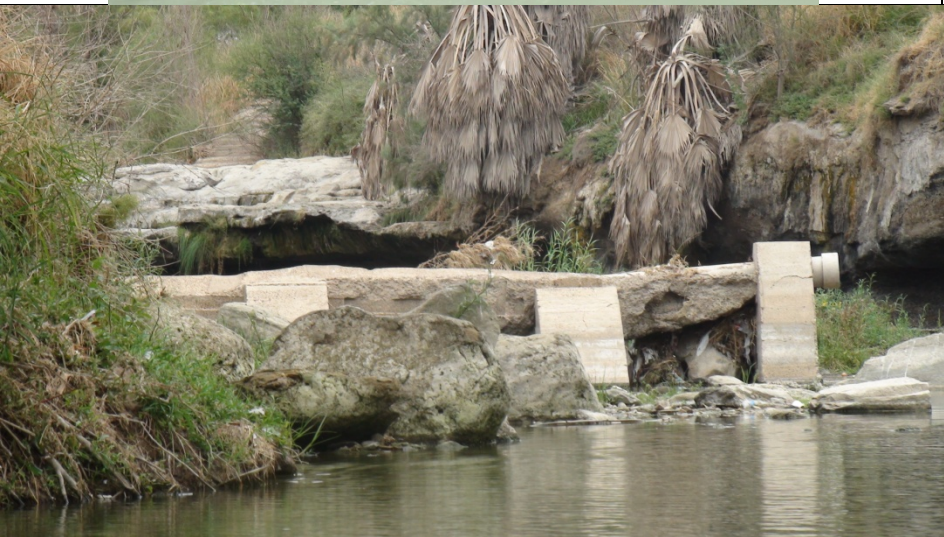
| | U.S. | <b>Feature 38b –</b><br><br>Metal pipe in Zacate Creek. | 27.49972, -99.49425 |

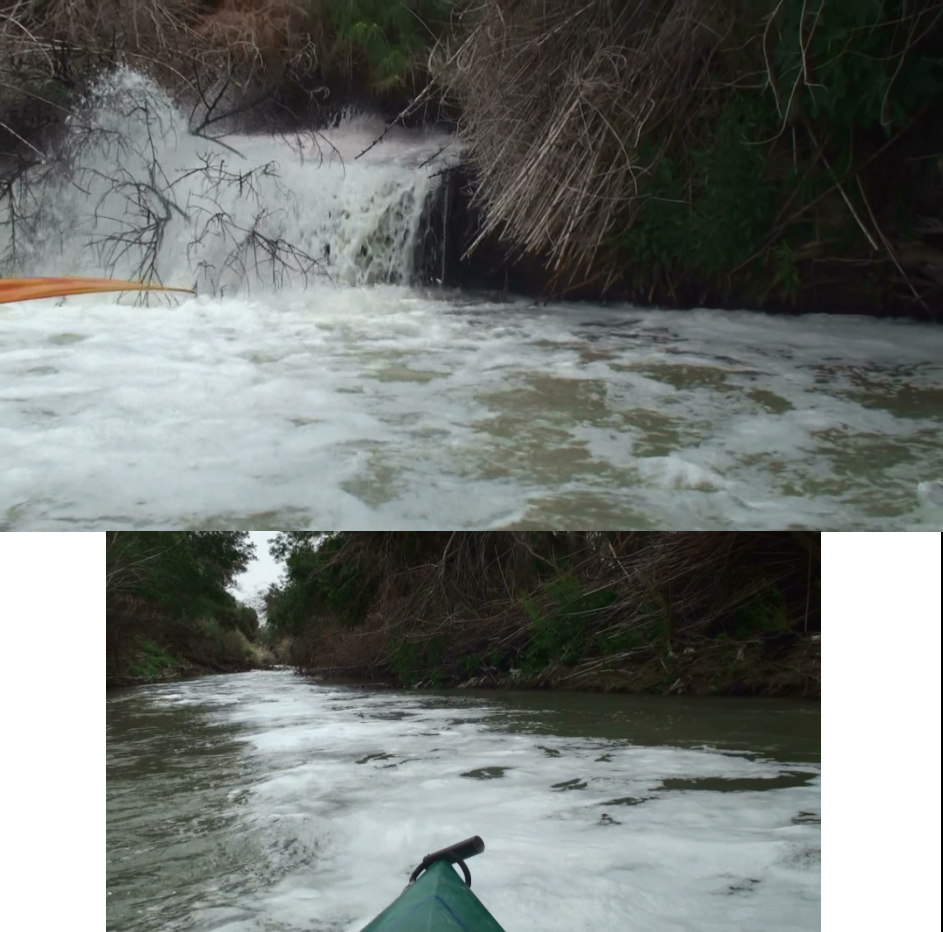
The bacteria values for the features of concern, listed in Table 2, show that the Feature 39, the Zacate Creek WWTP outfall, in the U.S., had low bacteria, and this drain is eliminated as a likely cause of bacteria in the river. The other drain in the U.S. (Feature 29) had bacteria levels above both U.S. and Mexican standards, but had much lower bacteria levels than other drains tested. This stormwater drain was not discharging at the time of sampling.

Three wastewater outfalls from the U.S. enter the Rio Grande in our study area. Zacate Creek WWTP is the only plant in the Target Area. As discussed previously, the Zacate Creek WWTP (F39) had low bacteria counts (10 #/100ml *E. coli* and 256.2 #/100ml fecal coliform) during the August sampling. River samples from the May sampling event were high upstream of the Zacate Creek WWTP. However, it is of note that the Zacate Creek WWTP has had effluent violations in the past two years <sup>[1]</sup>.

Although all three plants have had effluent violations in the past two years, because Zacate Creek WWTP had extremely low bacteria values during this study, we can conclude that Zacate Creek WWTP may not be contributing to the bacteria levels in the river, but the Southside and Regional plants may be contributing and should be investigated further. Both the Southside and Regional plants discharge downstream of the Target Area of this study and therefore were not part of the focus of the study.

| | U.S. | <p><b>Feature 39 –</b></p> <p>Zacate Creek WWTP outfall. Discharging large volume. Island between outfall and river creates a fast flow with lots of foam (second photograph). Fishermen have set up large nets at end of this island and outfall flow.</p> | 27.49846, -99.4933 |

The City of Laredo Utilities Department is improving and expanding both water and wastewater plants in Laredo. The City of Laredo received funds from the American Recovery and Reinvestment Act to upgrade the Jefferson Water Plant as well as several waterline replacements. Grants and bonds are also allowing the city to expand various wastewater treatment plants throughout the city and close the Zacate Creek WWTP by 2015 <sup>[21]</sup>.

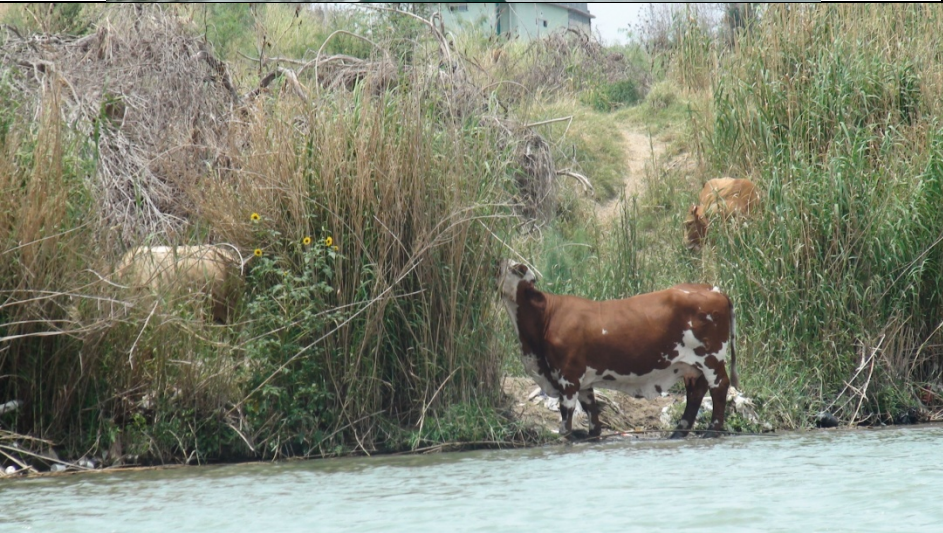
| | MEX | <p><b>Feature 40a –</b></p> <p>Cattle path leading up to a building on the bank. Lots of fishermen nearby.</p> | 27.49718, -99.49201 |

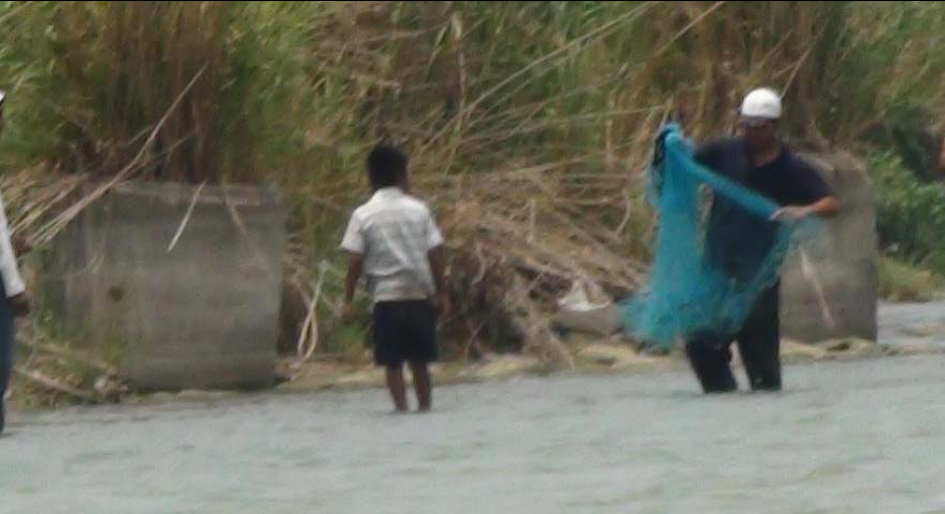
| | MEX | <b>Feature 40b –</b><br><br>Cement blocks in river. On opposite side of outfall island in 39b. Unable to survey exact coordinates or get closer photo | 27.49702, -99.4926 |

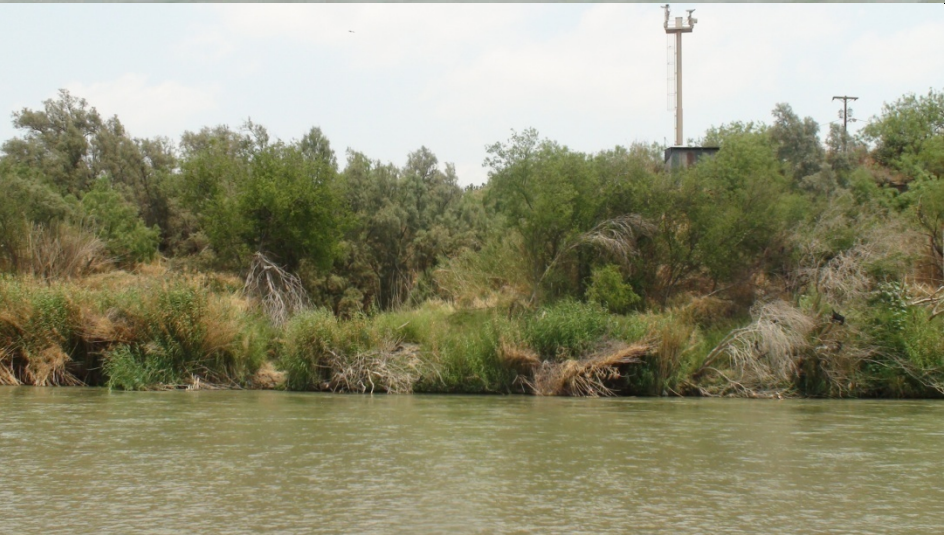
| | U.S. | <b>Feature 41 –</b><br><br>Tower and metal structure on U.S. bank with antenna. Possible old intake? No pipe visible on bank. | 27.49486, -99.48757 |

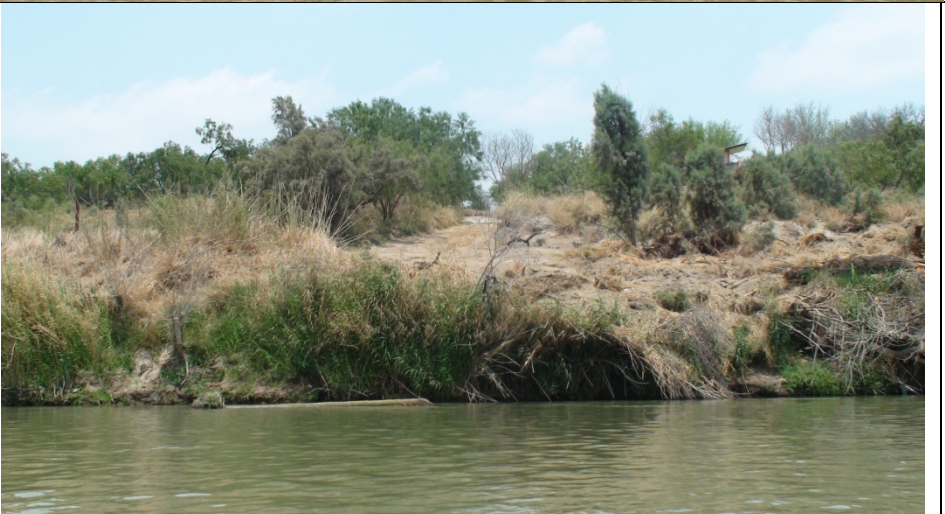
| | U.S. | <b>Feature 42a –</b><br><br>Dirt road down to river | 27.49239, -99.48344 |

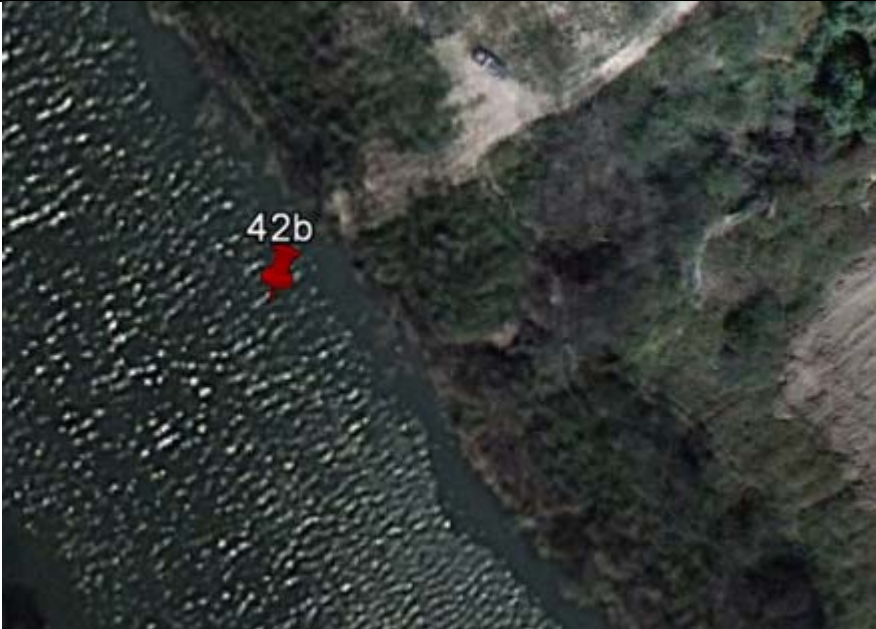
| | U.S. | <b>Feature 42b –</b><br><br>Dirt boat ramp.<br>No photo taken.<br>GPS estimated from Google Earth based on field notes (screenshot shown on left). | 27.49045,<br>-99.48235 |

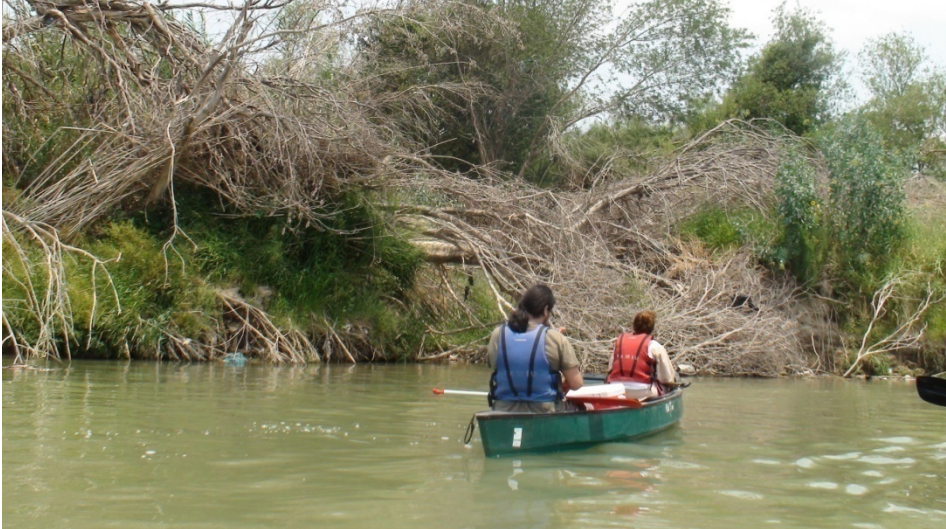
| | U.S. | <b>Feature 43 –</b><br><br>Small arroyo.<br>Outlet not clearly visible. | 27.49039,<br>-99.48214 |

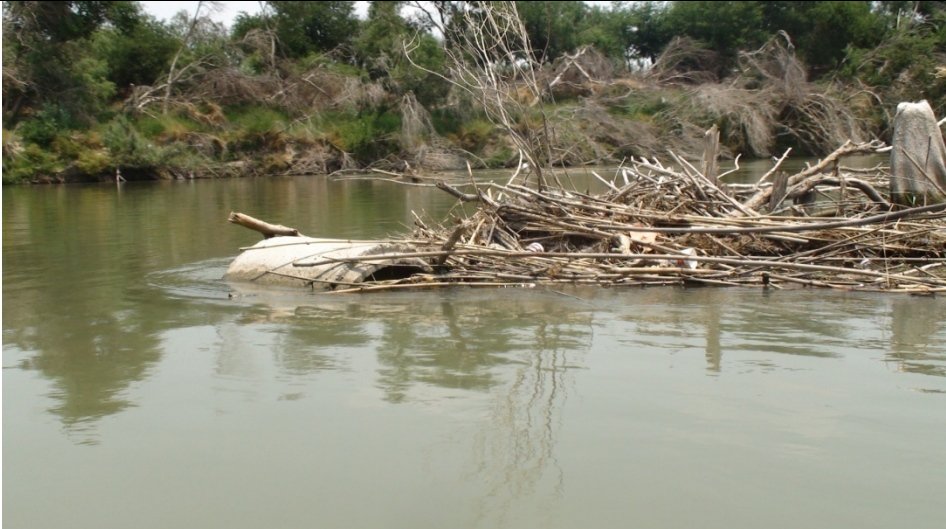
| | MEX<br>? | <b>Feature 44 –</b><br><br>Historical drain at Station 13148; however crew was unable to locate drain. Instead, crew saw a round piece of cement pipe just downstream of target drain location. | 27.48808,<br>-99.48117 |

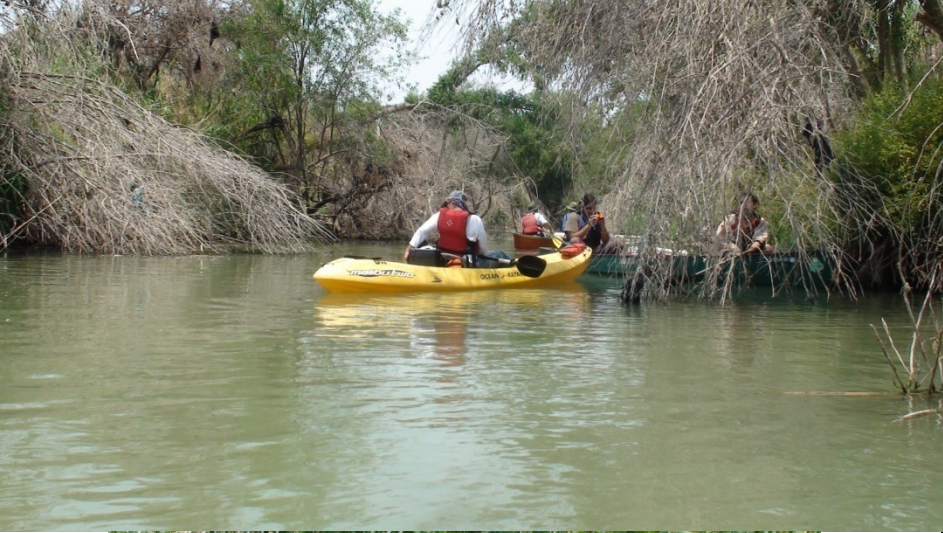
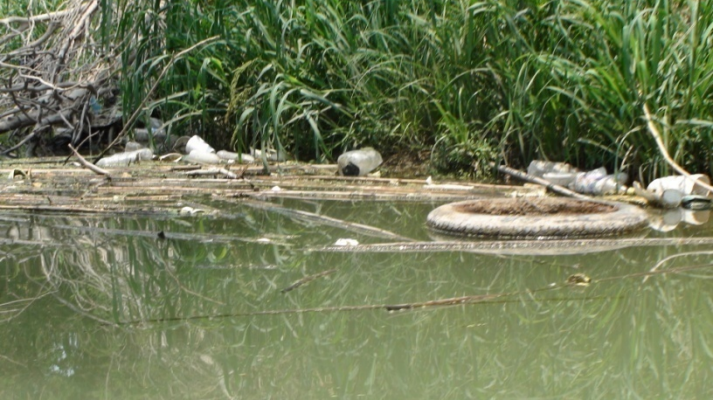
| | U.S. | <b>Feature 45a –</b><br><br>Chacon Creek and lots of trash in the creek. | 27.48394, -99.47919 |

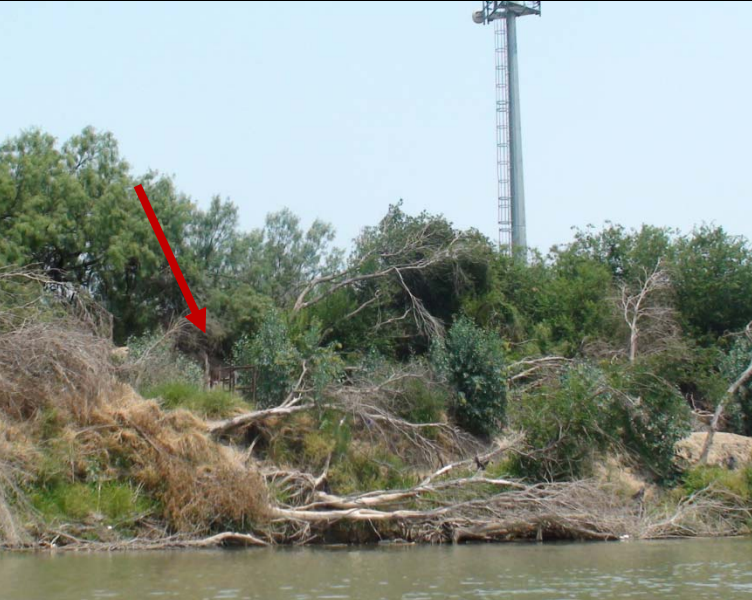
| | U.S. | <b>Feature 45b –</b><br><br>Tower with metal fence or stair rail structure on bank. Difficult to see. May be an intake or other structure. | 27.48490, -99.47948 |

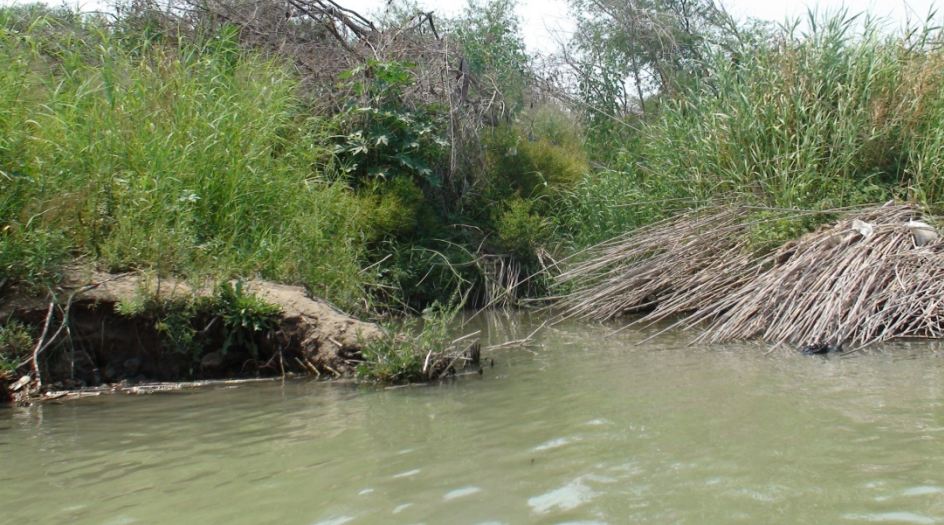
| | MEX | <p><b>Feature 46 –</b></p> <p>Tributary or erosion channel?</p> <p>Review of aerial photography does not seem to show any arroyos in the area.</p> | 27.48217, -99.47953 |

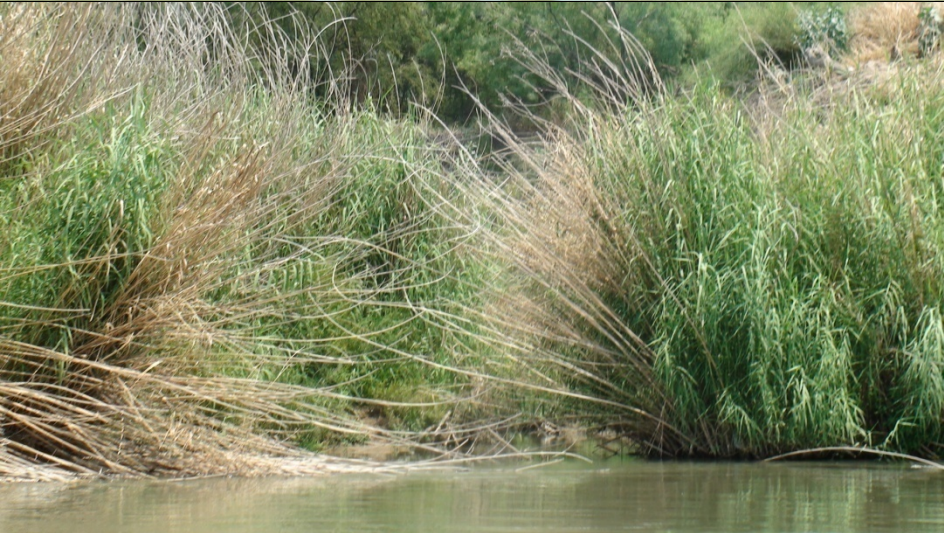
| | U.S. | <p><b>Feature 47a –</b></p> <p>Small tributary or erosion channel. Slight indication of structure behind vegetation but difficult to see. No structure seen in Google Earth. Just upstream of F47b.</p> | 27.47909, -99.4784 |

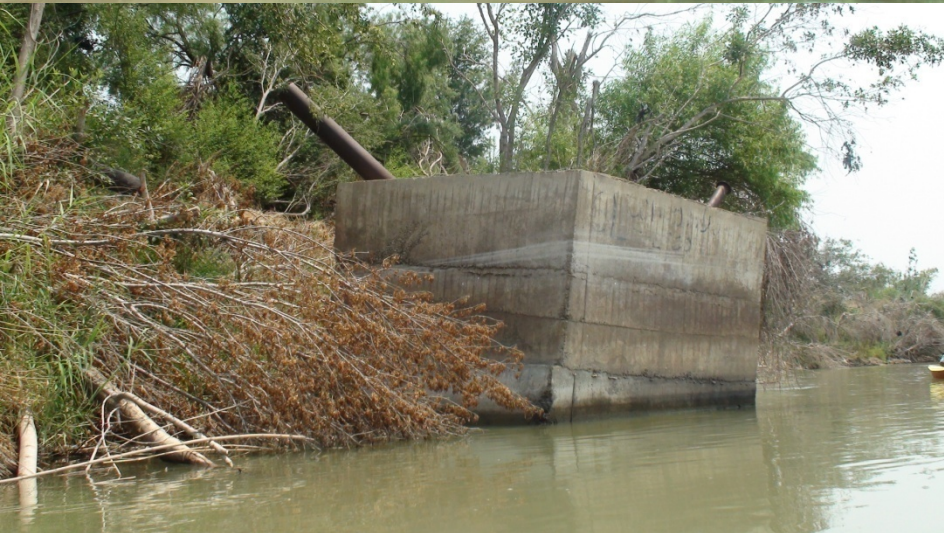
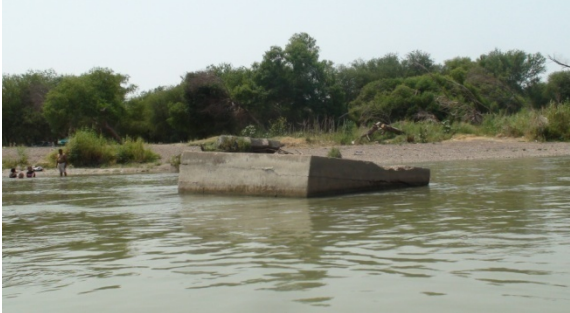
| | U.S. | <p><b>Feature 47b –</b></p> <p>Large cement block with metal pipes dislodged on bank, appears to be old sump. Piece of block is in center of river. Immediately upstream of block are two metal pipes that appear to be intake pipes.</p> | 27.47862, -99.47867 |

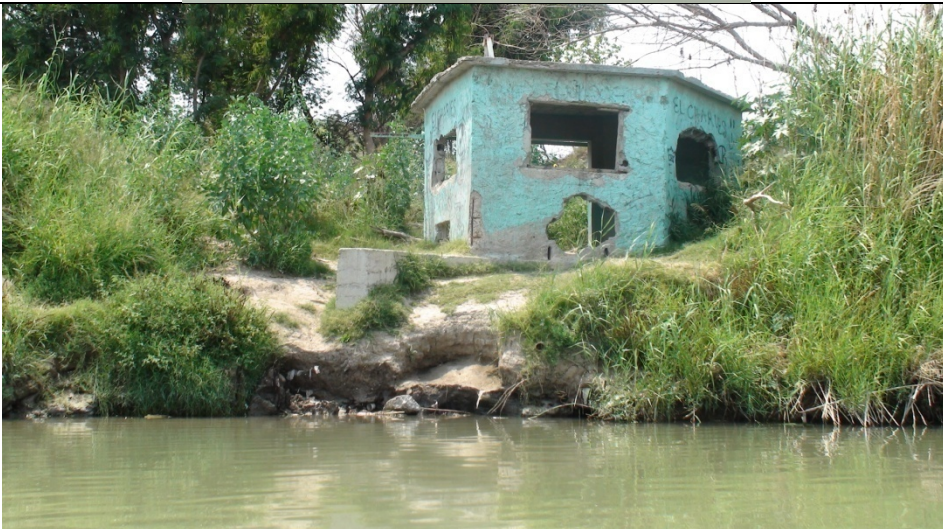
| | | | MEX | <b>Feature 48 –</b><br><br>Old blue building on Mexican bank just upstream of F49. | 27.47514, -99.48261 |

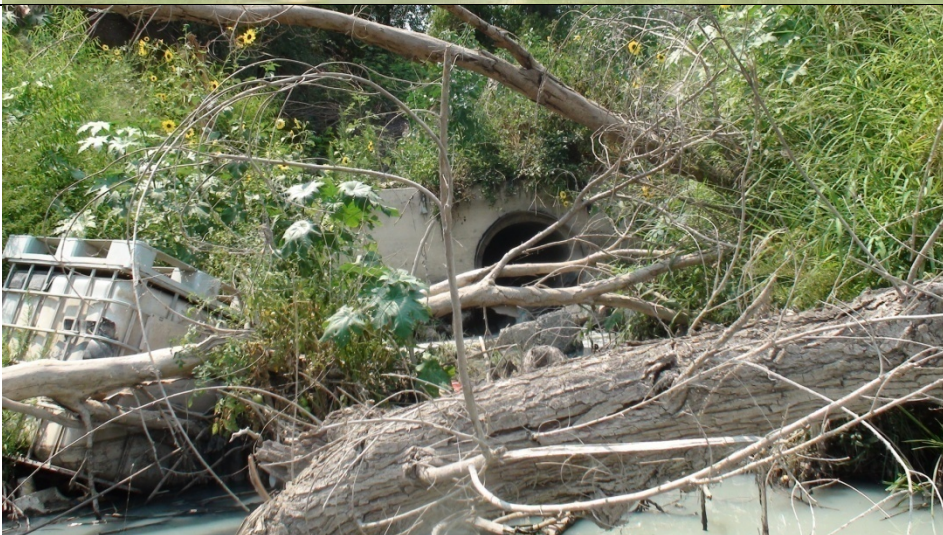
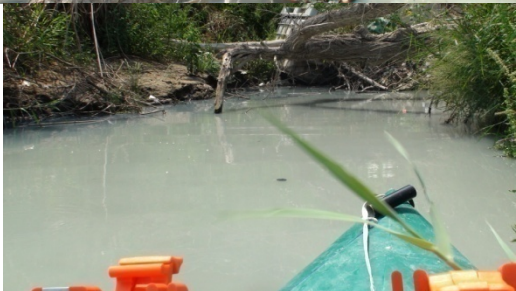
| | | | MEX | <b>Feature 49 –</b><br><br>Cement drain with pipe and murky grey/white discolored discharge. Lots of trash and foul smell. | 27.47479, -99.48296 |

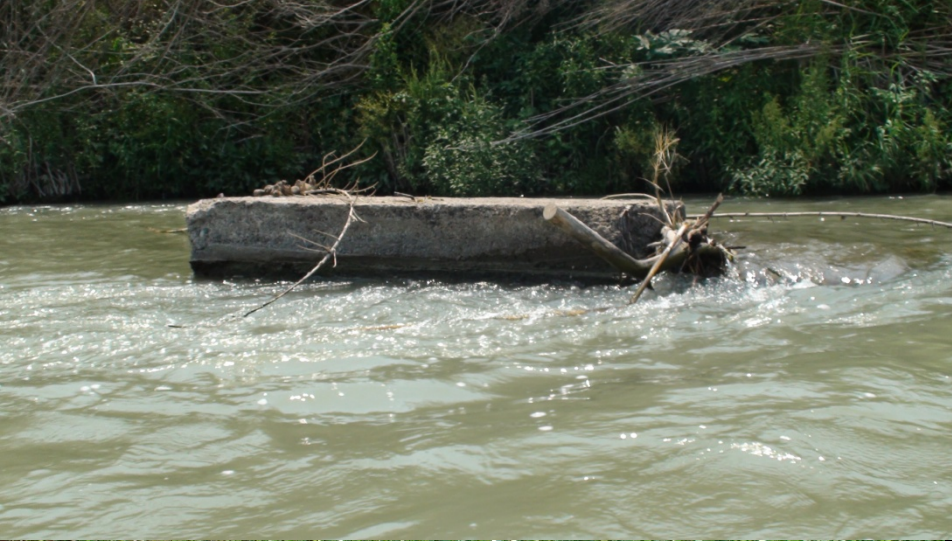
| | MEX | <p><b>Feature 50 –</b></p> <p>Crew looked for historical drain in Mexico at Station 13155; crew did not find drain, but did find cement structure debris in river below target drain location.</p> | 27.47053, -99.48317 |

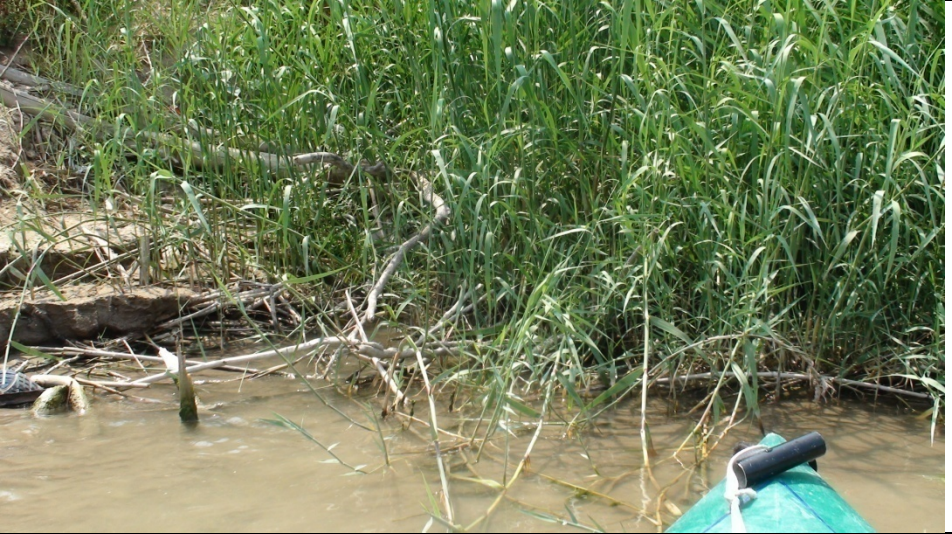
| | MEX | <p><b>Feature 51 –</b></p> <p>Audible discharge. Crew heard water flowing here but could not find a drain opening or pipe behind the cane.</p> | 27.46868, -99.48333 |

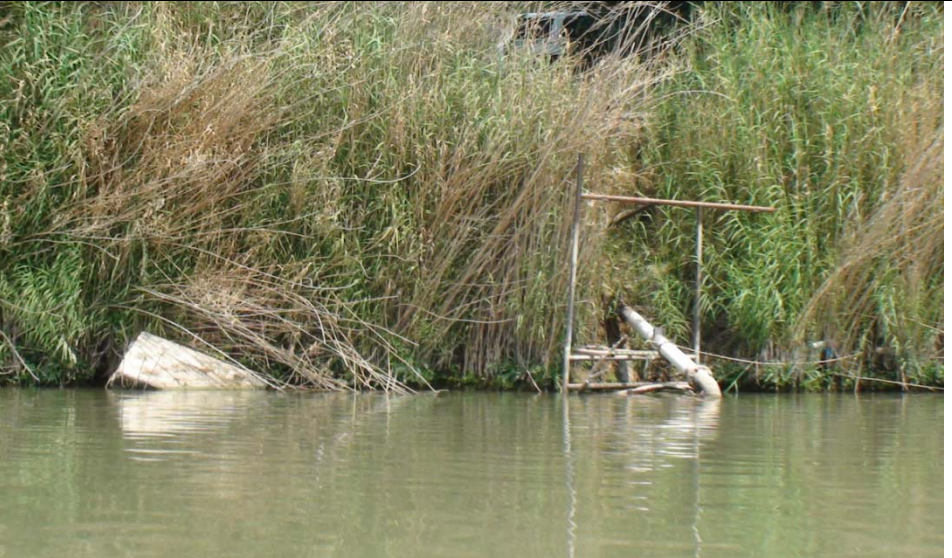
| | U.S. | <p><b>Feature 52 –</b></p> <p>Small pipe with white elbow, probably intake. Border Patrol agents standing here. Trash in river.</p> | 27.46702, -99.48306 |

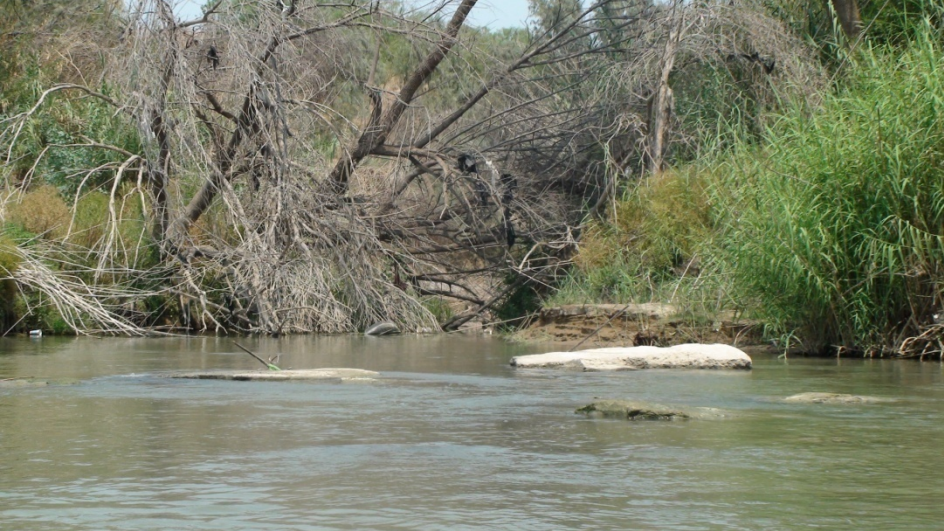
| | U.S. | <b>Feature 53 –</b><br><br>Creek with cement debris at confluence. | 27.46439,<br>-99.48483 |

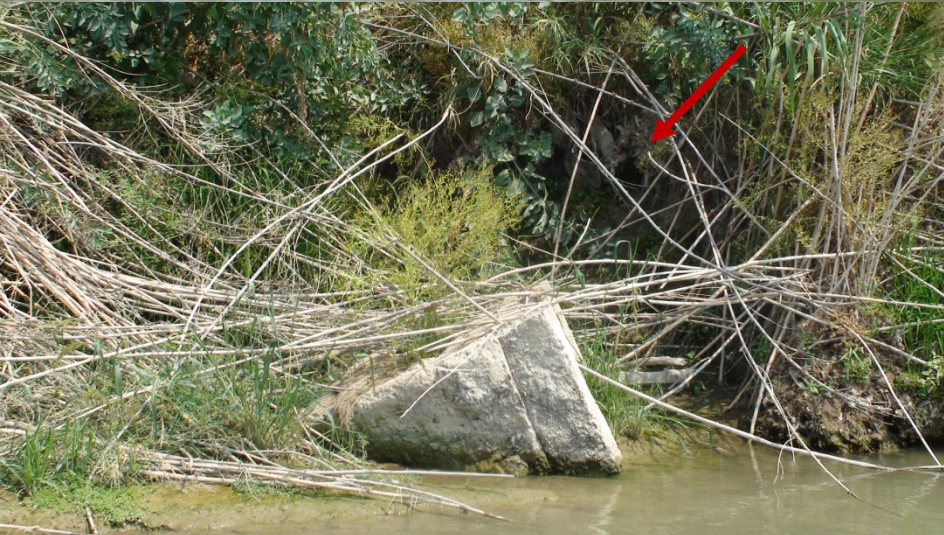
| | U.S. | <b>Feature 54a –</b><br><br>Old black pipe in bank with cement debris in river. Downstream of large house on bank. | 27.46237,<br>-99.48589 |

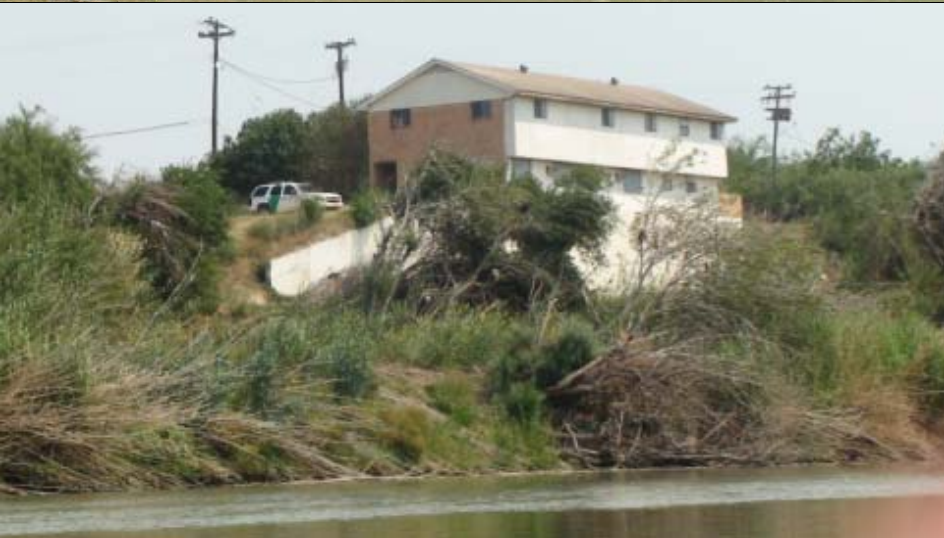
| | U.S. | <b>Feature 54b –</b><br><br>Large house on bank with large retaining wall on bank. Border Patrol vehicle parked here. Antenna. | 27.46217,<br>-99.48599 |

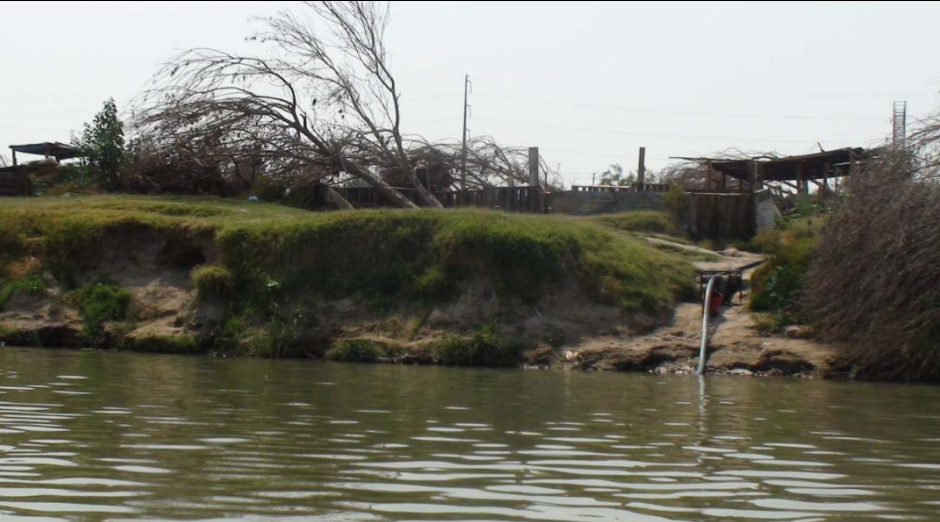
| | MEX | <b>Feature 55a –</b><br><br>Pump equipment on bank, not permanent pipe. Residential, possibly animal structures at top of bank. | 27.45934, -99.48855 |

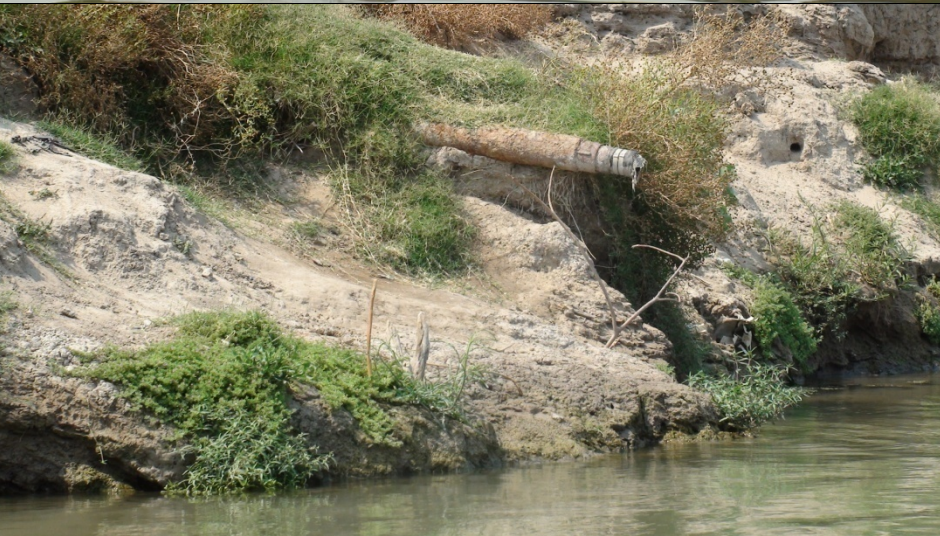
| | MEX | <b>Feature 55b –</b><br><br>Rusted pipe directly upstream of 55c. | 27.45854, -99.48943 |

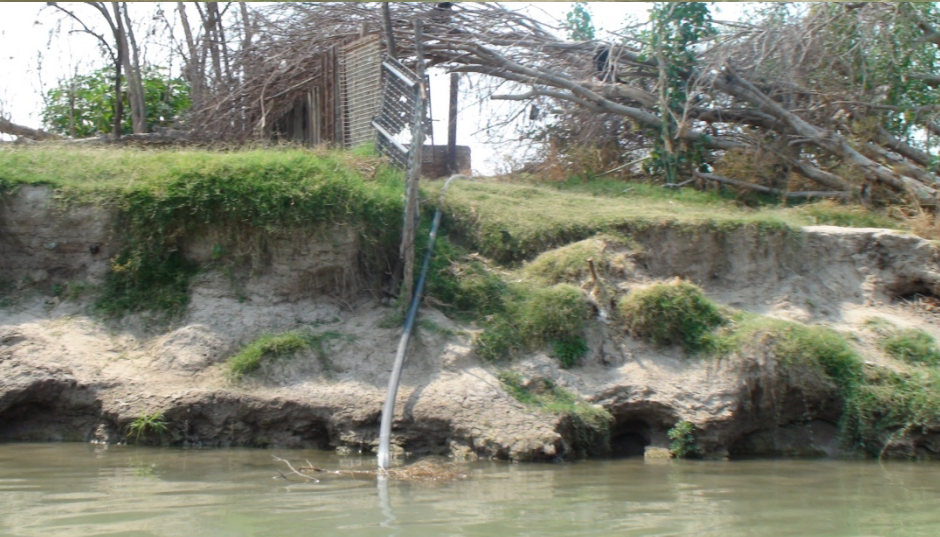
| | MEX | <b>Feature 55c –</b><br><br>Small blue intake pipe, not permanent pipe. Animal fences and grazing evidence. Just downstream of F55b. | 27.45858, -99.48944 |

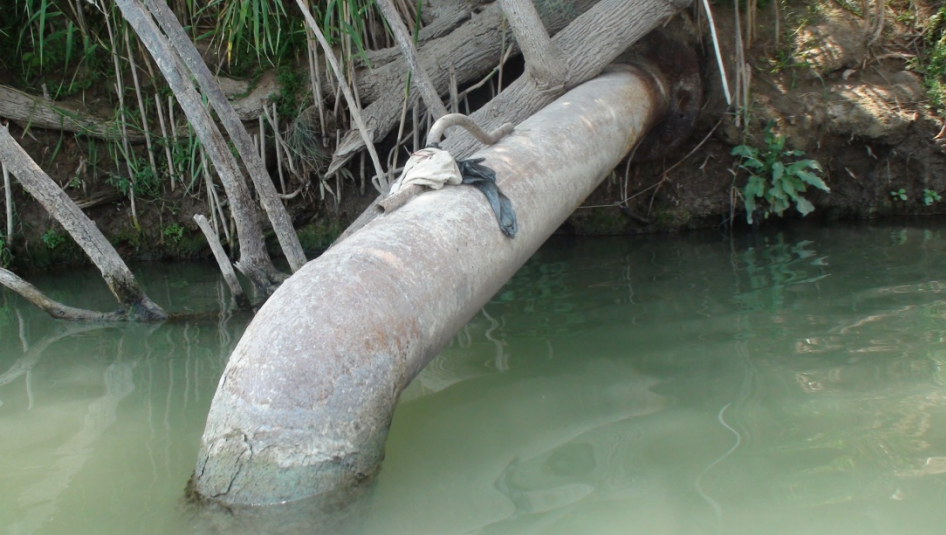
| | MEX | <p><b>Feature 58 –</b></p> <p>Large brown rusted pipe, appears to be intake.</p> | 27.45358, -99.4934 |

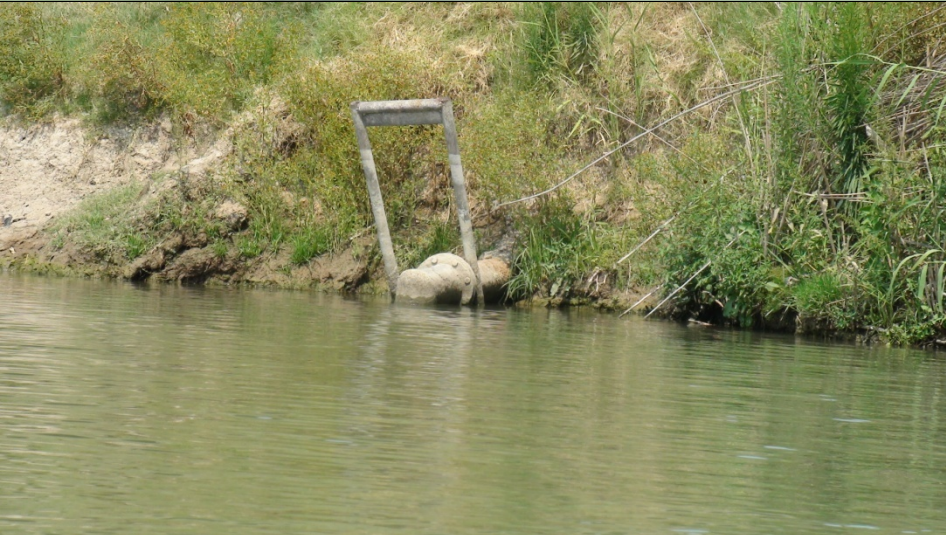
| | U.S. | <p><b>Feature 59 –</b></p> <p>Rusted pipe with metal frame, appears to be intake.</p> | 27.45137, -99.49356 |

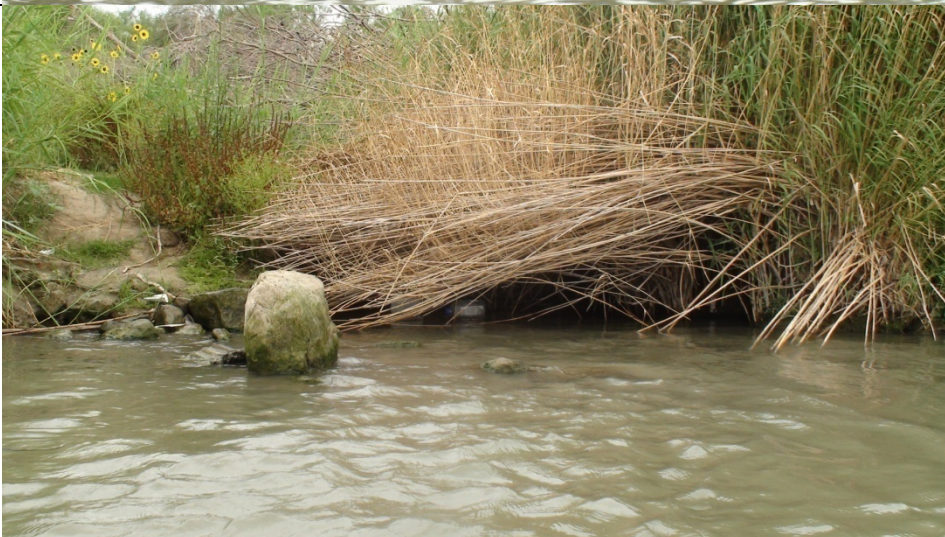
| | MEX | <b>Feature 62 –</b><br><br>Small side channel with dead cane and some trash and a path down to river next to it. | 27.44355, -99.49599 |

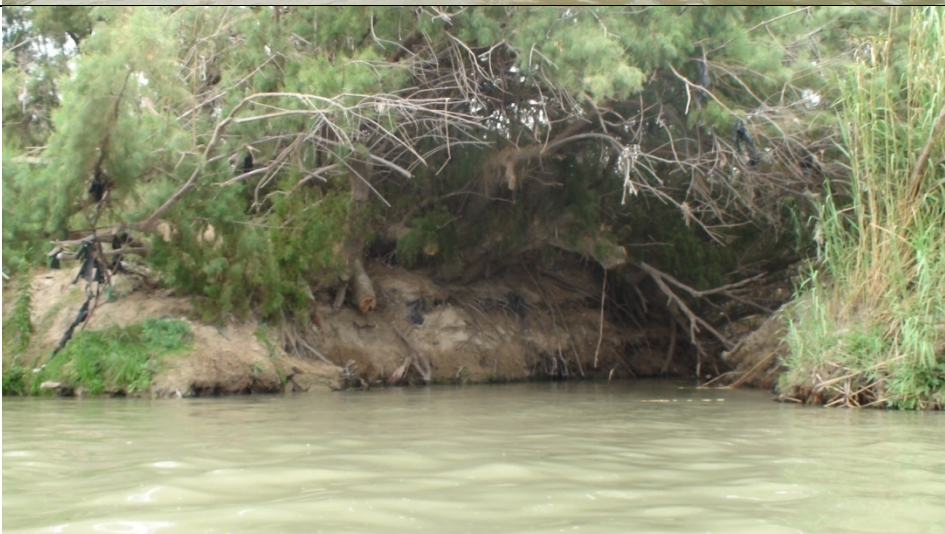
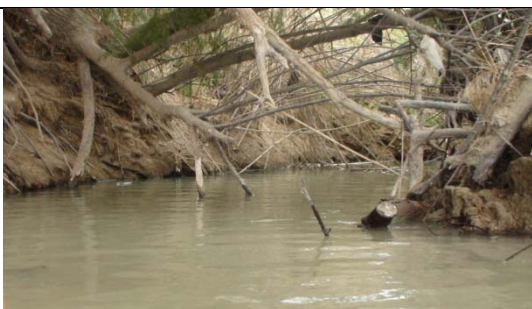
| | U.S. | <b>Feature 63 –</b><br><br>Arroyo with freshly cut logs clearing channel. | 27.44304, -99.49527 |

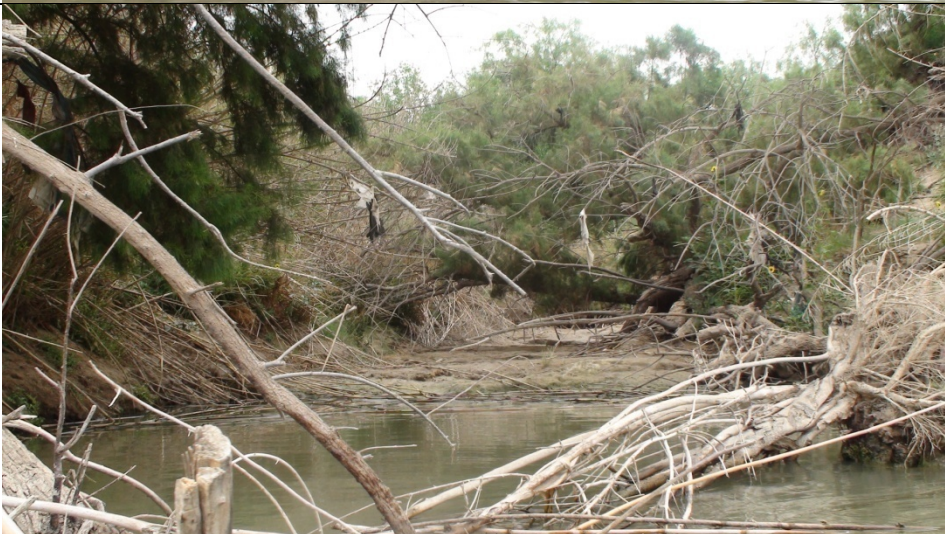
| | U.S. | <b>Feature 65 –</b><br><br>Dry arroyo across from F64. | 27.43188, -99.49322 | |

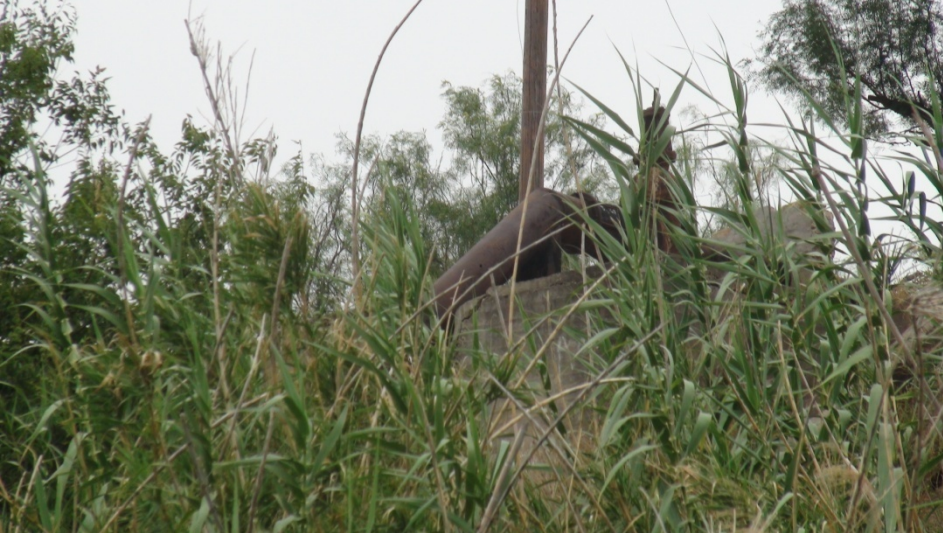
| | U.S. | <p><b>Feature 66 –</b></p> <p>Metal pipe and cement structure on top of U.S. bank. End of pipe near river not visible due to heavy cane. Structure appears to be pumping equipment.</p> | 27.42931, -99.49224 |

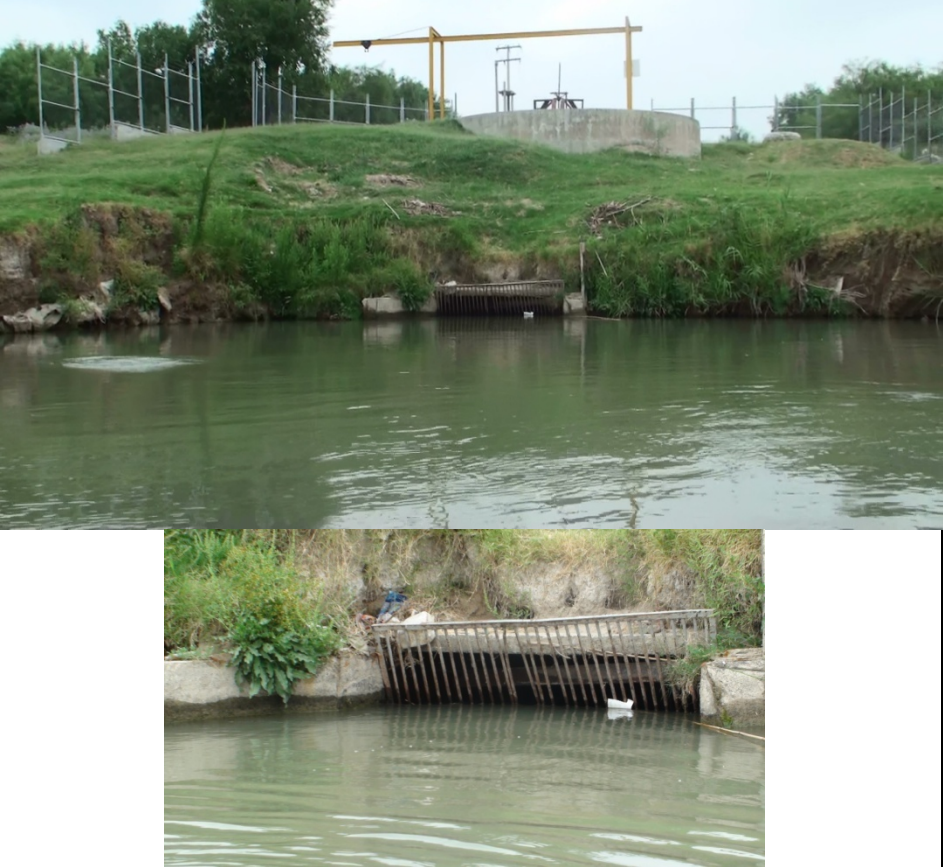
| | MEX | <p><b>Feature 67 –</b></p> <p>Large circular structure on bank, looks like pump, with drain and a grate covering the drain or intake. Crew heard water draining in to grate.</p> | 27.458, -99.49164 |

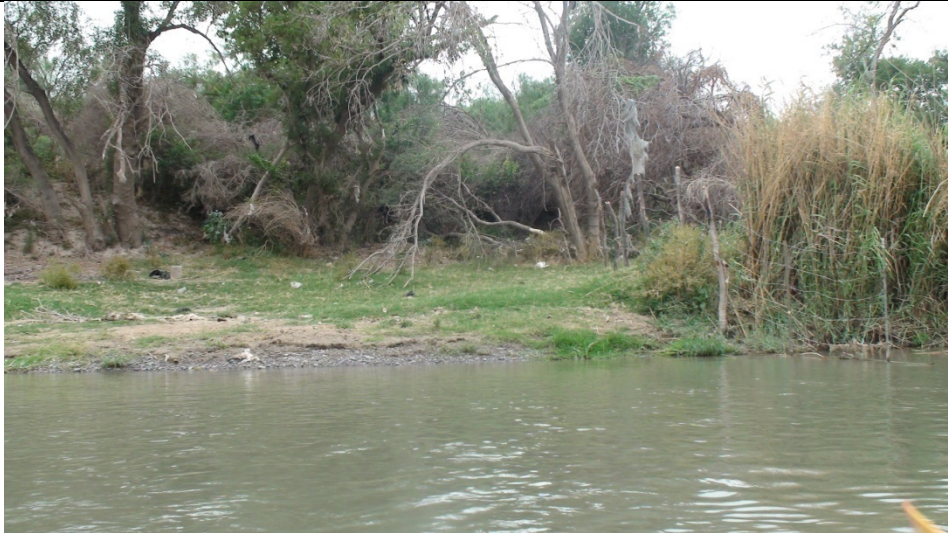
| | MEX | <p><b>Feature 68 –</b></p> <p>Grazing along bank. Fence separates grazed and non-grazed sections.</p> | 27.42414, -99.49153 |

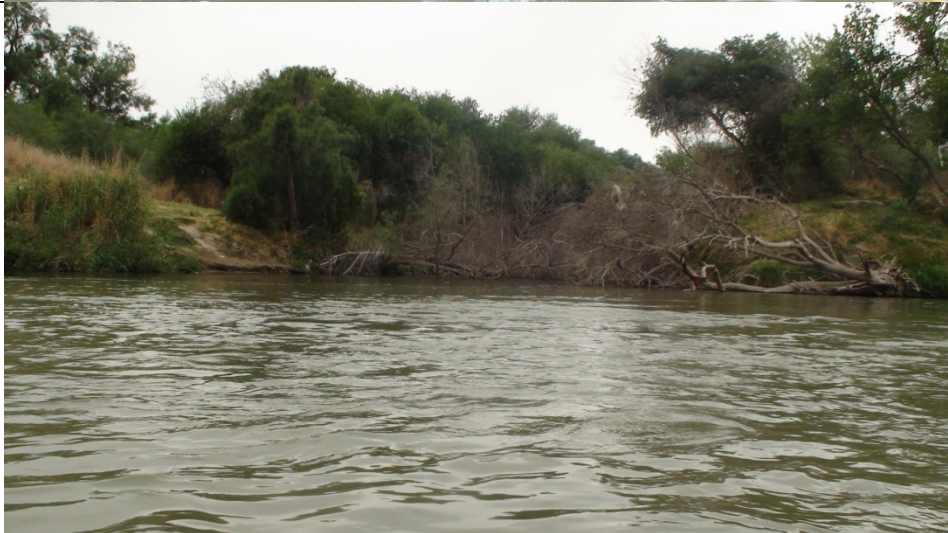
| | MEX | <p><b>Feature 69 –</b></p> <p>Arroyo El Coyote. Crew was unable to find NLIWTP effluent location near here; Mexican entities confirmed via phone while crews were out that the NLIWTP discharges into Arroyo El Coyote.</p> | 27.41817, -99.4903 |

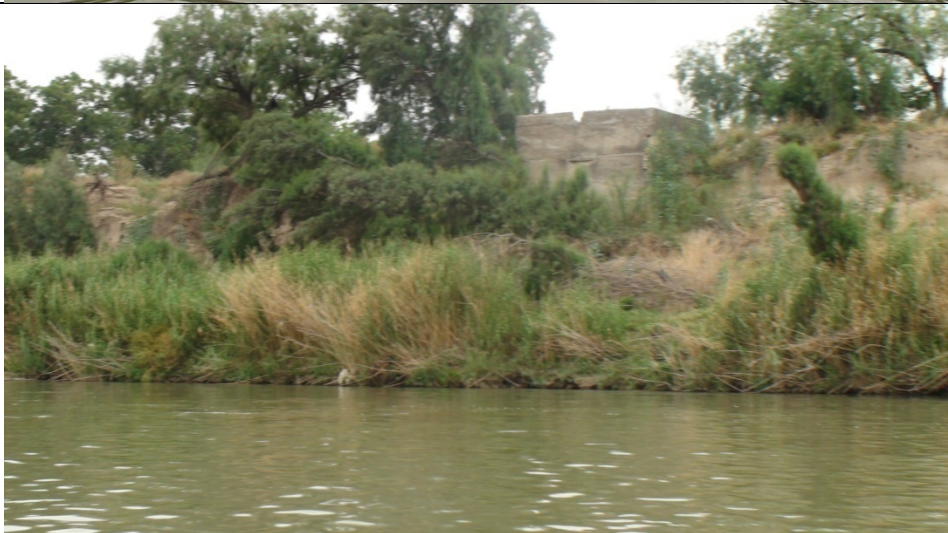
| | MEX | <p><b>Feature 70a –</b></p> <p>Cement square structure on bank.</p> | 27.41811, -99.48997 |

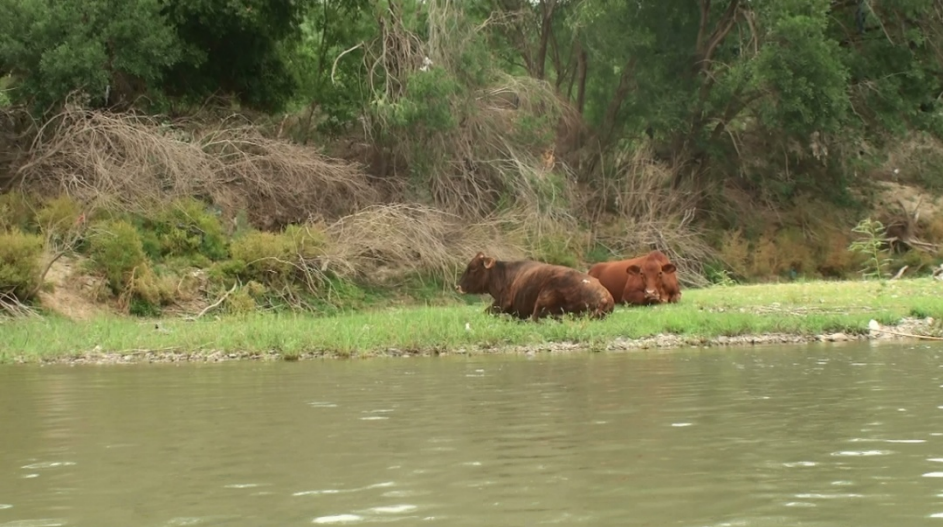
| | U.S. | <b>Feature 70b –</b><br><br>Island with cows.<br>Grazed. | 27.41783,<br>-99.48969 |

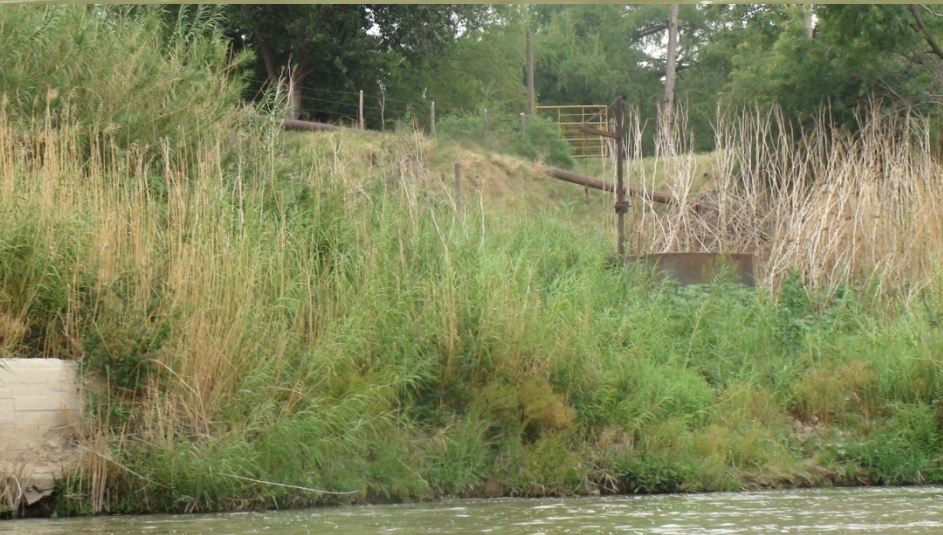
| | MEX | <b>Feature 71a –</b><br><br>Metal pipes and metal circular structure, appears to be well and pumping equipment. Crew thought this was ranch below NLIWTP effluent/ Arroyo El Coyote. | 27.4146<br>-99.48856 |

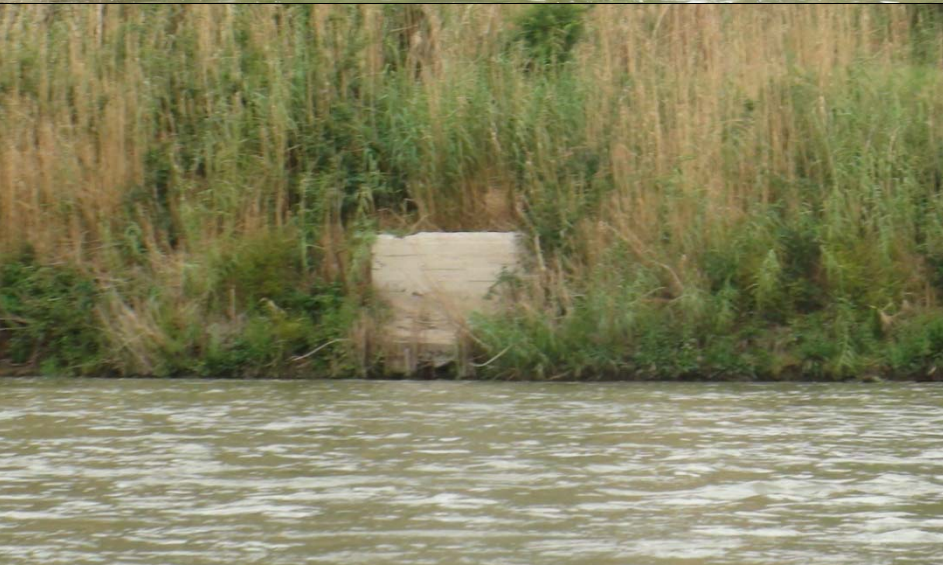
| | MEX | <b>Feature 71b –</b><br><br>Cement structure on bank directly downstream of F70a. | 27.41469,<br>-99.48856 |
