# **Bacteria Characterization in Rio Grande Segment 2304 near Laredo, Texas/ Nuevo Laredo, Tamaulipas**

**A Texas Clean Rivers Program Special Study  
FINAL REPORT**

**Field Work May and August 2011; Final Report November 2012**

**International Boundary and Water Commission, U.S. Section, Texas Clean Rivers Program**

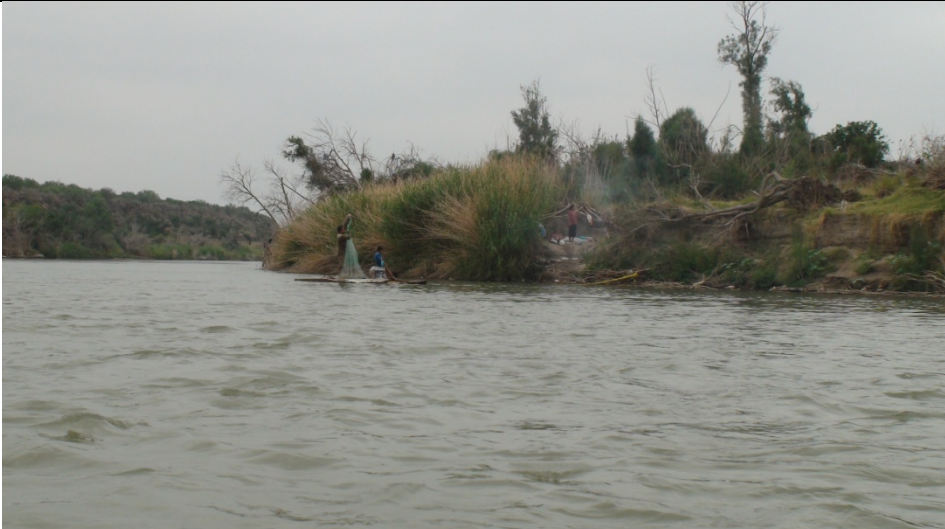
| | MEX | <b>Feature 71c –</b><br><br>Fishermen's path down to river with fire burning. Fishermen present. | 27.41333, -99.48797 |

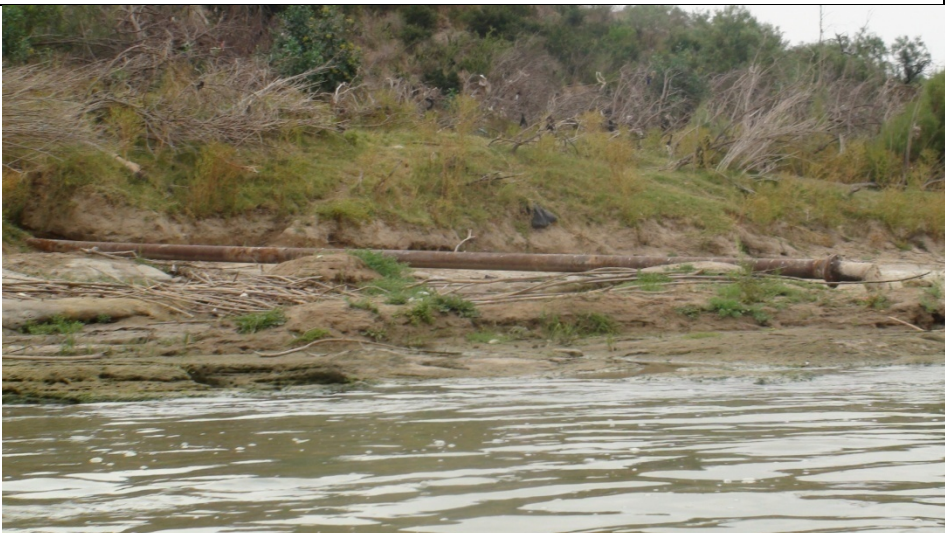
| | U.S. | <b>Feature 73a –</b><br><br>Long metal pipe, appears to be intake. | 27.41203, -99.48752 |

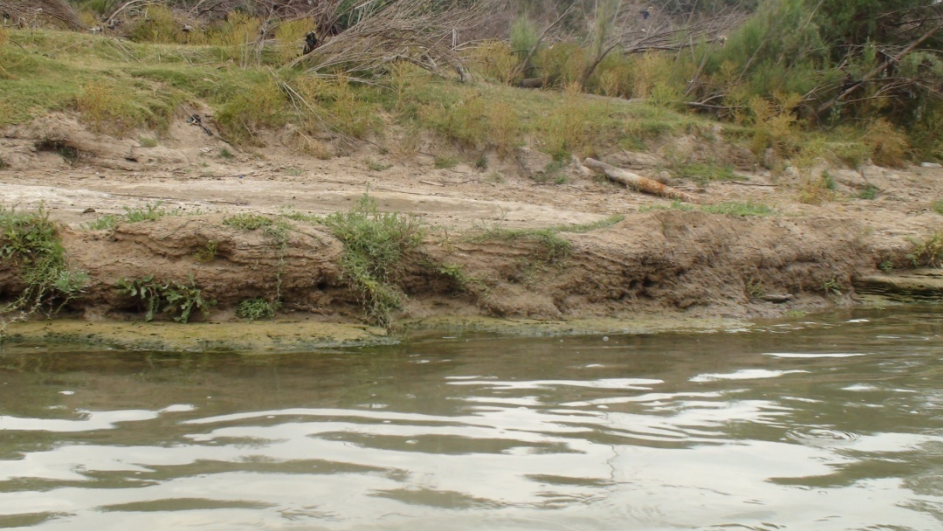
| | U.S. | <b>Feature 73b –</b><br><br>A second metal pipe next to F73. | 27.41203, -99.4875 |

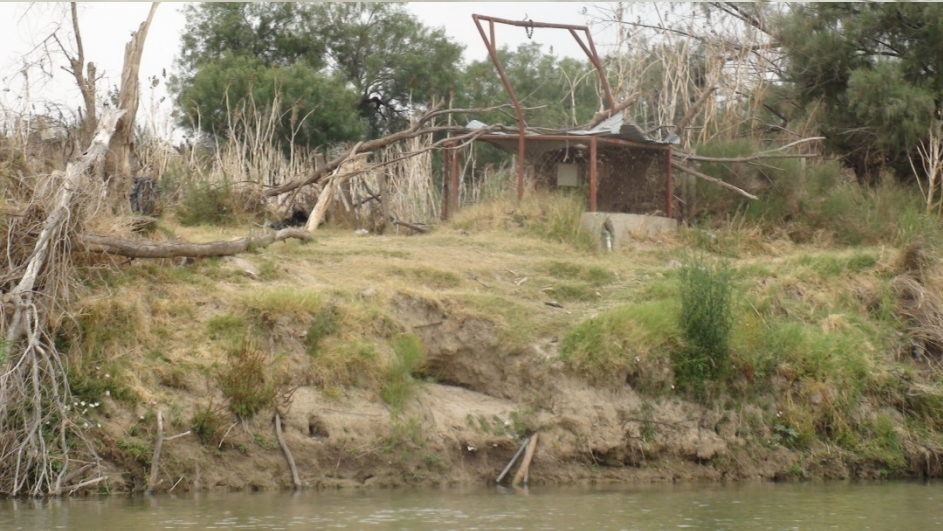
| | MEX | <b>Feature 74 –</b><br><br>3 Small blue-gray pipes with small red-framed building at top of bank. | 27.41182, -99.48784 |

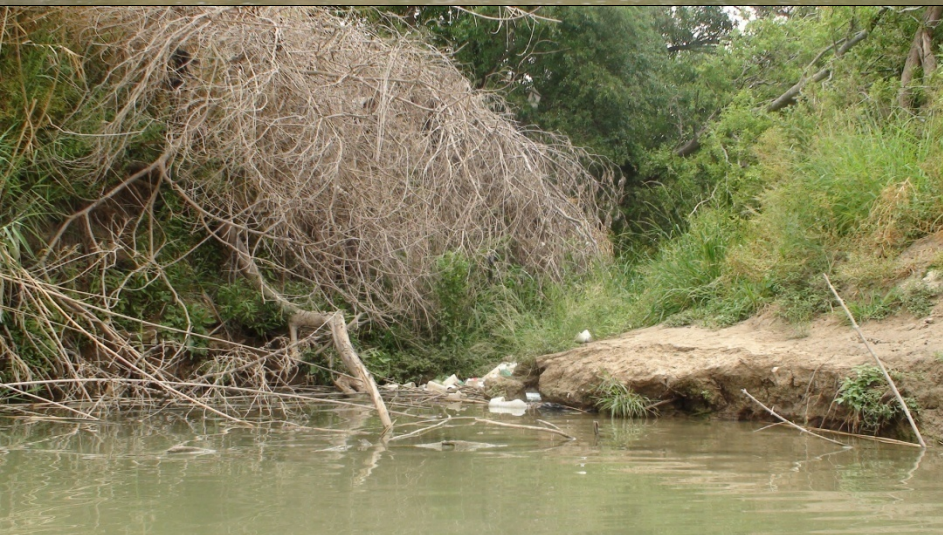
| | U.S. | <b>Feature 75 –</b><br><br>Arroyo with trash at mouth. | 27.40977, -99.48747 |

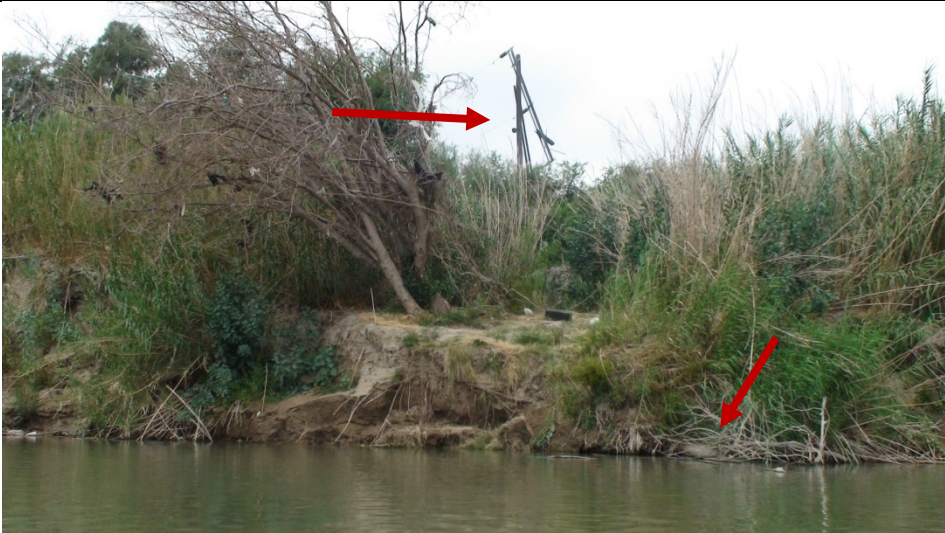
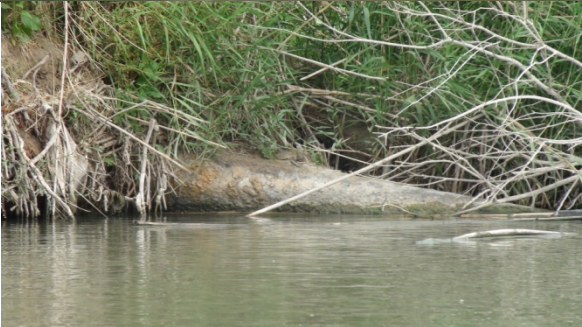
| | MEX | <b>Feature 76a –</b><br><br>Metal structure on bank and metal pipe almost hidden under water. | 27.40761, -99.48875 |

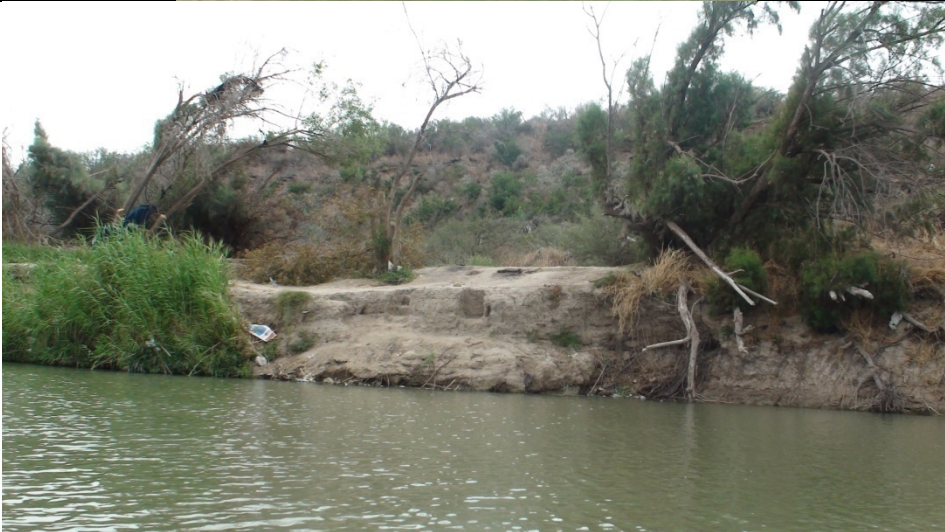
| | U.S. | <b>Feature 76b –</b><br><br>Path down to river with clearing on bank. | 27.40681, -99.48847 |

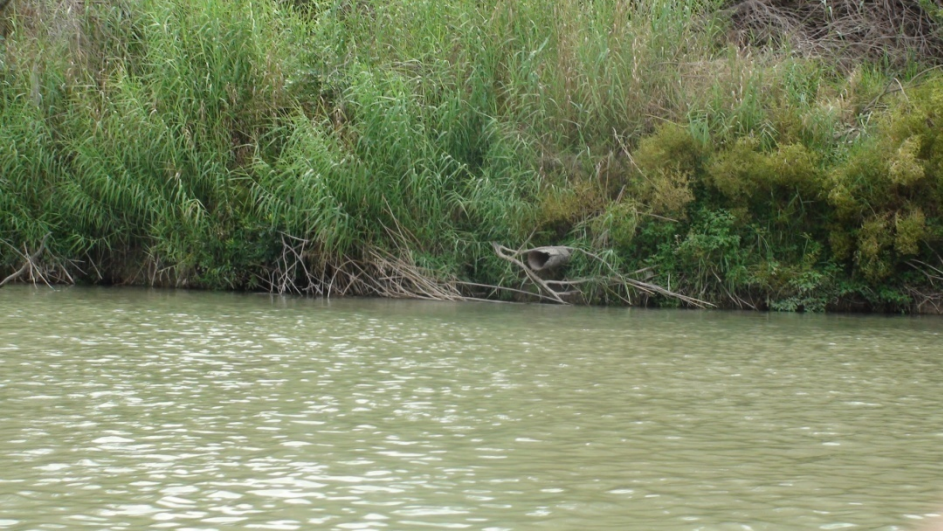
| | U.S. | <b>Feature 77a –</b><br><br>Small rusty pipe. | 27.40353,<br>-99.48883 |

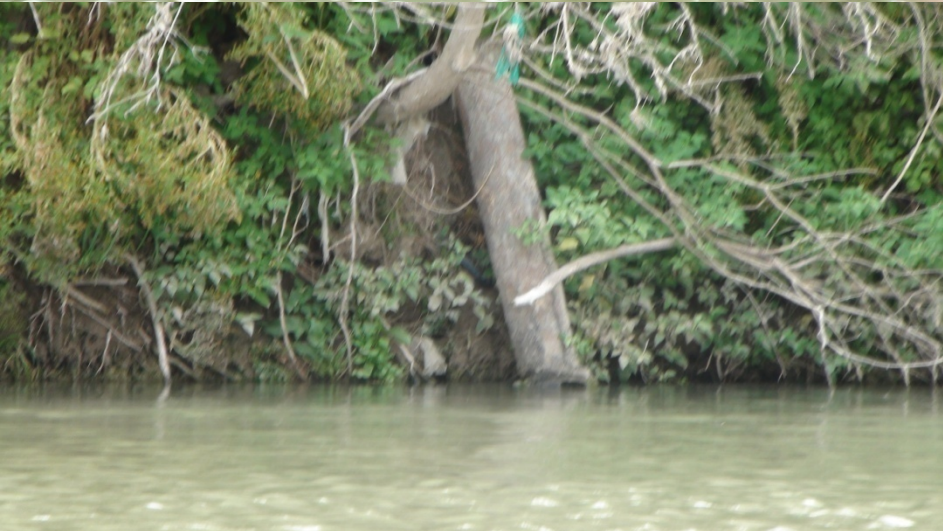
| | U.S. | <b>Feature 77b –</b><br><br>Small metal pipe just below 77a. | 27.40344,<br>-99.48872 |

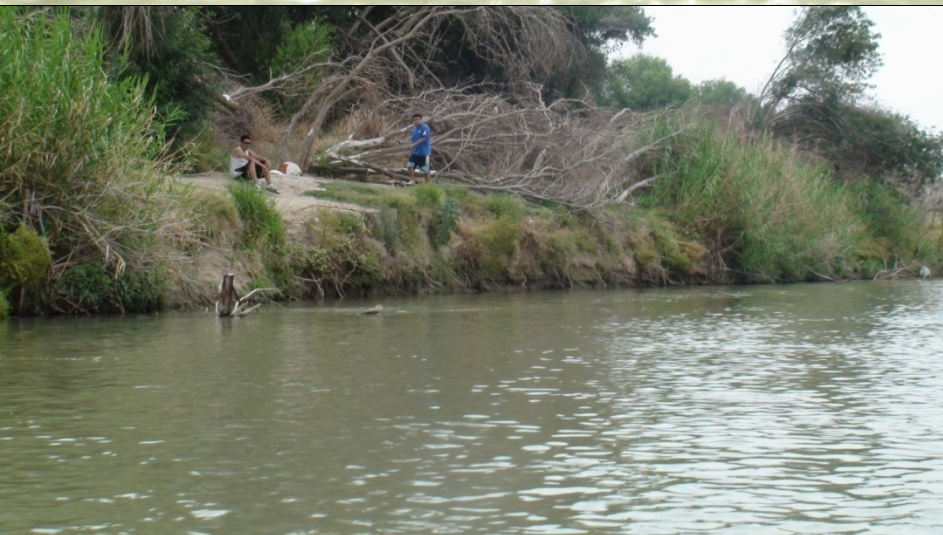
| | U.S. | <b>Feature 77c –</b><br><br>Path to river with fishermen just below F77b. | 27.40144,<br>-99.48897 |

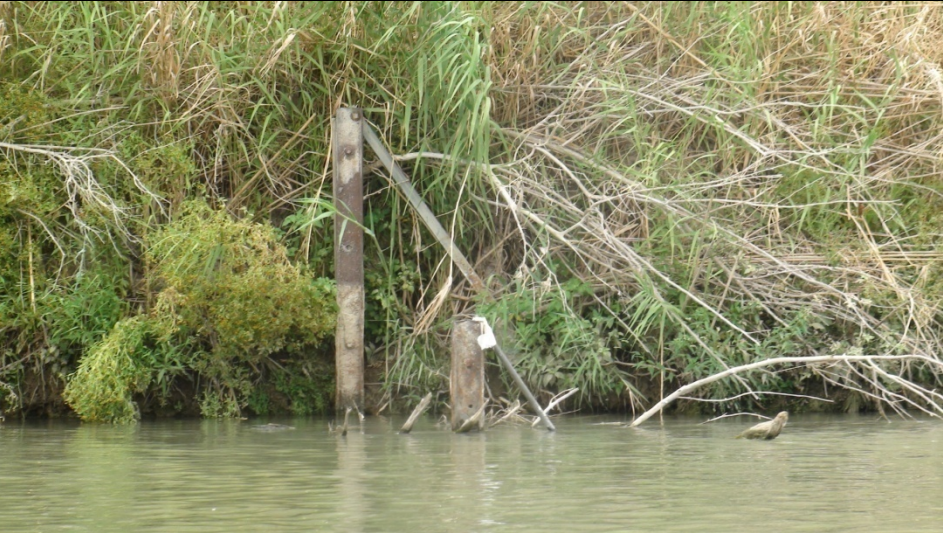
| | U.S. | <p><b>Feature 78 –</b></p> <p>Metal in water, appears to be a fence or old dock.</p> | 27.40111, -99.4891 |

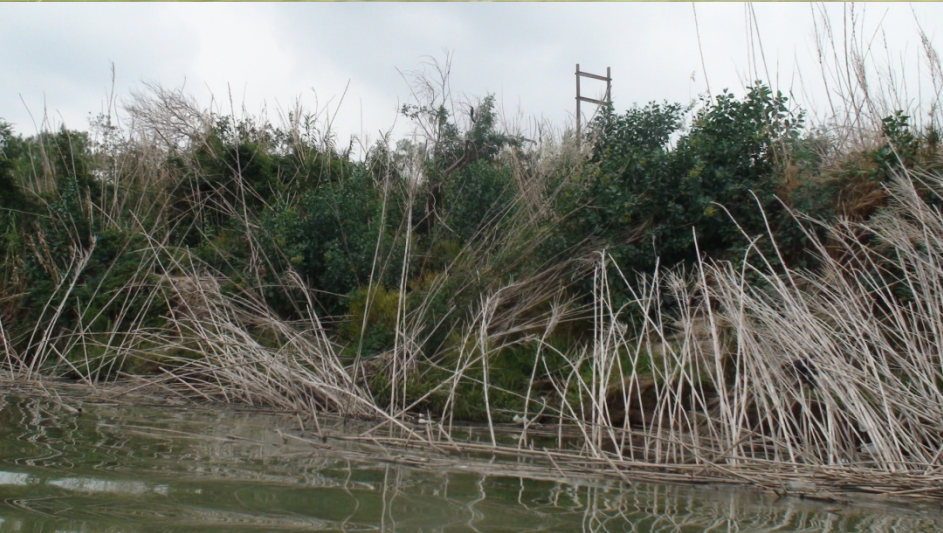
| | MEX | <p><b>Feature 79 –</b></p> <p>Metal structure visible on floodplain; however, no pipe or structure visible on bank due to vegetation.</p> | 27.39468, -99.49191 |

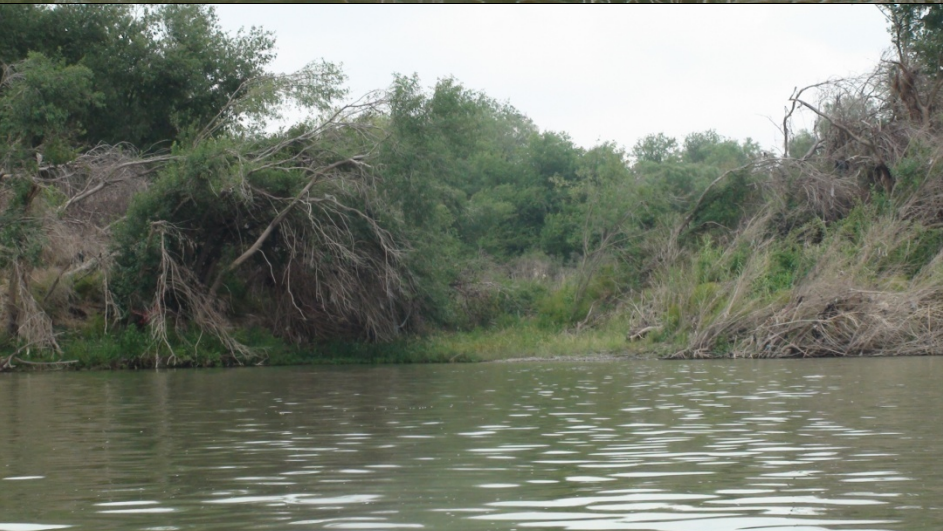
| | U.S. | <p><b>Feature 80 –</b></p> <p>Arroyo. Electric lines visible on Mexican side directly across from arroyo but no pipe or pump visible.</p> | 27.39329, -99.49273 |

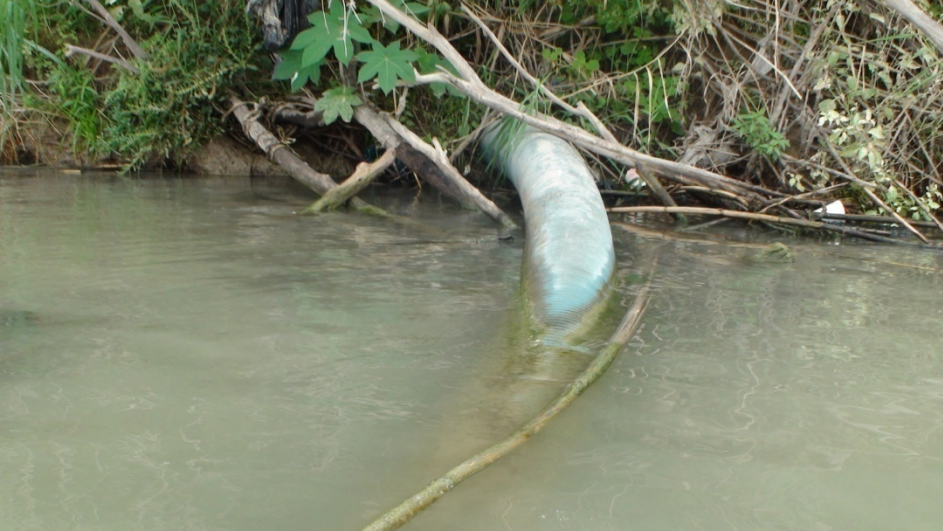
| | U.S. | <b>Feature 81 –</b><br><br>Plastic blue intake pipe. | 27.39035,<br>-99.49242 |

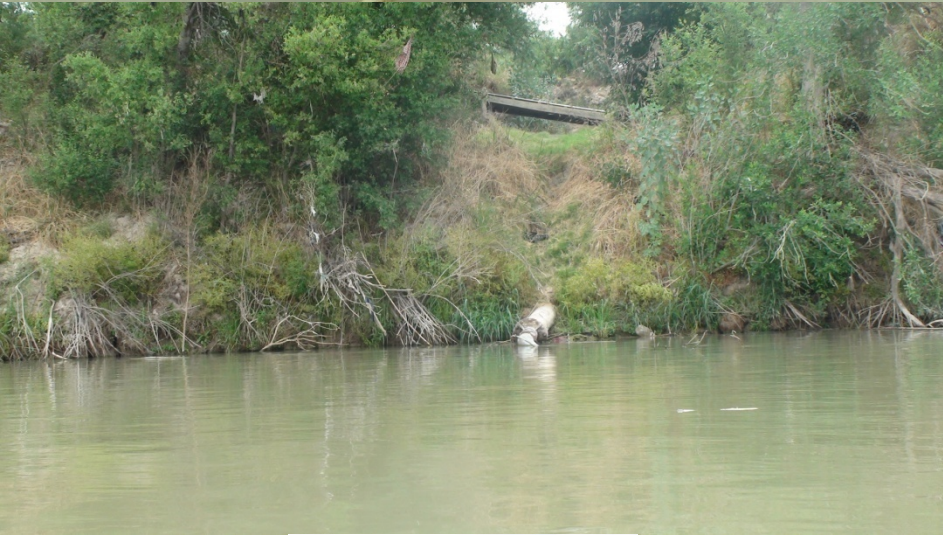
| <br> | U.S. | <b>Feature 82a –</b><br><br>Metal intake pipe. Above it is a pump structure with yellow pole and stairs. Above that is a tall tower, probably a Border Patrol lookout tower. | 27.38886,<br>-99.49258 |

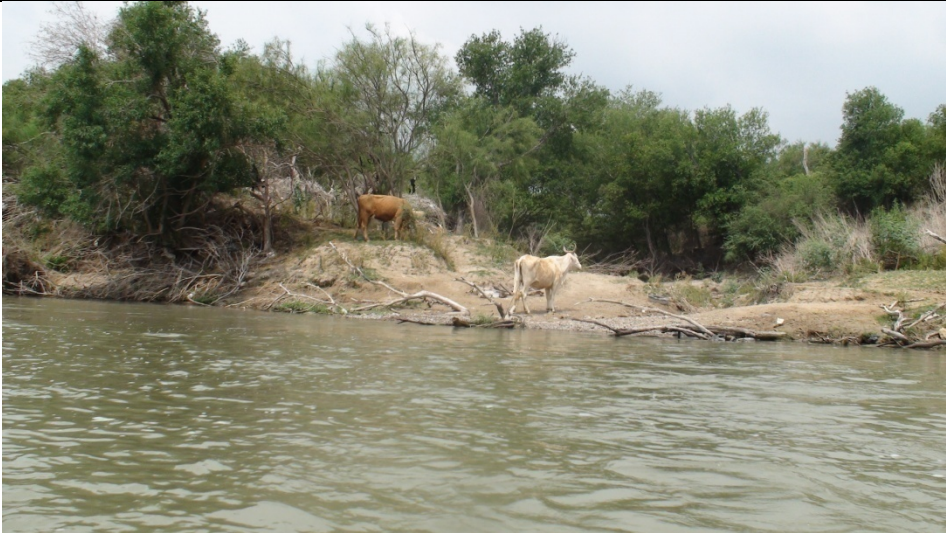
| | MEX | <b>Feature 82b –</b><br><br>Livestock path to river. | 27.37822,<br>-99.49447 |

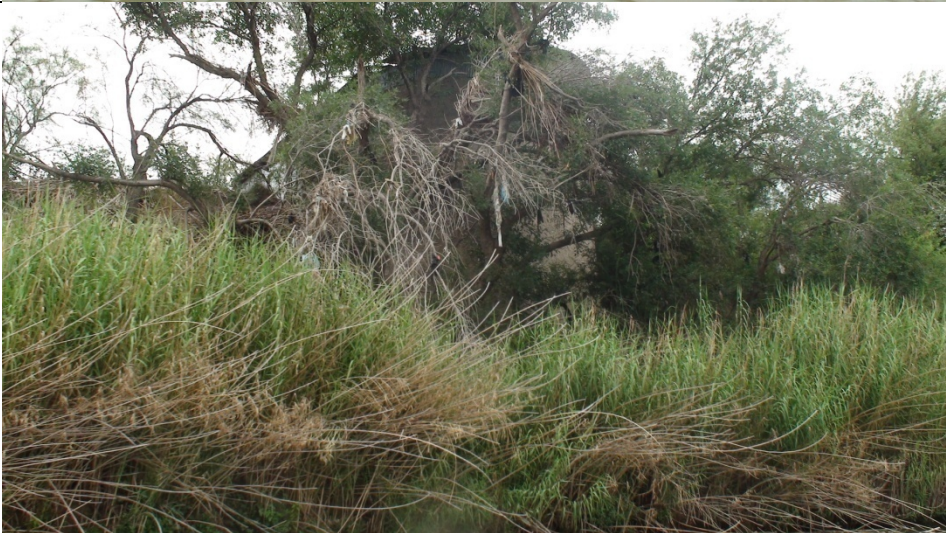
| | U.S. | <b>Feature 83 –</b><br><br>Round building on US bank. Appears residential or agricultural. | 27.37253,<br>-99.49734 |

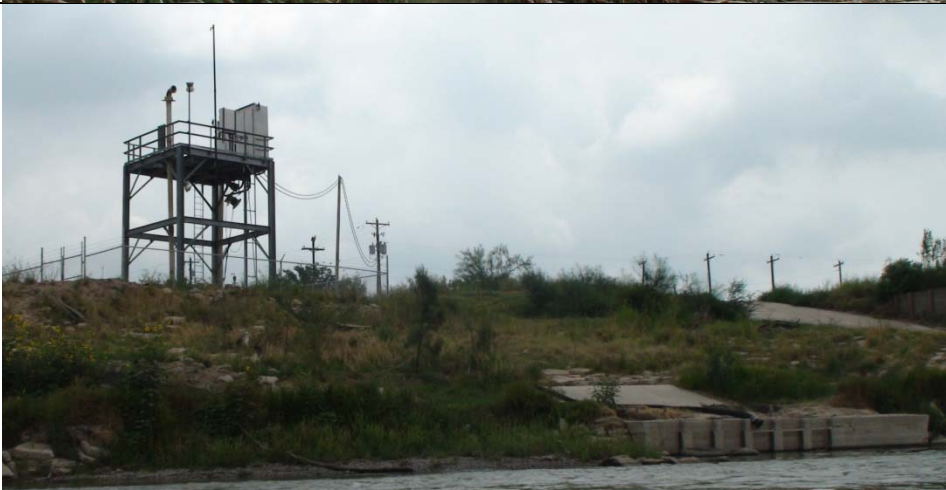
| | U.S. | <b>Feature 84 –</b><br><br>Intake for Webb County. | 27.36685,<br>-99.5021 |

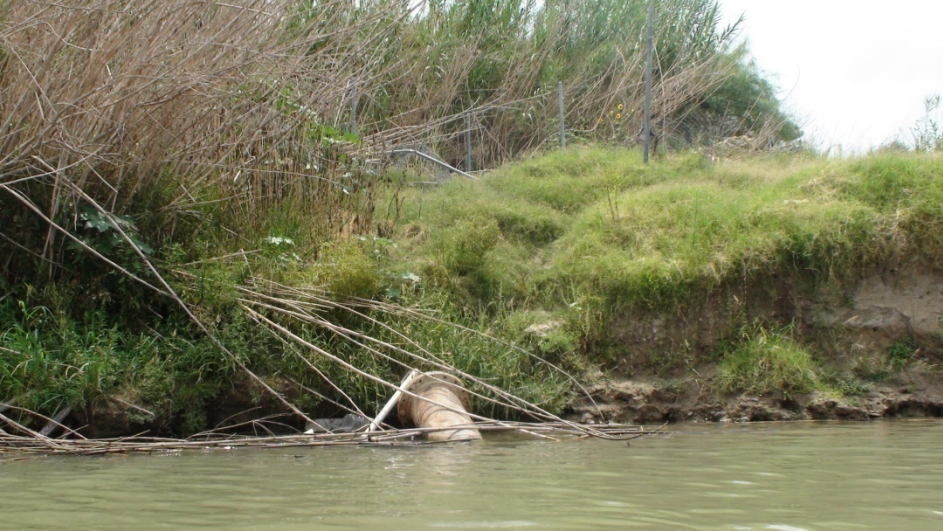
| | U.S. | <b>Feature 85 –</b><br><br>Metal pipe and fence on bank. | 27.36533,<br>-99.50295 |

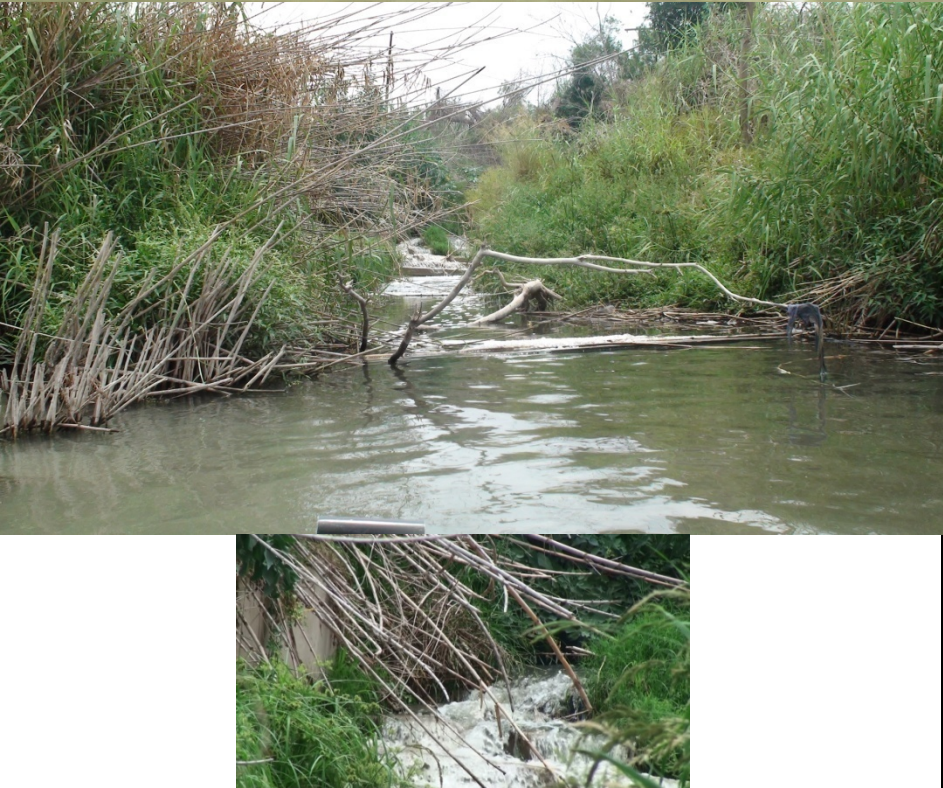
River samples at and below the Webb County Regional WWTP (Stations 13196d3 and 13196d4) were also high (*E. coli* values of 1553.1 #/100ml and 1413.6 #/100ml, respectively). The Regional WWTP has also had effluent violations in the past two years <sup>[1]</sup>.

| | U.S. | <b>Feature 86a –</b><br><br>WWTP outfall for Webb County. Discharging. Sudsy water. | 27.36494,<br>-99.50322 |

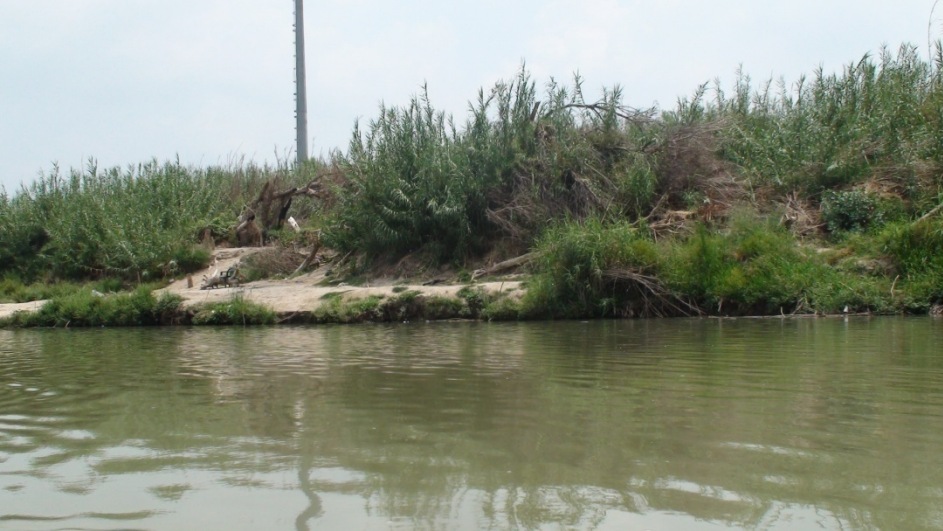
| | U.S. | <b>Feature 86b –</b><br><br>Clearing on bank below tower. | 27.36411,<br>-99.50317 |

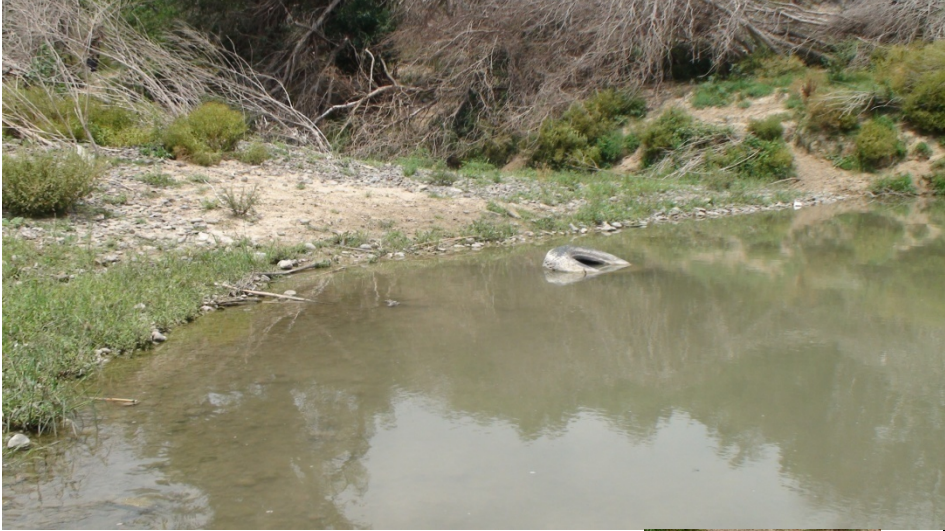
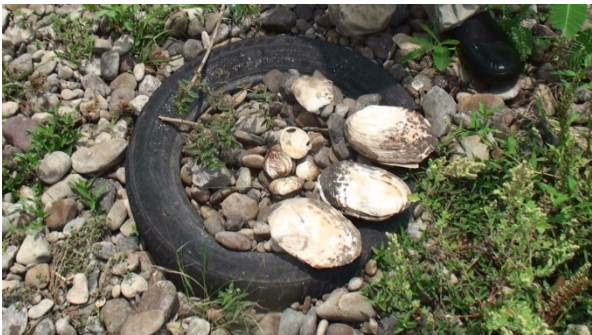
| | MEX | <p><b>Feature 88 –</b></p> <p>Dry arroyo with cow path (shown small in vertical photo) and tire trash. Several native mussel species found on this arroyo's sandbar.</p> | 27.3522, -99.50791 |

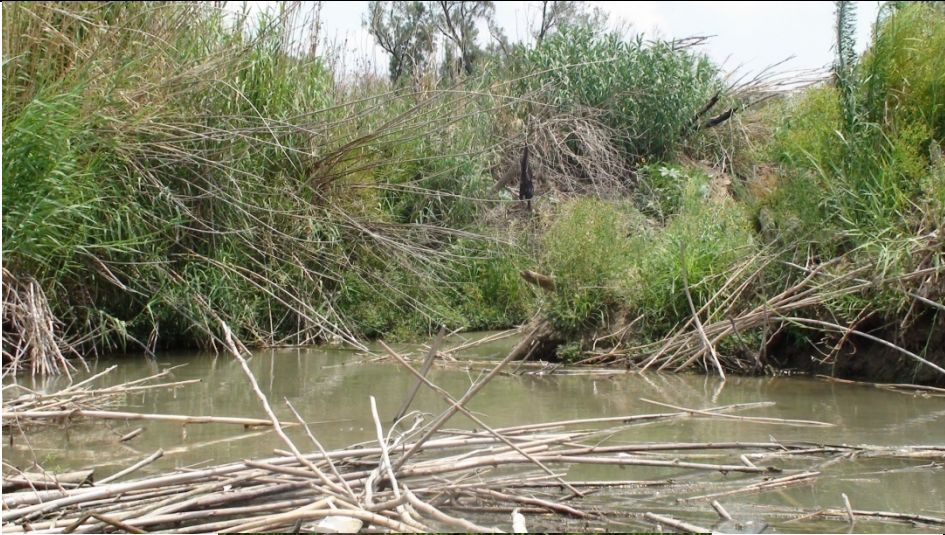
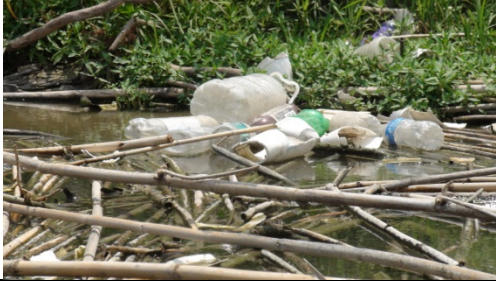
| | U.S. | <b>Feature 90 –</b><br><br>Arroyo at bottom of cliffs at El Cenizo park. Arroyo has lots of trash. | 27.33268,<br>-99.51008 |

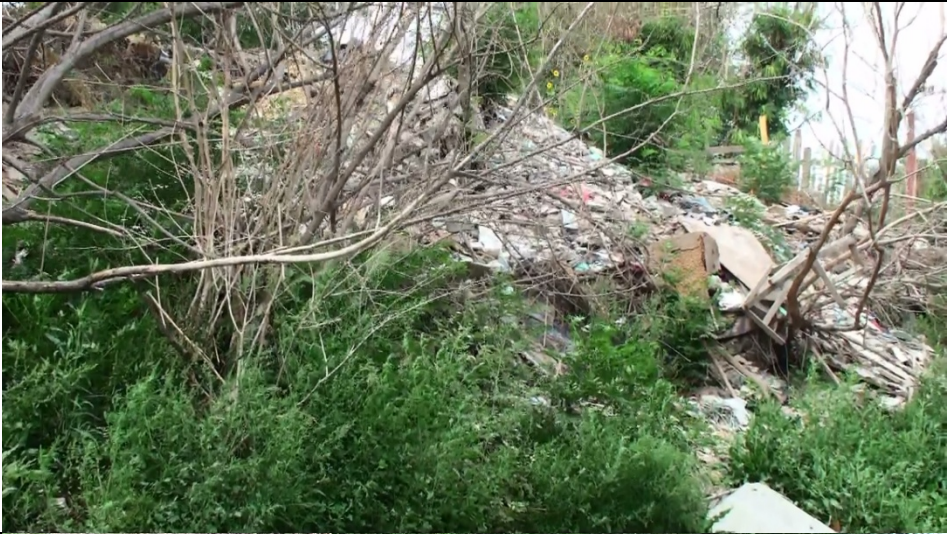
| Table D.1 Trash issues documented during Survey | |
|---|---|
| | Makeshift landfill on banks of Mexican Tributary, Feature 16 |

The study research team also recommends that local communities and regulatory entities in both countries pursue the trash issues documented in this study.

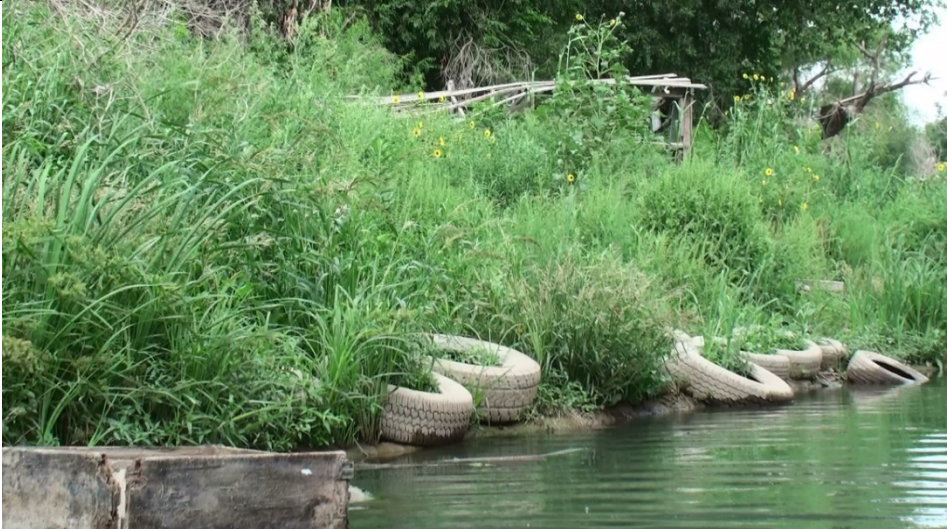
| Table D.1 Trash issues documented during Survey | |
|---|---|
| | Tires lining bank of tributary in Mexico Feature 16 |

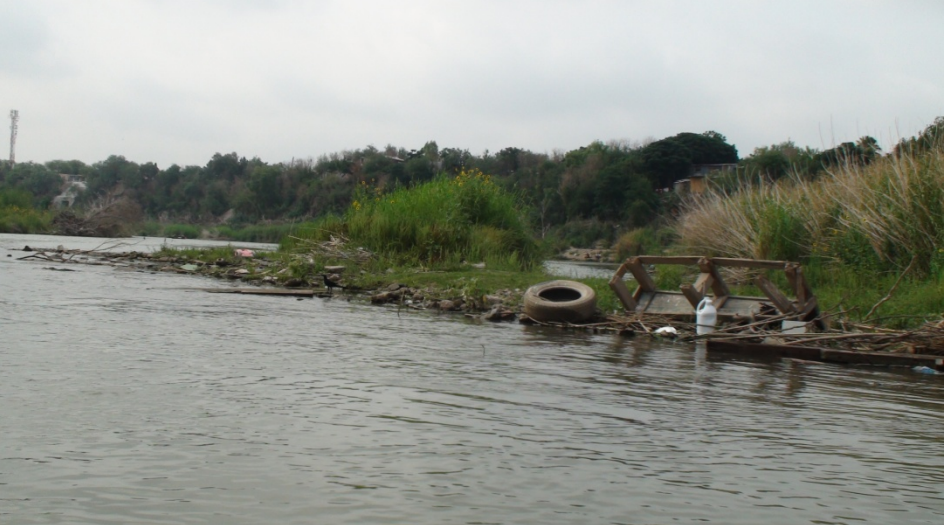
| | <p>Trash in river<br/>on sediment<br/>island above<br/>river bend,<br/>below Mexican<br/>tributary<br/>Feature 16<br/>27.4989,<br/>-99.5284</p> |

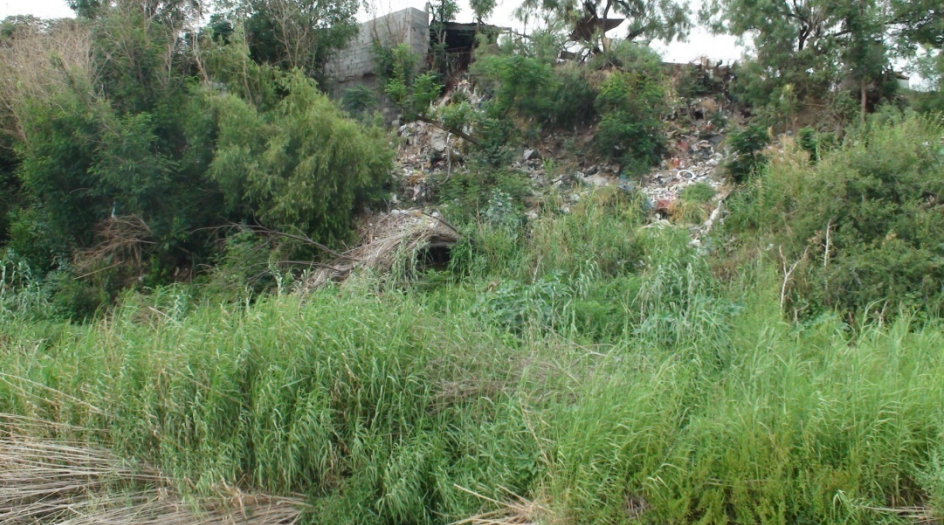
| | <p>Trash on<br/>Mexican bank,<br/>Feature 19</p> |

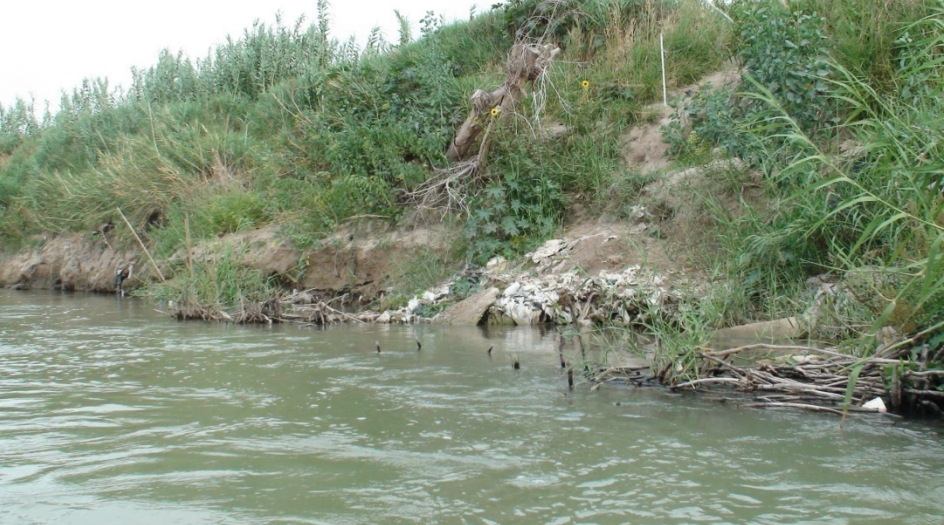
| | <p>Trash on U.S.<br/>bank, Feature<br/>28, 27.4994,<br/>-99.5129</p> |

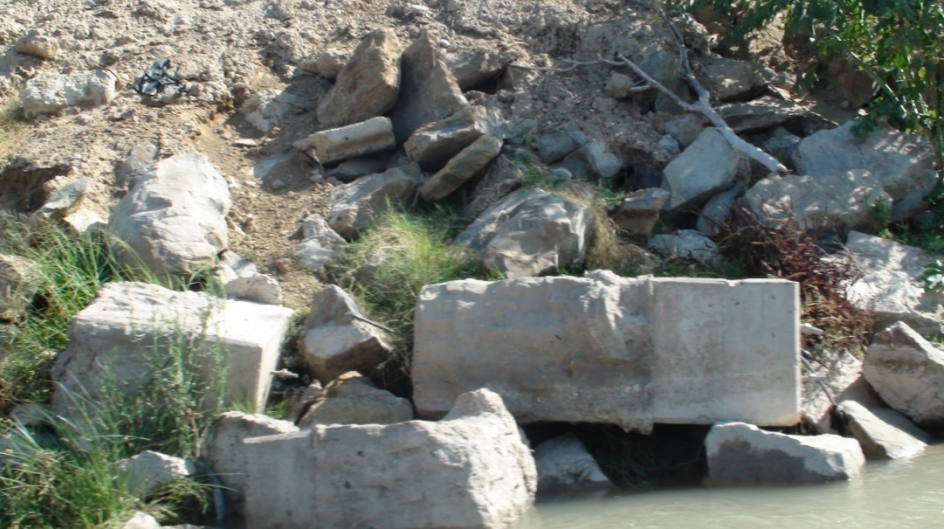
| | U.S. | <b>Feature 28b –</b><br><br>Cement blocks falling off U.S. banks, just downstream of Feature 28. Construction on bank after floods, loose sediment. | 27.49925,<br>-99.51278 |

| A photograph showing a riverbank on the US side. The bank is composed of a mix of natural rocks and large, rectangular concrete blocks, likely construction debris. Some green grass is growing between the rocks. The river water is visible in the foreground. | <p>Construction debris on the US side at Feature 28b below river bend above international bridges<br/>27.4992, -99.5128</p> |

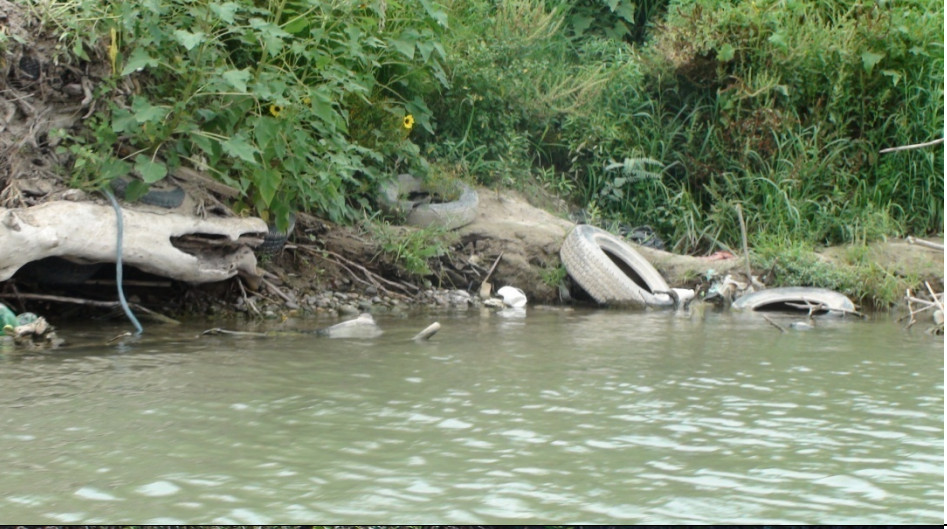
| A photograph of a riverbank on the Mexican side. The bank is covered with dense green vegetation, including tall grasses and some yellow flowers. Several old, discarded tires are visible, some partially buried in the soil and others floating in the water. A piece of driftwood is also visible on the bank. | <p>Tires and trash on Mexican bank, Feature 34b<br/>27.4997, -99.50119</p> |

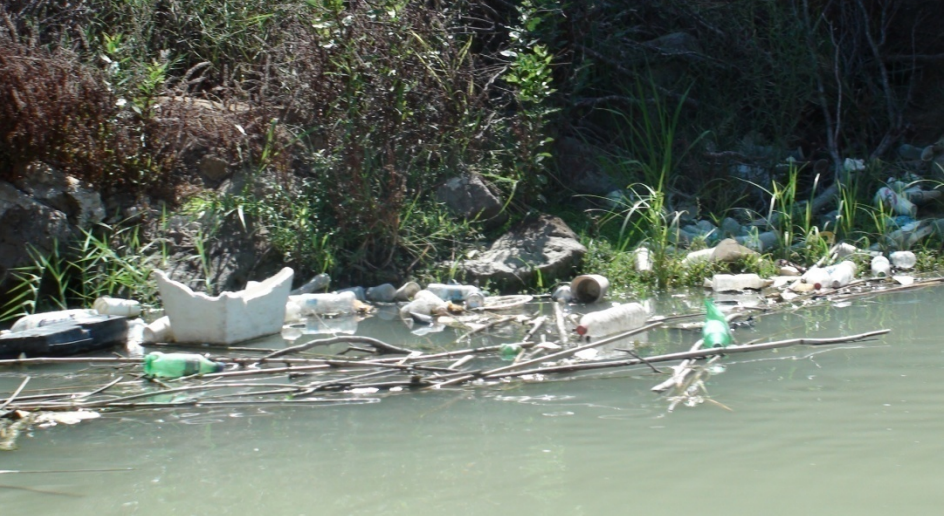
| A photograph showing a riverbank with significant trash accumulation. The bank is covered with dense, dark vegetation. In the foreground, there is a large pile of debris in the water and along the shore, including a white styrofoam cup, a green plastic bottle, and various sticks and branches. | <p>Trash in Zacate Creek at Feature 38</p> |

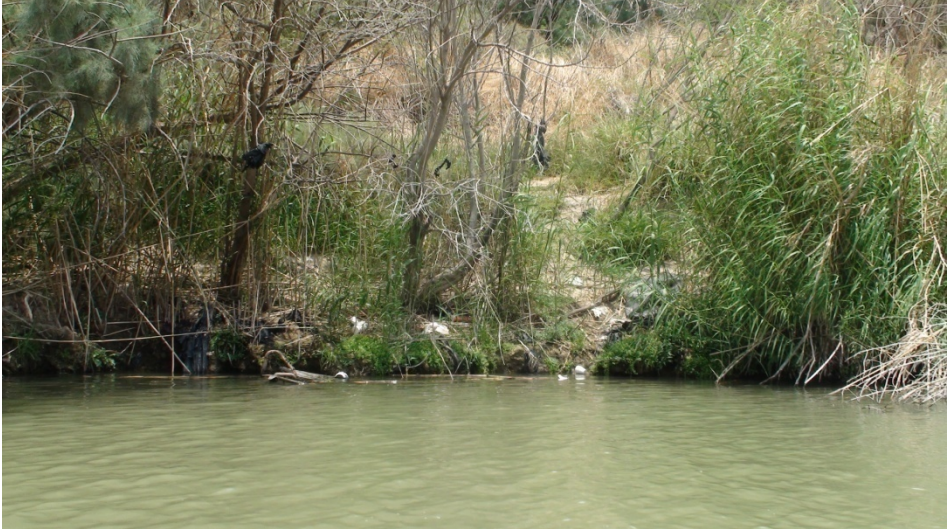
| | <p>Trash on U.S.<br/>bank between<br/>Features 40<br/>and 41<br/>27.4949,<br/>-99.4876</p> |

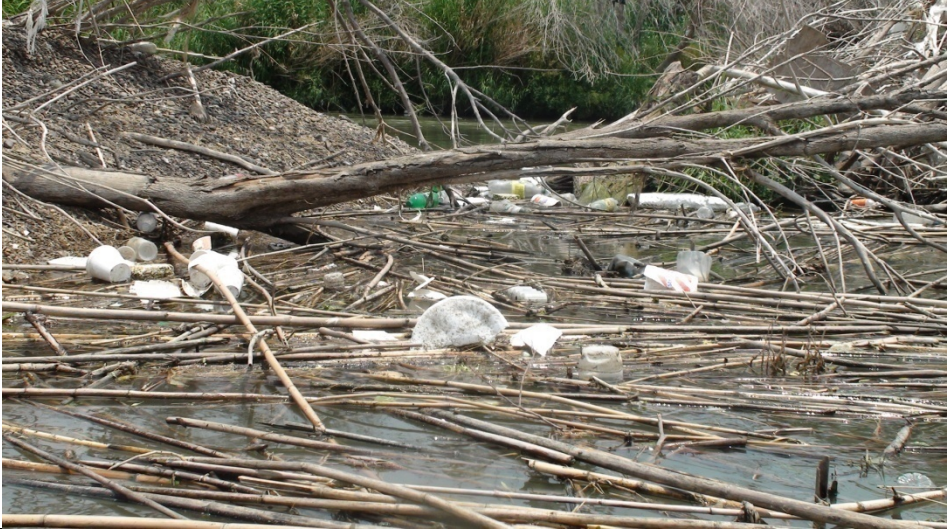
| | <p>Trash in river<br/>near Feature<br/>40<br/>27.4949,<br/>-99.4876</p> |

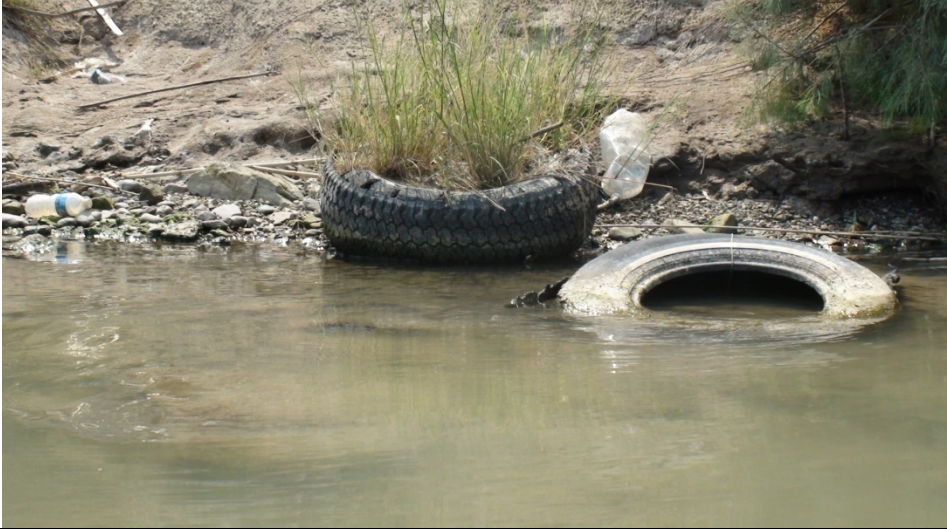
| | <p>Tires and trash<br/>below Feature<br/>56<br/>27.4566,<br/>-99.4915</p> |

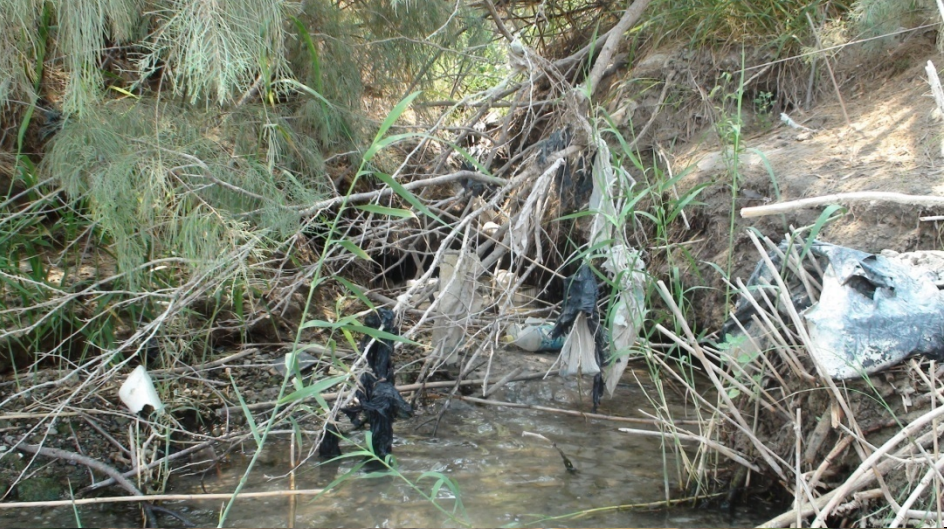
| | <p>Trash in Mexican arroyo at Feature 57</p> |

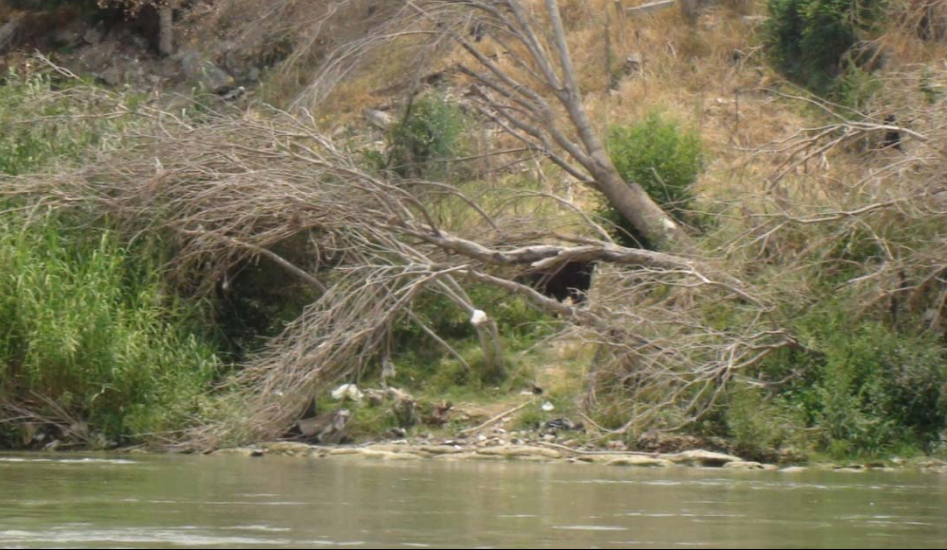
| | <p>Trash on U.S. bank upstream of Chacon Creek</p> |

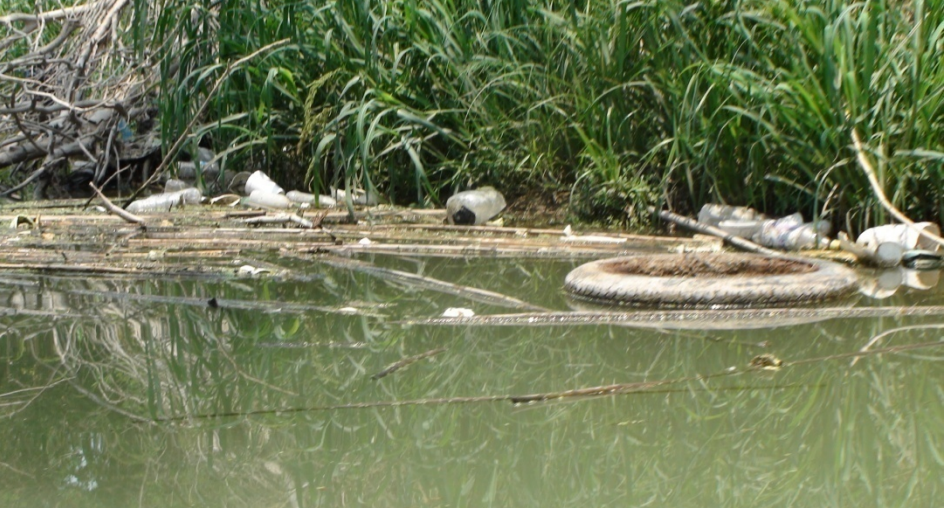
| | <p>Trash in Chacon Creek on the U.S. side<br/>27.48394<br/>-99.4792</p> |

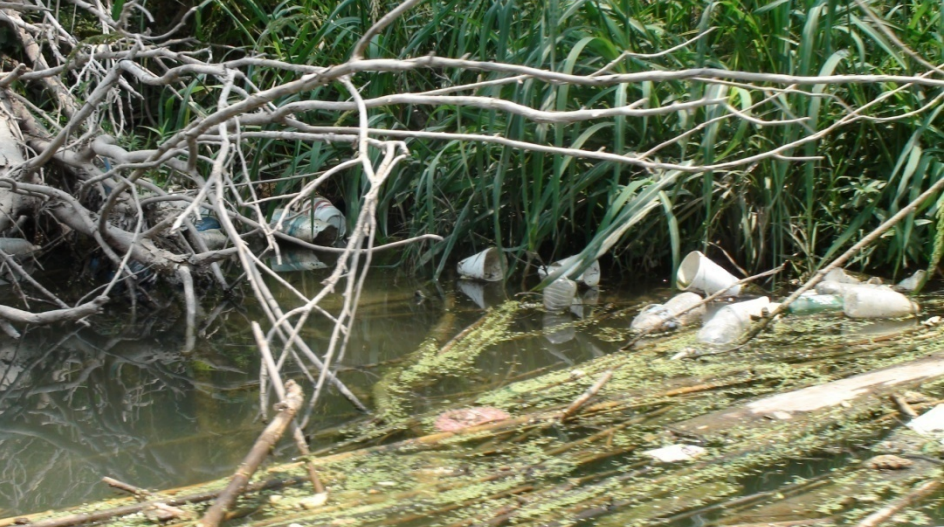
| | <p>Trash in Chacon Creek on the U.S. side</p> |

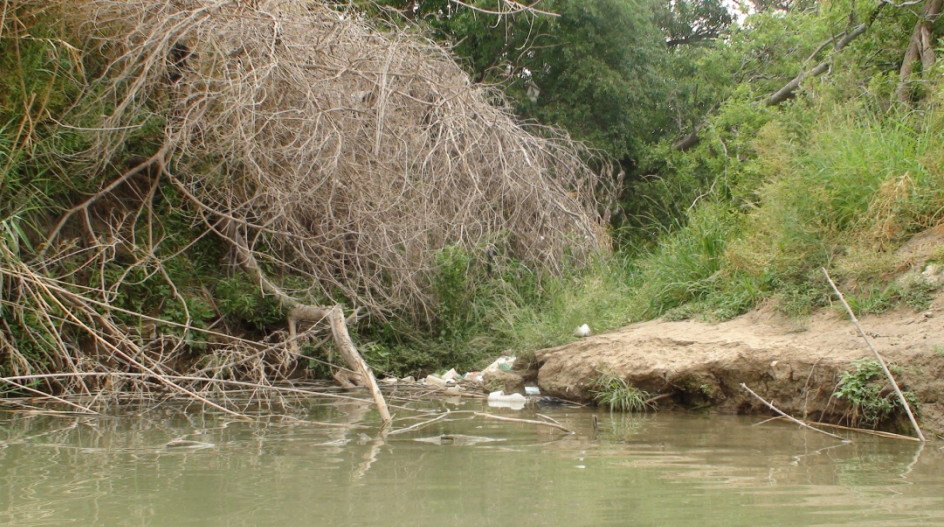
| | <p>Trash in US arroyo<br/>27.4098<br/>-99.4878</p> |

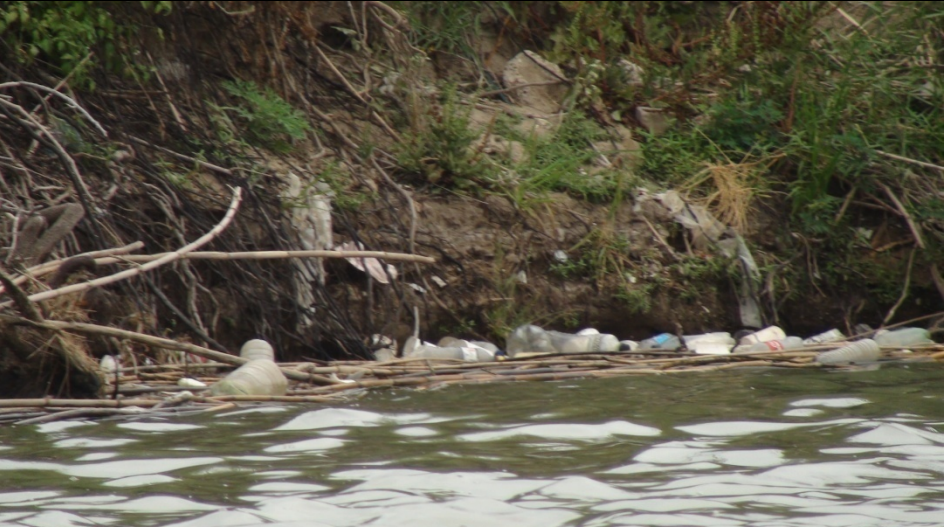
| | <p>Trash on Mexican bank near Laredo Community College South</p> |

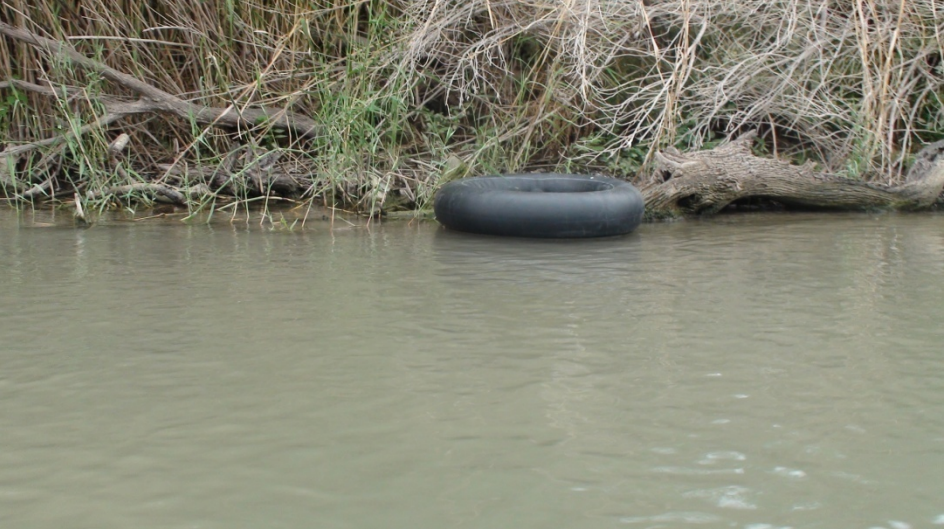
| | <p>Inner tube<br/>floating in river<br/>below Feature<br/>68</p> |
