# **Bacteria Characterization in Rio Grande Segment 2304 near Laredo, Texas/ Nuevo Laredo, Tamaulipas**

**A Texas Clean Rivers Program Special Study  
FINAL REPORT**

**Field Work May and August 2011; Final Report November 2012**

**International Boundary and Water Commission, U.S. Section, Texas Clean Rivers Program**

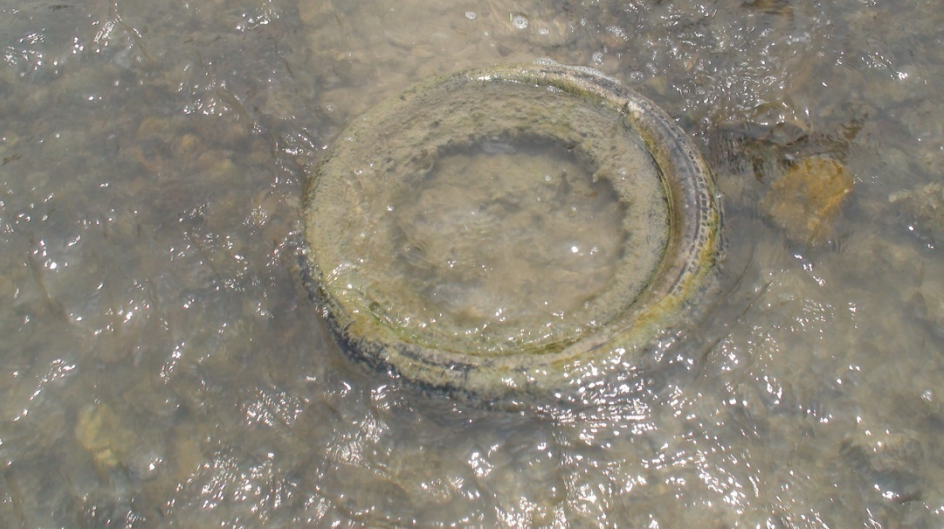
| | <p>Old tire in river<br/>at Feature 88</p> |

The study research team also recommends that local communities and regulatory entities in both countries pursue the trash issues documented in this study.

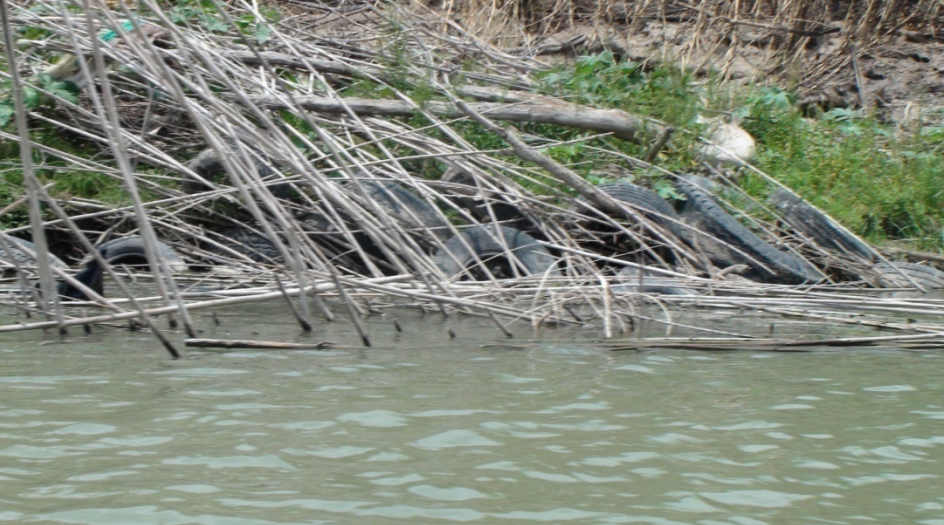
| | <p>Tires piled on<br/>US bank<br/>upstream of El<br/>Cenizo</p> |

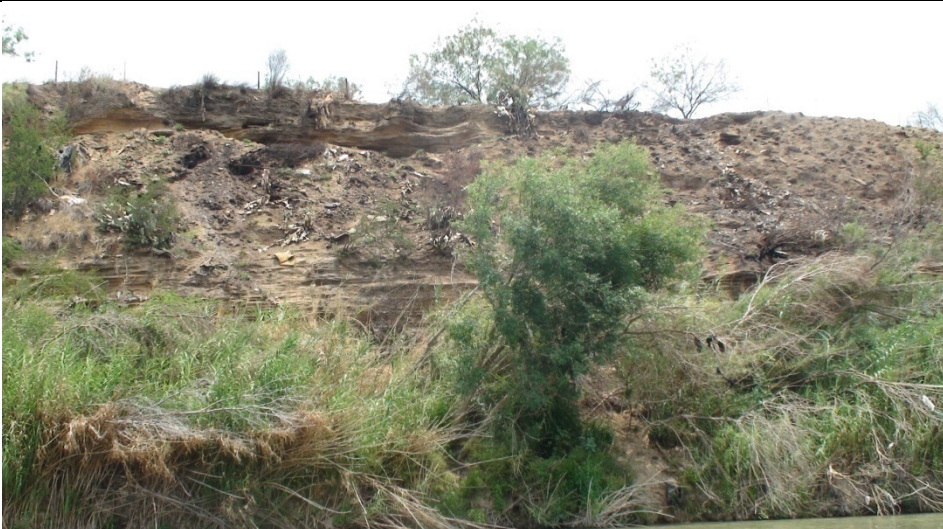
| | U.S. | <p><b>Feature 89 –</b></p> <p>Huge trash pile on cliffs at El Cenizo. Appears community dump trash over cliffs regularly.</p> | 27.33449, -99.5079 |

| | <p>Trash on cliffs<br/>near El Cenizo<br/>at Feature 89<br/>27.33449<br/>-99.5079</p> |

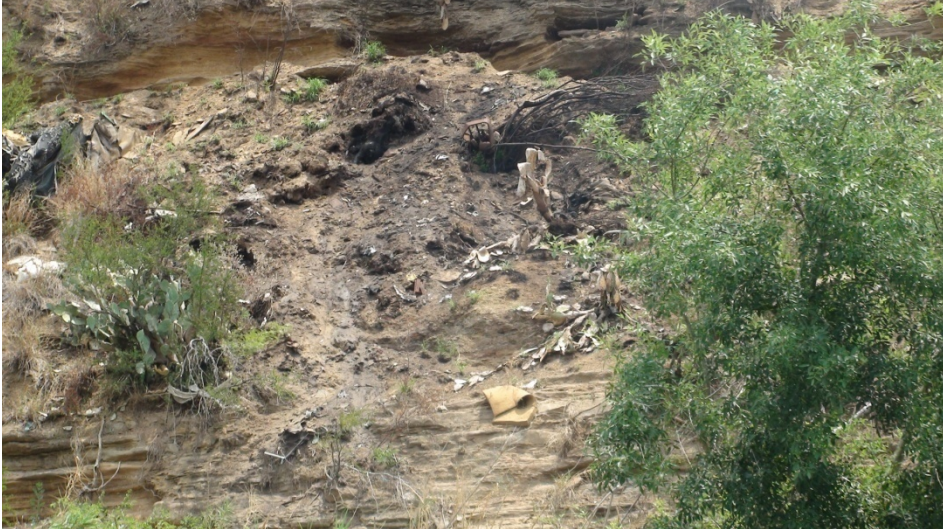
| | <p>Trash on cliffs<br/>near El Cenizo<br/>at Feature 89</p> |

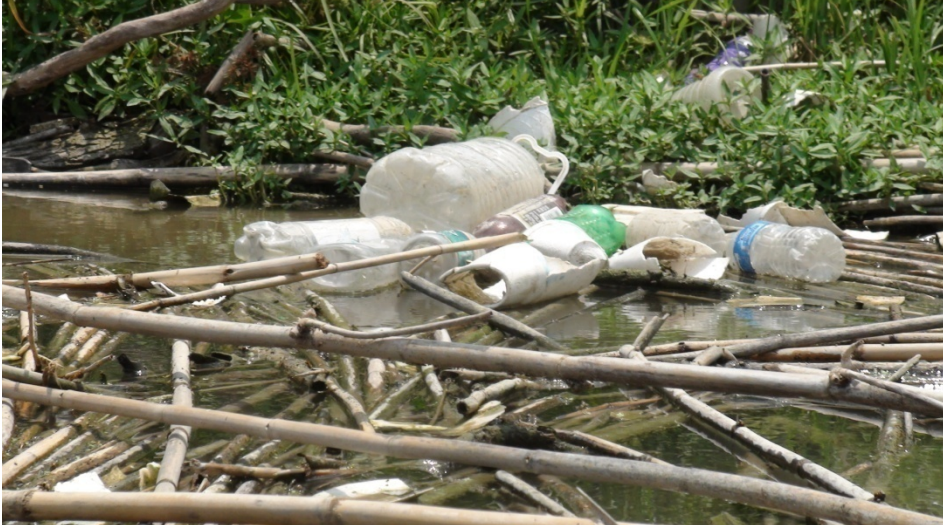
| | <p>Trash in U.S.<br/>arroyo near El<br/>Cenizo at<br/>Feature 90</p> |
