Conceptual Restoration Plan and Cumulative Effects Analysis, Rio Grande—Caballo Dam to American Dam, New Mexico and Texas

**United States Section
International Boundary and Water
Commission (USIBWC)
Under (MOU) IBM 92-21, IWO No. 31**

**U.S. Army Corps of Engineers
Albuquerque District**

March 5, 2009

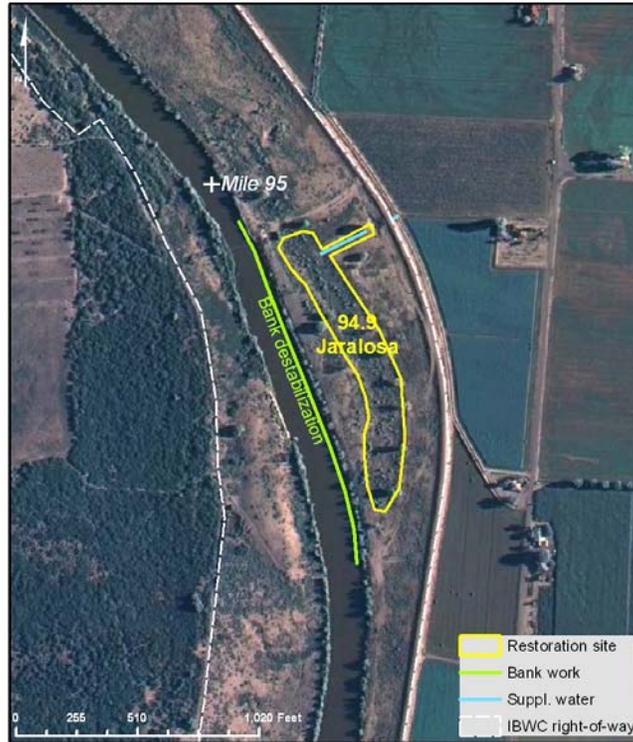
Figure 4.2. Jaralosa restoration site.

The Jaralosa site includes an abandoned meander bend of approximately 4.5 acres (**Figure 4.2**). Most of the floodplain surface in the abandoned channel is about 4 feet higher than the 3,500-cfs release water-surface elevation, and the remainder of the overbank surface is about 9 feet higher.

The site is vegetated by native and non-native herbaceous vegetation, arrow-weed, and scattered saltcedar that resprouts between mowing cycles. A few remnant but senescent cottonwood trees are present.

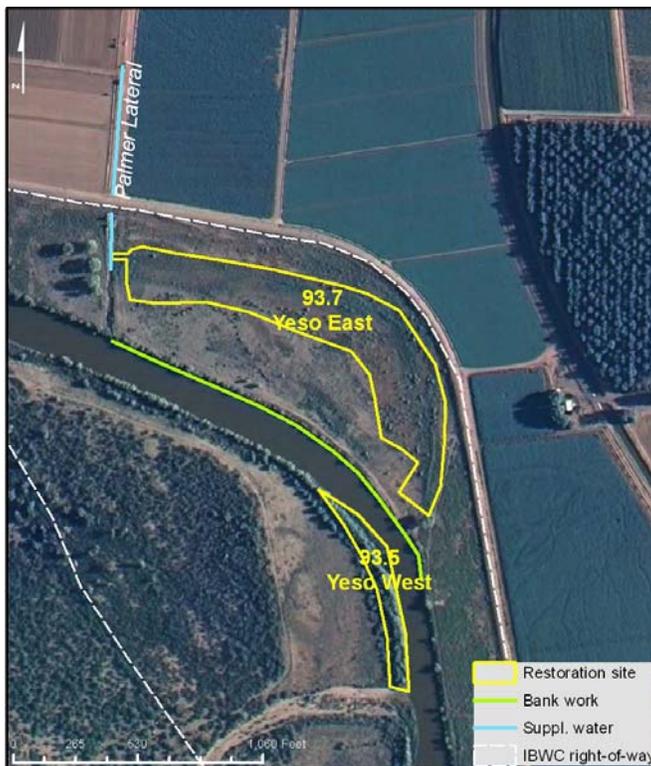
Figure 4.4. Yeso East restoration site.

The Yeso East site is situated on the east bank of a river bend (**Figure 4.4**) and the floodplain is an average of 5 feet higher than the 3,500-cfs Caballo release water-surface elevation. As a result, inundation at this discharge is not possible without substantial excavation.

A 9.7-acre, shallow depression (likely a former channel meander) through the center of the site is primarily vegetated by non-native weeds (mostly amaranth), and alkali sacaton, aster, and arrow-weed that resprout between mowing cycles. The surrounding area (outside of the yellow polygon) is vegetated by saltgrass, and sparse alkali sacaton and arrow-weed.

Bank destabilization is recommended along approximately 1,800 feet of the outside of the bend (i.e., east bank) to widen the channel and encourage river migration. Saltcedar along the bank can be removed by extraction or scrapping. During the low-flow period, the bank should be shaved at a slope with a bulldozer or excavator, and bank riprap material, if present, removed. The excavation from the bank destabilization would not be excessive and can be placed at the riverward toe of the bank for removal by high flows. Waste deposition should be less than 1 acre in extent below the Ordinary High-water Mark (OHWM).

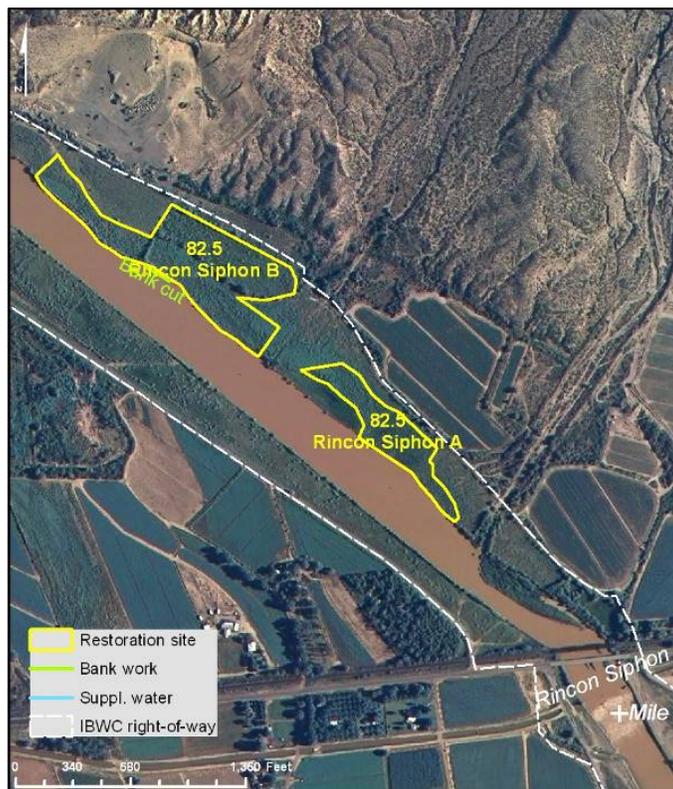
Figure 4.11. Rincon Siphon restoration site.

This site consists of two parcels, 4.5 and 11.8 acres in size that could potentially be inundated by the target restoration releases (**Figure 4.11**). An intervening area of higher ground separates the parcels where an unnamed arroyo empties onto the floodplain.

FLO-2D modeling indicates that overbank areas at this site would begin to be inundated by a 4,000-cfs release from Caballo Dam. The water surface elevation for the 3,500-cfs Caballo release is just below the bank elevation and much of the overbank area is slightly lower than the riverbank.

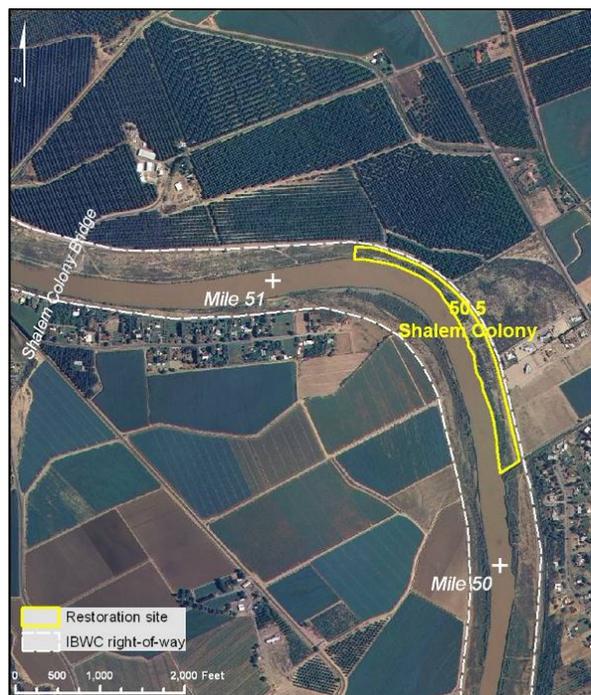
This 14.2-acre site is about a mile downstream from the Shalem Colony Bridge on the east bank of the river (**Figure 4.26**). The riverward half of the site consists of the largest stand of screwbean mesquite observed in the study area downstream from Leasburg Dam. In a Memorandum of Understanding between the USIBWC and the Southwest Environmental Center dated March 22, 1999, the USIBWC agreed to refrain from vegetation management in a 35-foot-wide band along the river channel. In practice, mowing has been discontinued in a much wider band, such that screwbean mesquite now occupies approximately 5 acres. Alkali sacaton, saltgrass, and spike dropseed (*Sporobolus contractus*) form a well developed ground cover under the maturing trees and throughout the rest of the site. Resprouting coyote willow is scattered throughout the regularly mowed areas.

Figure 4.26. Shalem Colony restoration site.

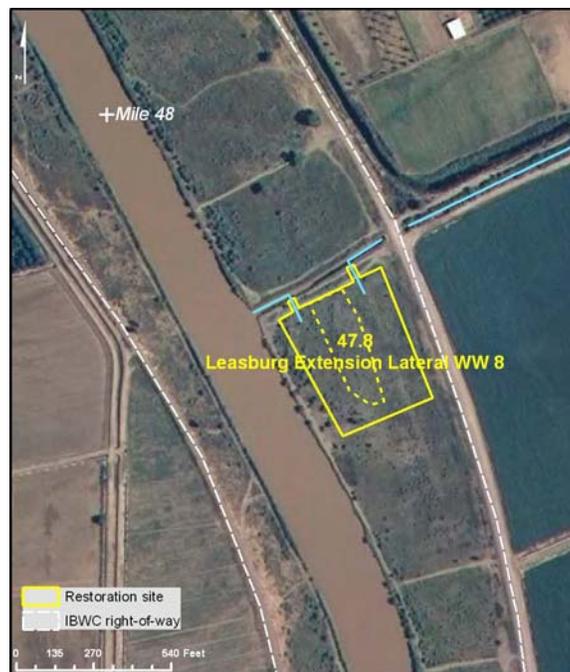
Figure 4.27. Leasburg Extension Lateral Wasteway 8 restoration site.

Vegetation at the Wasteway 8 site consists of mowed grassland with scattered, resprouting saltcedar (Figure 4.27). The ground surface is nearly level and is about 4 feet above the water surface of the 1,500-cfs release from Caballo Dam, the usual lower discharge under existing conditions during the growing season).

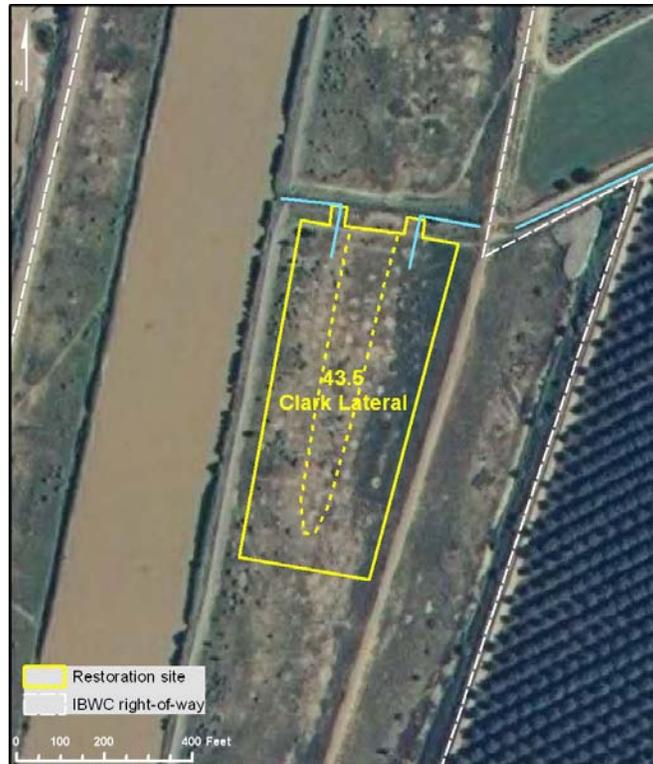
The Clark Lateral site is on the east bank of the river halfway between the I-10 and Mesilla bridges (Figure 4.28).

Figure 4.28. Clark Lateral restoration site.

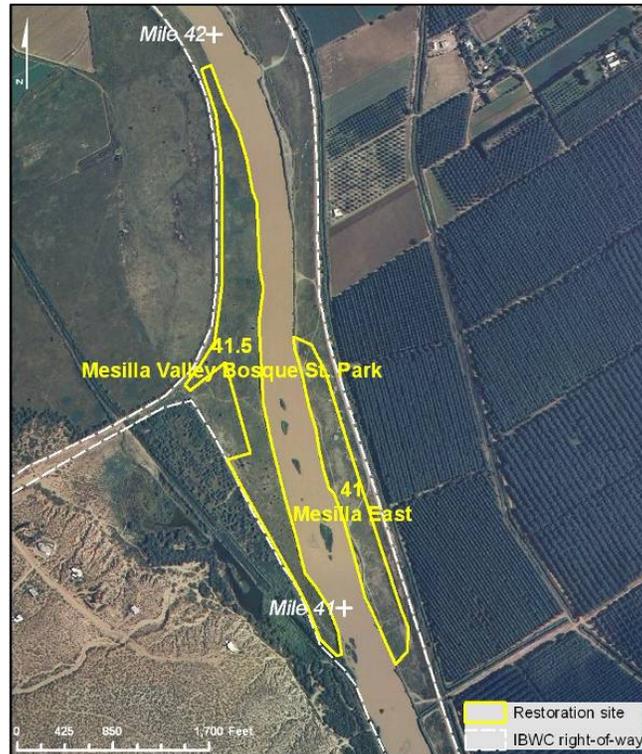
The Mesilla Valley Bosque State Park site entails 31.8 acres within the USIBWC right-of-way west of the levee (Figure 4.29). The FLO-2D model predicted that a small (about 6 acres) area in the central part of the site would be inundated by a 5,000-cfs Caballo release.

Figure 4.29. Mesilla Valley Bosque State Park restoration site.

Existing vegetation within the footprint shown in Figure 4.29 is a mixture of mowed grassland and wet meadow, robust coyote willow bordering the bankline, scattered cottonwoods, and, in the downstream portion, saltcedar.

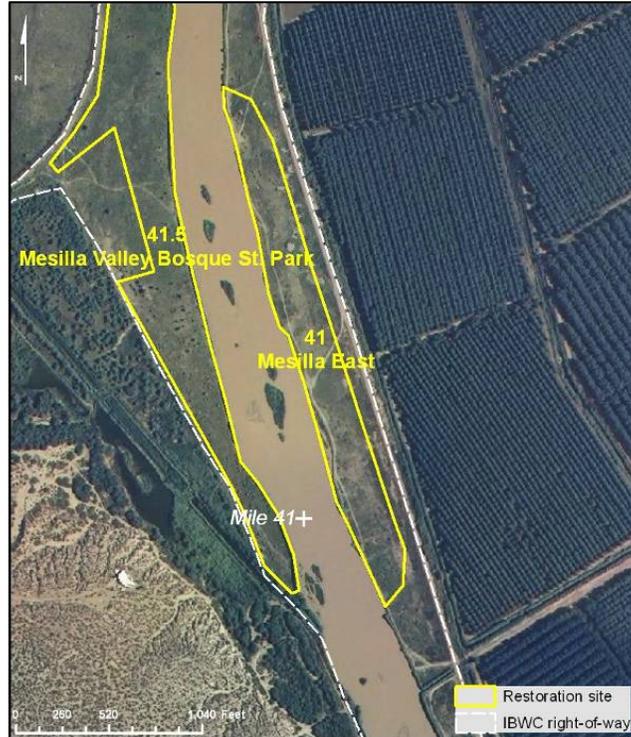
The Mesilla East site covers 15.8 acres on the east bank of the river, opposite Mesilla Valley Bosque State Park (Figure 4.30). The site is an average of 1.5 feet higher than the water-surface elevation of the 3,500-cfs Caballo release. At the southern end of the site, the FLO-2D model predicted that Caballo releases of 3,250 to 5,000 cfs would inundate approximately 6.6 acres. A backwater effect from the downstream Mesilla Dam tends to elevate the water surface at the restoration site.

Figure 4.30. Mesilla East restoration site.

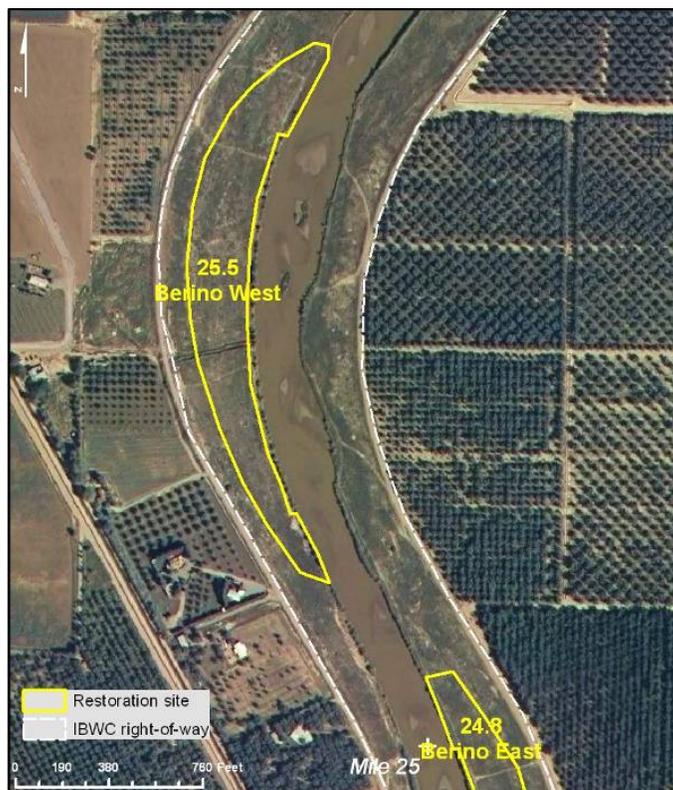
The Berino West site is located on the west river bank approximately one mile upstream from the Berino Bridge (Figure 4.31). The baseline FLO-2D model predicted that the 10.3-acre site would be inundated by Caballo Dam releases of 4,500 cfs and greater. This site is the first overbank area larger than 10 acres that would be inundated by this range of flows in the 34-mile reach below Leasburg Dam. The site is an average of one foot higher than the water-surface elevation for the 3,500-cfs Caballo release.

Figure 4.31. Berino West restoration site.

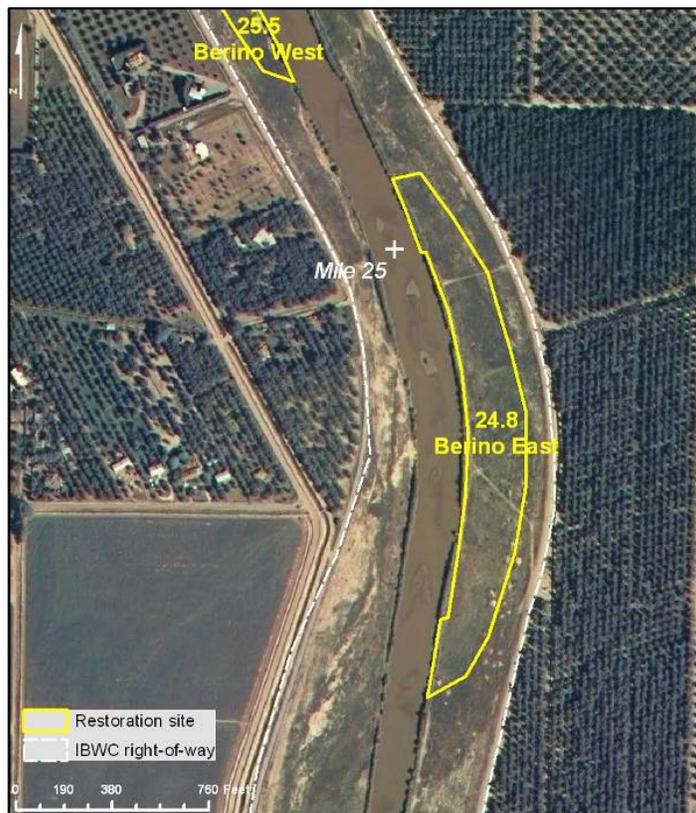
The Berino East site is on the east bank of the Rio Grande approximately 0.6 miles upstream from the Berino Bridge, and immediately downstream from the Berino West restoration site (Figure 4.32). The FLO-2D model predicted that this 9.5-acre site would be entirely inundated by Caballo releases of 4,500 cfs or more. The site is an average of 0.7 feet higher the water-surface elevation of the 3,500-cfs Caballo release.

Figure 4.32. Berino East restoration site.

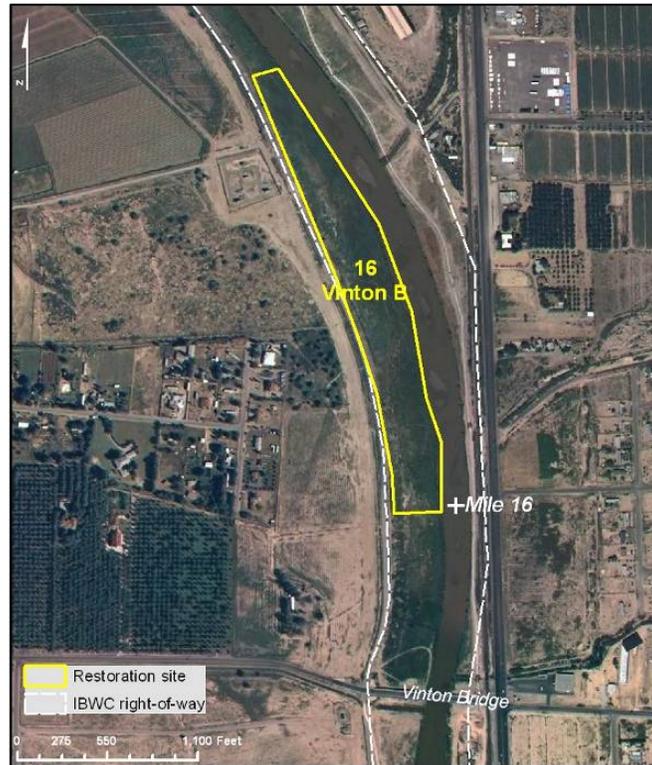
The 20-acre Vinton B site is also on the west bank of the river approximately 0.25 miles upstream from the Vinton Bridge (**Figure 4.34**). This site is predicted by the FLO-2D model to begin flooding with a 2,500-cfs Caballo release and be fully inundated by the 4,000-cfs release.

Figure 4.34. Vinton B restoration site.

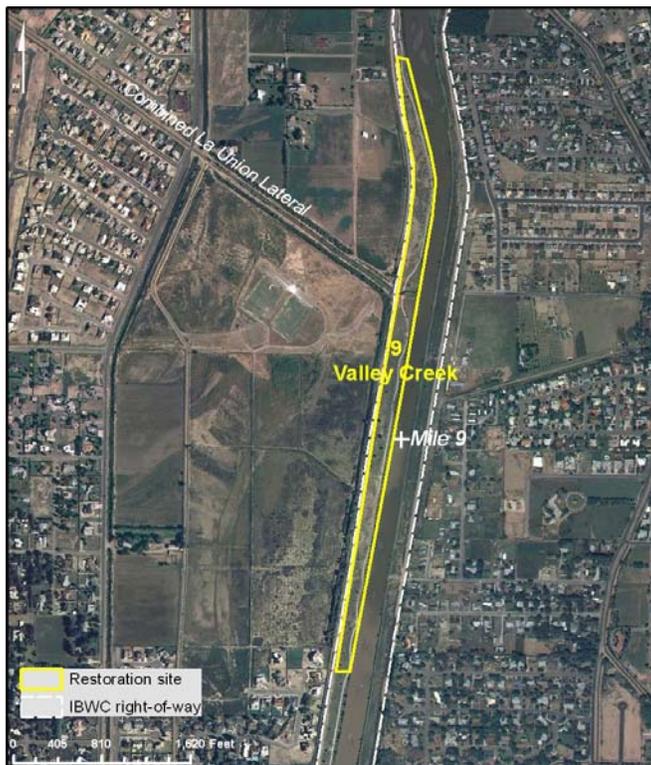
The 22-acre Valley Creek site is on the west bank of the river beginning approximately 0.7 miles upstream from the Country Club bridge and extending 1.1 miles to the north (**Figure 4.35**). A portion of the Rio Grande Trail System traverses this long, narrow site, and Valley Creek Park lies immediately to the west. This site is predicted by the FLO-2D model to begin flooding with the 2,750-cfs Caballo release and would be fully inundated by the 3,500-cfs release.

Figure 4.35. Valley Creek restoration site.

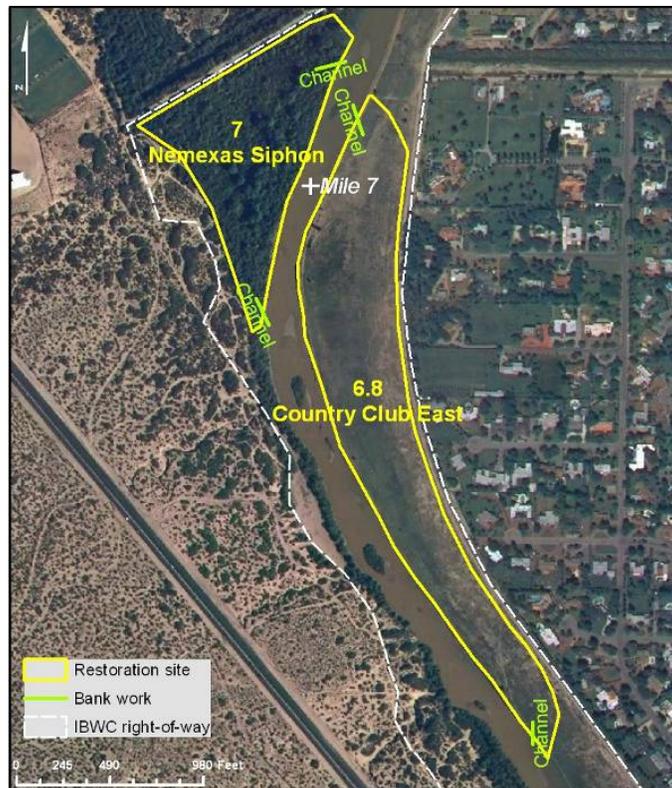
This 29-acre site is on the east bank of the river, opposite and extending downstream from the Nemexas Siphon site (**Figure 4.38**). The northern 21 acres are within New Mexico and the southern 8 acres are in Texas. FLO-2D modeling indicates that overbank inundation begins near RM 6.3 at a 3,000-cfs Caballo release, and flooding extends both upstream and downstream with increasing discharges. The site would be fully inundated by Caballo releases of 4,000 cfs and higher.

Figure 4.38. Country Club East restoration site.

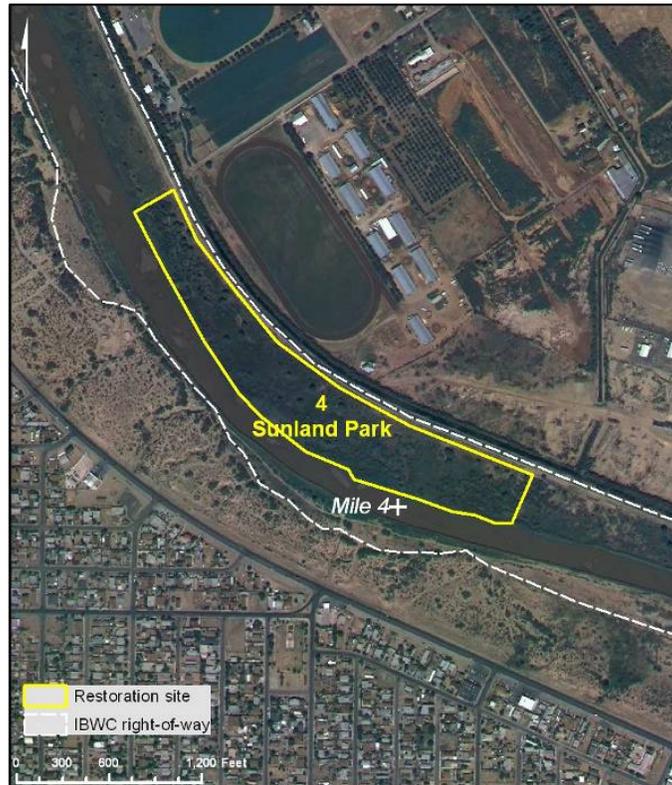
The Sunland Park restoration site covers 28.8 acres on the east bank (Figure 4.40). This site is predicted by the FLO-2D model to begin flooding with the 3,250-cfs Caballo release, and be fully inundated by the 3,500-cfs release.

Figure 4.40. Sunland Park restoration site.

Existing vegetation consists of relatively dense grasses (primarily saltgrass) and scattered cottonwoods and shrubs. Minor saltcedar resprouting occurs between mowing.

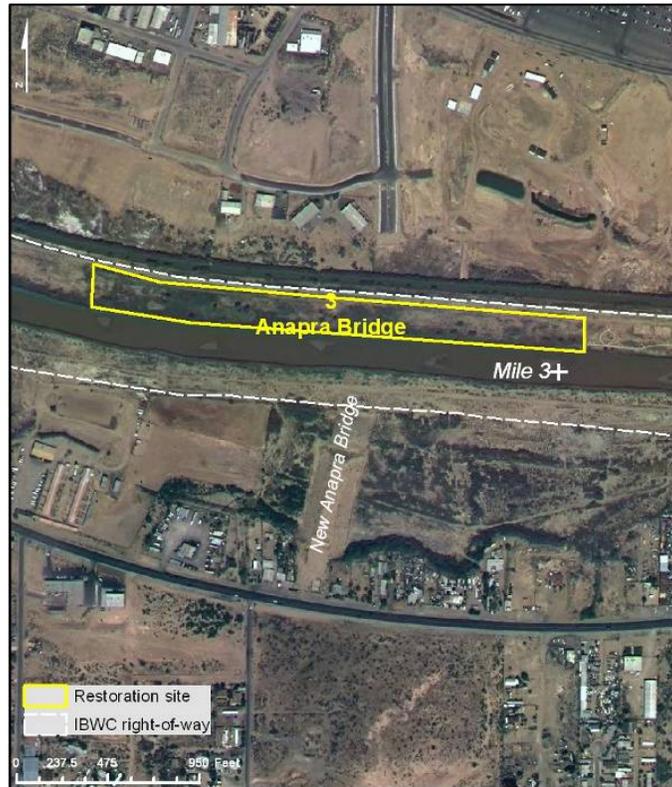
The last restoration site spans the crossing of the new Anapra Bridge (**Figure 4.41**). A public parking area is located at the southern end of the site and trails extend to north. The 11-acre site is predicted to be inundated by a 2,750- to 3,500-cfs release from Caballo Dam.

Figure 4.41. Anapra Bridge restoration site.

The site is moderately vegetated with grasses (primarily saltgrass) and mature cottonwoods, coyote willow, and screwbean mesquite.

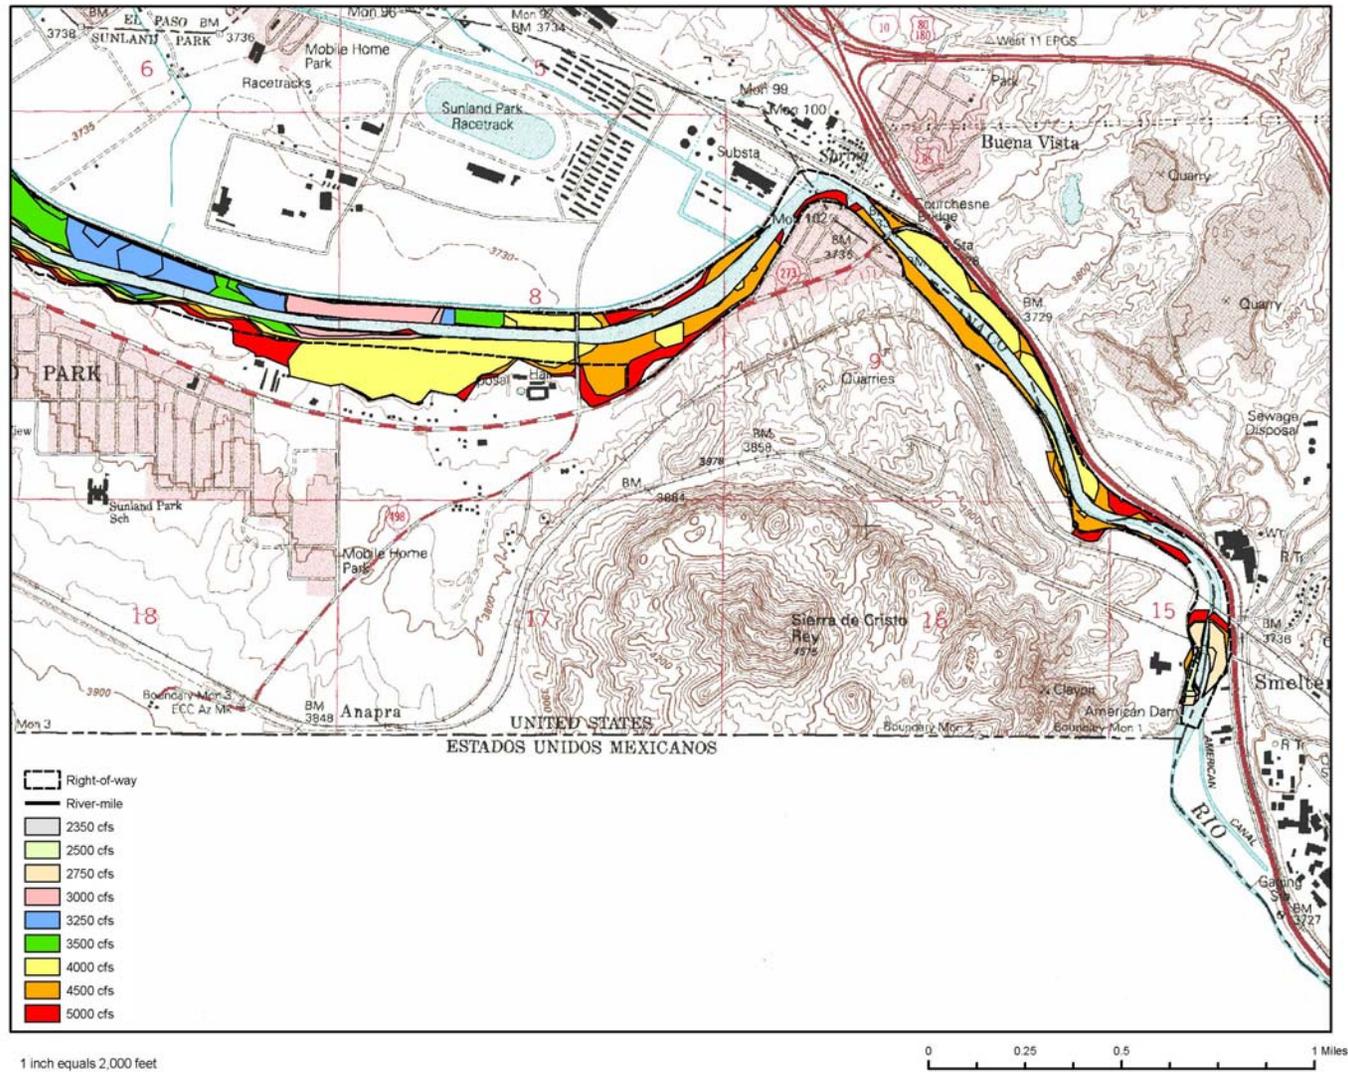
Inundation areas from FLO-2D model
River-mile 3 - 0
