**SITE IMPLEMENTATION PLANS**

**RIO GRANDE CANALIZATION PROJECT**  
**RIVER RESTORATION IMPLEMENTATION PLAN**

Prepared for:  
United States Section  
International Boundary and Water Commission

Prepared by:  
TRC Environmental Corporation

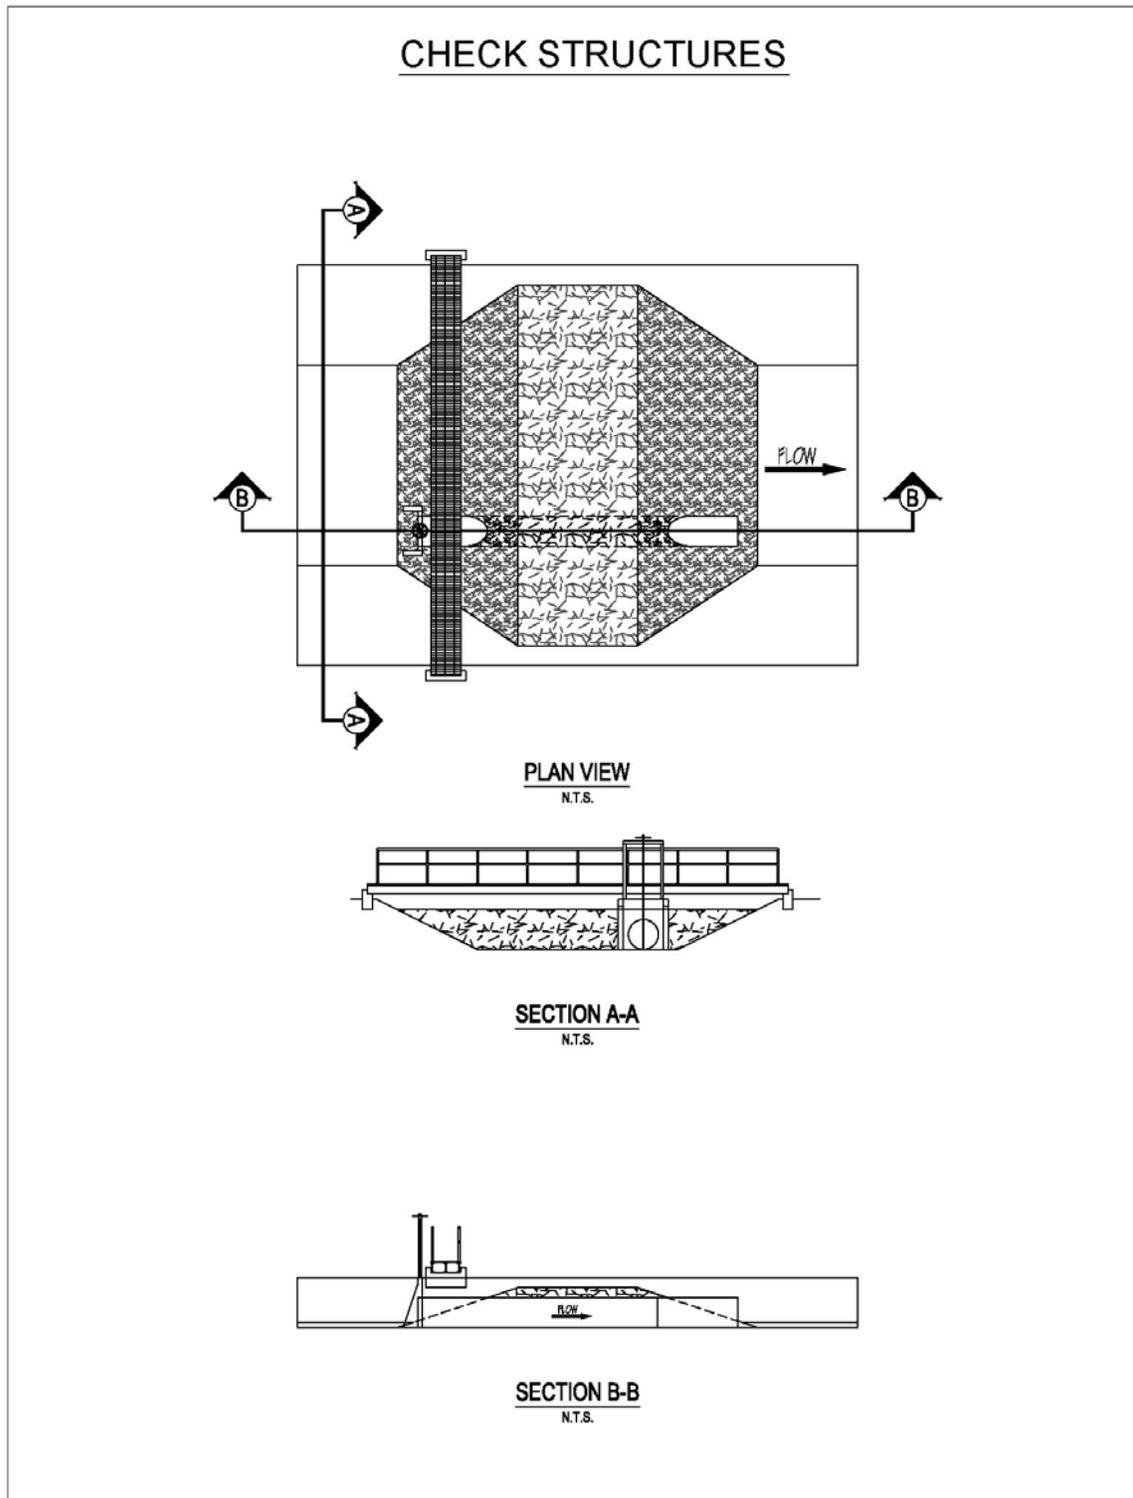
**Figure 9-1. Check Structure**

Source: Elephant Butte Irrigation District

Site 19 – Clark Lateral is to have supplemental irrigation (see site plan, Appendix A). The site area is 6.1 acres. Groundwater depths may be too deep to sustain the target vegetation. Water would be diverted from the wasteway adjacent to the north side of the site with a check structure and standard irrigation turnout. The water would be conveyed via a grassed swale around the site. Excess water would be returned to the wasteway with a gated return. Details of these structures are shown in Figures 9-1, 9-2, and 9-3.

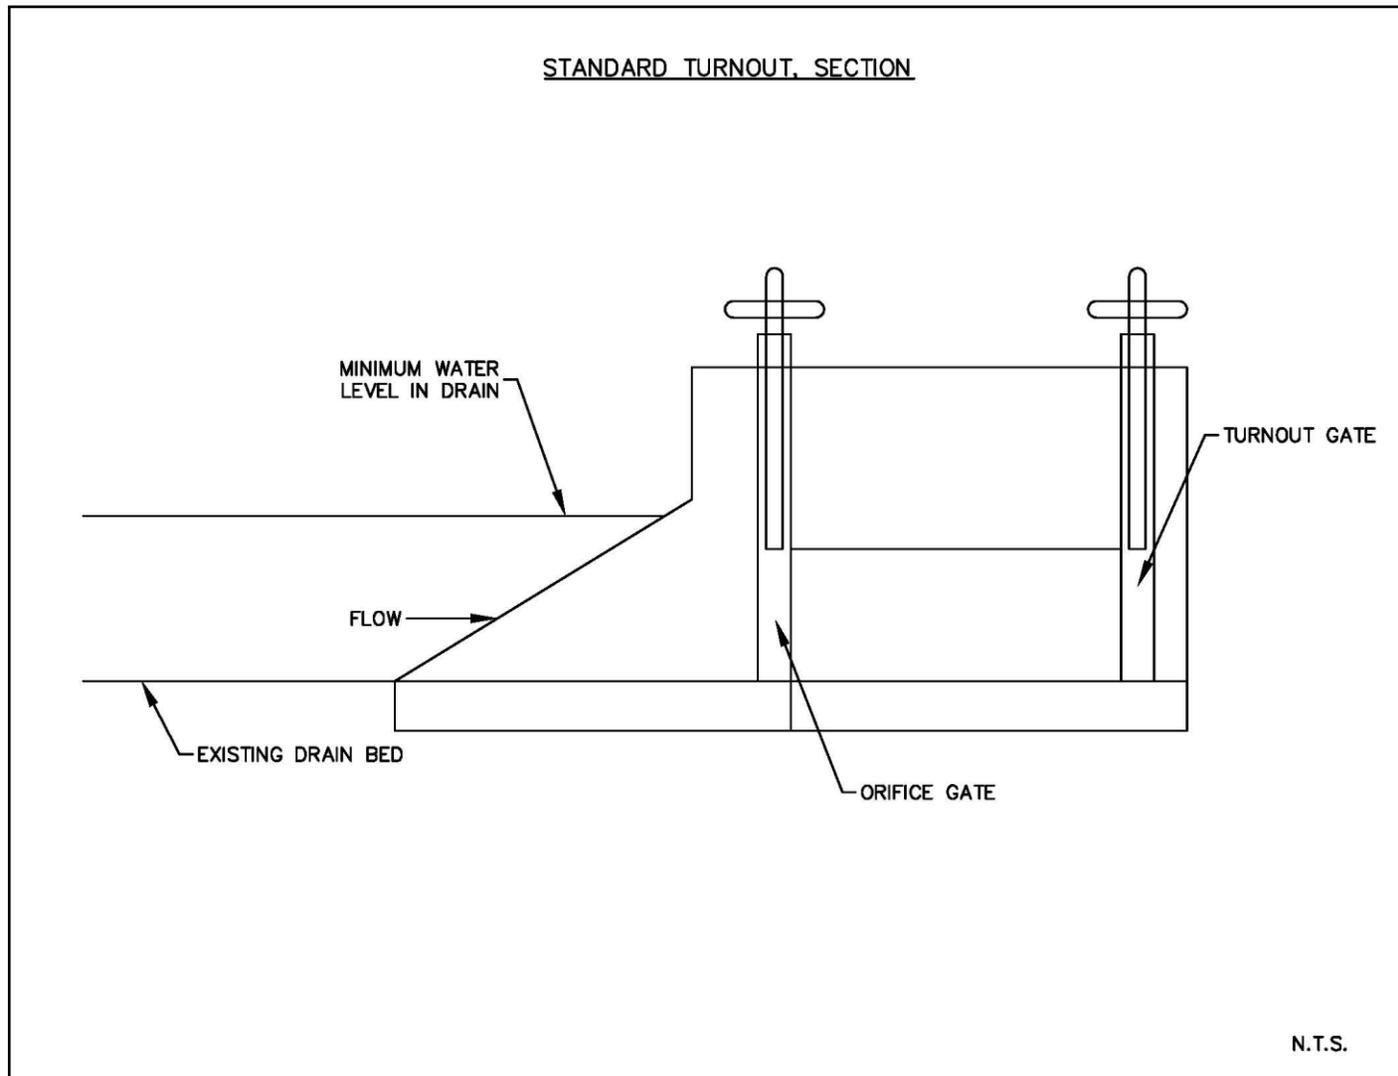
**Figure 9-2. Standard Irrigation Turnout**

Source: USACE, 2009

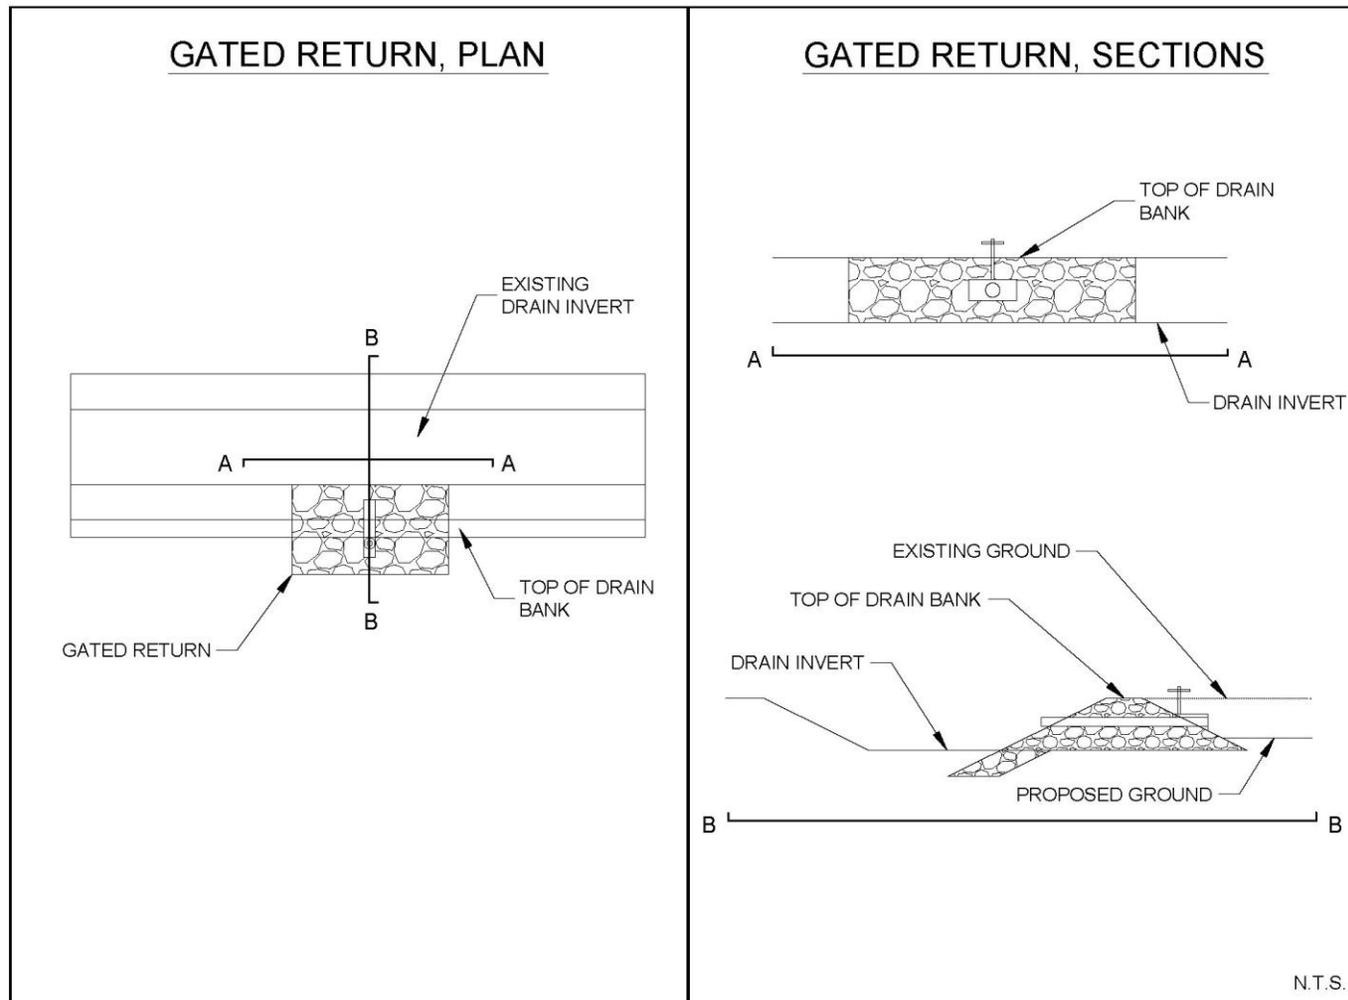
Figure 9-3. Gated Return

Source: USACE, 2009

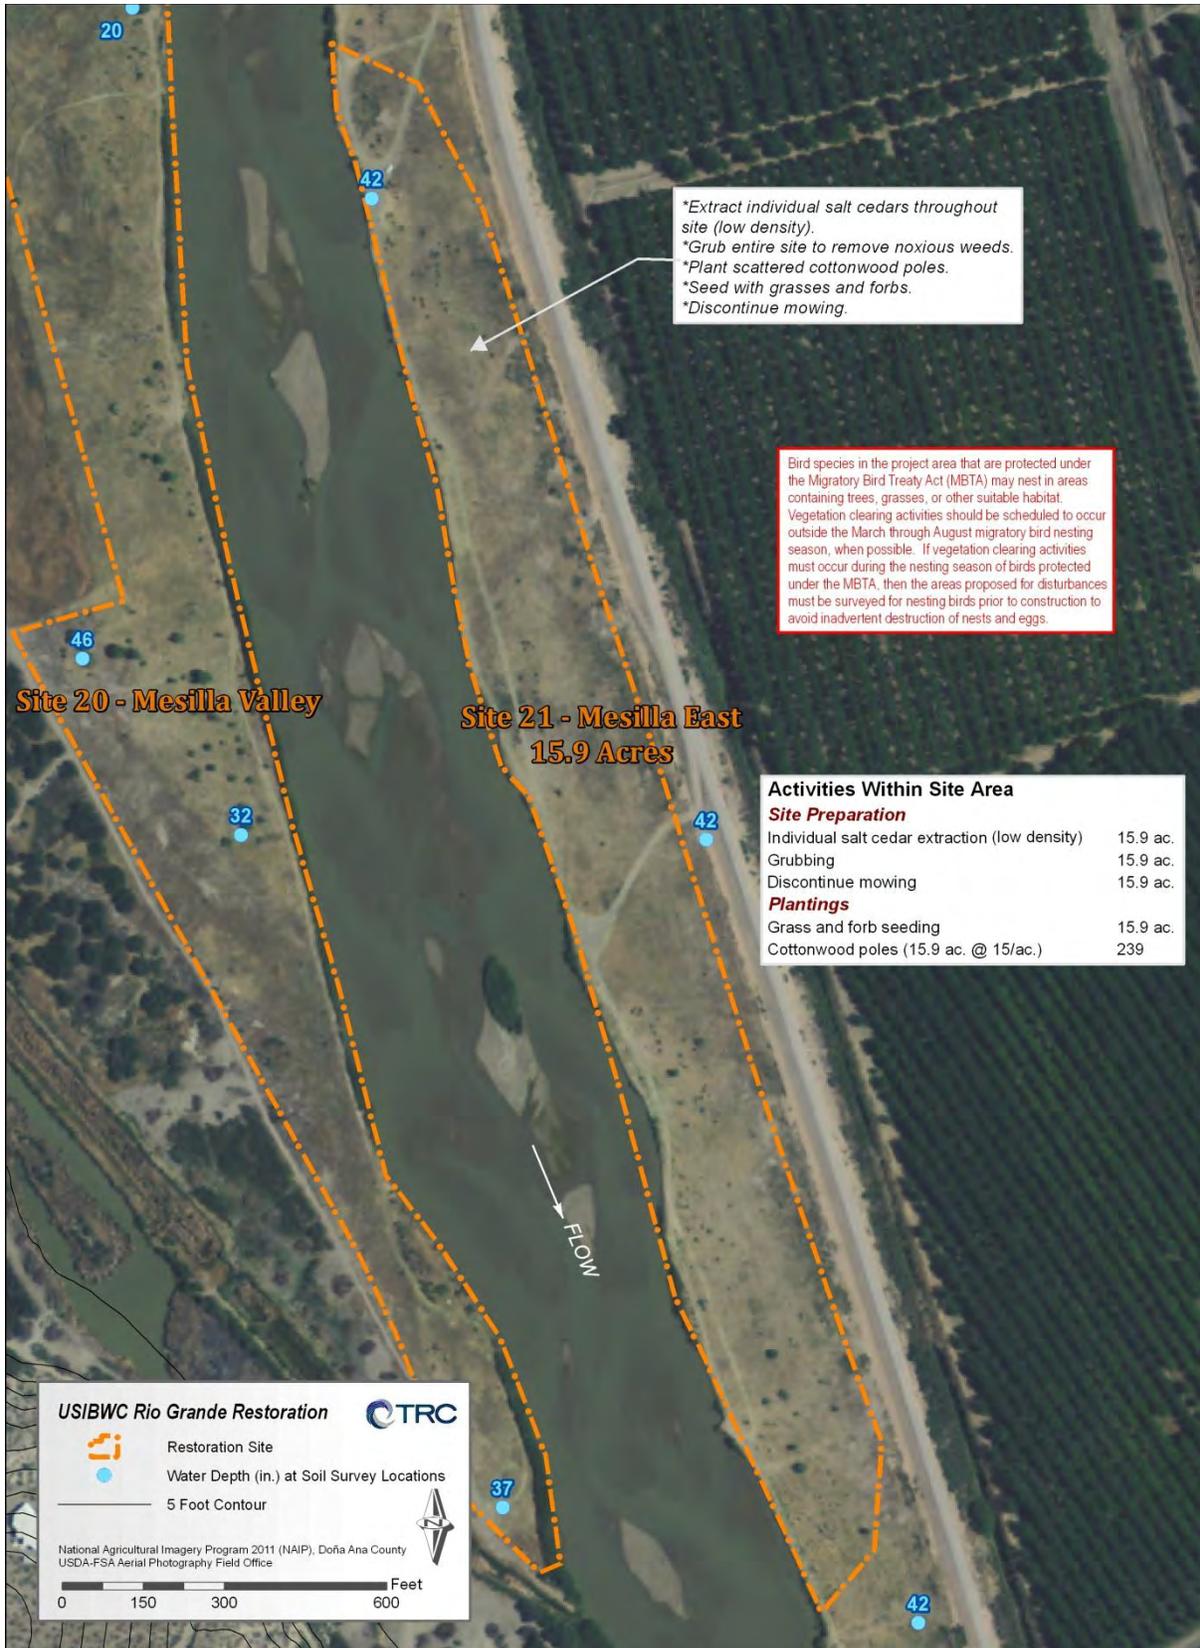
Site 21 – Mesilla East

\*Extract individual salt cedars throughout site (low density).  
 \*Grub entire site to remove noxious weeds.  
 \*Plant scattered cottonwood poles.  
 \*Seed with grasses and forbs.  
 \*Discontinue mowing.

Bird species in the project area that are protected under the Migratory Bird Treaty Act (MBTA) may nest in areas containing trees, grasses, or other suitable habitat. Vegetation clearing activities should be scheduled to occur outside the March through August migratory bird nesting season, when possible. If vegetation clearing activities must occur during the nesting season of birds protected under the MBTA, then the areas proposed for disturbances must be surveyed for nesting birds prior to construction to avoid inadvertent destruction of nests and eggs.
