# DEVELOPMENT OF ALTERNATIVES FOR CANUTILLO FLOOD CONTROL IMPROVEMENTS

# **RIO GRANDE CANALIZATION PROJECT**

# **VOLUME 1**

February 2007

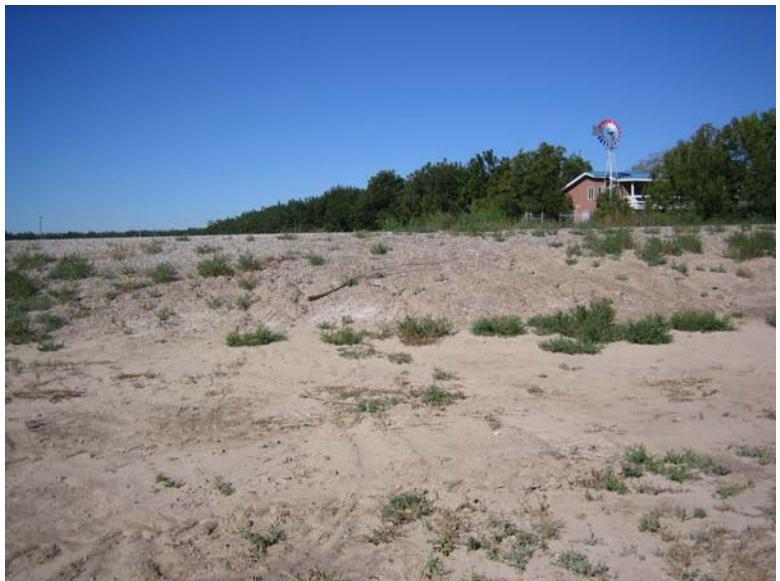
The west levee is an earthen structure, and the top of levee is generally 6 to 7 feet above natural ground. Although very minor rills were observed, the levee was in very good condition. The top is approximately 14-feet wide and has a gravel maintenance road throughout in good condition.

West Levee Downstream of Canutillo Bridge

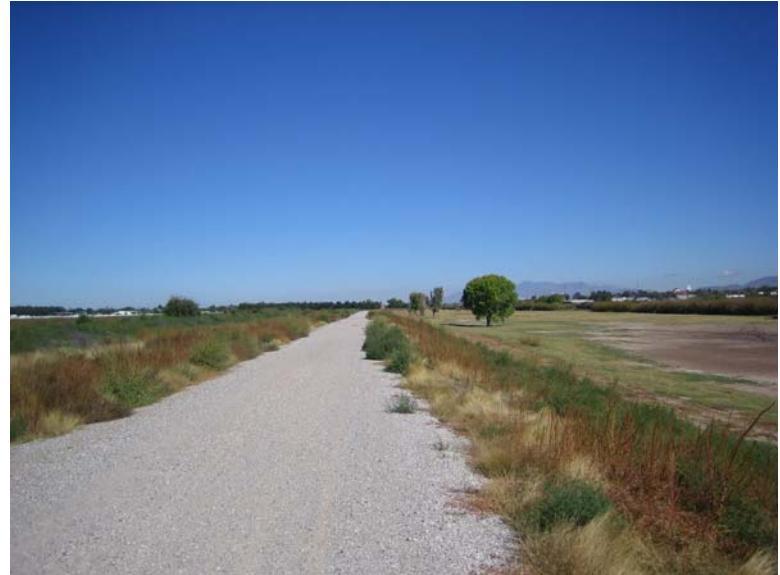
A park is located between the west levee and west bank of the Rio Grande. The park includes a sidewalk and aesthetic stone fencing. The sidewalk is adjacent to the levee near the intersections of Borderland Road and FM 259. Raising the levee at these locations may require slope paving or a retaining wall to maintain the condition of the sidewalk. Farm land adjacent to the west levee is irrigated and the pump station for the Canutillo Lateral is located adjacent to the levee approximately 2,800 feet north of Borderland Road. An open drainage ditch is observed 2,600 feet north of the pump station. This outfall crosses the levee with a pipe culvert which will need to be extended if the levee is raised. Elevating the levee profile at its current horizontal alignment appears to be the best option for flood control.

West Levee Gravel Roadway

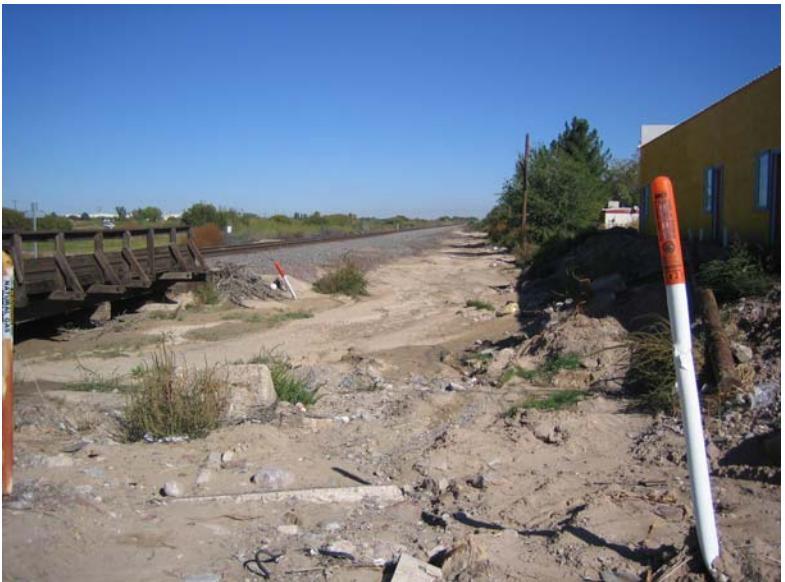
The east levee is an earthen berm from the southern limits of the study area to Borderland Road, and it is in excellent condition. The railroad serves as the east levee from approximately 680 feet north of Borderland Rd. to the northern limit of the study area. The east levee from Borderland Rd. to the railroad is an existing maintenance road within IBWC property. It appears that the berm serves as a levee, but the 2005 study does not indicate a levee at this location.

Railroad (East Levee) at Canutillo Bridge
