# ARROYO COLORADO AT HARLINGEN FLOOD FLOW IMPROVEMENT PROJECT

## CAMERON COUNTY, TEXAS

## FINAL ENVIRONMENTAL ASSESSMENT AND FINDING OF NO SIGNIFICANT IMPACT

**Report Designation**: Final Environmental Assessment (EA)

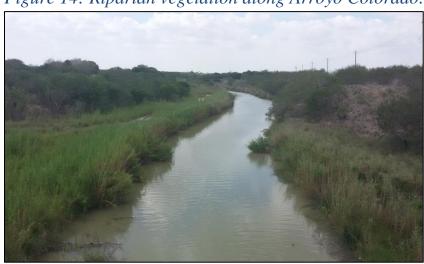
**Figure 14** shows riparian vegetation along Arroyo Colorado, as seen from the FM 509 bridge looking west (upstream). The low terraces in this area are dominated by common reed, and higher elevations are dominated by woody species.

Figure 14: Riparian vegetation along Arroyo Colorado.

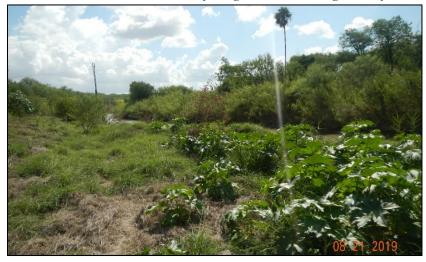
Figure 15: Herbaceous and woody vegetation along Arroyo Colorado.

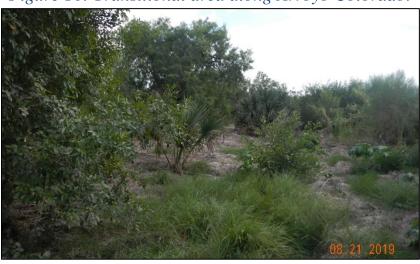
**Figure 16** shows a transitional area between three vegetation types. In the foreground to the right, grasses and other herbaceous species dominate. In the left of frame, woody species typical of riparian areas dominate, and in the background right of frame, woody species are transitioning to species typical of upland areas.

Figure 16: Transitional area along Arroyo Colorado.
